# Initial Regulated Building Material Survey

**Irving R. Newhouse Senate Building  
215 Sid Snyder Avenue SW  
Olympia, WA 98504**

**Report Date: 01/28/2022**  
**PacRim#: 17283**

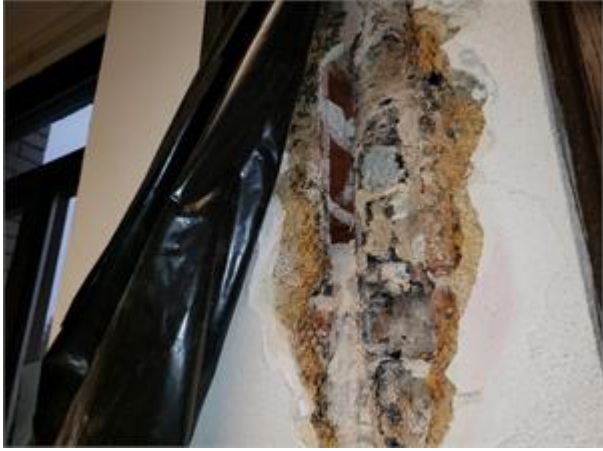
Sample			Sample Date	05-Jan-2022
<b>Project Name</b>	Irving R. Newhouse Senate Building			
<b>Sample Type</b>	Physical Sample	<b>AHERA Category</b>	TSI	
<b>Sample Number</b>	02	<b>Homogenous Material Number</b>	2	
<b>Material Description</b>	Pipe Insulation			
<b>Homogenous Mtl Area</b>	N/A			
<b>Sample Location</b>	Rm 212, West wall.			
<b>Quantity</b>	8	<b>Unit of Measure</b>	Lineal Feet	
<b>Asbestos Type/%</b>	<b>Chrysotile 60-65%</b>			
<b>Sample Photo</b>

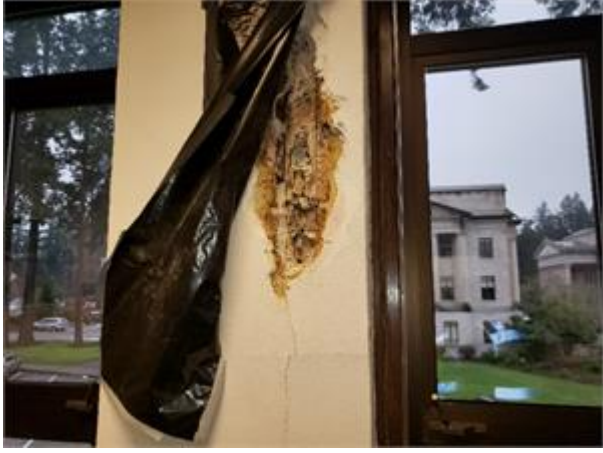
Sample		Sample Date	05-Jan-2022
<b>Project Name</b>	Irving R. Newhouse Senate Building		
<b>Sample Type</b>	Physical Sample	<b>AHERA Category</b>	TSI
<b>Sample Number</b>	04	<b>Homogenous Material Number</b>	2
<b>Material Description</b>	Pipe Insulation		
<b>Homogenous Mtl Area</b>	N/A		
<b>Sample Location</b>	Rm 212		
<b>Quantity</b>	8	<b>Unit of Measure</b>	Lineal Feet
<b>Asbestos Type/%</b>	<b>Chrysotile 50-55%</b>		
<b>Sample Photo</b>

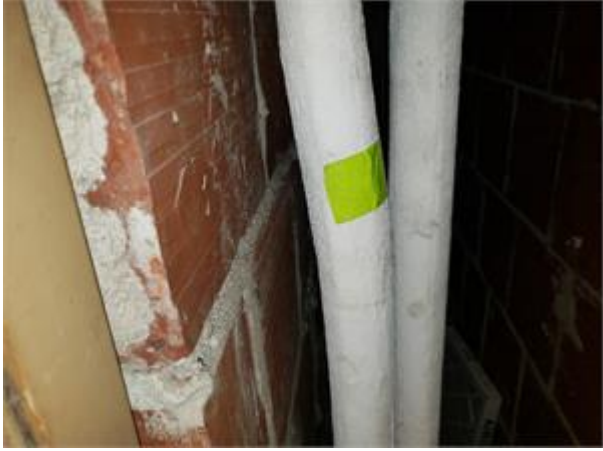
Sample		Sample Date	05-Jan-2022
<b>Project Name</b>	Irving R. Newhouse Senate Building		
<b>Sample Type</b>	Physical Sample	<b>AHERA Category</b>	TSI
<b>Sample Number</b>	10	<b>Homogenous Material Number</b>	8
<b>Material Description</b>	Pipe Fitting Insulation		
<b>Homogenous Mtl Area</b>	N/A		
<b>Sample Location</b>	2nd floor, janitorial closet		
<b>Quantity</b>	20	<b>Unit of Measure</b>	Lineal Feet
<b>Asbestos Type/%</b>	<b>Chrysotile 7-10%</b>		
<b>Sample Photo</b>

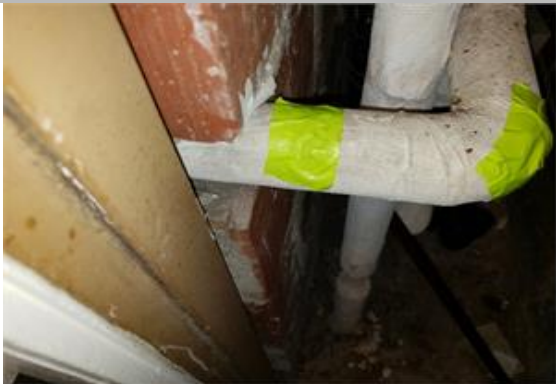
Sample		Sample Date	05-Jan-2022
<b>Project Name</b>	Irving R. Newhouse Senate Building		
<b>Sample Type</b>	Physical Sample	<b>AHERA Category</b>	TSI
<b>Sample Number</b>	12	<b>Homogenous Material Number</b>	8
<b>Material Description</b>	Pipe Fitting Insulation		
<b>Homogenous Mtl Area</b>	N/A		
<b>Sample Location</b>	2nd floor, janitorial closet.		
<b>Quantity</b>	See 10	<b>Unit of Measure</b>	Each
<b>Asbestos Type/%</b>	<b>Layer 1: (Painted wrap) None Detected</b> <b>Layer 2: (White insulation) <span style="color: red;">Chrysotile 5-7%</span></b>		
<b>Sample Photo</b>

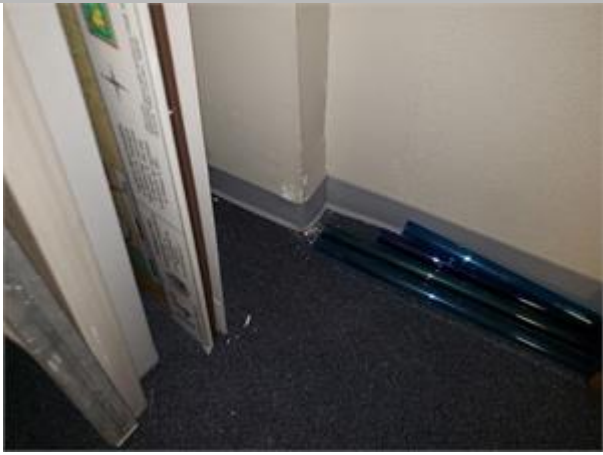
Sample			Sample Date	05-Jan-2022
<b>Project Name</b>	Irving R. Newhouse Senate Building			
<b>Sample Type</b>	Physical Sample	<b>AHERA Category</b>	TSI	
<b>Sample Number</b>	18	<b>Homogenous Material Number</b>	8	
<b>Material Description</b>	Pipe Fitting Insulation			
<b>Homogenous Mtl Area</b>	N/A			
<b>Sample Location</b>	2nd floor, at women's bathroom, pipe chase.			
<b>Quantity</b>	6	<b>Unit of Measure</b>	Each	
<b>Asbestos Type/%</b>	<b>Chrysotile 5-7%</b>			
<b>Sample Photo</b>

<b>Field Sample Number:</b> <u>18</u>	<b>Field Sample Description:</b>	<b>Field Sample Location:</b>	<b>Analyst:</b> WFG
<b>Lab ID:</b> 2022-01-0171	Pipe Fitting Insulation	2nd floor, at women's bathroom, pipe chase.	<b>Analysis Date:</b> 1/12/2022
<b>Lab Sample Description</b>	<b>Asbestos Type/%</b>	<b>Non-Asbestos Fibers</b>	<b>Non-Fibrous Materials</b>
Off-white to light grey, chalky, rust-stained insulation material with embedded fibers	<b>Chrysotile 5-7%</b>	Cellulose <1%	Mineral Aggregate, Binder, Diatomaceous Earth

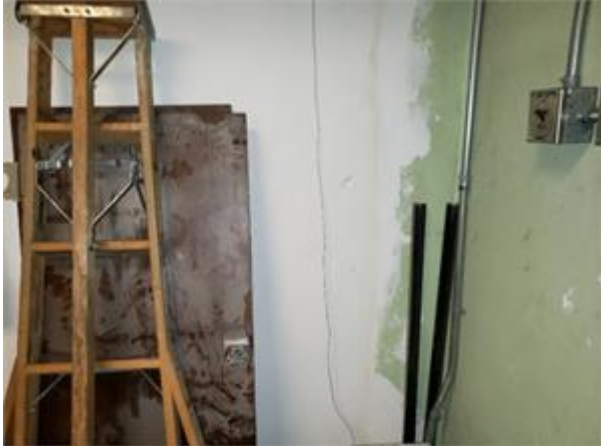
Sample		Sample Date	05-Jan-2022
<b>Project Name</b>	Irving R. Newhouse Senate Building		
<b>Sample Type</b>	Physical Sample	<b>AHERA Category</b>	Surfacing
<b>Sample Number</b>	35	<b>Homogenous Material Number</b>	3
<b>Material Description</b>	Hard Plaster Walls and Ceilings		
<b>Homogenous Mtl Area</b>	N/A		
<b>Sample Location</b>	Basement, in mechanical room, south wall.		
<b>Quantity</b>	190	<b>Unit of Measure</b>	Square Feet
<b>Asbestos Type/%</b>	<b>Layer 1: (Painted plaster) None Detected</b> <b>Layer 2: (Lt grn/wht plaster) Chrysotile &lt;1%</b>		
<b>Sample Photo</b>

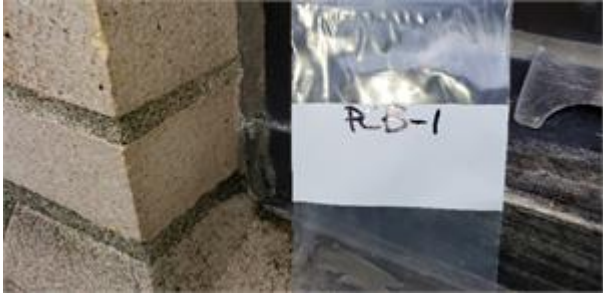
Sample			
<b>Project Name</b>	Irving R. Newhouse Senate Building		
<b>Sample Date</b>	05-Jan-2022		
<b>Sample Type</b>	Solid		
<b>Sample Number</b>	02		
<b>Material Description</b>	Window sealant		
<b>Sample Location</b>	Back of building Floor 1		
<b>PCB Result</b>	Aroclor 1254 – <b>1.3 mg/kg</b>		
<b>Sample Photo</b>
