HISTORIC STRUCTURE REPORT

LOUISE HANSON DUPLEX

1417-1419 COLUMBIA STREET SOUTHWEST  
OLYMPIA, WASHINGTON

JUNE 15, 2011

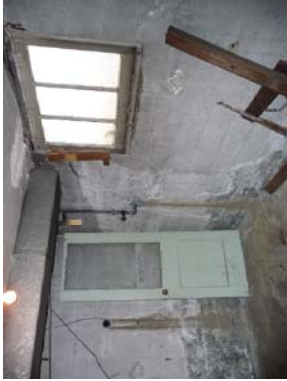
CHARACTER DEFINING FEATURES	LOCATION/QUANTITY	MODIFICATION	CONDITION	IMAGE
Cast-In-Place Concrete Foundation, Concrete slab.	All of foundation.	None.	Good condition, w/ isolated cases of efflorescence along the base of the wall.

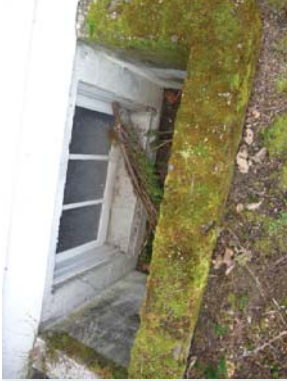
Window Wells	(2) on the East Elevation, (1) at the North Elevation	None.	Biological growth along the top.

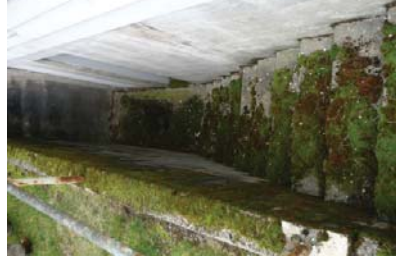
Concrete Entry Platform/Concrete Stairs	Concrete Slab at each of the (4) Entries/Concrete Stairs to Basement	None.	The concrete entry platforms are in good condition, with some biological growth. The stairs to the Basement exhibit extreme biological growth. Steps at the south elevation are settling.

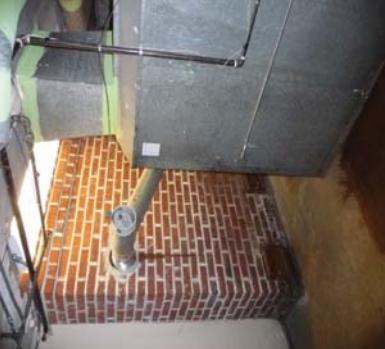
CHARACTER DEFINING FEATURES	LOCATION/QUANTITY	MODIFICATION	CONDITION	IMAGE
Masonry Chimney	At Chimney.	In 1998 the chimney was removed to the attic. A metal flue was added to vent the furnace.	Good condition where visible.

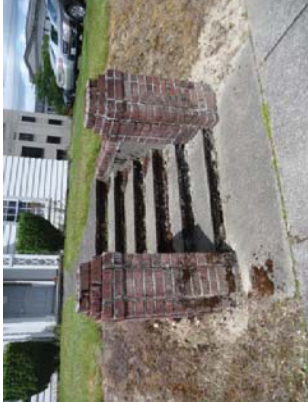
<p data-bbox="727 531 751 741">Chimney in Basement</p>
Masonry Light Fixture Base	At east entry	Light fixtures removed.	Poor condition, needs to be repointed and missing brick to be replaced.

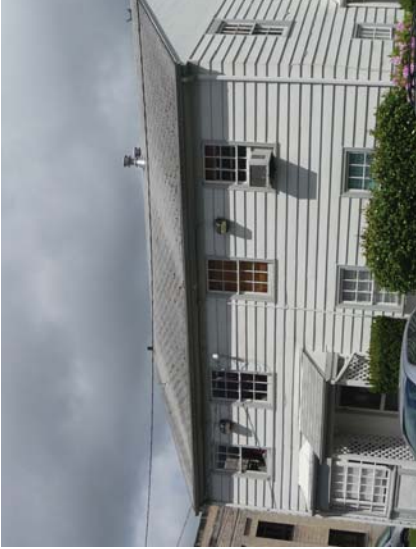
CHARACTER DEFINING FEATURES	LOCATION/QUANTITY	MODIFICATION	CONDITION	IMAGE
Composite Roof, Sheet Metal Gutters and Downspouts	All of exterior of the building.	Original roofing material was replaced with a composite roof and sheet metal gutters and downspouts in 1998.	Needs to be replaced.

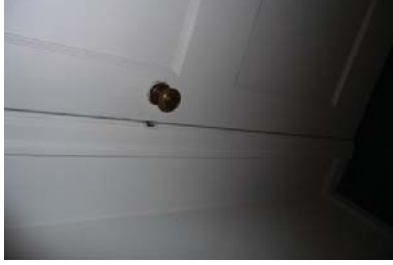
The doors are in good condition. It would be preferable to remove the flush panel wood doors and replace with doors that match the historic, as well door hardware that is more in keeping with the historical hardware.

Historic recessed panel door/original brass hardware

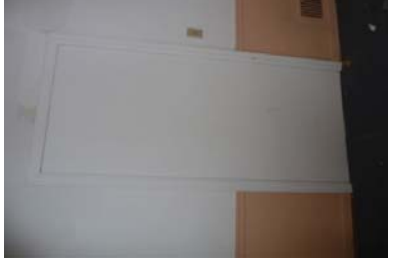
Contemporary flush wood door

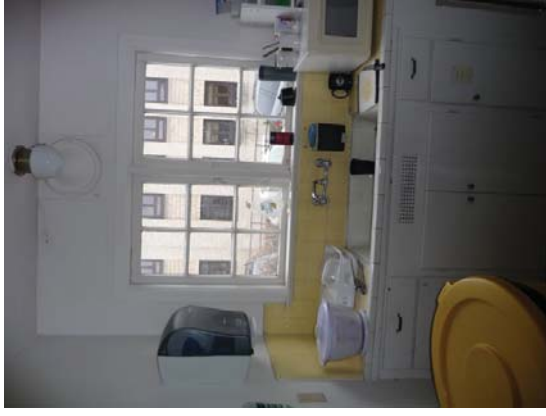
CHARACTER DEFINING FEATURES	LOCATION/QUANTITY	MODIFICATION	CONDITION	IMAGE
Built-in Cabinets	Wood cabinets and drawers at South Unit kitchen and at closets. Removed at North Unit kitchen.	Without historic plans, it is unclear if there were any built-ins that were removed. Those built-ins that are visible have been minimally modified.	Fair. Many of the knobs are missing and the cabinets and drawers do not shut properly.

<p data-bbox="889 583 914 751">Kitchen built-ins</p>

- Refinish the floors
- Reveal plaster ceilings that have been covered
- Replace non-historic doors with new recessed panel doors to match the historic configuration
- Install new cabinetry/door hardware to match the historic elements
- Rehabilitate cabinetry doors to operable condition and provide more appropriate light fixtures.

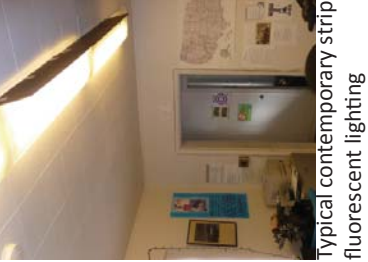
CHARACTER DEFINING FEATURES	LOCATION/QUANTITY	MODIFICATION	CONDITION	IMAGE
Light Fixtures	<p><u>Interior:</u> 1st and 2nd Floors: Strip fluorescent lighting at offices, with some historic pendant mounted fixtures in common areas, wall hung sconces at the bathrooms and (1) suspended fixture at the North Unit stair landing.</p> <p><u>Exterior:</u> <b>East</b> (1) original ceiling mounted at front entry <b>North</b> (1) original ceiling mounted at front entry (2) wall-mounted flood lights <b>South</b> (1) original ceiling mounted at front entry (2) wall-mounted flood lights <b>West</b> (1) original ceiling mounted at front entry (1) wall-mounted flood lights</p>	<p>Many of the original fixtures have been re-moved in the common areas. The suspended fixture in the stair landing has had the glass-shade removed, as has the wall-hung fixture at stairs.</p>	<p>Fair. Missing shades should be replaced. Historic light fixtures should be refurbished, including cleaning paint off of the historic canopies where they have been overpainted.</p>

<p>Typical contemporary strip fluorescent lighting</p>
