ASBESTOS SURVEY REPORT

STATE OF WASHINGTON
DEPARTMENT OF GENERAL ADMINISTRATION
OLYMPIA, WASHINGTON

SHUMAKER BUILDING (# 94)

E&AS Project #94-260

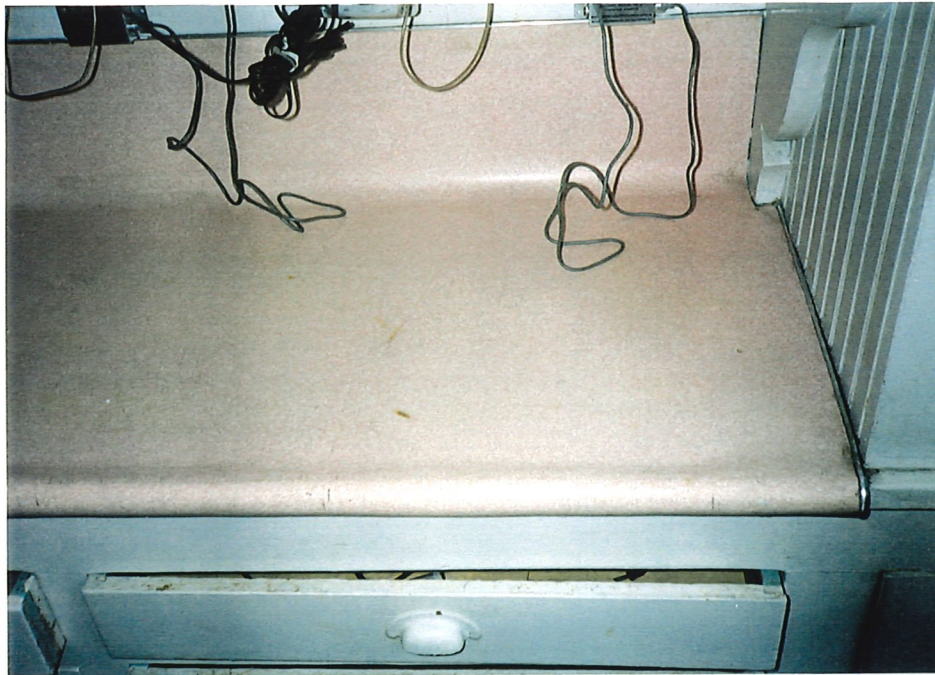
Pink sheet floor covering (Type 2) located on the kitchen counter tested positive for asbestos. The asbestos is located in the friable felt backing. This material is in good condition and is of low concern unless damaged by cutting, tearing, etc.

The material presents a relatively low concern in its current condition. Avoid activities that may impact this material. +/- 15 SF of pink sheet floor covering with asbestos-containing felt backing noted in good condition. See floor plans (Tab 2, Section 2) for material locations.

A: ASBESTOS-CONTAINING SHEET VINYL;
KITCHEN COUNTER.

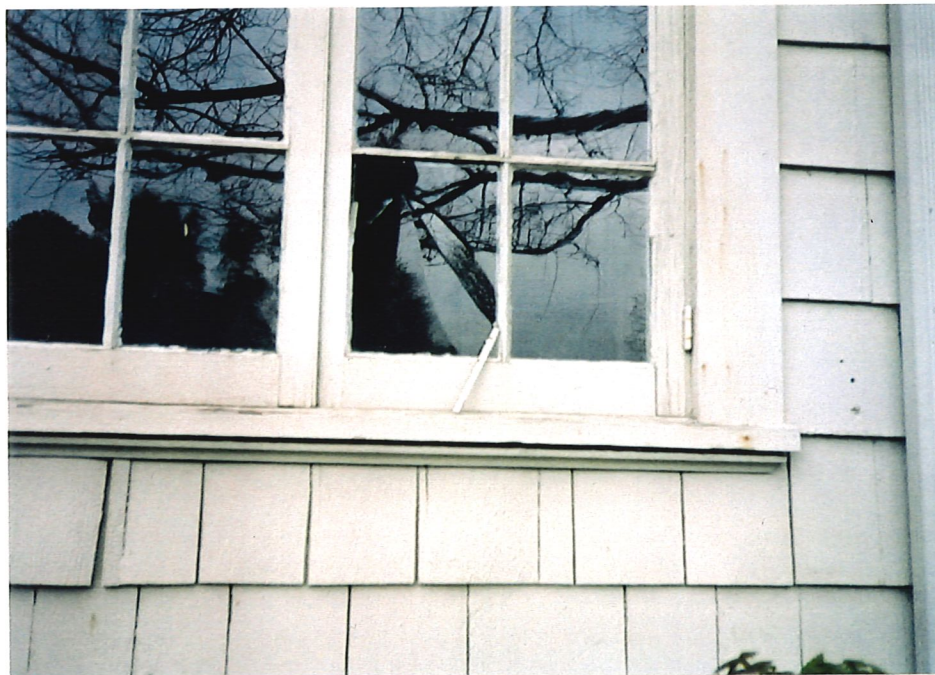
Window putty located on the exterior windows tested positive for asbestos. This gray pliable material is in good condition and is of low concern.

Gray glazing compound on edges of window frames found to be predominantly in good condition.

B: ASBESTOS-CONTAINING WINDOW PUTTY;
EXTERIOR WINDOW.

Maintain material in good condition and routinely apply thick coat of encapsulant (e.g. paint) as needed.
