Pre-Renovation Limited Hazardous Building Materials Survey Report

Washington Center for Deaf and Hard of Hearing Youth (CDHY)
Northrop Hall
611 Grand Boulevard
Vancouver, Washington 98661

September 2022

PBS Project 25570.006, Phase 0001

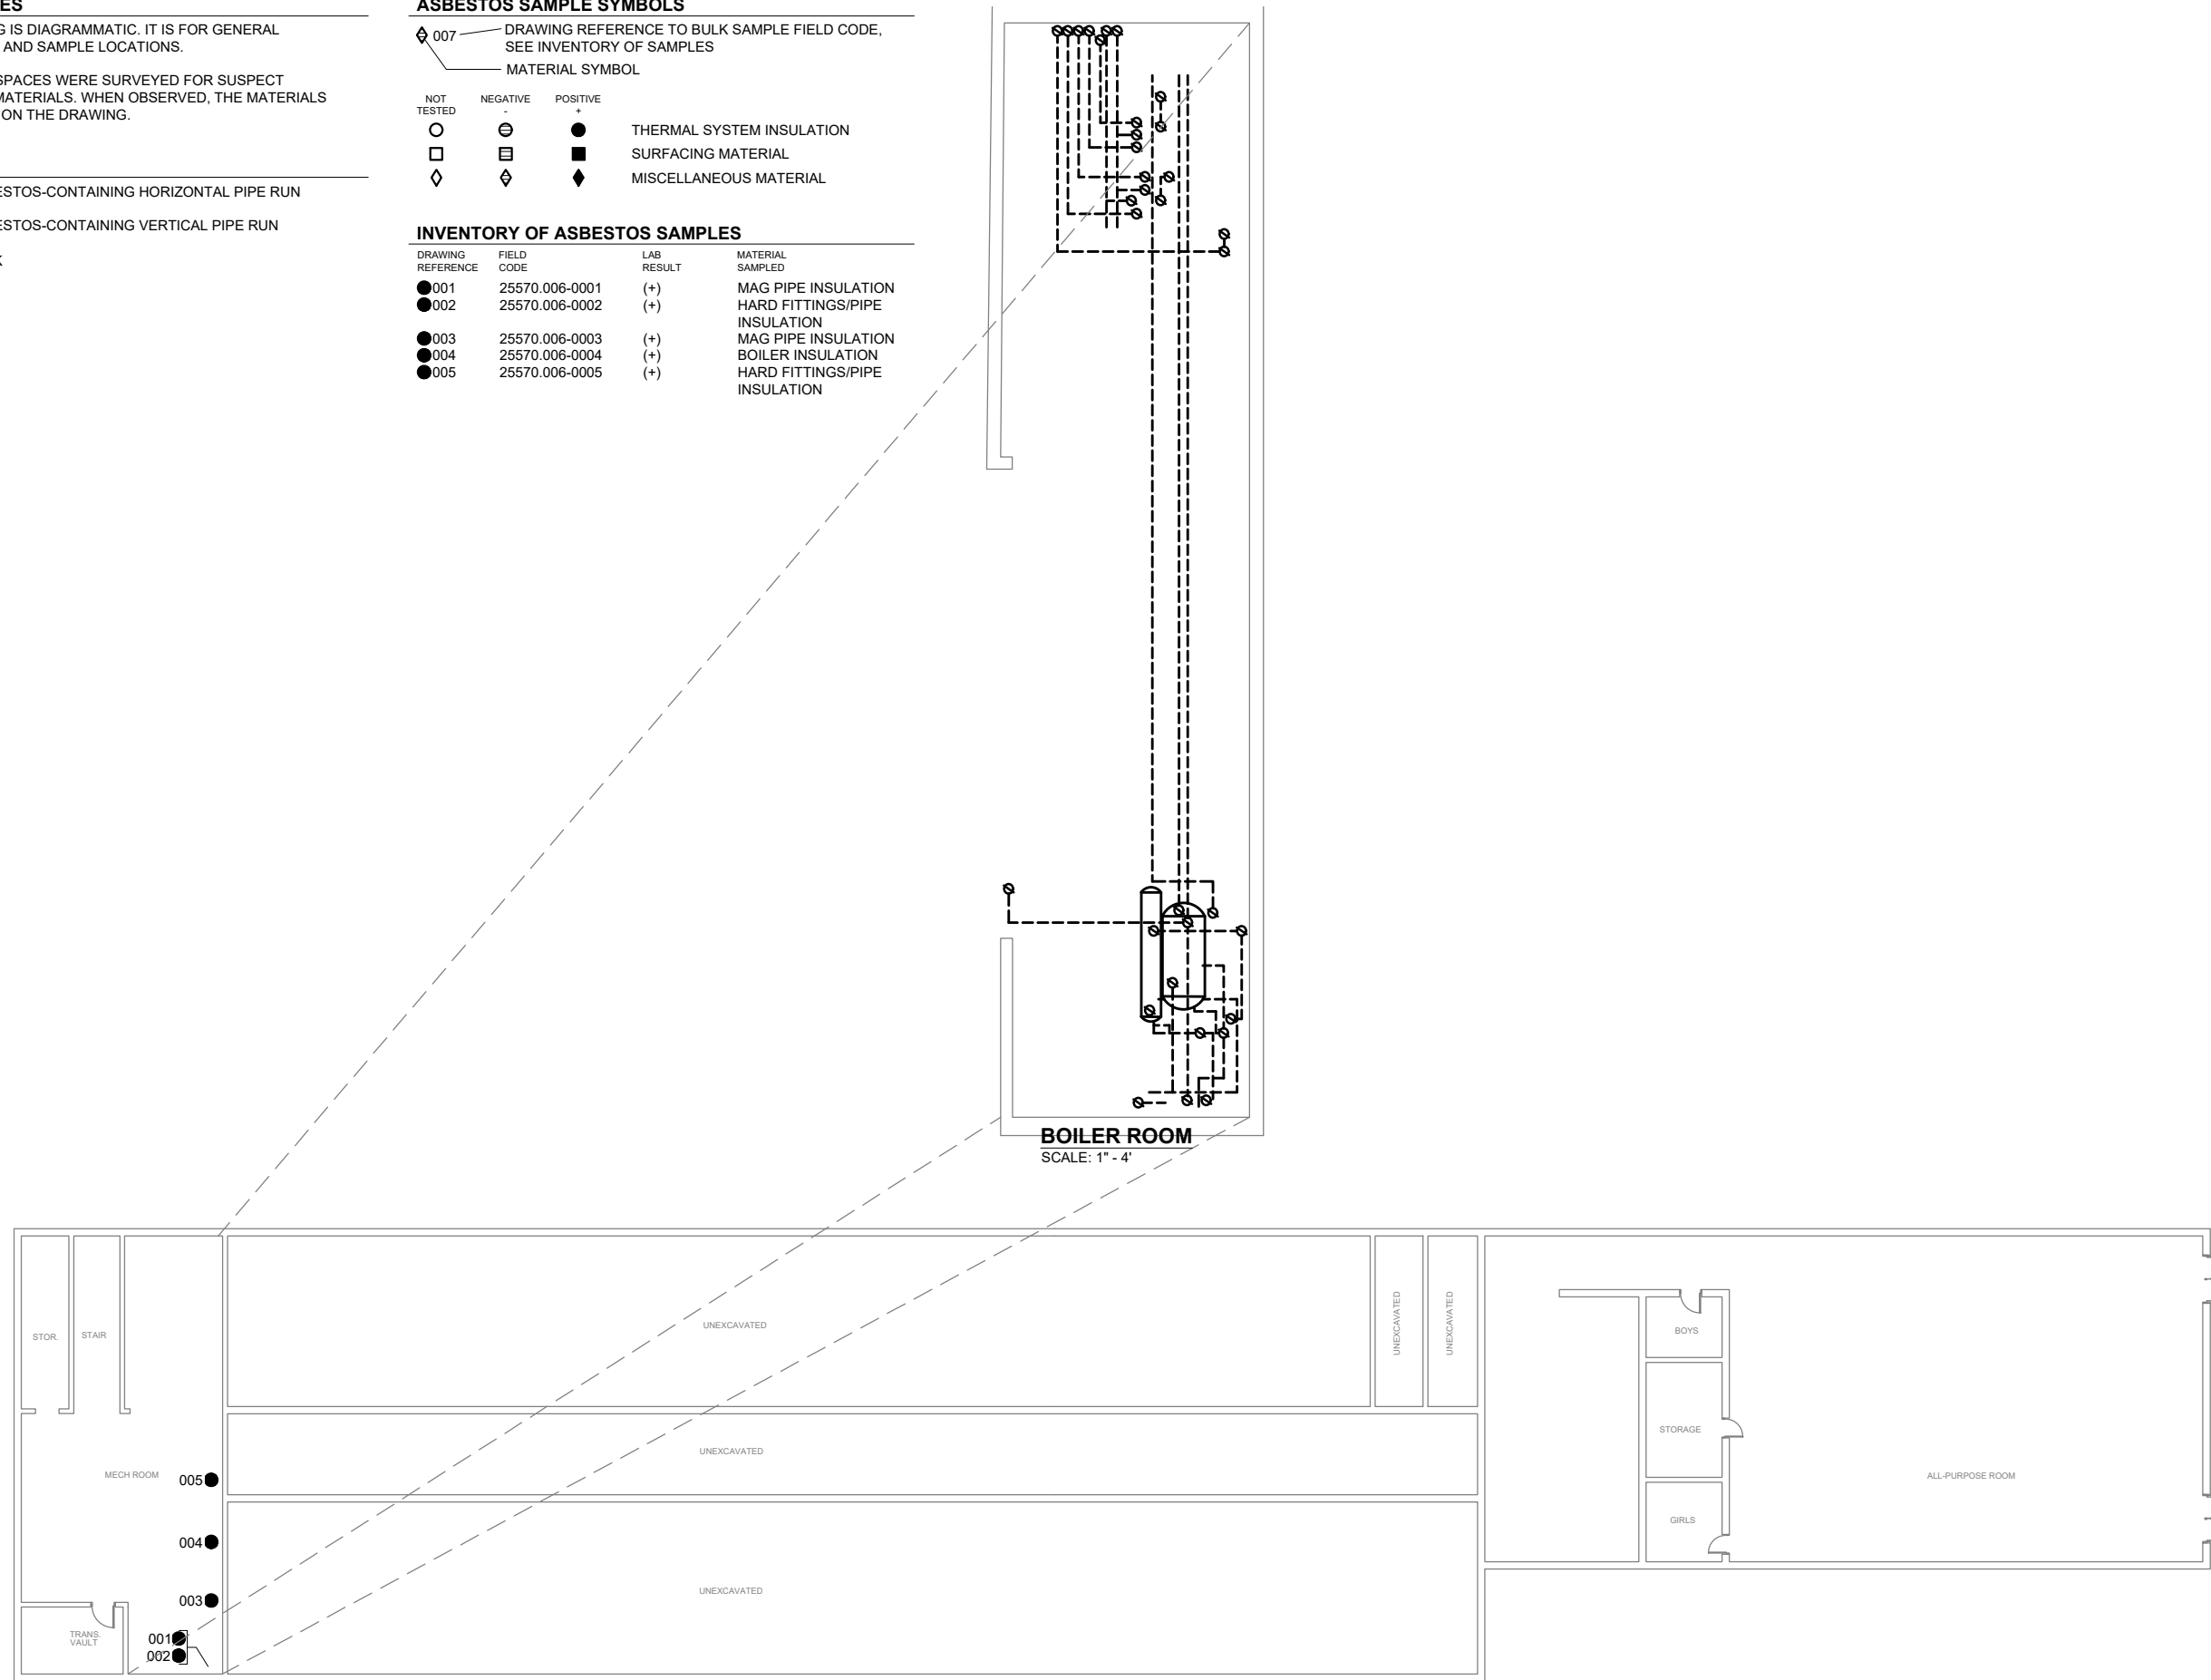
BASEMENT

DRAWING REFERENCE	FIELD CODE	LAB RESULT	MATERIAL SAMPLED
●001	25570.006-0001	(+)	MAG PIPE INSULATION
●002	25570.006-0002	(+)	HARD FITTINGS/PIPE INSULATION
●003	25570.006-0003	(+)	MAG PIPE INSULATION
●004	25570.006-0004	(+)	BOILER INSULATION
●005	25570.006-0005	(+)	HARD FITTINGS/PIPE INSULATION

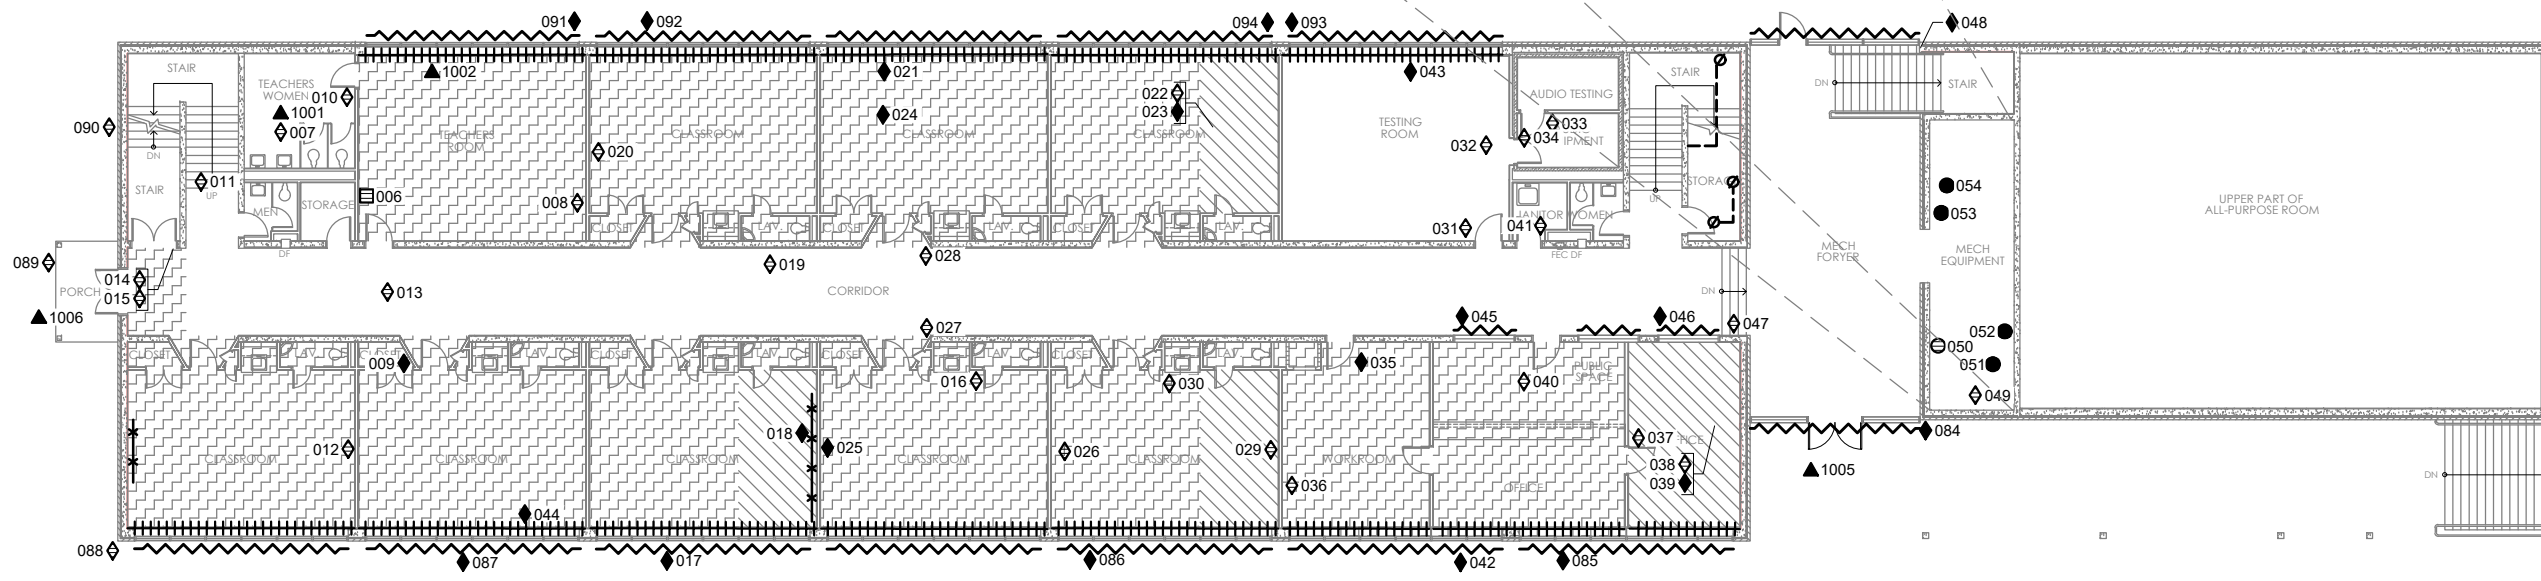
SAMPLE NUMBER	FIELD CODE	LAB RESULT (ppm)	MATERIAL DESCRIPTION
▲1001	25570.006-1001	3,120	PAINT ON TEACHERS ROOM 108; STAFF RESTROOM, CEILING, GYPSUM, LIGHT TAN, DAMAGED CONDITION
▲1002	25570.006-1002	161	PAINT ON TEACHERS ROOM 108; EAST SIDE RADIATOR PANEL, METAL, BEIGE, DAMAGED CONDITION
▲1005	25570.006-1005	3,940	PAINT ON FIRST FLOOR WEST MAIN ENTRY; EXTERIOR OVERHANG, WOOD, EGG-SHELL, DAMAGED CONDITION
▲1006	25570.006-1006	108	PAINT ON FIRST FLOOR; NORTH EXTERIOR ENTRY OVERHANG, METAL, EGG-SHELL, DAMAGED CONDITION
