Capitol Lake Dam/5th Ave Bridge, Olympia, WA UNDERWATER INSPECTION REPORT

June 22, 2007

OLYMPIA FIFTH AVENUE DAM
UNDERWATER INSPECTION

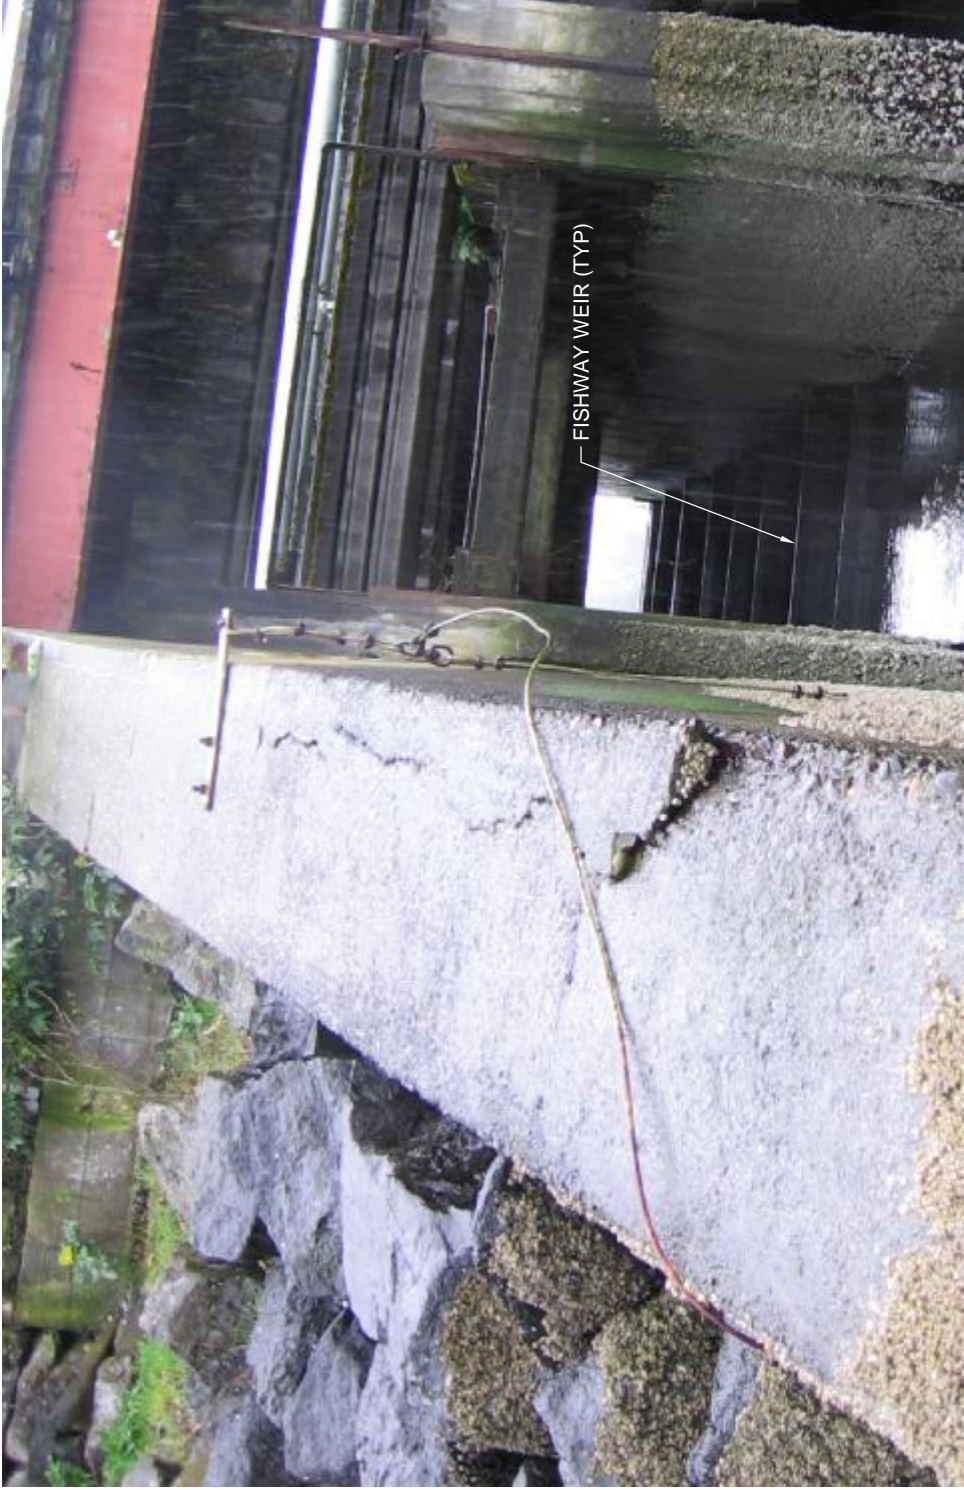
Photograph
1

CLOSED CORROSION SPALL

EAST DOWNSTREAM WING WALL

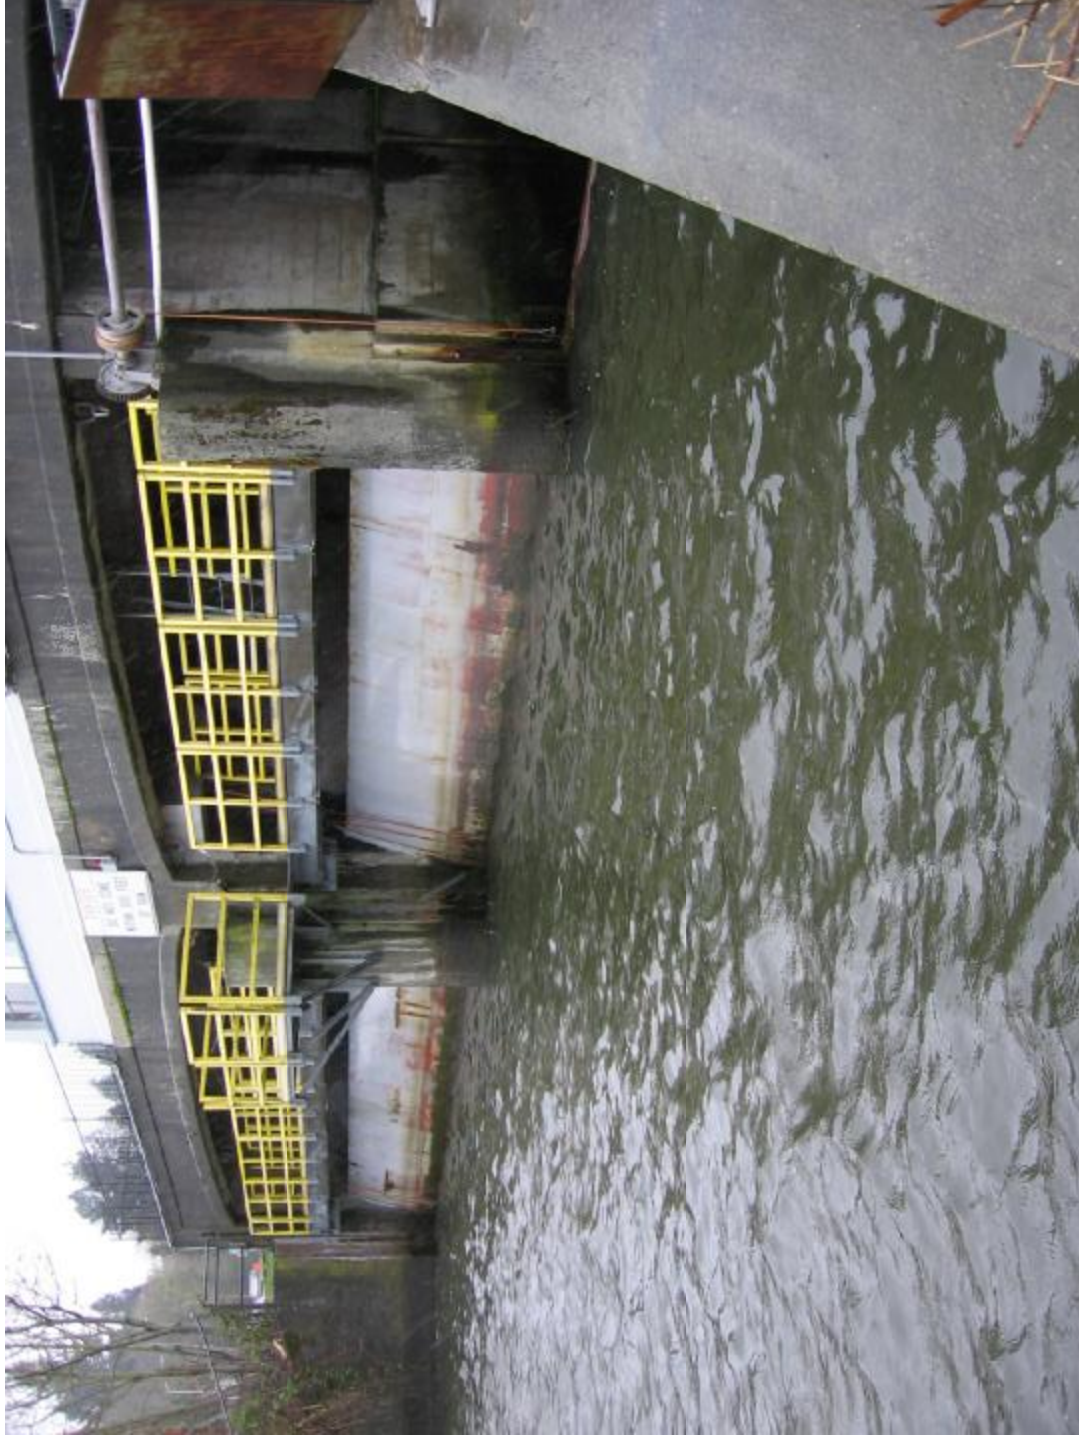
Photograph
2

LOOKING NORTH FROM CAPITOL LAKE

RADIAL ARM GATES

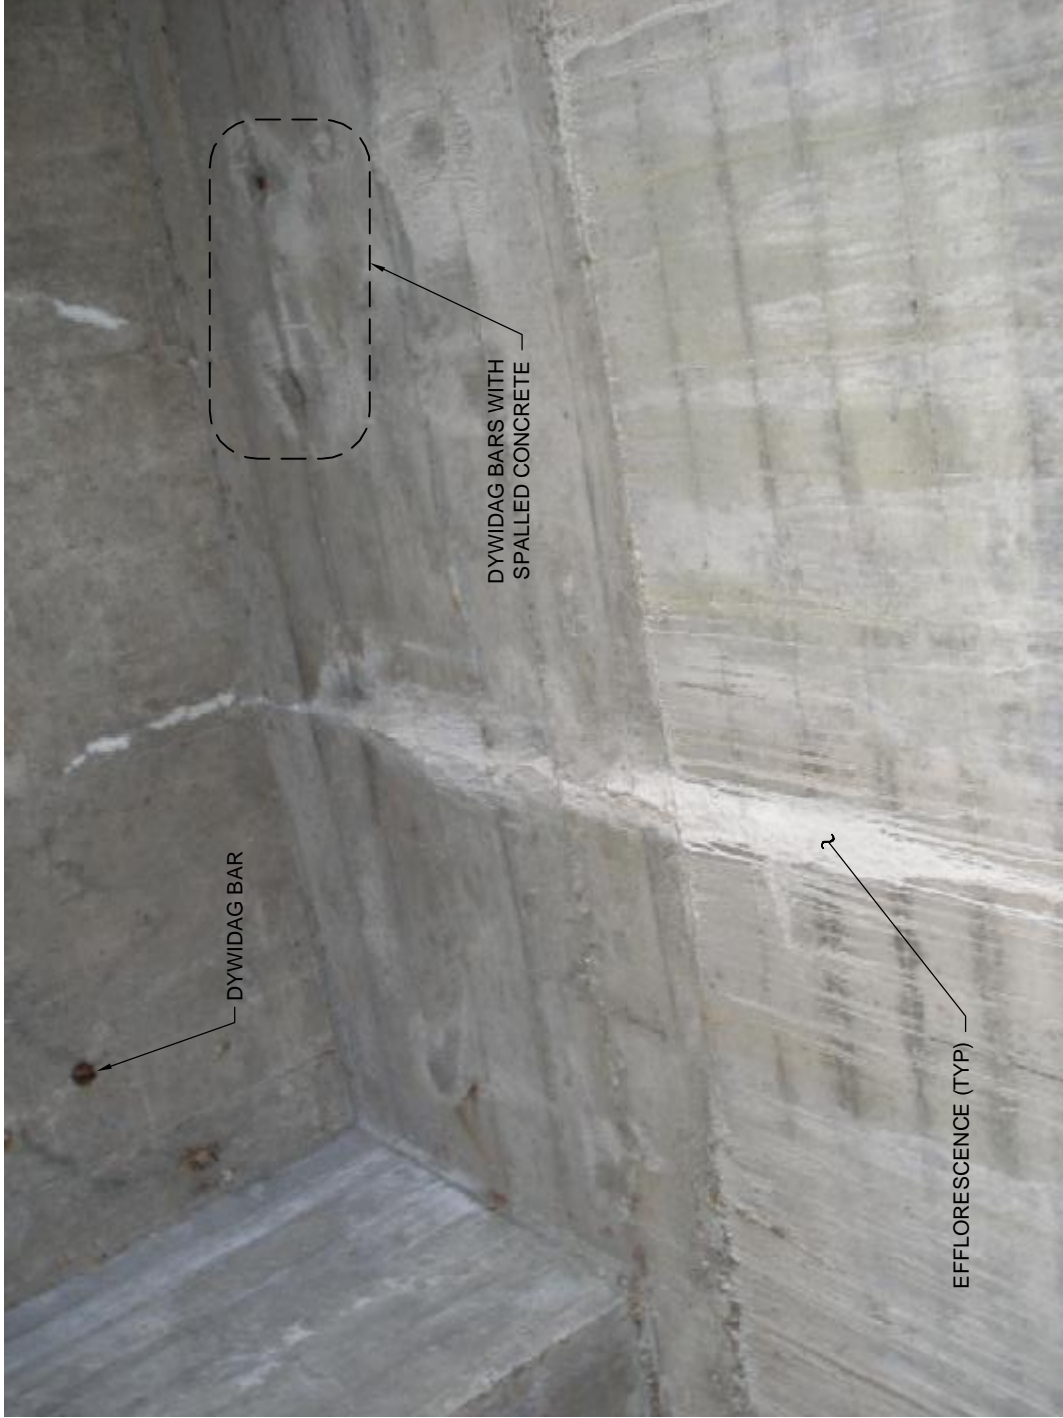
Photograph
3

EFFLORESCENCE AND DYWIDAG BARS

WEST ABUTMENT (DOWNSTREAM)

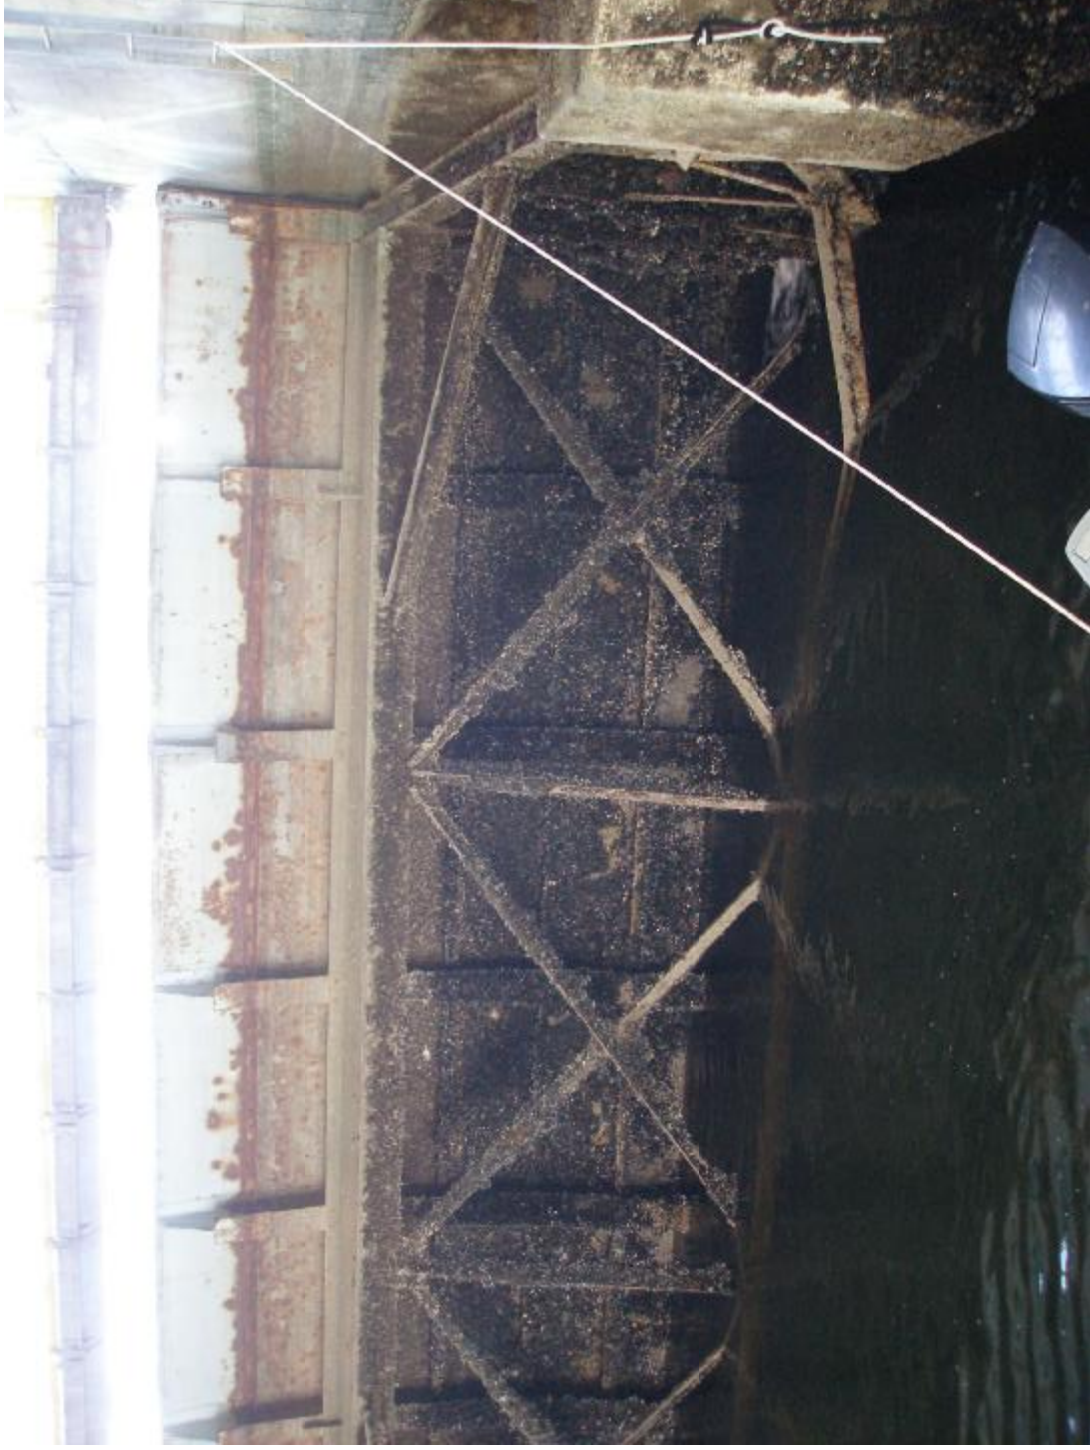
Photograph
4

LOOKING SOUTH

WEST RADIAL ARM GATE

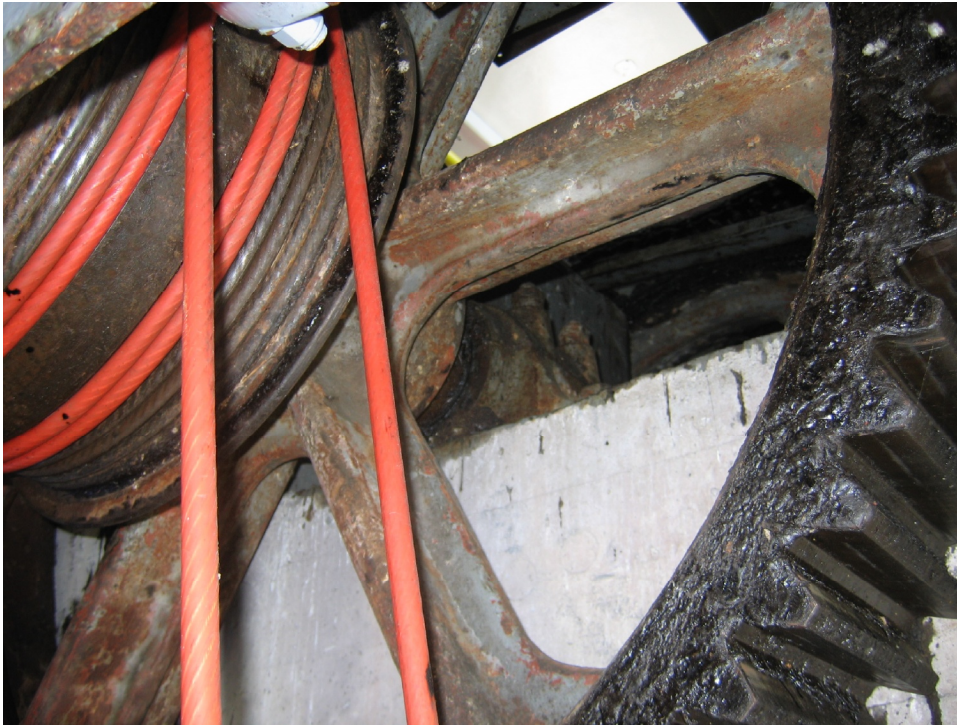
The wire rope drums are connected to an open spur gear set which is driven by a chain and sprocket arrangement. Based upon our limited inspection the gears for both gates appear to be in good condition. There is an absence of visible damage to the gear teeth (cracking or surface damage) or any excessive tooth wear. Gear alignment would appear to be good due to the absence of any appreciable rounding of the gear teeth or evidence of undercutting. The drive chain is well lubricated and tensioned.

Figure 1
East Gate Drum and Bull Gear

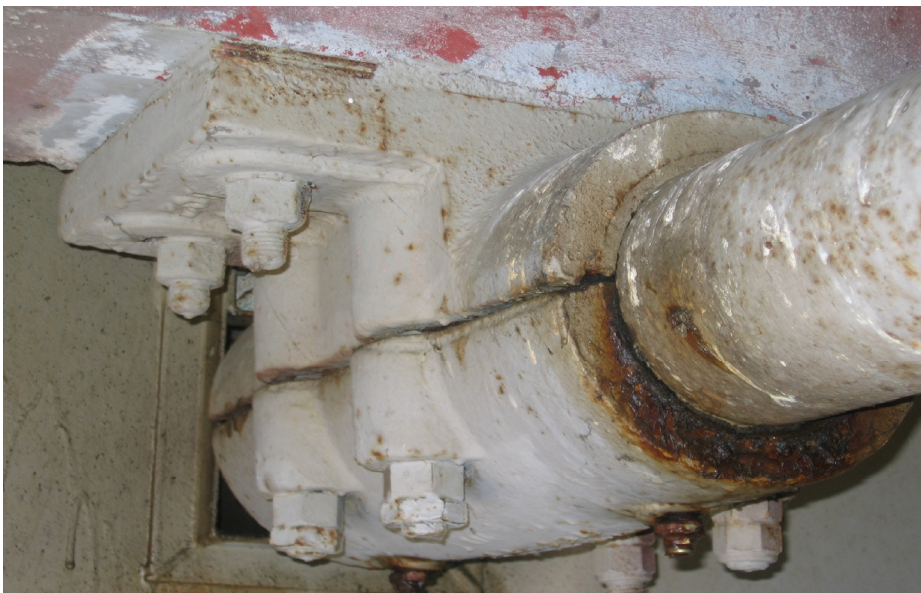
The radial gates are lifted by four plastic coated wire ropes, one pair at each end of the gate. The ropes are connected to the gates using an "equalizer" plate and pin. The equalizer ensures that the two ropes share the load equally. The ropes, rope terminators, and equalizer mounting hardware appear to have been recently replaced and are in very good condition. The ropes are stored on two grooved steel drums connected through a common shaft (see figure 1). The ropes are wound on the drums in a neat orderly fashion. We did not observe any evidence of damage to the wire ropes. Pillow block bearing assemblies support the shaft. All the shaft bearings are fitted with grease couplings for re-lubrication. For both gates the shaft bearings and drive shaft show the onset of corrosion. On the west gate a noisy bearing was identified at the far west end (see figure 2).

Figure 2
West Gate Pillow Block Bearing

The tide gate machinery is generally in good operational condition and appears to be receiving adequate preventative maintenance. There were no significant corrosion concerns identified with the machinery at this point in time. The hoisting wire ropes should be inspected on a 6 month interval by a qualified technician experienced with hoisting equipment. Wire rope damage can be difficult to detect and inspection is further complicated by the rope plastic coating. The gearing and chain drive equipment should provide years of reliable service with periodic lubrication. Due to the age of the machinery we recommend inspection gears, sprockets, chain, and machinery shaft alignment on a 4 month interval. The shafts should be realignment if required. Shaft miss-alignment is a major contributor to premature bearing failure. The noisy shaft bearing on the west gate should be replaced immediately.

Based upon our brief inspection of the tide gates our assessment of the machinery and control system is generally most favorable. Although some of the equipment is quite old the equipment is well maintained and in good working condition with an absence of significant deterioration. With the exception of a noisy bearing and the addition of a backup EOT limit switch on the East Gate, we did not identify any component or system that is in critical need of attention. The pillow block shaft bearing on the west gate should be replaced immediately.

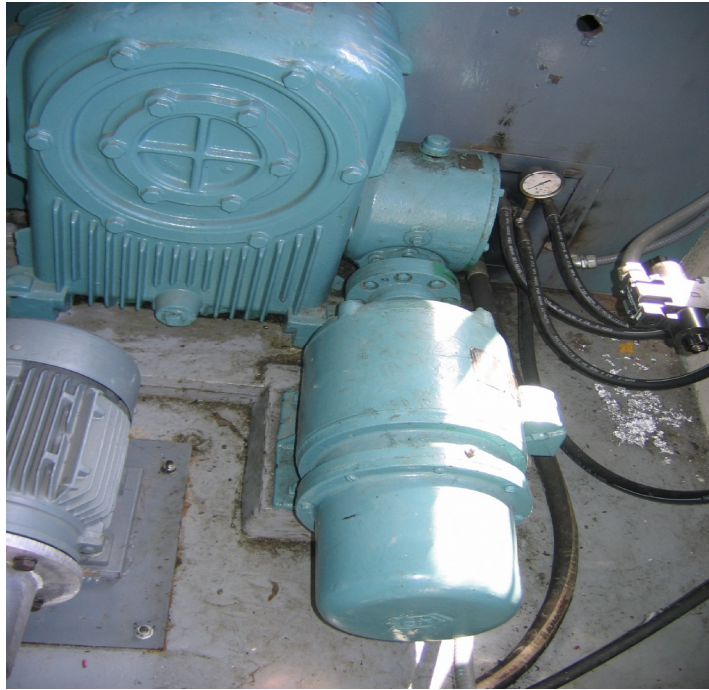
The drive sprockets are connected to a cone type gear reducer with a 625 to 1 gear ratio. The gear reducers do not exhibit any alarming noises or show any signs of leaking oil from the shaft seals. The east and west gate drive mechanisms still have their original gear reducers (see figure 3).

West Gate Motor: The West Tide Gate motor and brake combination appears to be part of the original installation and therefore is about 60 years old. Its operation appears to be satisfactory although testing the windings might prove otherwise. We feel this motor is past its useful and reliable life of about 50 years and is overdue for replacement.

Figure 3
West Gate Motor & Reducer

The east and west gate drive mechanisms still have their original gear reducers. Based on an estimated average of 2.5 opening/closing cycles per day, a 15 minute operation time per cycle and covering a 55 year period, these gear reducers have an estimated 25,000 hours of service. It is our opinion that the gear reducers are beginning to reach the limit of normal operating life for equipment of this type. Despite an absence of gear reducer damage we recommend a through inspection of both units. The reducers lubricating oil should be sampled and analyzed by a lab to possibly identify the presence of metal particles or other containments. We recommend consideration given to preemptively replacing the gear reducers based upon their age. The motor brakes on both gate motors should be inspected for wear on a 4 month interval.

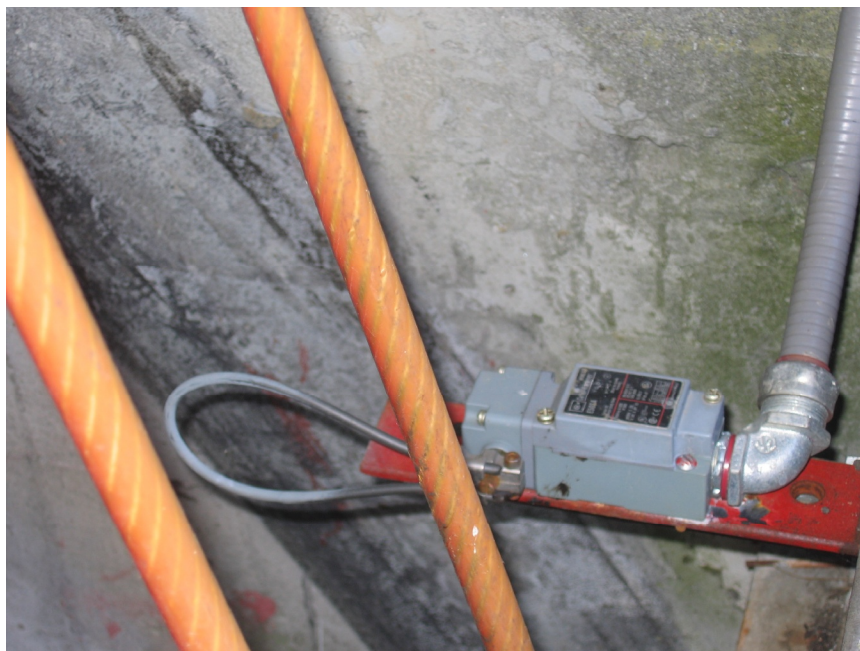
Figure 7
West Gate Back-Up Limit Switch

actual cause of the wire rope breaking and the east gate being damaged. As a result of this accident the second switch has been added to the West Gate to directly break the connection to the controller coil. If the technician's suspicions are true, it is imperative that a limit switch be added to the East Gate to detect the full up position. This switch would serve as a back-up to the rotary switch currently used and will be similar to the arrangement already used on the West Gate. This type of backup is a very common practice on wire rope systems.

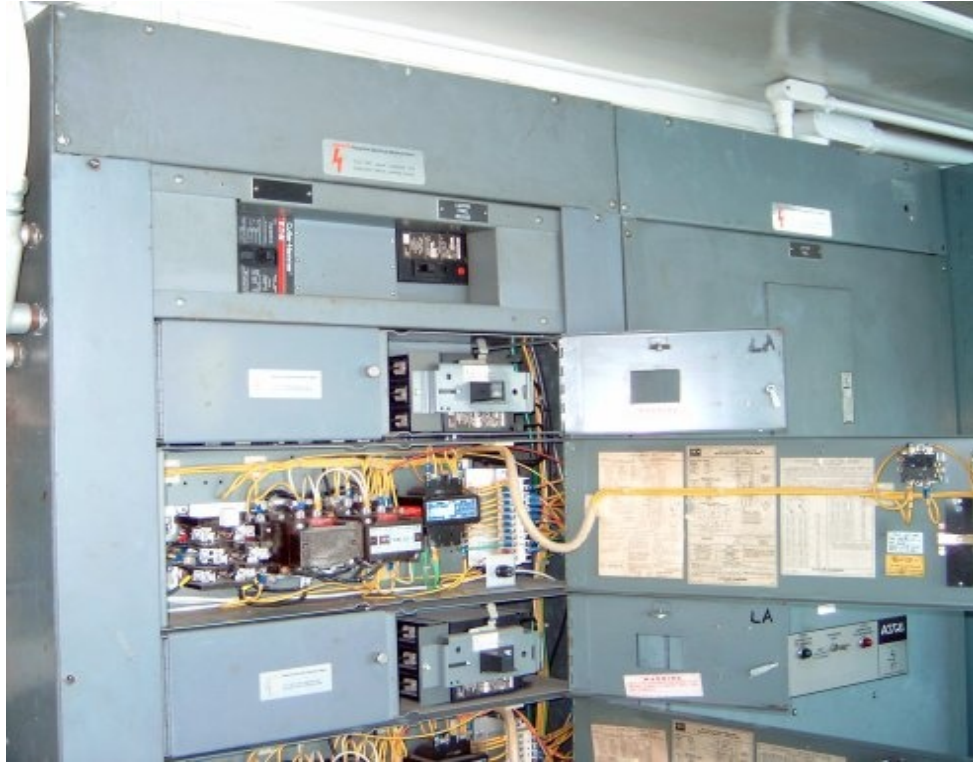
The distribution panel and motor control center occupy a free-standing multi-compartment two section enclosure. The right hand section houses the power distribution equipment and the automatic transfer switch (ATS) used to operate on generated power when the utility power is interrupted. The left hand section is the Motor Control Center (MCC) and houses the circuit breakers and motor controllers required for gate operation (see figure 8). Overall the enclosure appears to be in good condition, although some corrosion is evident at the bottom.

Motor Control Center (Left Section): The multi-compartmented motor control center houses all the circuit breakers and motor controllers for the three gate motors and the emergency hydraulic power unit pump motor. Again, the controllers and circuit breakers are somewhat dated, all are dusty, but appear to be in good operating condition. No buzzing of the contactor armatures was detected during the times they were energized, such as would occur if the armatures had been hammered excessively or if dirt and/or iron filings had accumulated. Continued good preventive maintenance should keep this equipment reliable for the next ten years or more.

Figure 8
Power Distribution Section (Right)
Motor Control Center – with compartments opened (Left)

Additionally, due to accumulation of the dust observed, we recommend a thorough cleaning of the distribution and control components, cleaning and adjusting controller contacts, tightening bus, circuit breaker, and terminal connections, and lubricating where required. The control components should be vacuumed and wiped, not blown, clean. A good cleaning should be scheduled for every 2-3 years. Electrical contacts should be inspected for pitting and arc chutes examined for residual material from arc splashing on a yearly basis, replacing as necessary. Lubrication should occur during the contact inspection.

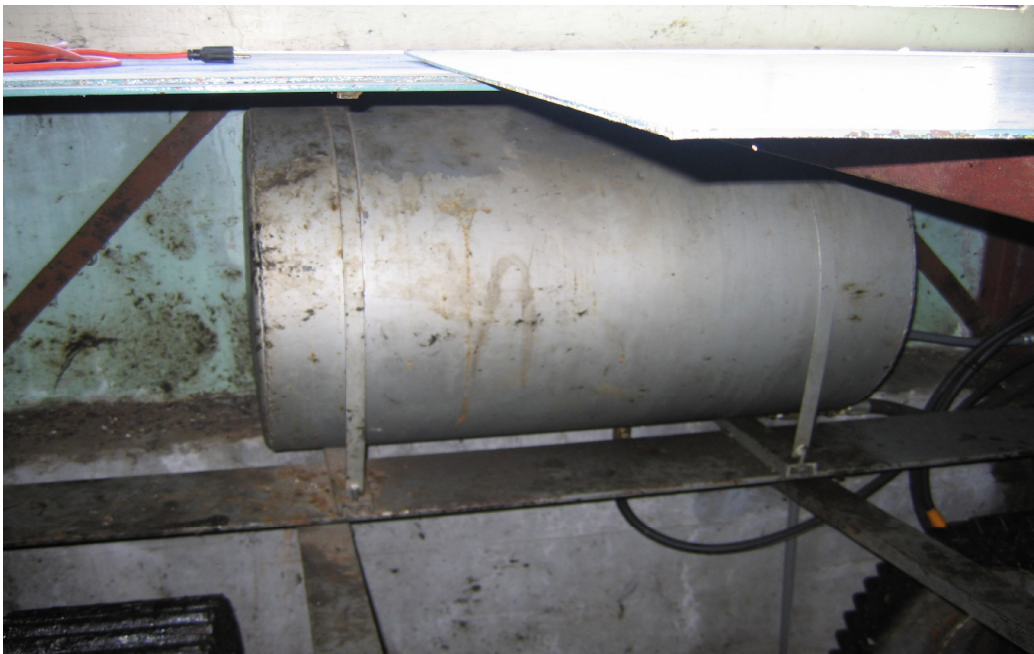
All elements of the standby hydraulic system appear to be in good condition. The hydraulic cylinders are judged to be in very good condition and may have been replaced or rebuilt recently. We could not get access to the hydraulic reservoir tank to check the inside for corrosion. The location of the hydraulic reservoir is in the general area of the hoist open gears (see figure 9). The gates and water are directly below this area. In order to address environmental concerns related to hydraulic fluid spill the reservoir should be fitted with a drip pan or incorporate spill containment provisions. Additionally, the reservoir mounting arrangement appears to be inadequate and not in line with industry standards. All of the hoses and hydraulic fittings appear to be free from any leaks. The emergency gate lift Hydraulic Power Unit (HPU) is controlled by the operator through a pendant on a portable cord. The control system operates satisfactorily.

Figure 9
Hydraulic Reservoir
