ASBESTOS SURVEY REPORT

**STATE OF WASHINGTON
DEPARTMENT OF GENERAL ADMINISTRATION
OLYMPIA, WASHINGTON**

INSTITUTIONS BUILDING (# 15)

E&AS Project #94-260

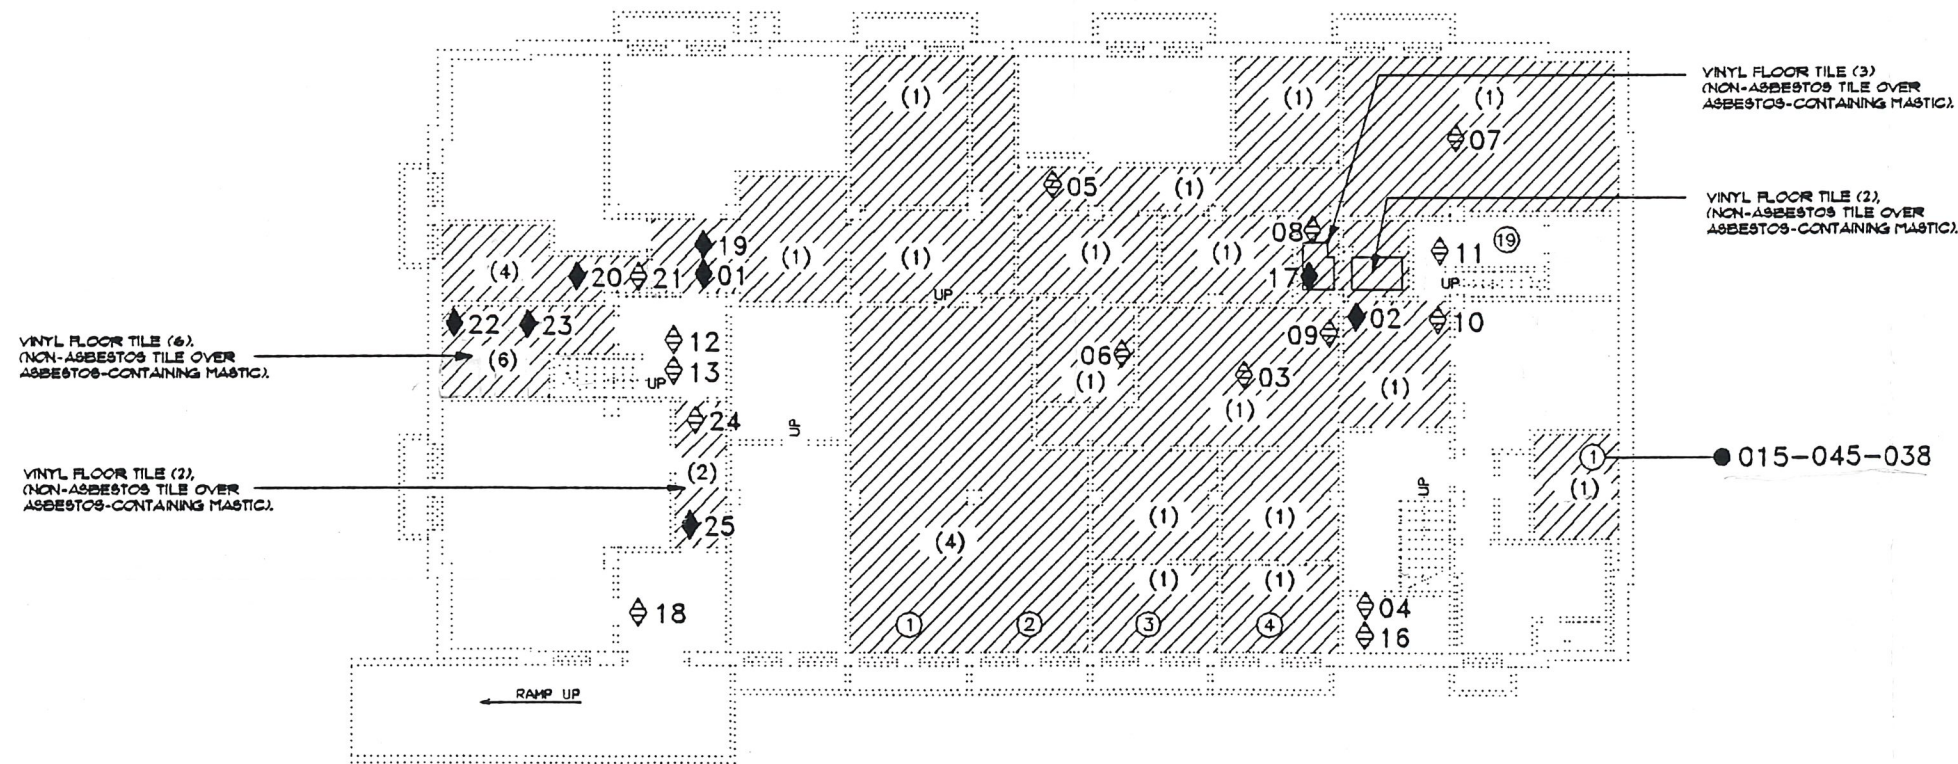
BASEMENT FLOOR PLAN
 SCALE: 1"=20'

●015-045-038	(+)	HARD FITTING ON FIBERGLASS
--------------	-----	----------------------------

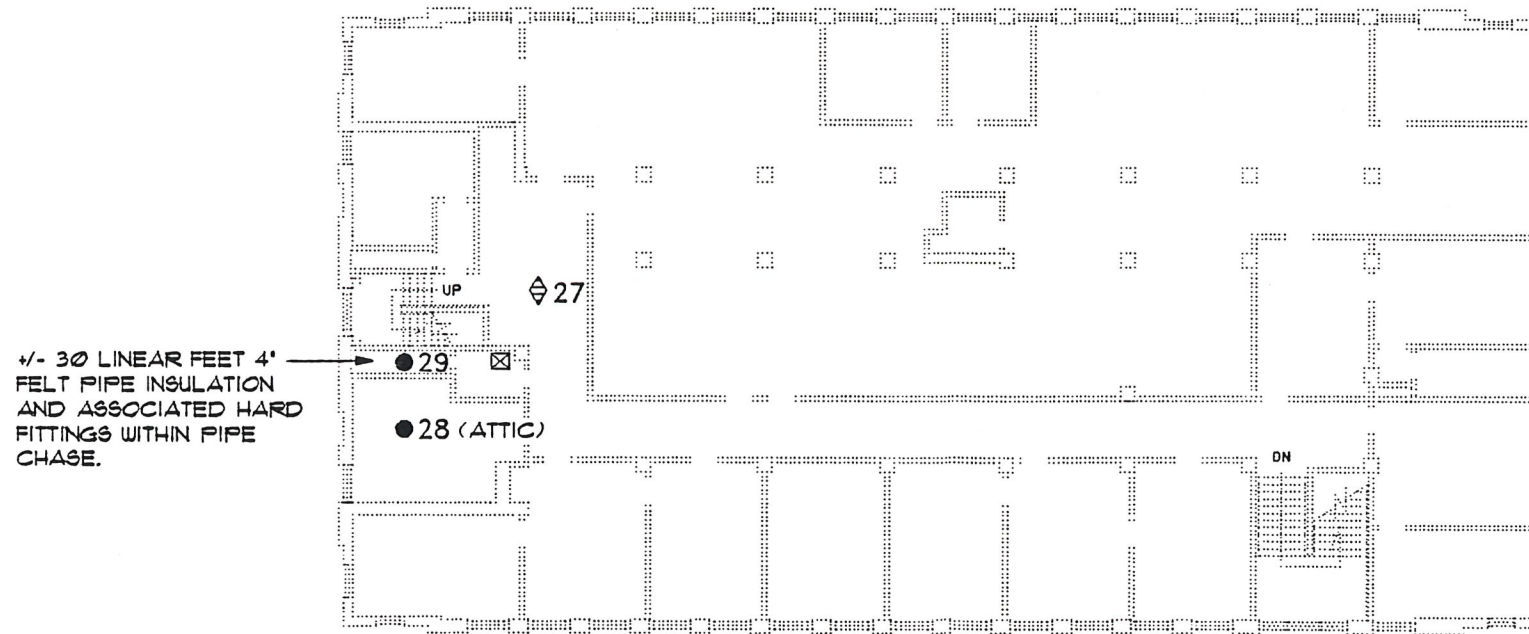
SECOND FLOOR PLAN

1/2- 30 LINEAR FEET 4' FELT PIPE INSULATION AND ASSOCIATED HARD FITTINGS WITHIN PIPE CHASE.

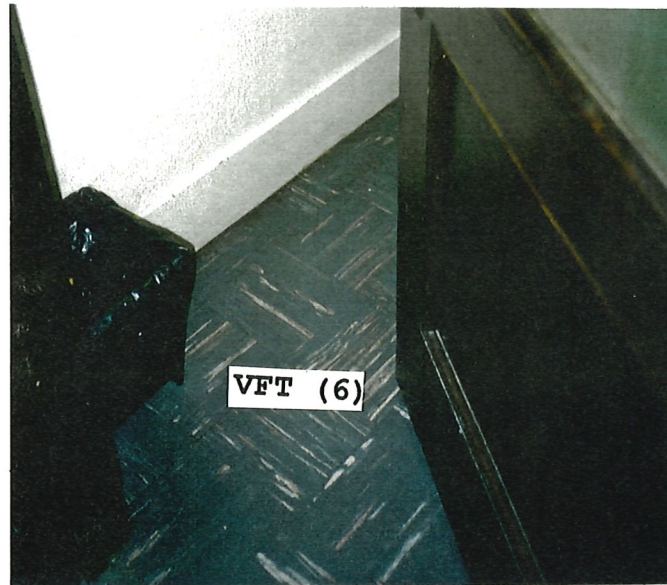
Non-friable 9" x 9" floor tiles and associated mastic found in the basement were found to contain asbestos. The asbestos-containing floor tiles located in the basement include the red, dark red, and tan colored tile. (Gray and light red colored tile tested negative). All floor tile mastic in the basement tested positive for asbestos, except the mastic associated with the light red colored tile. These materials are a low concern in their present condition.

NON-ASBESTOS FLOOR TILE w/ ASBESTOS-CONTAINING MASTIC;
EAST STAIRWELL ROOM; BASEMENT LEVEL.

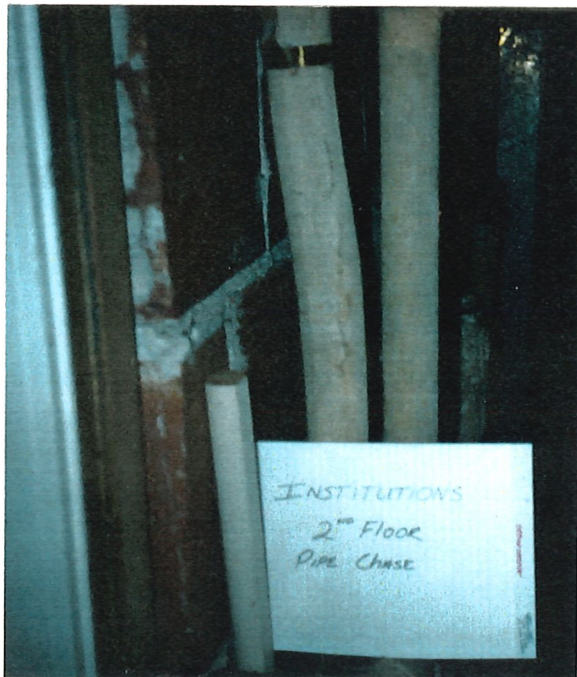
Felt pipe insulation found in the second floor pipe chase was observed in good condition. This pipe chase is open to the attic. Access to this area should be restricted to minimize damage potential and to prevent fiber migration from the attic area.

Outer layer of lagging reduces the friability classification. If the lagging becomes damaged, the exposed material is moderately to highly friable. Only exposed pipes were documented. It is likely that insulated pipe runs are in enclosed ceiling and wall spaces. There are +/- 30 LF accessible in pipe chase. The chase is open to the attic area.

ASBESTOS-CONTAINING FELT WRAP PIPE
INSULATION; SECOND FLOOR PIPE CHASE AT
ATTIC ACCESS.

Immediately isolate area and restrict access to only trained personnel. Repair damaged material. Label material and continue to implement Operations & Maintenance program.

Avoid storing material in pipe chase to minimize damage/exposure potential.

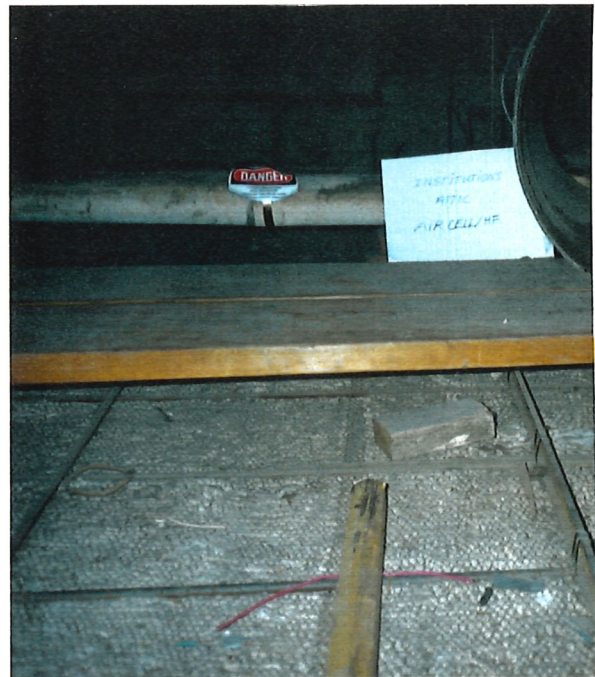
Friable asbestos-containing air cell and felt pipe insulation and associated hard fittings exist on the steam heat and domestic hot water piping systems in the attic and second floor pipe chase. This material is damaged in the attic space and debris is present. Access to this area should be restricted until repair or abatement occurs.

Outer layer of lagging reduces the friability classification. If the lagging becomes damaged, the exposed material is moderately to highly friable. Only exposed pipes were documented. It is likely that insulated pipe runs are enclosed in ceiling and wall spaces. Debris was noted at damage sites. Repair should include debris removal.

ASBESTOS-CONTAINING AIR CELL PIPE
INSULATION; ATTIC CRAWLSPACE AT ROOF
ACCESS.

Immediately isolate area and restrict access to only trained personnel. Repair material. Label material and continue to implement Operations & Maintenance program.
