Hazardous Materials Survey Report

Pierce College, Olympic South

Post Abatement

July 2022
PBS Project 40535.488

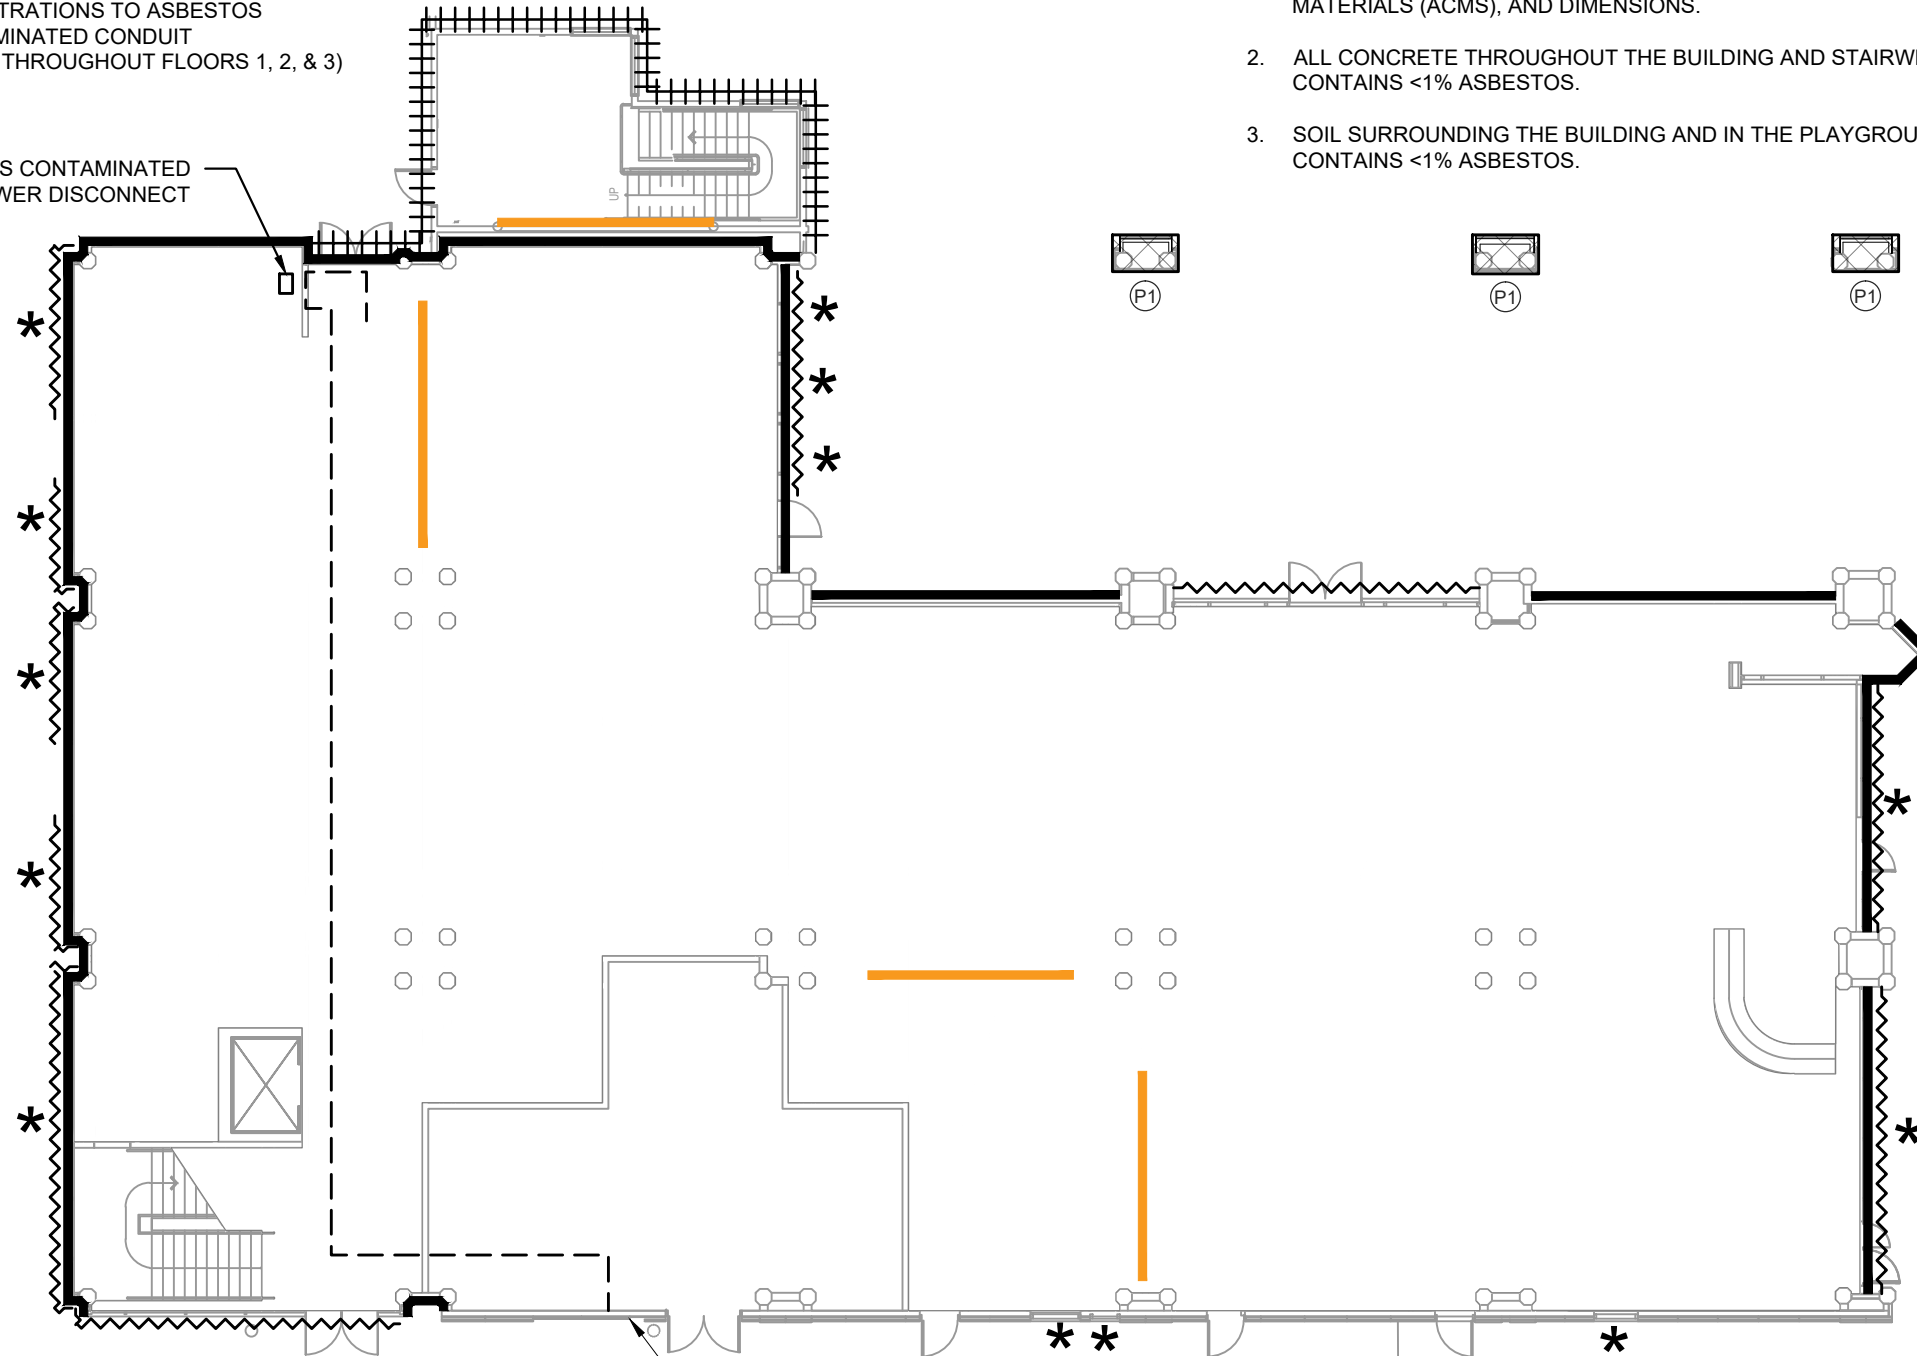
ASBESTOS CONTAMINATED SUB-GRADE ELECTRICAL VAULT AND ASSOCIATED CONDUIT UNDER OLYMPIC SOUTH

ASBESTOS CONTAMINATED EMERGENCY POWER DISCONNECT

ASBESTOS CONTAMINATED SUB-GRADE ELECTRICAL VAULTS AND ASSOCIATED SUBGRADE CONDUIT

ASBESTOS CONTAMINATED POWER SHUT-OFF PANEL AND ASSOCIATED CONDUIT

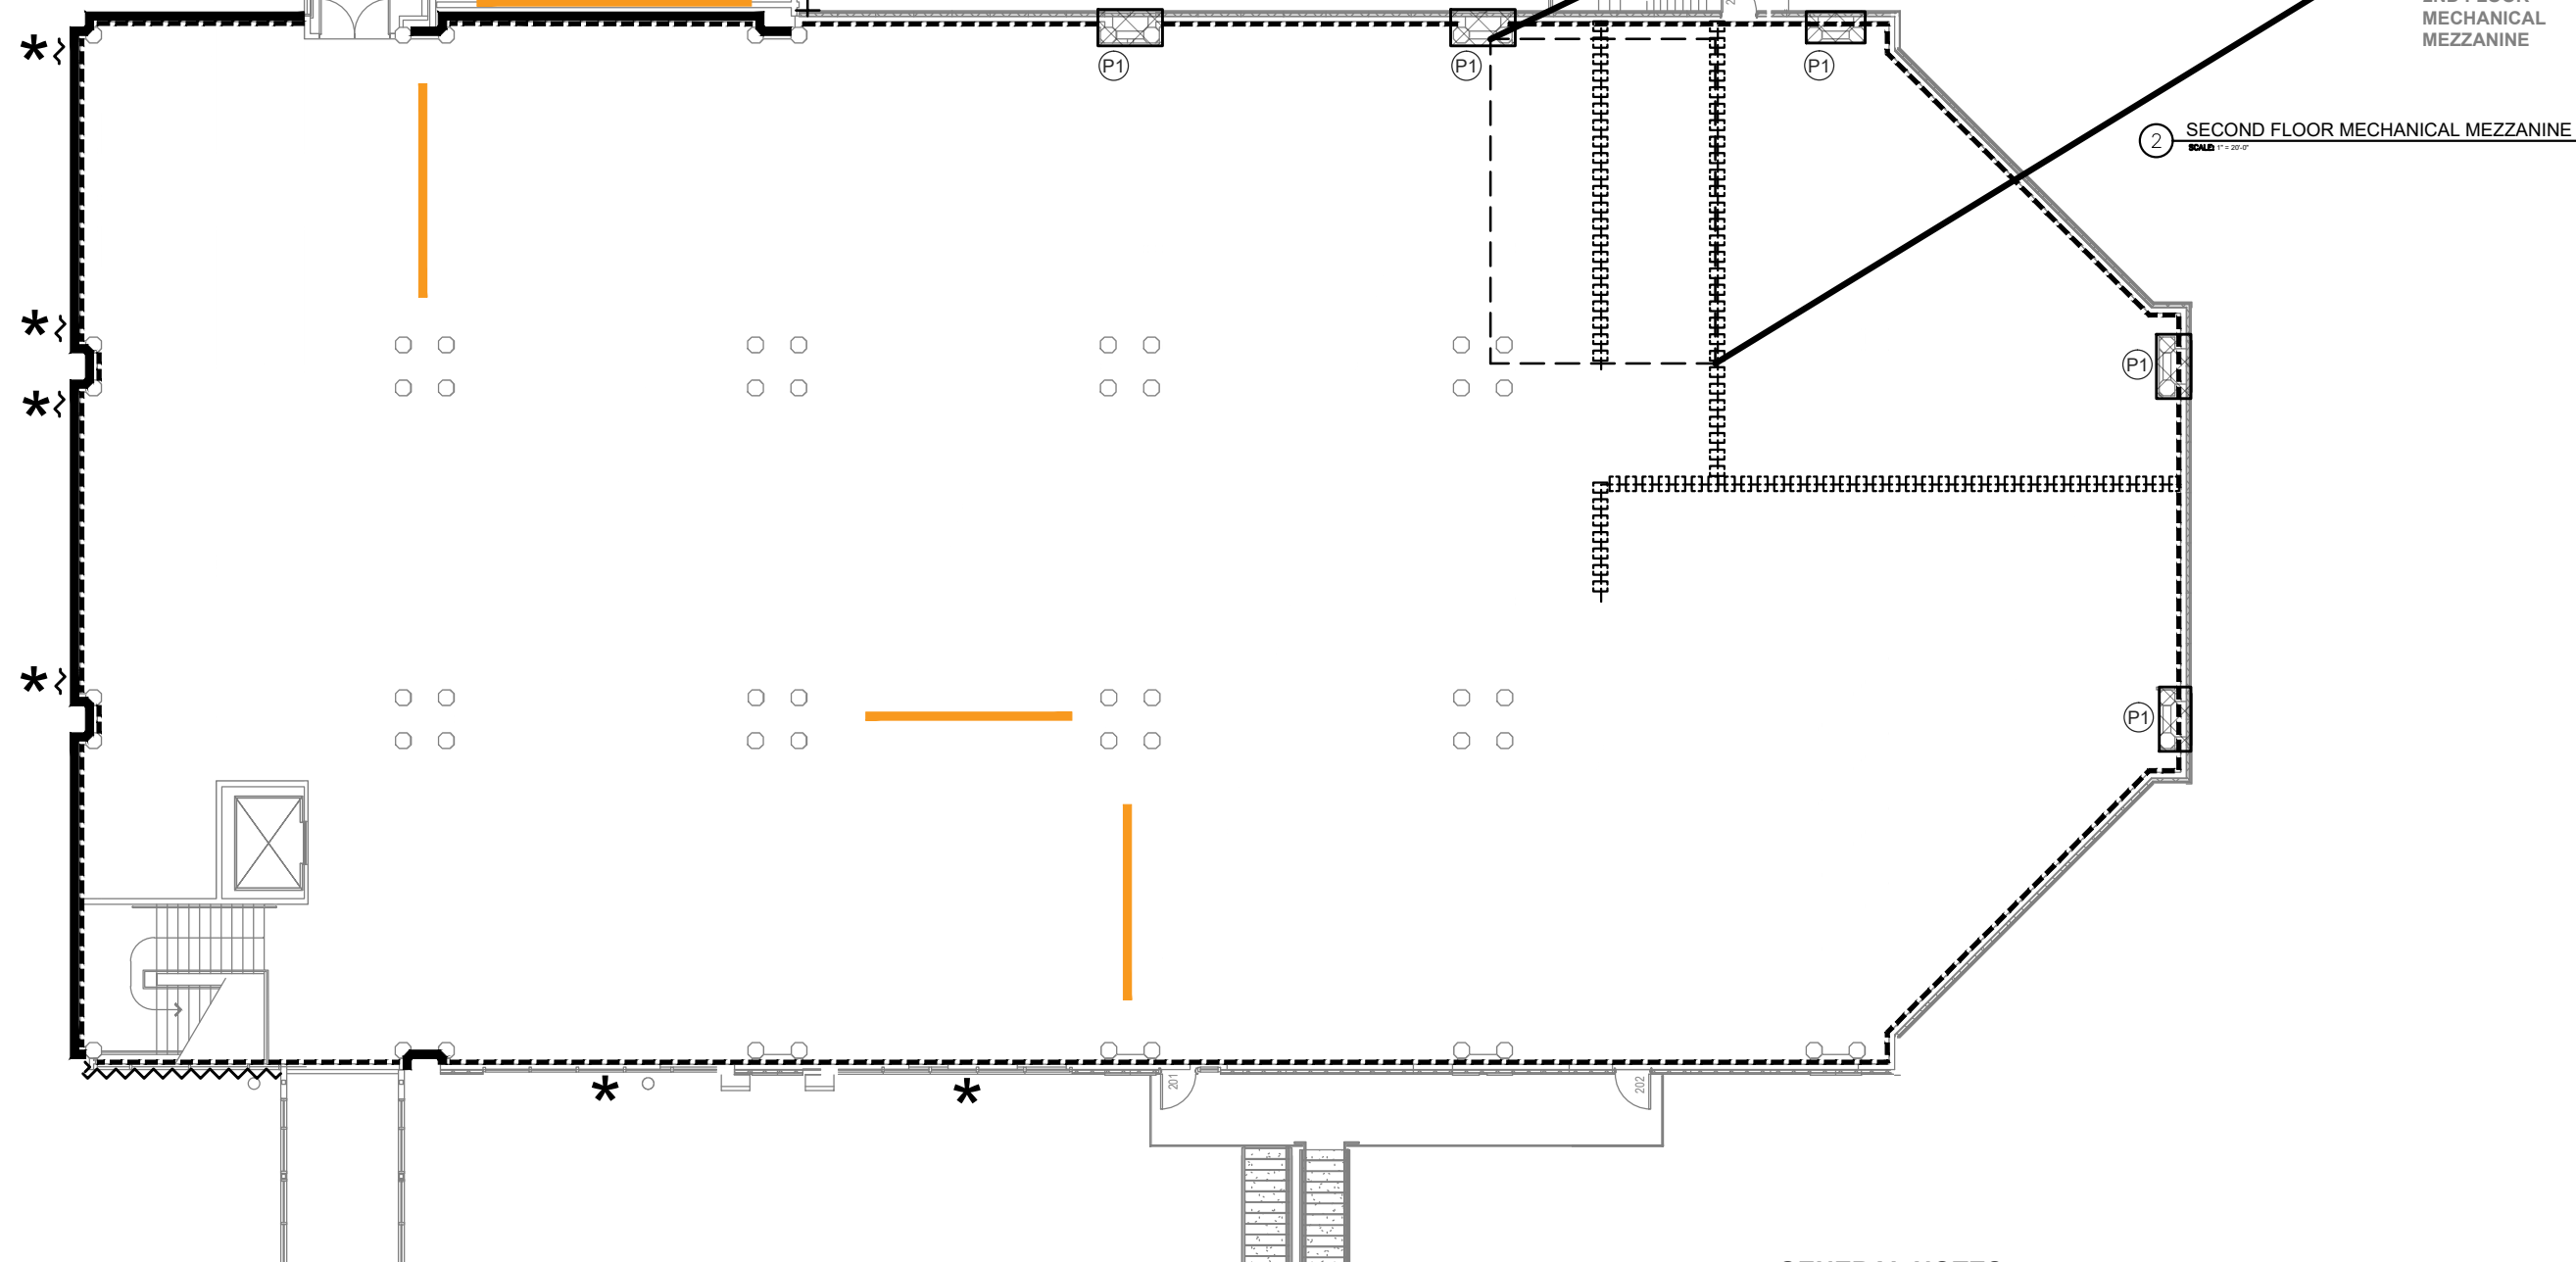
1 SECOND FLOOR
SCALE: 1" = 16'-0"
PROJECT NORTH

P1: ASBESTOS CONTAMINATED EXTERIOR COLUMN CAVITY
