Subject: City of Everett Application for Project Approval Using Design-Build (D-B)
Water Filtration Plant East Clearwell Roof Replacement

ROOF ASSESSMENT REPORT

Everett Water Filtration Plant

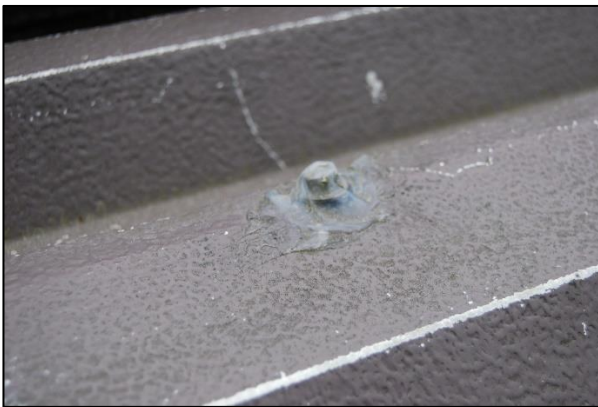
- **Flashing and Caulking**
The flashing around the access hatches was in poor condition and had been patched using caulk. The exposed fasteners throughout the roof showed evidence of being overdriven and had been caulked over to fix leakage.

Exposed Fasteners Caulked Over (typ.)

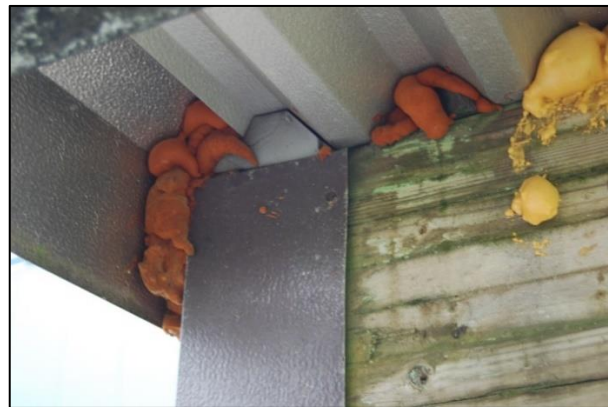
- **Foam Filler**
The foam eave filler strips were missing in various areas and were shrinking because of heat. Spray polyurethane foam was used to seal these gaps throughout the roof.

Foam Eave Filler/Spray Polyurethane Foam (typ.)

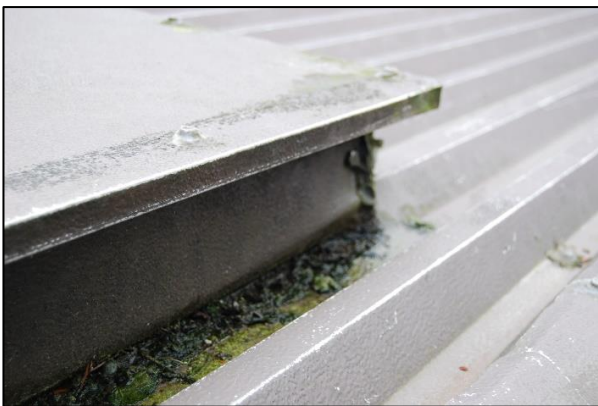
Mold/Mildew at Equipment Hatch Flashing

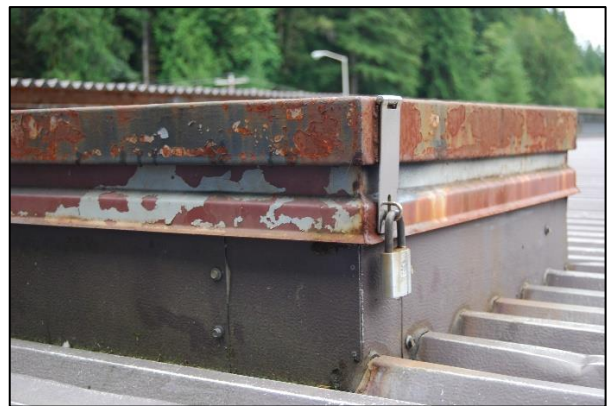
Rust at Access Hatch in Northwest Corner

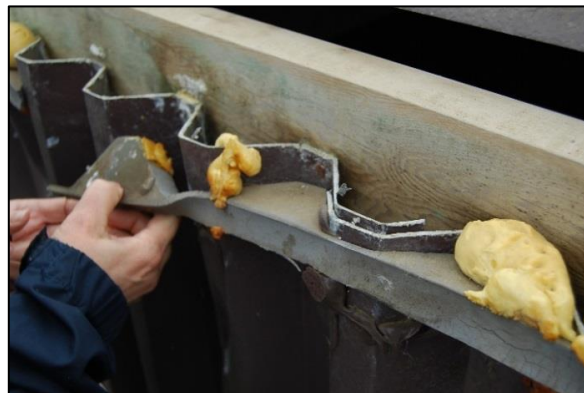
Foam Eave Filler at North Elevation Flashing

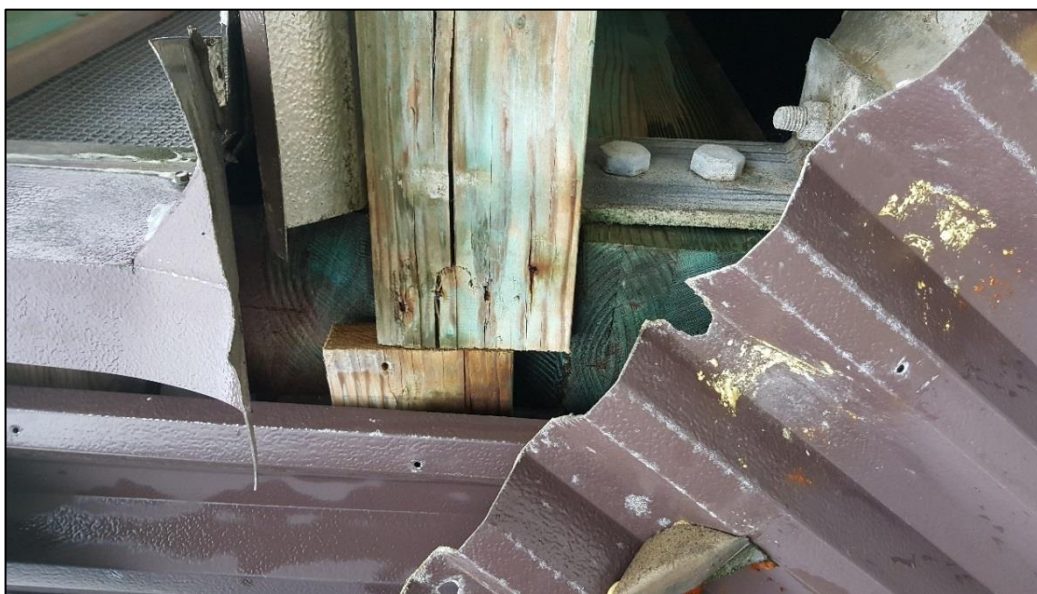
- **Metal Roof Decking**
The roof decking observed was in fair to poor condition, with several corroded areas located around the fastener attachment points at the panel edges.
- **Siding Rim/Skirt for Siding Attachment**
Fasteners attaching a continuous 2x6 rim along the top of the building were completely corroded leaving the rim detached.
- **Roof Decking Ledger**

Corroded Metal Decking Panels at Fastener Attachment Points

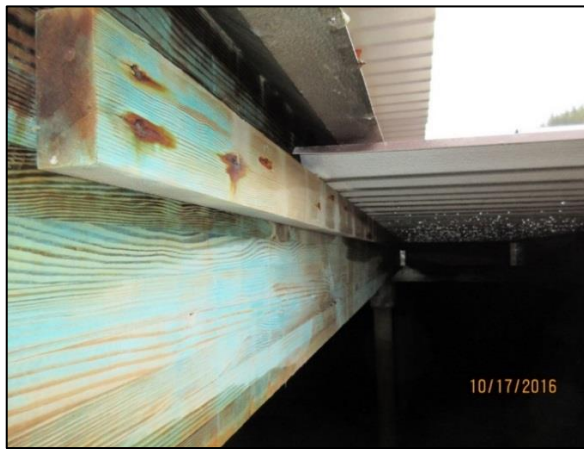
The roof decking at the center ridge is supported by a continuous 2x4 ledger fastened to the face of the glulam purlins with nails. Many of the nails have been completely corroded leaving the ledger completely detached in some cases.

Detached 2x4 Decking Support Ledger at Rim

- The 2x4 ledger supporting the metal roof decking on either side of the ridge is completely detached in some locations. It is possible that the unsupported decking could collapse under the weight of personnel or even a design snow load event. We recommend that the existing 2x4 ledger be reattached with corrosion resistant fasteners. We recommend that a second 2x4 ledger be sistered to the existing ledger to provide additional support for the edge of the metal decking.

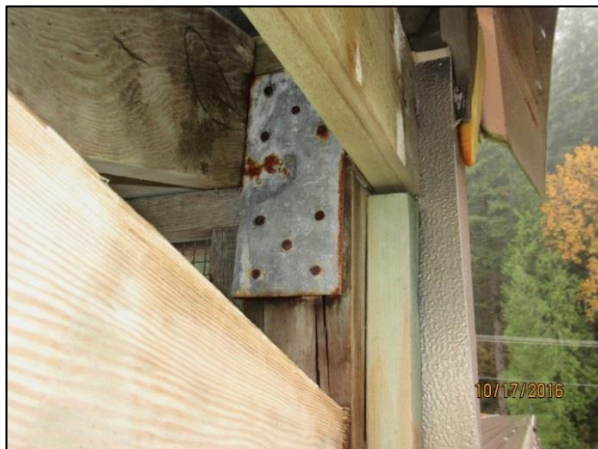
- **Glulam Hangers and Fasteners**
In general, most of the hangers and their fasteners had substantial corrosion. In some cases the fasteners had been completely corroded through, leaving the hangers detached. However, the glulam purlin hangers that are embedded in the top of the concrete wall along the south side of the building were observed to be in good condition with little to no corrosion.

Typical Corroded Hanger and Fasteners at Ridge

- All corroded hangers and fasteners supporting the purlins, blocking, and pop-up ridge structure should be replaced. Alternatively, temporary steel supports could be attached beneath the corroded hangers. A structural engineer should be retained to provide a design of the steel supports and their attachments.

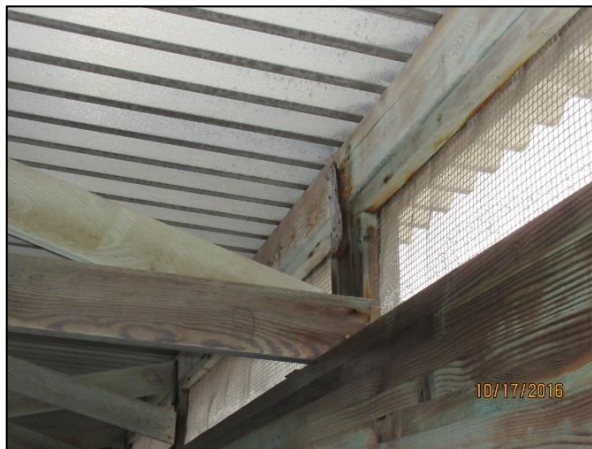
Typical Corroded Hanger and Fasteners at Pop-up Ridge Structure

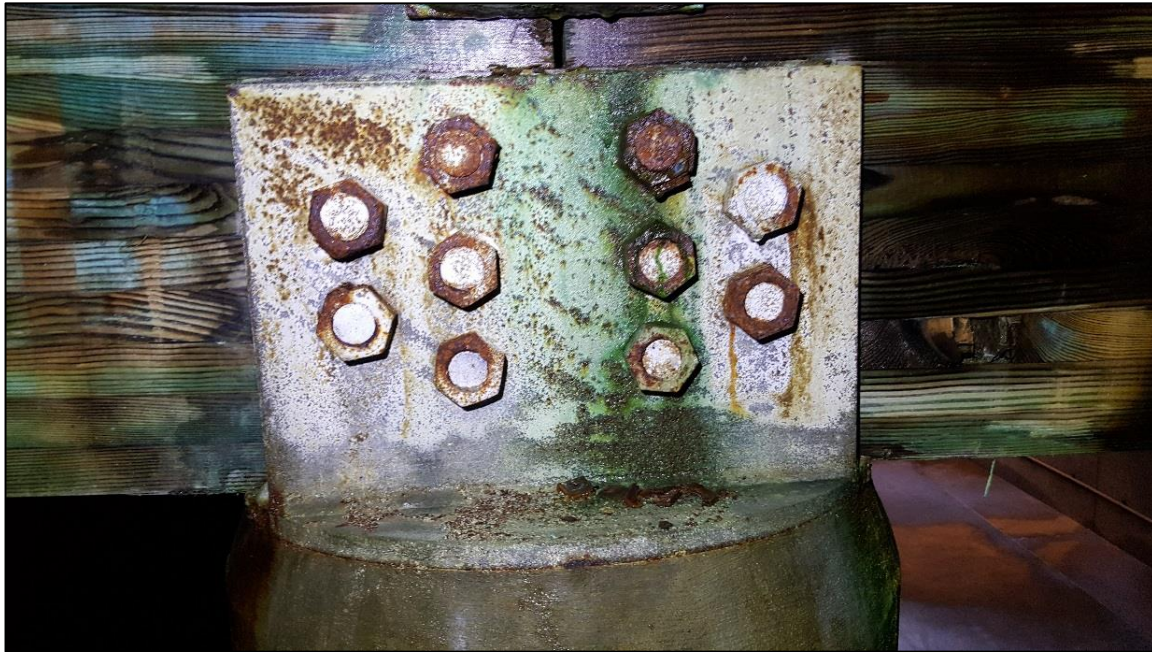
Typical Corroded Hanger and Fasteners at Girder Support Column

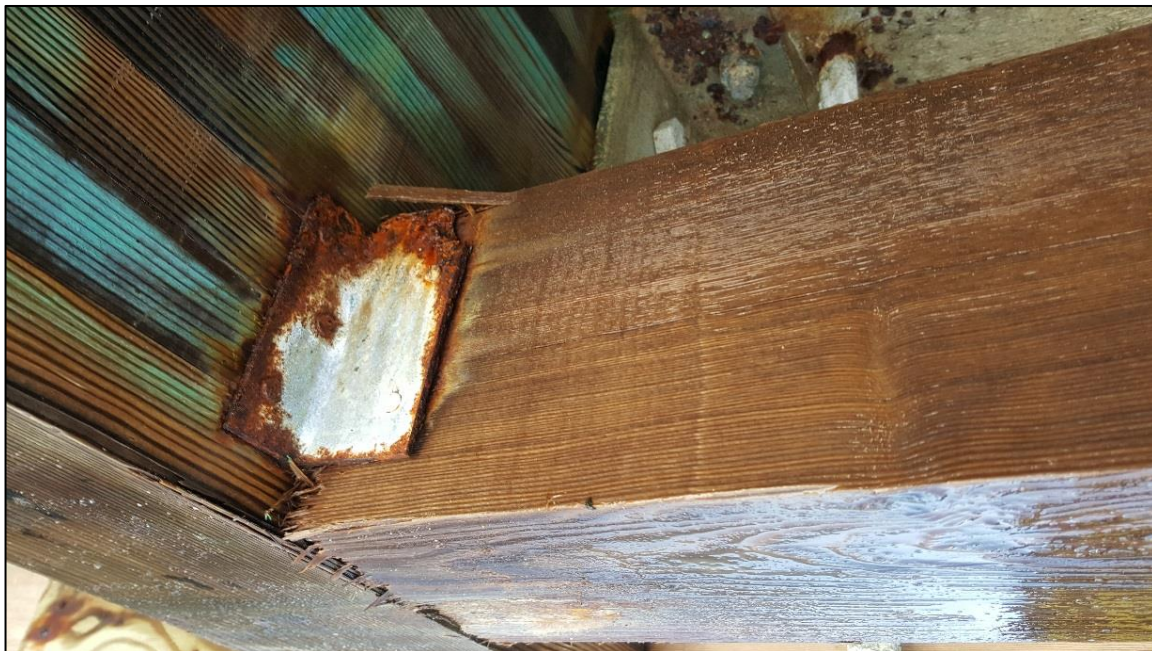
Typical Corroded Hanger and Fasteners at Blocking

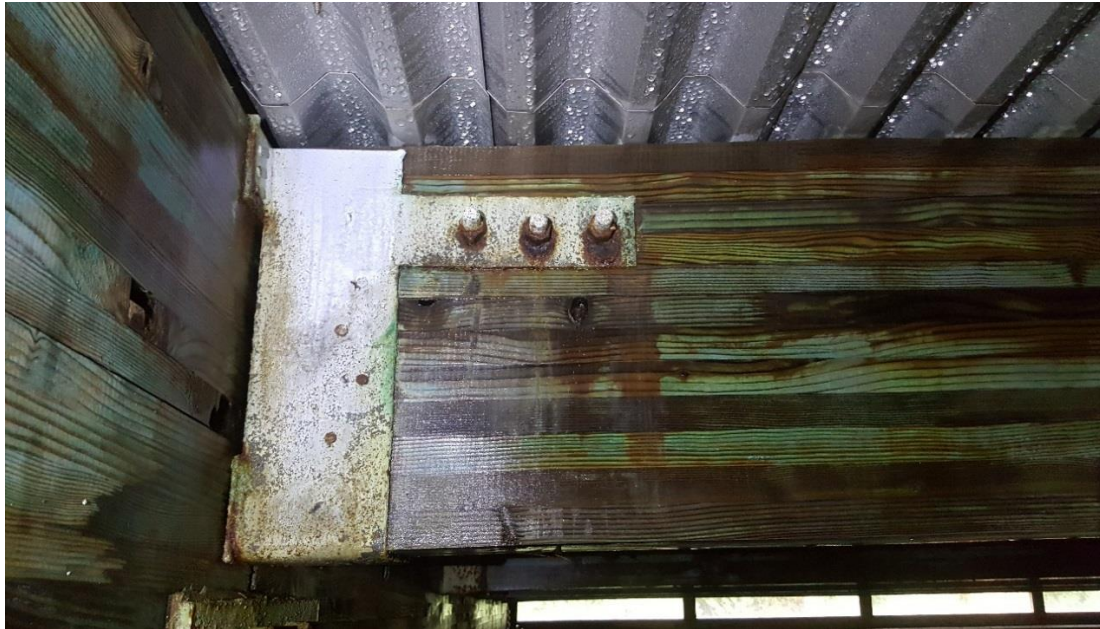
Typical Corroded Purlin Hanger

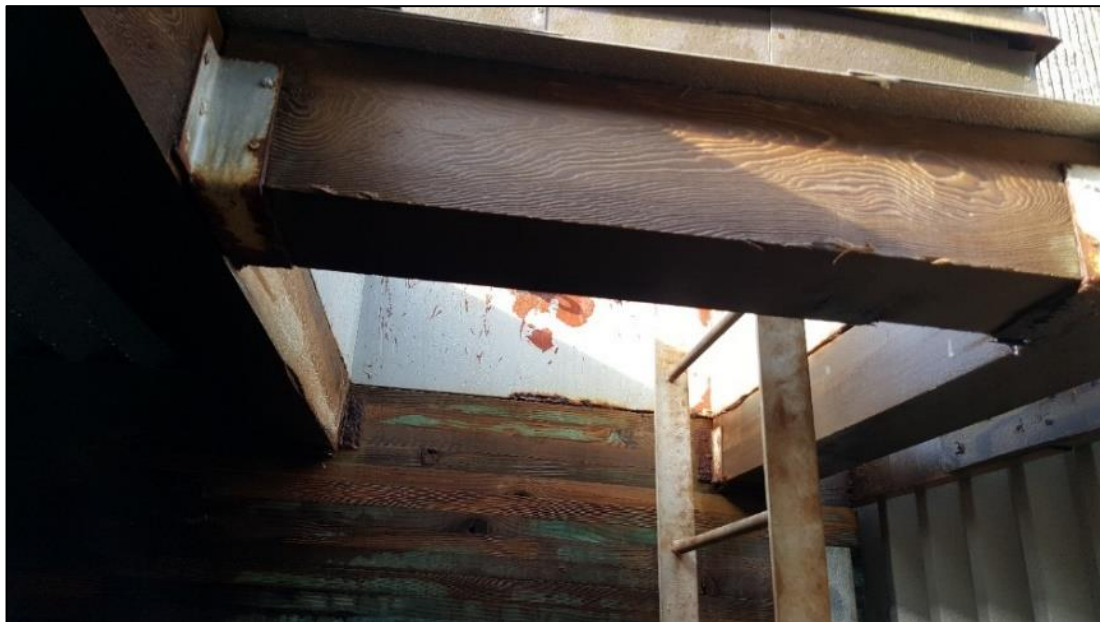
- **Access Hatches**
The blocking hangers and fasteners supporting the access hatches were found to be substantially corroded and in some cases completely detached.

Corroded Hangers at Access Hatch Blocking

- The hangers supporting the access hatch blocking members should be removed and replaced.
- The 2x6 rim/skirt attachment should be reattached to the ends of the glulam to provide secure support of the metal siding.

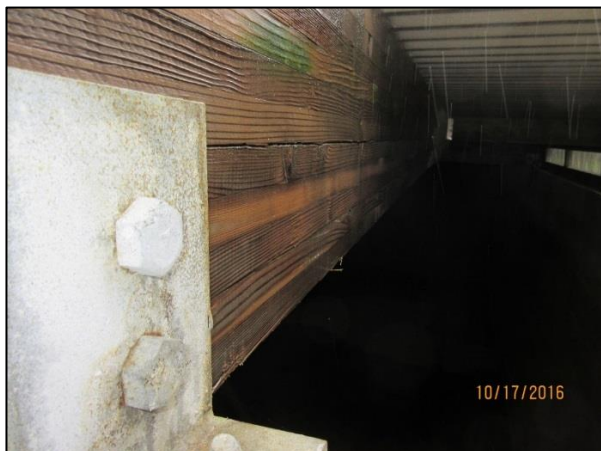
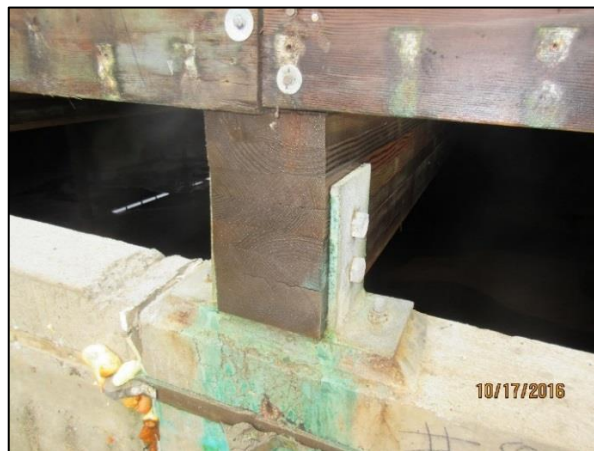
- **Glulam Purlins**
All of the observed purlins had considerable delamination between plies. The delamination appeared to be concentrated near the supports and was fairly consistent on all of the purlins. Additionally, a considerable amount of moisture was observed at the beam ends and it appeared that much of the preservative treatment had been washed off. The preservative treatment appeared to be ACZA, as evidenced by its green color. Although the preservative treatment appeared to be mostly leached out from the wood, we observed negligible decay in the glulam purlins. However, it is likely that decay is present in the ends of the purlins where the hanger corrosion was observed.

Typical Delamination of Glulam Purlins

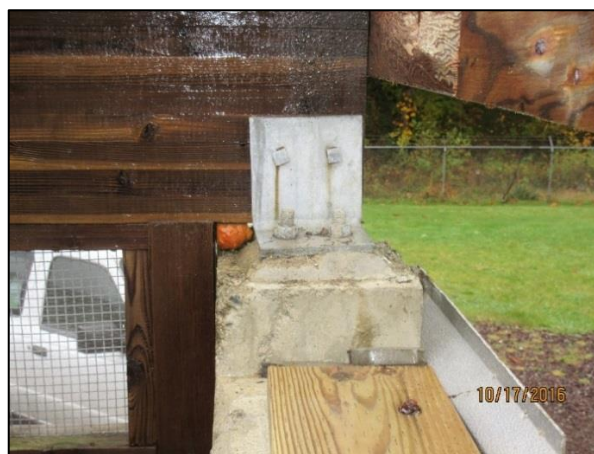
- **Glulam Girders**
The glulam girders running east/west were observed to have delamination at the exposed ends at the exterior walls. Decay of up to 1" deep was observed at the beam ends.

Signs of Corrosion in Perimeter Glulam Beam
