Legislative Chambers Skylight Restoration Feasibility Study

Washington State Legislative Building

Washington State Department of Enterprise Services

April 4, 2017

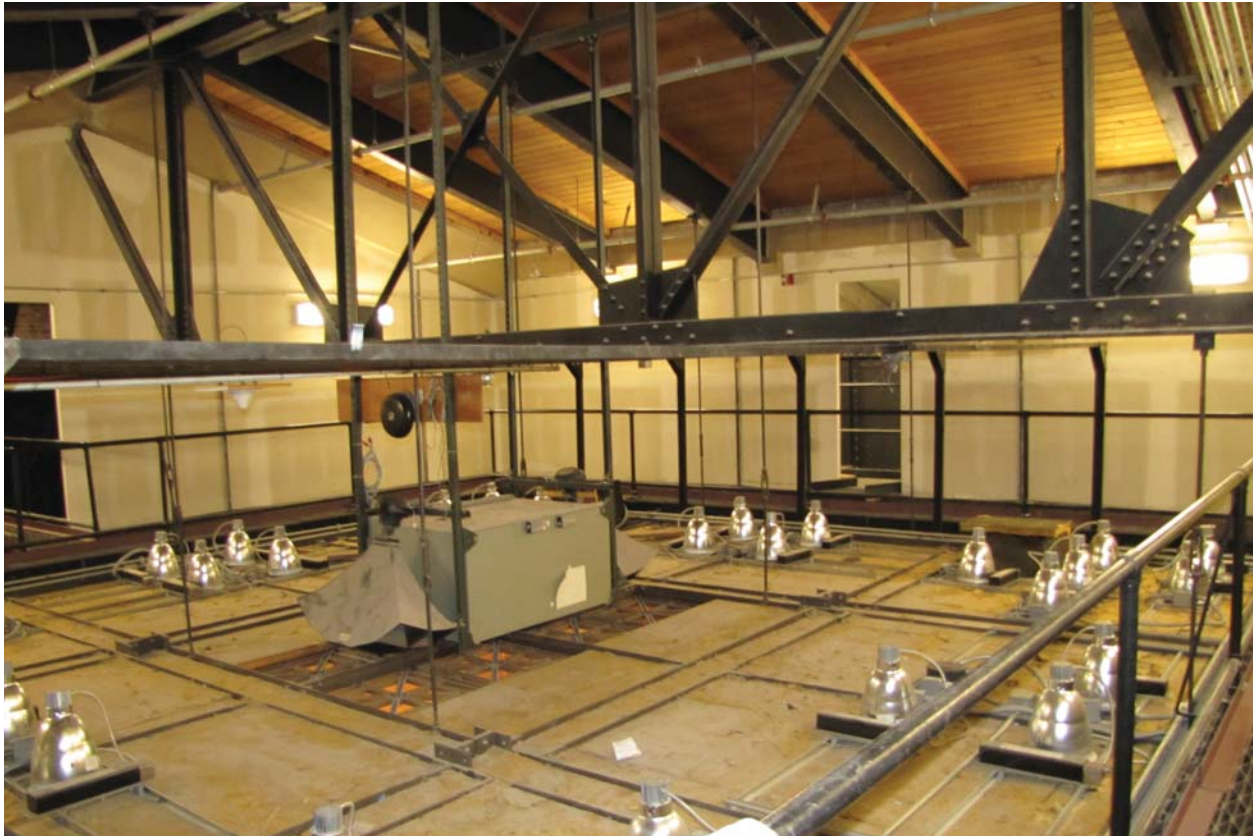
Figure ES05: House skylight attic showing top of bronze ceiling laylight with speaker cluster at the center. A perimeter catwalk provides access.

It is recommended to paint everything (conduit, pipes, structure, walls, railings, etc.) with a highly reflective white paint to create a light box in the skylight attic space. This will allow light from the skylights to bounce from surface to surface minimizing any shadowing from the various objects in the space. To complete the lightbox, doors or sliding panels will need to be added at the existing entry points to other areas of the attic.

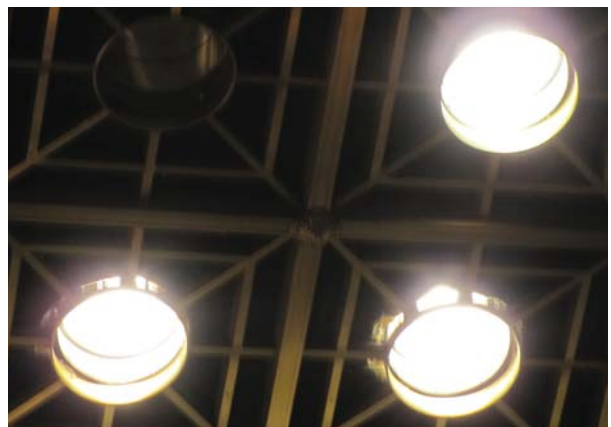
The installed downlights were not designed for the current application and do not fit properly in the openings of the grid. The rings/ downlight reflectors do not line up, creating light leaks around the grid system (see Figure 21). Color shifting, which is when the color of the lamp changes (for instance from more of a warm tone to a greenish or bluish tone) was also present as seen in Figure 19 which is common for metal halide lamps as they age.

Figure 21: Light leaks / misalignment of downlights

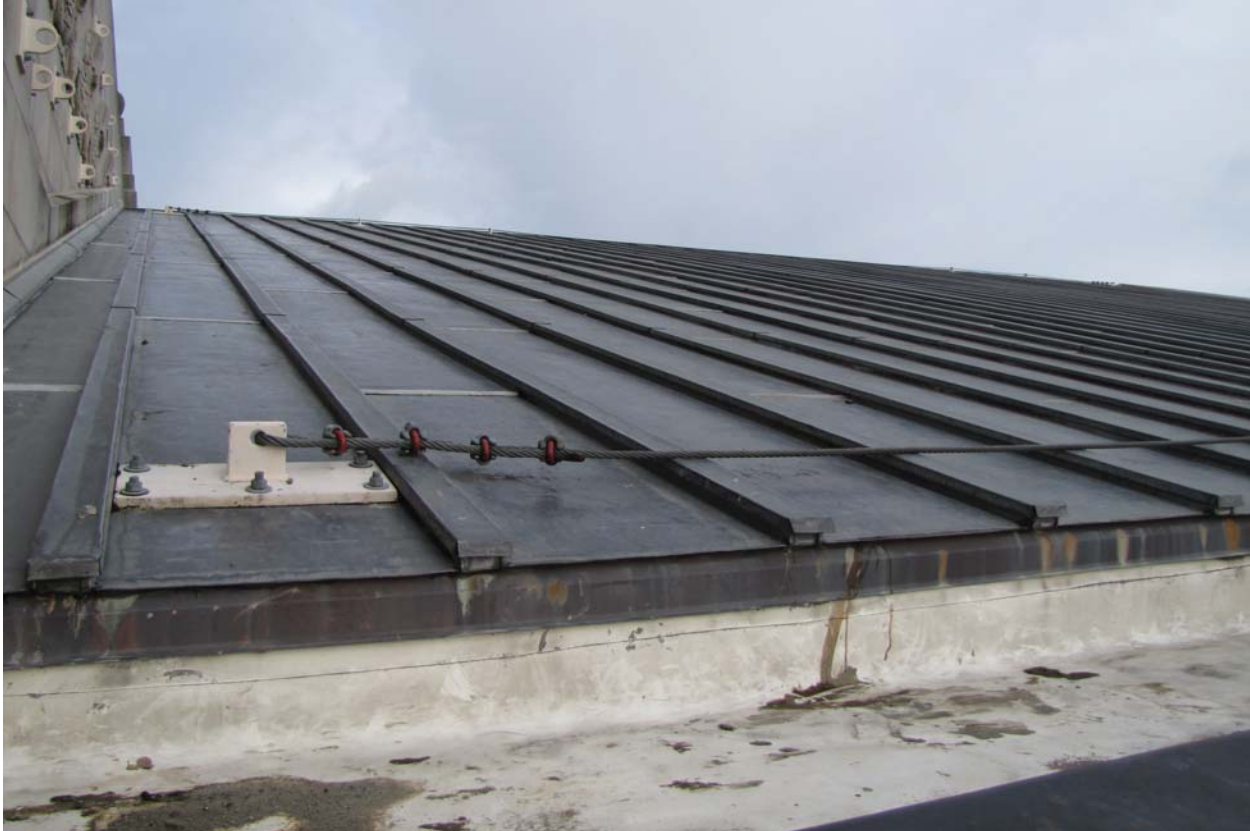
Figure 29: Existing batten seam roof. Corrosion is visible at the perimeter flashing.

ARG was able to view the existing roof from one vantage point which is shown in Figure 29 above. From this view, the roof panels appear to be in excellent condition with no
