Memorandum

То:	Amy Kim Project Manager
	Washington State Dept. Enterprise Services
From:	Carolyn Moore, Archaeologist
	Kelly Yeates, ICF Project Manager
	Tait Elder, Principle Archaeologist
Date:	March 29, 2022
Re:	WA State - Legislative Campus Modernization Archaeology Services
	Newhouse Building Geotechnical Monitoring (Revised)

LCM Archaeological Monitoring, Newhouse Building Borings March 29, 2022

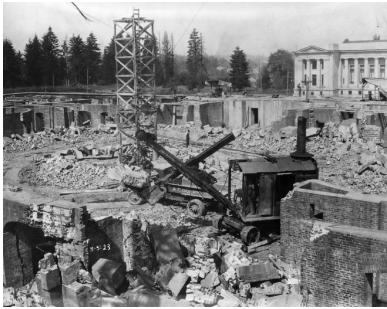
Photo 1- Removal of original Capitol building foundation, 1923. On file at: https://www.sos.wa.gov/legacy/legbuilding/construction.aspx

Because of the relative homogeneity of the observed soils and absence of buried surfaces, it appears that the pre-development ground surface has been graded. This is consistent with the historically documented widespread landscape modifications that occurred across the Capitol Campus in the early twentieth century (Photos 1, 2, and 3).

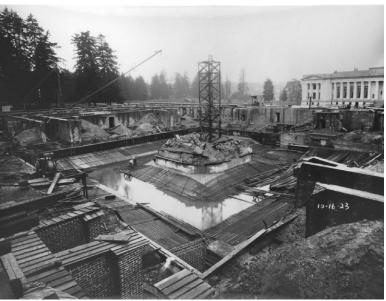
Photo 2- Installation of new Capitol Building foundation, 1923. On file at: https://www.sos.wa.gov/legacy/legbuilding/construction.aspx

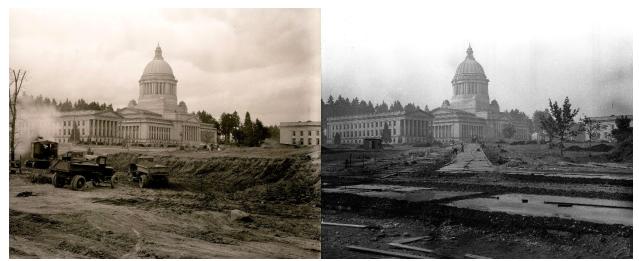
Photo 3- Grading of Campus, 1930. Photographer: Vibert Jeffers, in Susan Parish Photograph Collection (1889-1990).

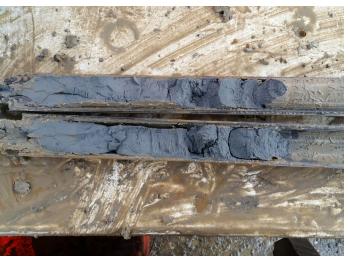
Figure 2- Sediment overview from B-1.

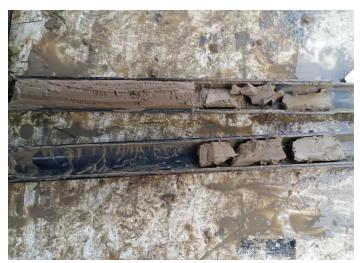
Figure 3- Sediments observed from B-2.

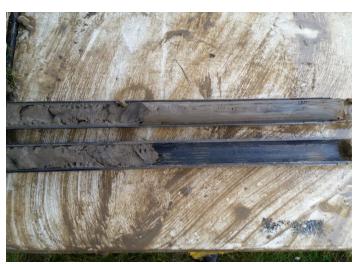
Figure 4- Sediments observed from B-2.

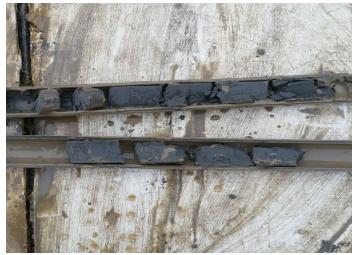
Figure 5- Sediments observed from B-2.

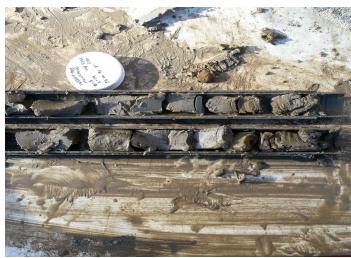
Figure 7- Sediments observed from B-3.

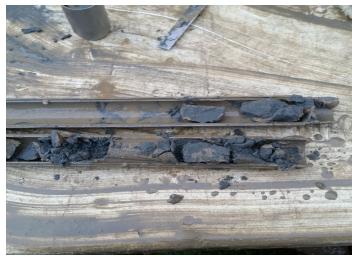
Figure 8- Sediments observed from B-3.

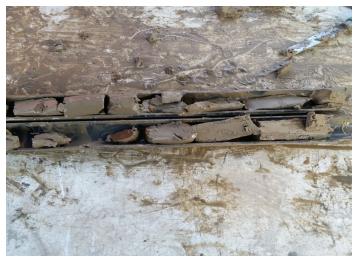
Figure 9- Sediments observed from B-4a

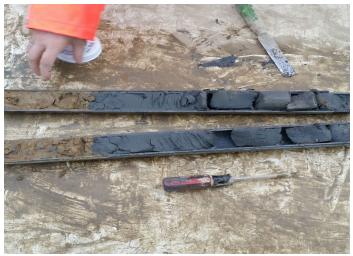
Figure 10- Sediments observed from B-4a.

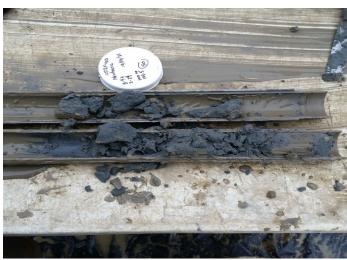
Figure 11- Sediments observed at the bottom of B-4a.
