State Project No. 2013-245

Washington State Legislative Building Dome / Access Stair Evaluation

State Capitol Campus, Olympia, WA

June 28, 2013

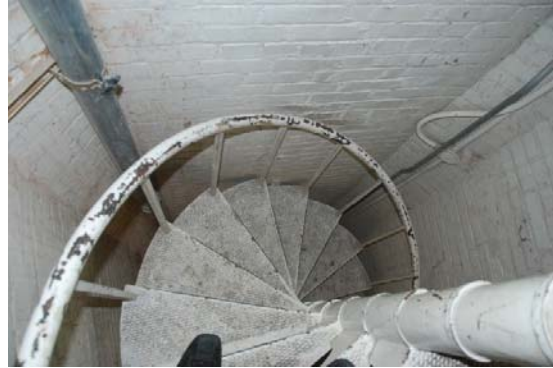
Photo 2.1

The access stairs are best described in three parts, the spiral staircase (Photo 2.1), the arcing staircase (Photo 9.1), and the cantilever platform with spiral staircase atop (Photo 16.1). Each stair has been modified over time. The lower spiral staircase had a steel frame installed as part of the 1965 earthquake repairs (Photos 5.1 and 8.1) which greatly narrows the exit path. The arcing stairs added steel safety cage shrouds (Photo 13.1), and the cantilevered platform had steel cables installed (Photo 17.1). The access stairs have been determined by Legislative Facilities to be a "confined space" due to single point of access and the limited width of the spiral stairs, as such no public access is allowed. One of the goals of this study (to be performed by the architects) is determine whether the stairs could be re-opened to limited staff access.

The cast iron spiral stairs (Photos 2.1 to 7.1) consist of 178 stacked treads that slide over a 4" (outside diameter) vertical pipe with bolts on the exterior side of the treads to provide continuity to hold them in place (Photo 6.1). A computer model was developed to theoretically depict the spiral staircase, representing a complete 360° spiral from landing to landing. This model was analyzed with various loading conditions to check the stresses in all components for worse case loading conditions. The performance of the system is adequate for the service load as described above, however there is observed movement of the stair as people transit up and down the stair. This movement is more of a nuisance and does not indicate the stairs have inadequate strength.

1. In order to enhance the performance of the stairs, we recommend replacing the spiral staircase stabilizing anchors and adding new anchors per Details 1-3. This will reduce the lateral motion of the stairs.
2. We also recommend that the stairs continue to be monitored for signs of structural distress every two to four years by a qualified structural engineer.

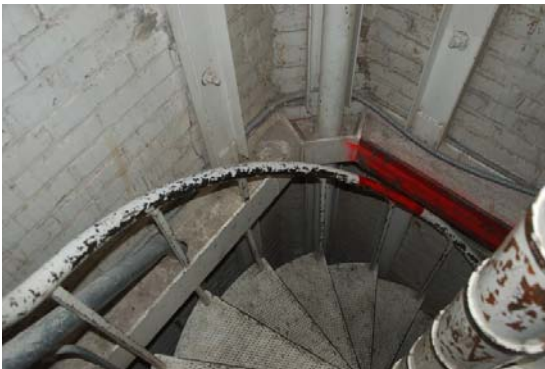
Photo 5.1

This movement is normally resisted by a system of bent plates and bolts that attach the stairs to the surrounding masonry and concrete walls (Photo 7.1). The stabilizing anchors were found in only one orthogonal direction and some anchors were entirely deficient (Photo 7.1). The spiral staircase space width is also impacted by the steel retrofit frames at mid-height (Photos 5.1 and 8.1) that were added as part of the post 1965 earthquake repairs.

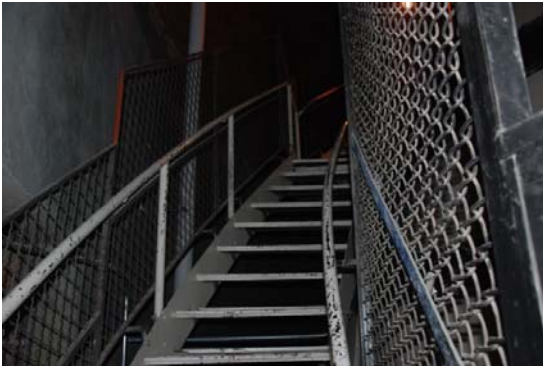
Photo 9.1

The arcing stairs (Photo 9.1 to 13.1) wrap around the concrete cone that supports the lantern and is located between the inner and outer domes. It starts at the top of the spiral stairs at the base of the cone and continues to an elevation of approximately 8 feet below the lantern. The cast iron arcing stairs are braced with triangular steel frames (Photos 10.1 and 11.1) at the landings (Photo 12.1) and at mid-flight between landings. The triangular steel frames and their through-bolt plated anchors were analyzed and found to be structurally sufficient. The arcing stairs have a steel shroud cage (Photo 13.1) installed around each side of the stairs which has minimal structural effect on the stairs. The arching stairs are adequate for reference loading.

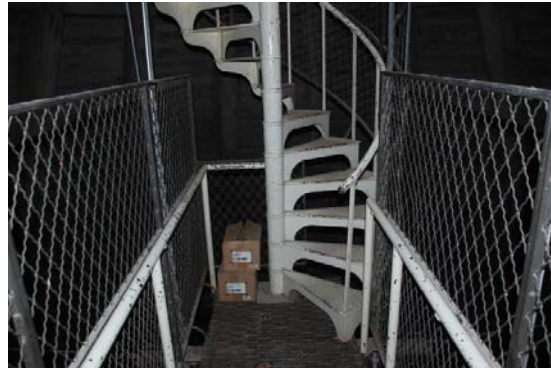
Photo 16.1

Resting on the cantilever platform is a short section of spiral stair identical to the lower spiral stair. This stair provides access to the Lantern (Photo 16.1). Based on the analysis of the lower spiral staircase this staircase is adequate for service loading.
