4. APPENDIX

General Administration Building Drawing List

Predesign
Executive Office Plaza/Heritage Center

Project #2006-117
September 2006

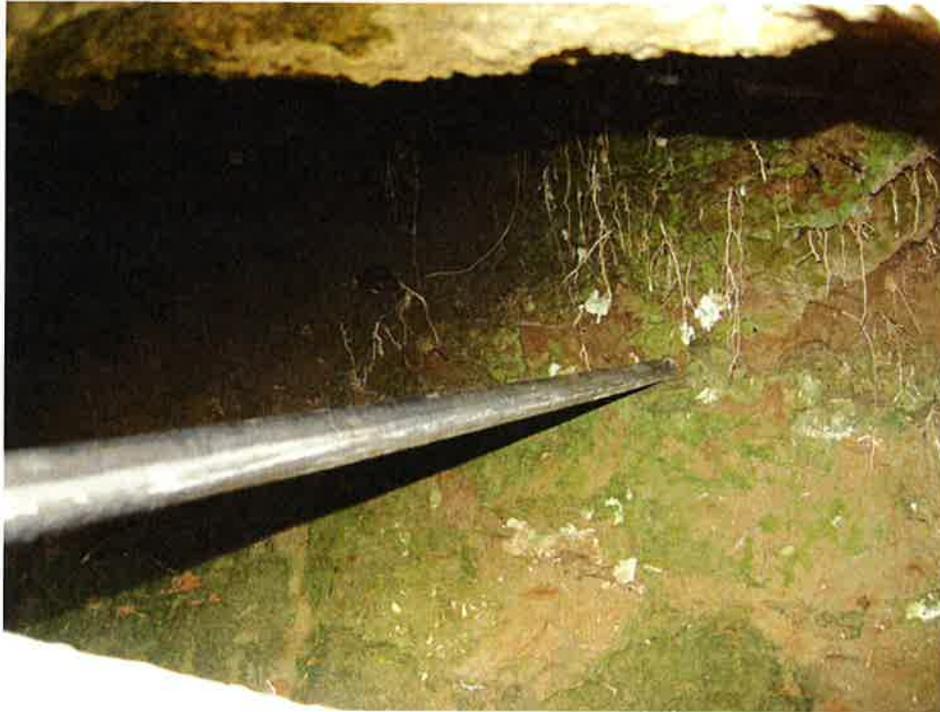
Photo 1. Void in Bay G, at approximately the upper tieback row, looking through gap between lagging boards. Void up to 3 feet deep. Note concrete at top of picture. Void has chimneyed up behind concrete approximately 1.5 feet. Void extends to approximately 4 feet below the row 1 tiebacks.

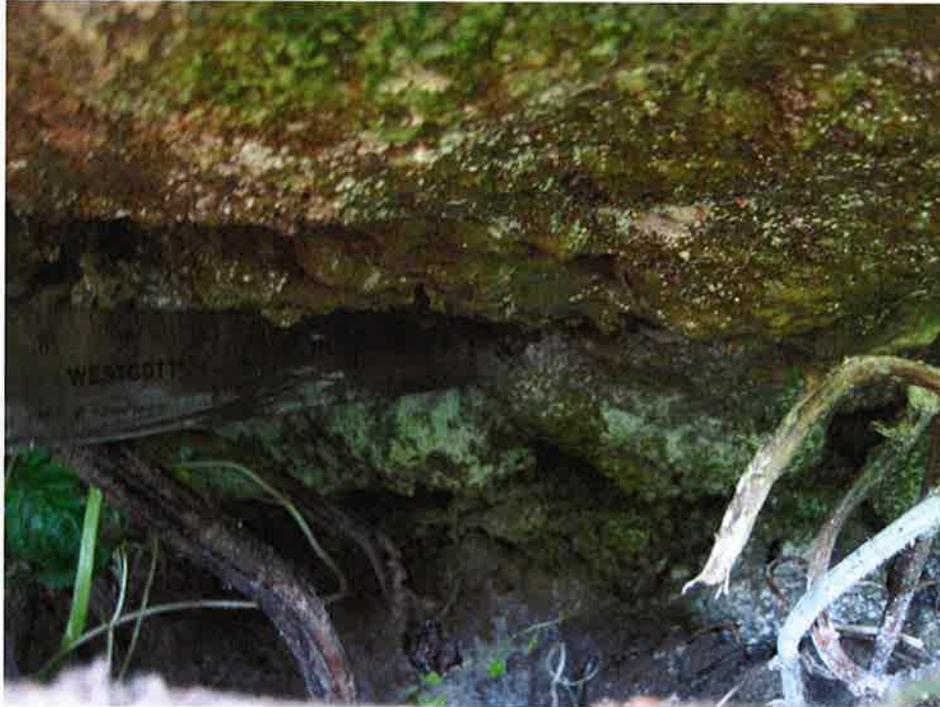
Photo 2. Void at Bay N, approximately 4 feet below the upper tieback row. Photo taken looking through gap between lagging boards. Void extends approximately 2 to 2.5 feet behind the wood lagging. Note concrete above ruler.

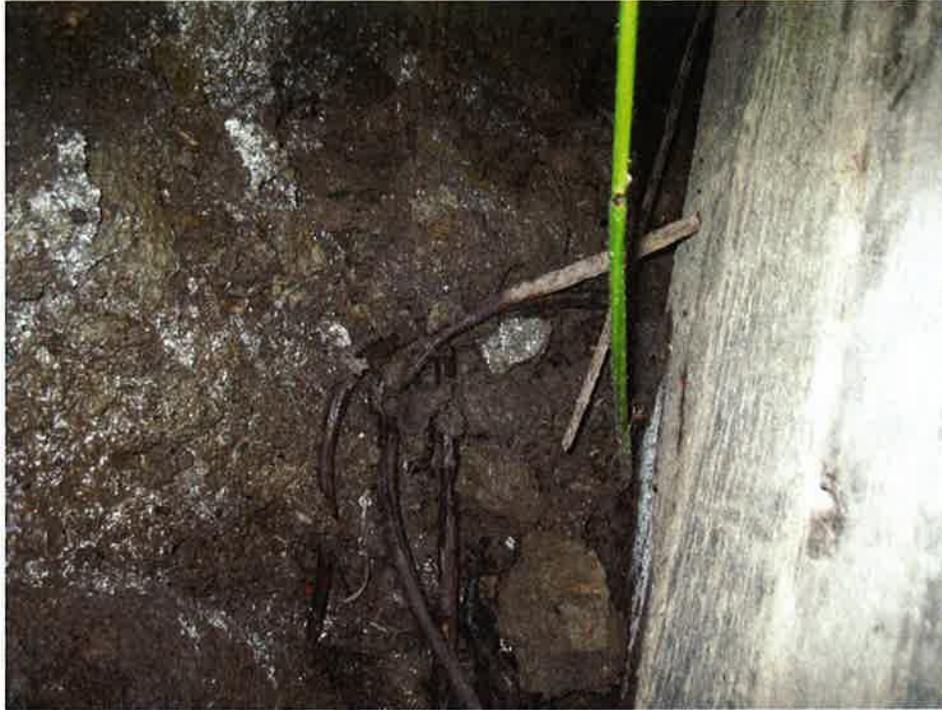
Photo 3. Void behind lagging board in Bay L. Void extends to approximately 3 feet behind the wood lagging (on right side of photograph) and is up to approximately 3 feet high.

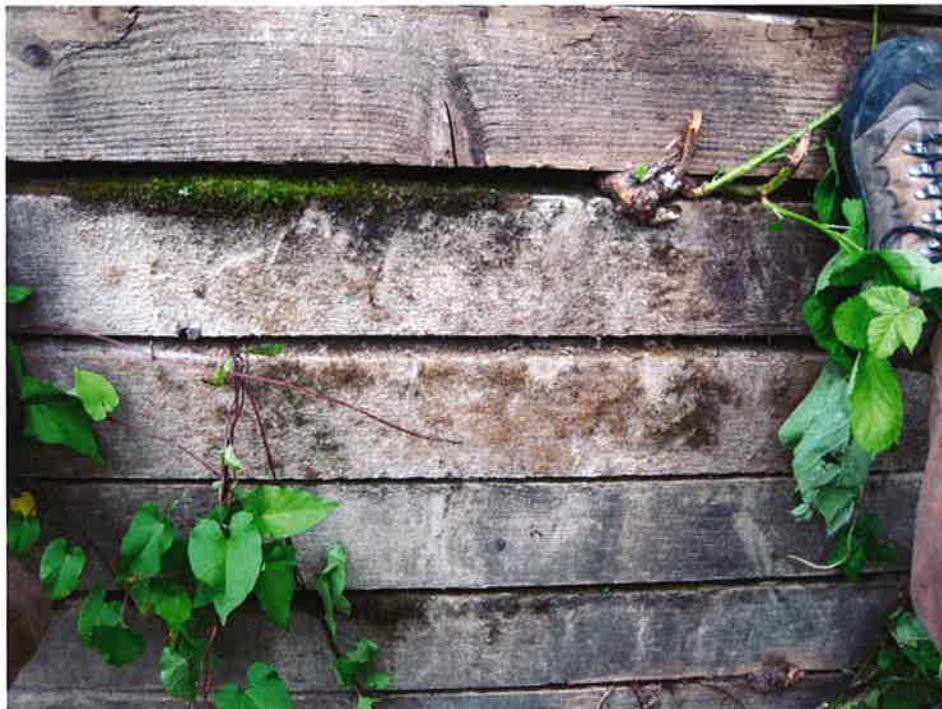
Photo 4. Bay N at approximately 8 feet below the upper tieback row. Indication of soil movement through gaps in lagging board and down wall face. Observed at the bottom of 2.5-ft-deep void.

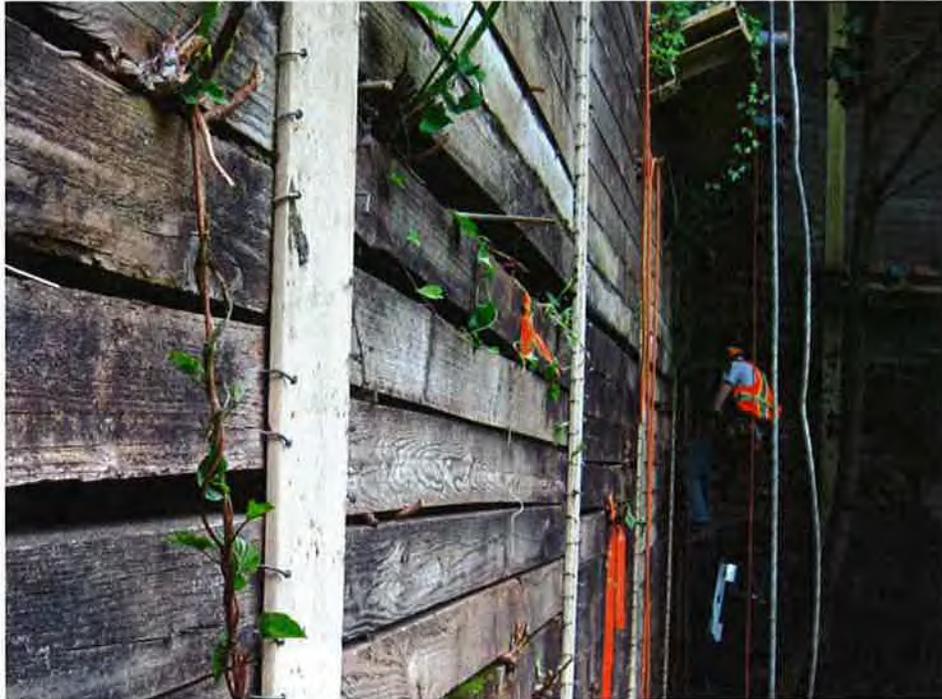
Photo 5. Gaps between lagging boards from Bay M, looking south.
