Inspection Report

Facility: Tacoma Rhodes Broadway Building

Department of Enterprise Services, Tacoma, WA

Work Order #: 35207

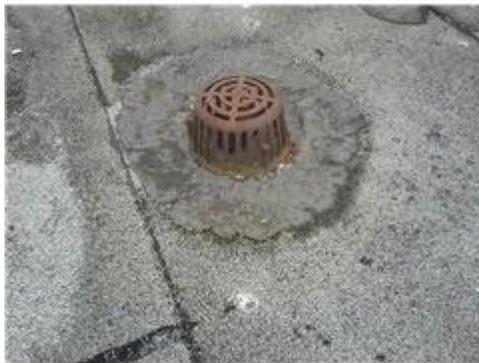
Condition: D-114 Drain- failed patch
Severity: 3 - Immediate Action
Qty: SF: 3 LF: 8 EA: 1

The patch has failed. A permanent repair is required as soon as possible.

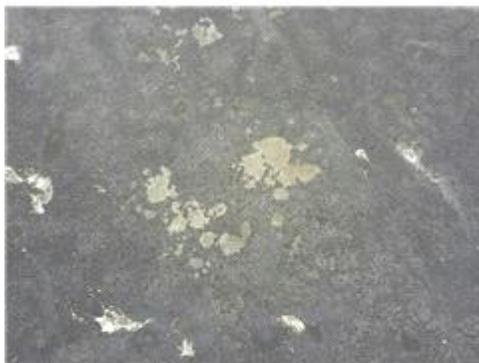
Condition: F-100 Field Membrane- deteriorated
Severity: 3 - Immediate Action
Qty: SF: 3750 LF: 250 EA: 1

The roof membrane is deteriorated and should be replaced to avoid further degradation.

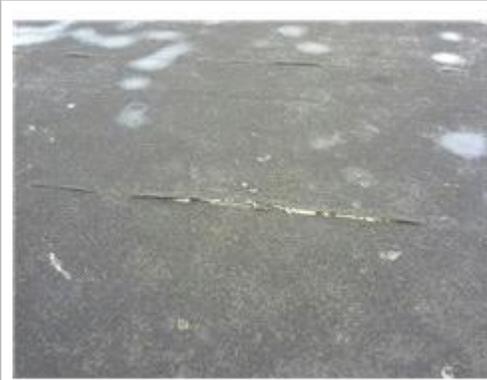
Condition: F-110 Field Membrane- open lap

Severity: 3 - Immediate Action

An opening has formed at the edge of the felt that will allow water penetration.

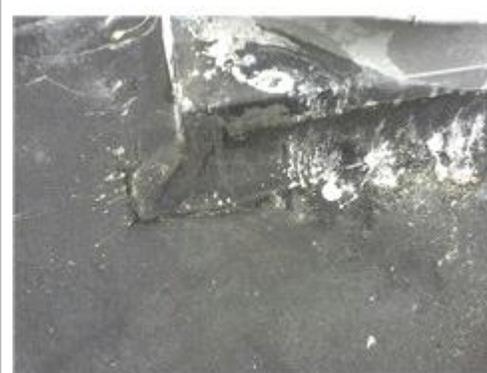
Condition: P-104 Penetration- splits

Severity: 3 - Immediate Action

Splits in membrane flashing caused by deterioration or roof movement will allow water to penetrate.

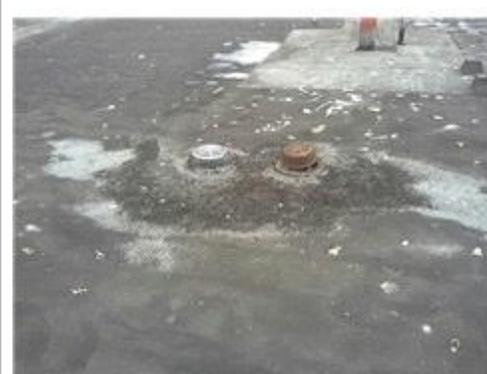
Condition: 004- Debris on roof

Severity: 2 - Secondary Repair

Debris were noted to be moderate at this time.

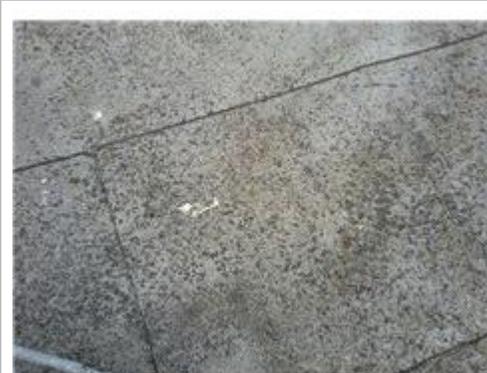
Condition: F-118 Field Membrane- loss of granules

Severity: 2 - Secondary Repair

The mineral granules have come off the cap sheet, exposing the underlying felt, which will lead to premature deterioration.

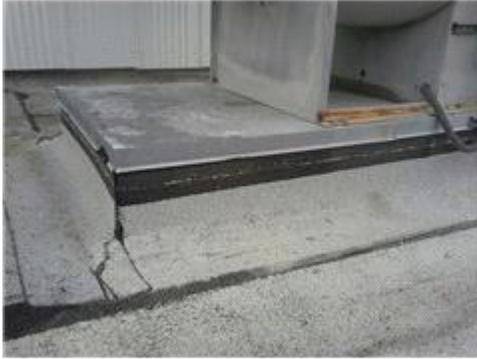
Condition: P-150 Penetration- improper detail

Severity: 2 - Secondary Repair

Flashing membrane doesn't go up the curb to the top and needs counter flashing to be added.

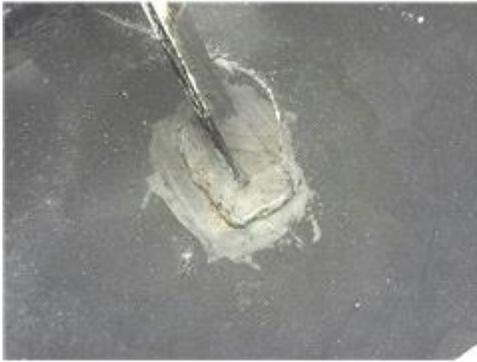
Condition: PP-152 Pitch Pan- Sealant failure

Severity: 2 - Secondary Repair

Sealant should be removed and replaced to prevent water entry. This is Typical of 26 locations.

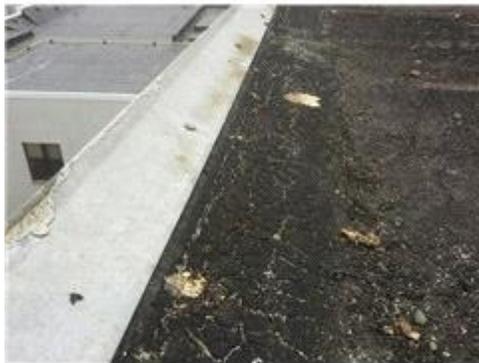
Condition: BF-100 Base Flashing- deteriorated
Severity: 3 - Immediate Action
Qty: SF: 1 LF: 4 EA: 1

The flashing membrane is worn/aged and should be replaced to avoid potential leaks.

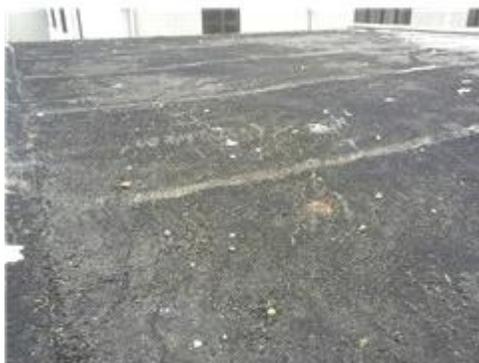
Condition: F-100 Field Membrane- deteriorated
Severity: 3 - Immediate Action
Qty: SF: 1 LF: 4 EA: 1

The roof membrane is worn/aged and should be planned for replacement

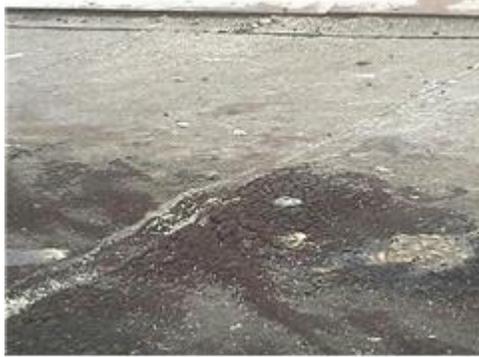
Condition: F-200 Field Membrane- blister

Severity: 2 - Secondary Repair

Blisters are caused by gases trapped between the roof system and have the potential of being ruptured with foot traffic.

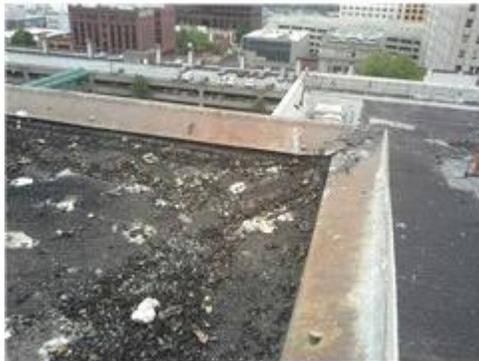
Condition: MC-300 Metal Cap- loose/missing fasteners

Severity: 2 - Secondary Repair

Metal flashing has loose/missing fasteners. Install new fasteners as required to secure flashing.

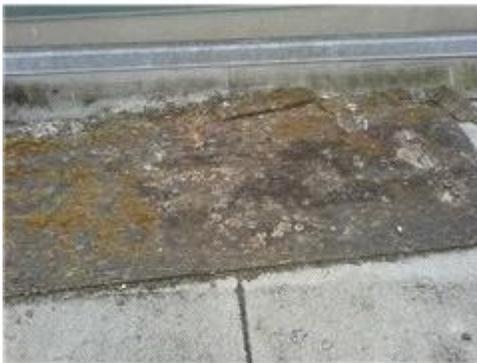
Condition: 004- Debris on roof
Severity: 2 - Secondary Repair
Qty: SF: 1 LF: 4 EA: 1

Two pieces of plywood have been left on roof and are deteriorating. Recommend removing the plywood to prevent premature aging of roofing system.

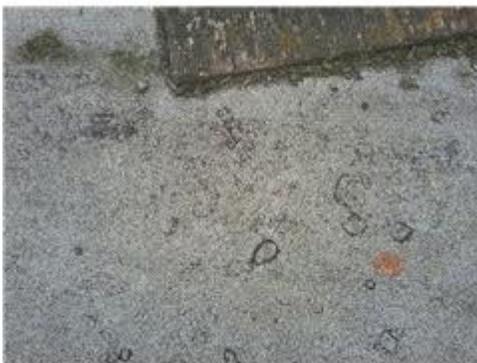
Condition: F-118 Field Membrane- loss of granules
Severity: 2 - Secondary Repair
Qty: SF: 1 LF: 4 EA: 1

The mineral granules have come off the cap sheet, exposing the underlying felt, which will lead to premature deterioration.

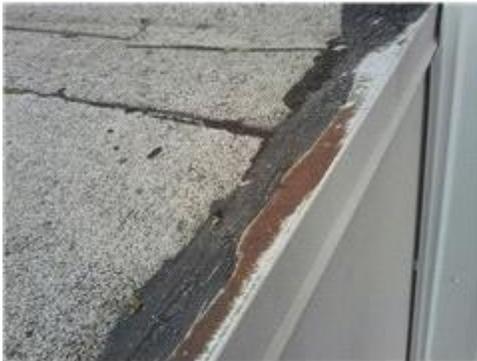
Condition: BF-114 Base Flashing- failed patch
Severity: 3 - Immediate Action
Qty: SF: 4 LF: 10 EA: 1

The current patch has failed. A permanent repair is required as soon as possible.

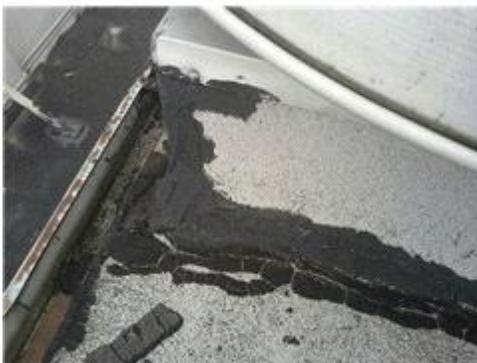
Condition: P-114 Penetration- failed patch
Severity: 3 - Immediate Action
Qty: SF: 3 LF: 7 EA: 1

The patch has failed. A permanent repair is required as soon as possible.

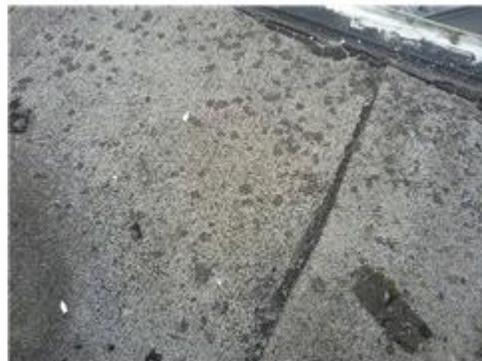
Condition: F-118 Field Membrane- loss of granules

Severity: 2 - Secondary Repair

The mineral granules have come off the cap sheet, exposing the underlying felt, which will lead to premature deterioration.

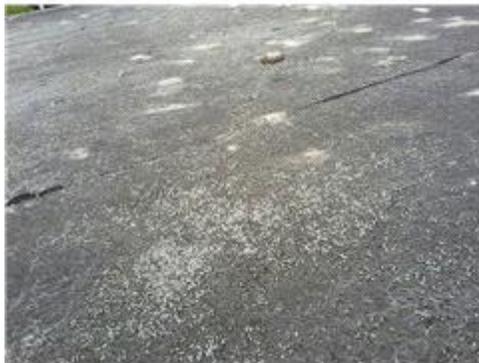
Condition: F-100 Field Membrane- deteriorated
Severity: 3 - Immediate Action
Qty: SF: 248 LF: 67 EA: 1

The roof membrane is deteriorated and should be replaced to avoid further degradation.

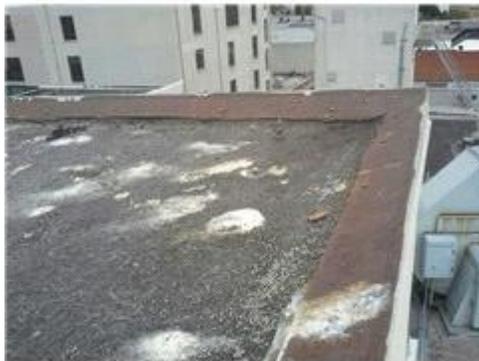
Condition: MC-302 Metal Cap- corrosion
Severity: 1 - Monitor
Qty: SF: 0 LF: 42 EA: 1

Metal flashing has corroded which can eventually lead to failing sheet metal flashing.
