TACOMA RHODES CENTER
Buildings Assessment
Tacoma, Washington

BCRA Design
2106 Pacific Avenue, Suite 300
Tacoma Wa, 98422
Ph: 253-627-4367
Fx: 253-627-4395
BCRA Job No. R06224

State Agreement No. 2007-003 A(1)

TACOMA RHODES CENTER BUILDINGS ASSESSMENT

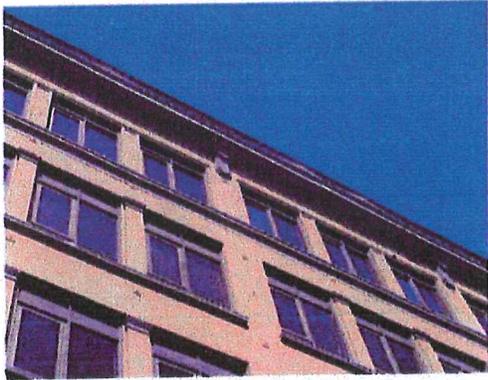
Cornice damage

4.08	Repair exterior brick veneer, sills, and cornices						\$114,000.00	Item includes sill restoration and replacement, brick veneer repairs and cornice repair.

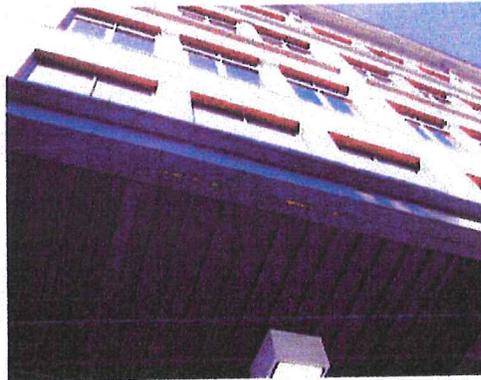
Front Canopy rust

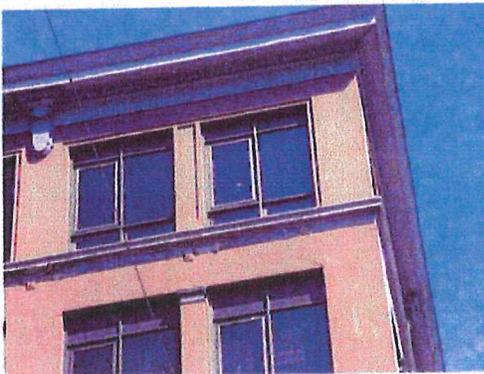
South – East Corner damage

4.0 EXTERIOR ENVELOPE								
4.0 Previous State Scope Items								
4.02	Remove and rebuild cracked and displaced brick at southeast corner						\$0.00	Use 2006 estimat for escalation to 2007

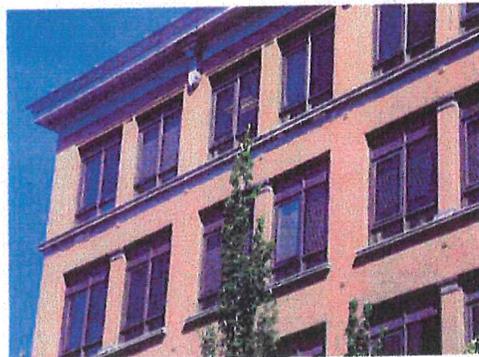
South wall sill condition

4.03	Selective grinding and pointing of brick						\$48,816.00	
4.04	Clean, prep, and paint sheet metal cornice						\$0.00	
4.05	Sandstone Window Sills - remove loose stone and coat with water repellent sealer		WJE Report: Sills that are badly deteriorated should be replaced with pre-cast concrete sills				\$5,233.00	Verify that work is not duplicated in line item below for exterior brick, sill and cornice repair.

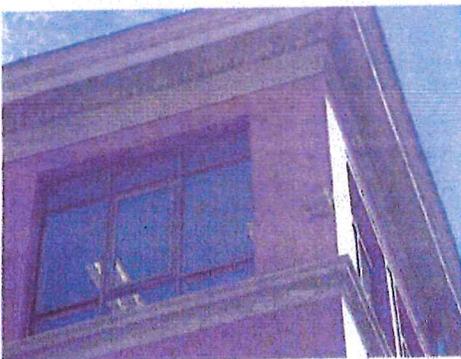
Condition of mortar

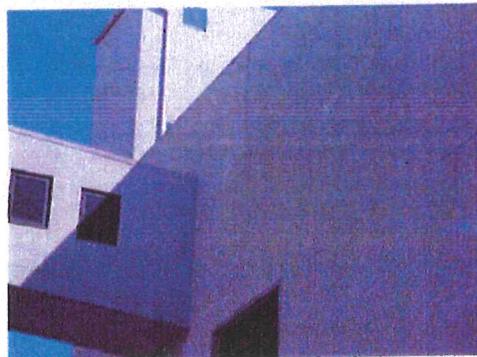
Stucco – cracked and peeling

4.13	Doors		replace doors at roof access and freight elevator penthouse				\$3,420.00	
4.14	Wall - Stucco	Some cracking and peeling conditions	Clean, repair, prep and paint		sf	5,900	\$14,797.00

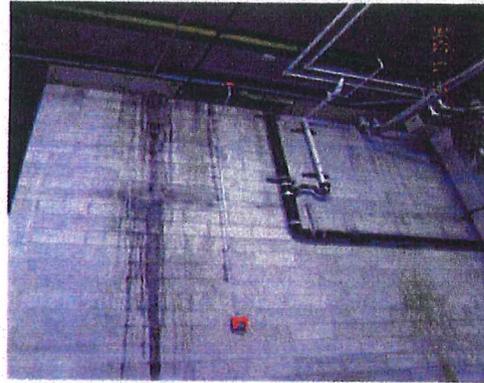
Evidence of water leaks – 1st Floor West

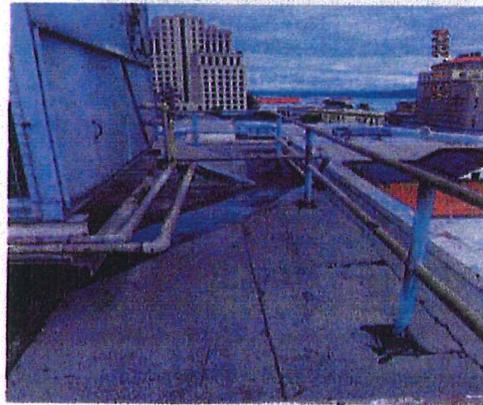
Existing BUR roof condition on 7th floor roof

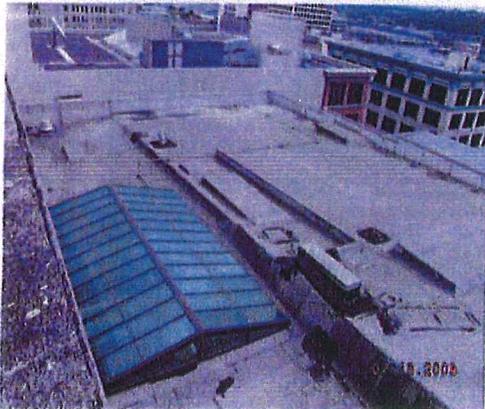
5th floor BUR roof and skylight

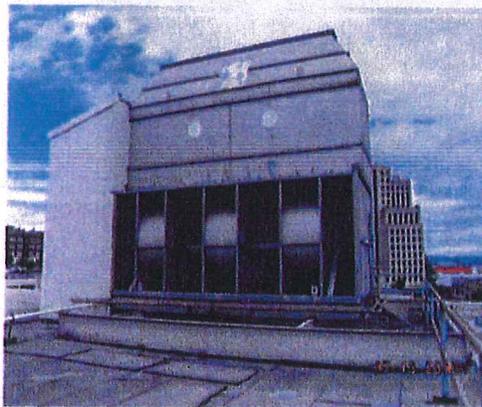
The boiler and cooling tower are original vintage. They are beyond their recommended service life. Additionally, the boiler is not located within fire resistive construction, as would be required by modern codes.

Cooling Tower at 7th floor roof

It is also recommended that the boiler and cooling tower be replaced. This is a point of consolidation for the hydronics system. A single failure can cause the entire system to be non-functional. For this reason, along with the age of equipment, it is recommended that this equipment be replaced. As part of this replacement, consideration should be given to replacing the boiler with multiple smaller boilers to allow for some redundancy.

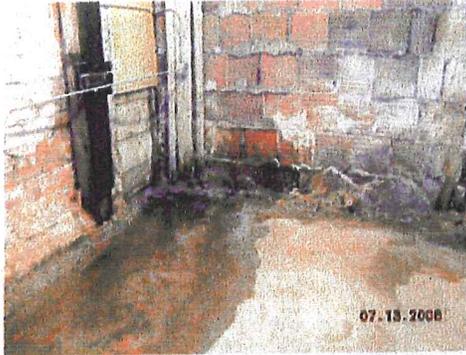
Ground water in basement

No major plumbing work is being recommended at this time. It is, however, recommended that a sump pump system be installed in the basement to mitigate flooding issues from groundwater intrusion.

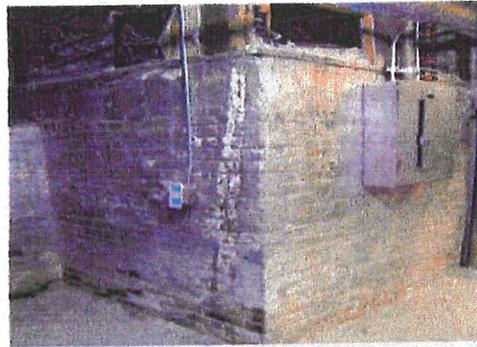
Suspected lead base paint in basement

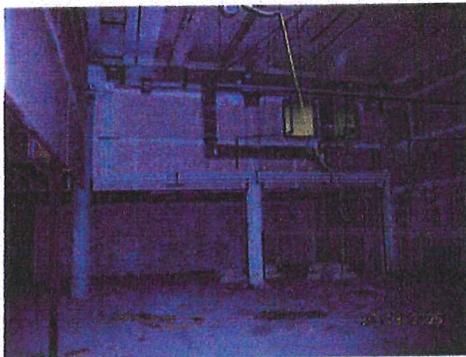
First Floor – Incomplete West tenant shell space

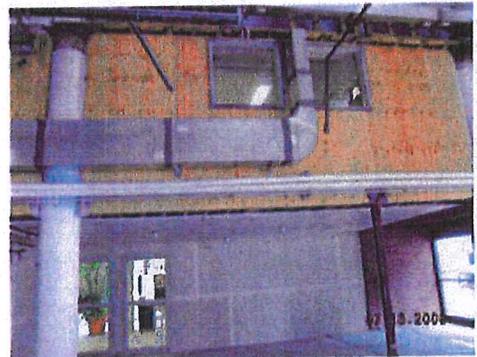
First floor – Incomplete East tenant shell space

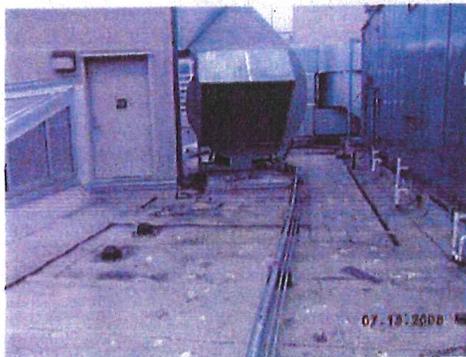
Existing BUR Roof condition

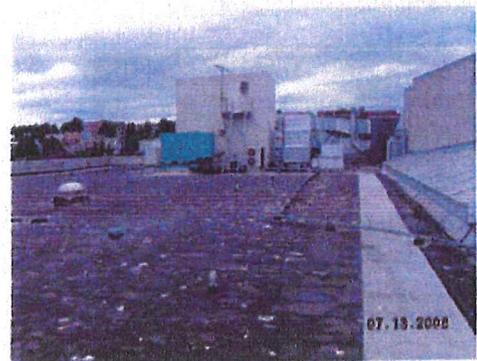
Existing BUR Roof condition

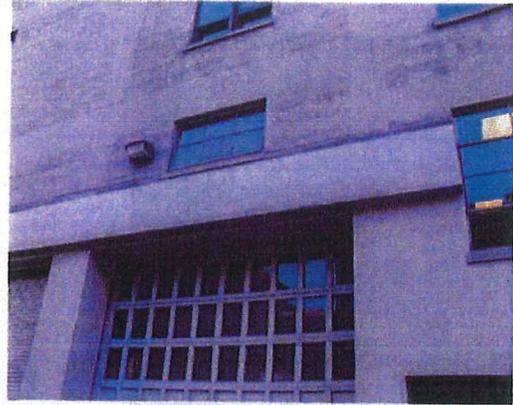
Steel windows to be replaced along C-Street

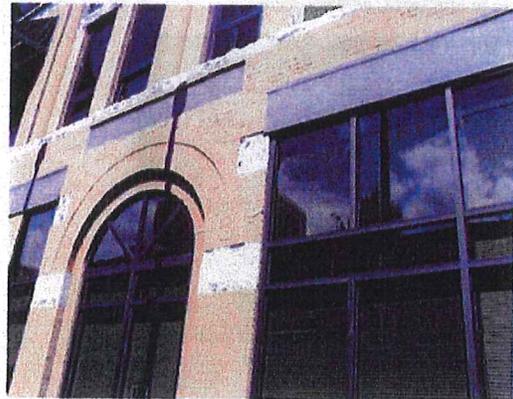
Condition of brick on Market St. side south end

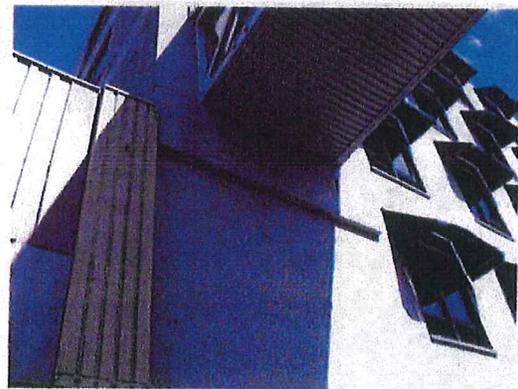
cracked and peeling stucco on Market St. - north end

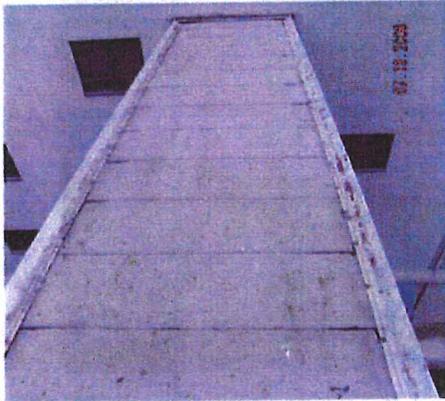
Broadway to Market St. bridge – roof

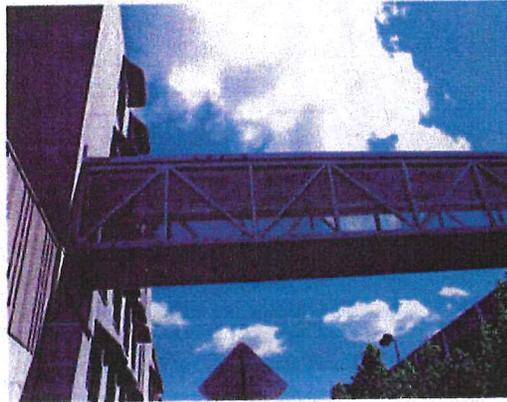
Market St to Garage bridge – peeling paint

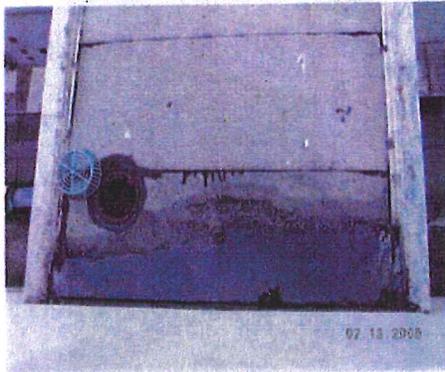
Sky bridge roof condition

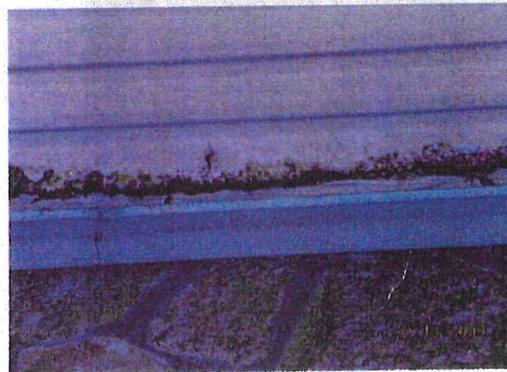
Rust at connection of metal garage deck and sky bridge
