Preliminary Arborist Report

Site: Capitol Campus - Newhouse Building and Surrounding Area
Olympia, WA 98504

Re: Development Preparation Tree Assessment and Sonic Tomography

Date: November 24, 2021

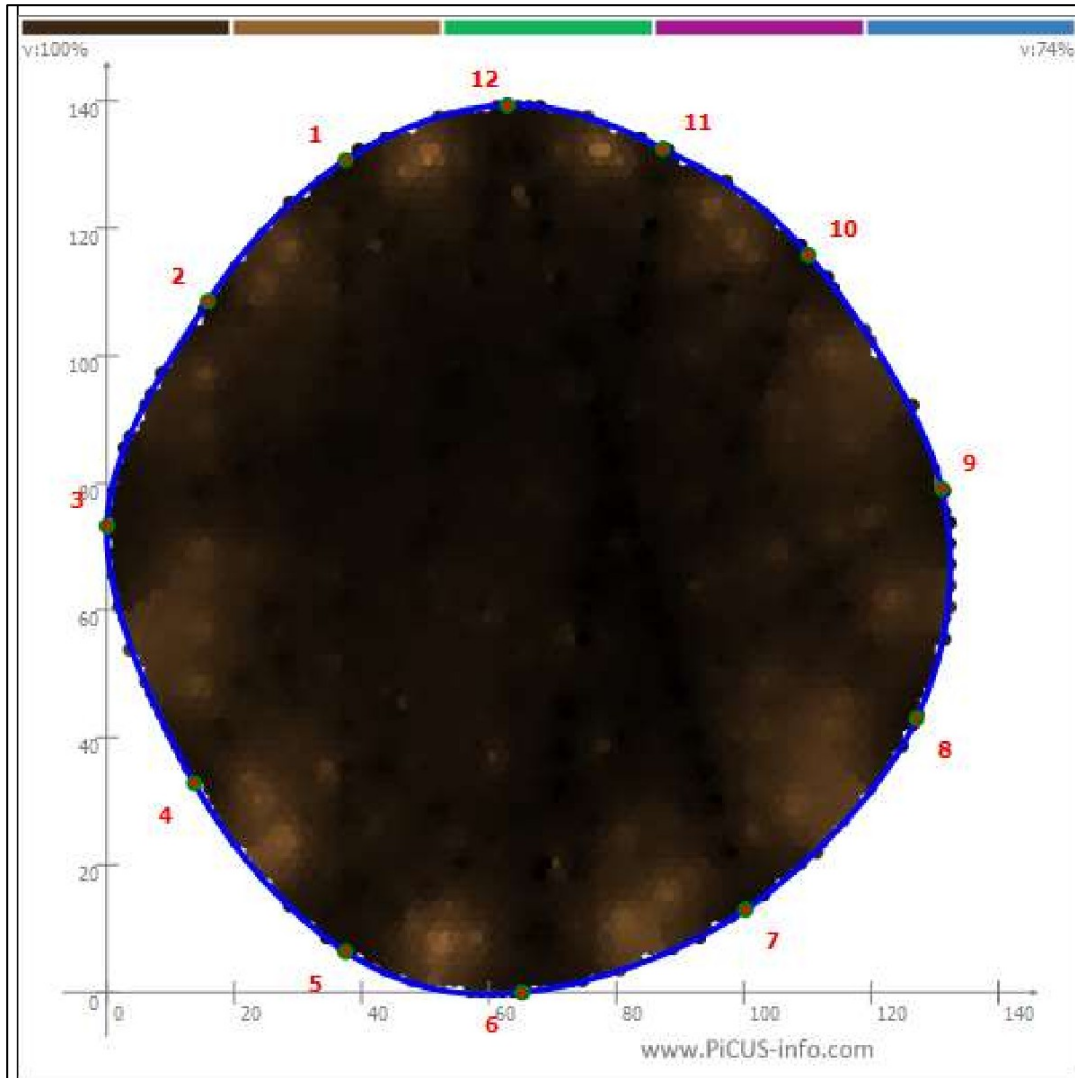
We were asked to perform sonic tomography on this tree to determine if there is any internal decay. The sonic tomography was performed at 45-inches above the base and indicated sound wood throughout (Figure 1).

Figure 1. Sonic tomogram showing sound wood, the brown area, throughout the trunk at 45-inches above the base.

Due to the size and prominence of tree 13-15 we have rated the retention value as high. Care should be taken when demolishing the existing Newhouse Building to ensure debris does not enter the tree protection zone. Any new structure built to the east of this tree should remain within the existing building footprint to minimize disturbance to the soils around the tree.

To further minimize disturbance the existing Newhouse Building foundation should remain in place to the east of the tree with the new structures foundation installed immediately east of the old foundation. By retaining the old foundation soil disturbance will be minimized.

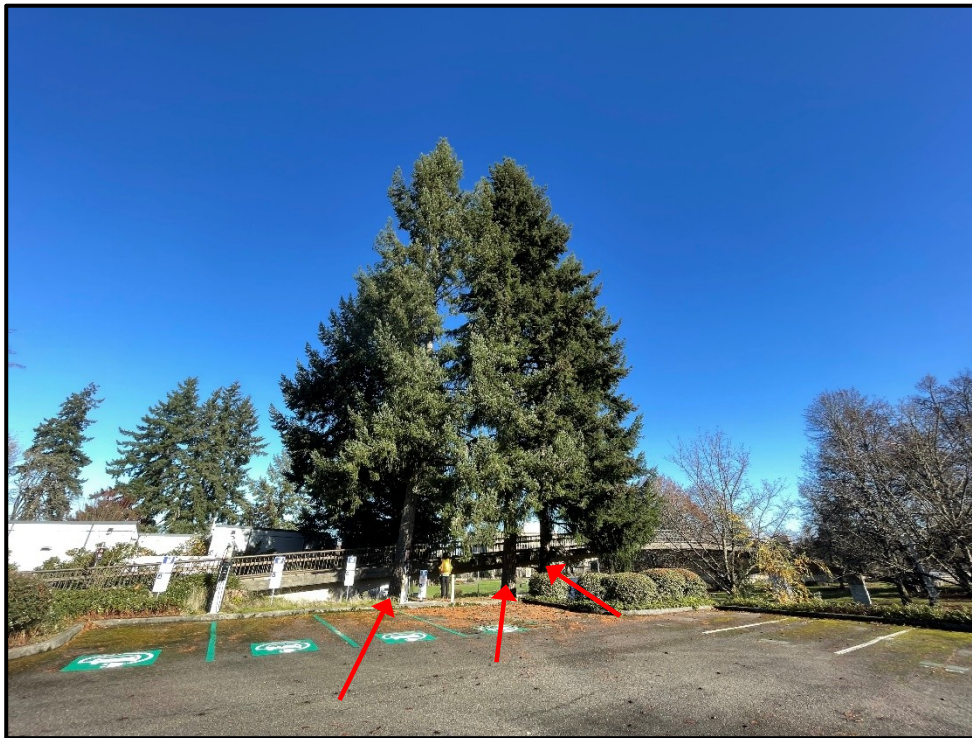
These three trees are all Douglas-fir trees located south of the pedestrian bridge and approximately 5-feet north of the parking lot. All three are in good health and excellent structural condition with straight trunks and good branch spacing. An electric vehicle charging station was recently installed approximately 4-feet to the south of tree 13-25 and may have caused root damage.

Photo 1. Trees 13-25, 13-26, and 13-27 from left to right, indicated by red arrows, in relation to existing infrastructure.

The retention value of these trees is high due to their location near the pedestrian foot bridge, good health and excellent structural condition. If these trees are to be retained the existing hardscape and infrastructure must be carefully demolished to minimally disturb the soils within the TPZ.

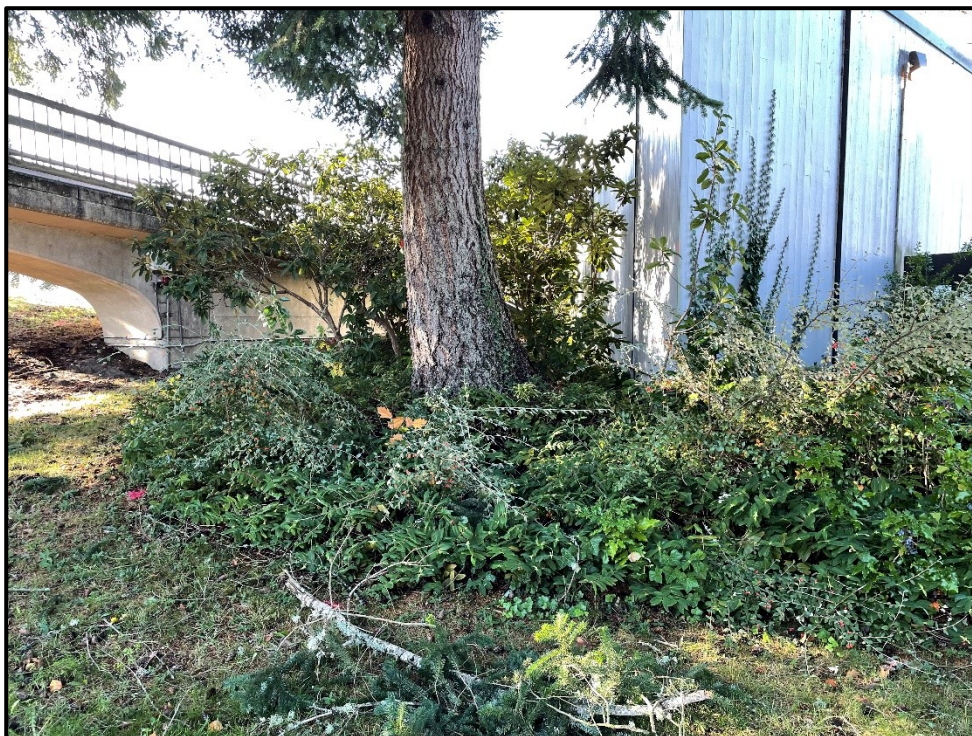
Tree 13-23 is a Douglas-fir tree with a DSH of 29.8-inches located approximately 5-feet to the east of the closed visitor center on the east side of the site. This tree is in good health and good structural condition with a very mildly swept base.

Photo 2. Tree 13-23 with the slightly swept base in relation to the closed visitor center building.

Tree 13-23 has a high retention value, and if retained care must be taken when demolishing the adjacent building to prevent damage to the tree and disturbance to the soils within the TPZ.

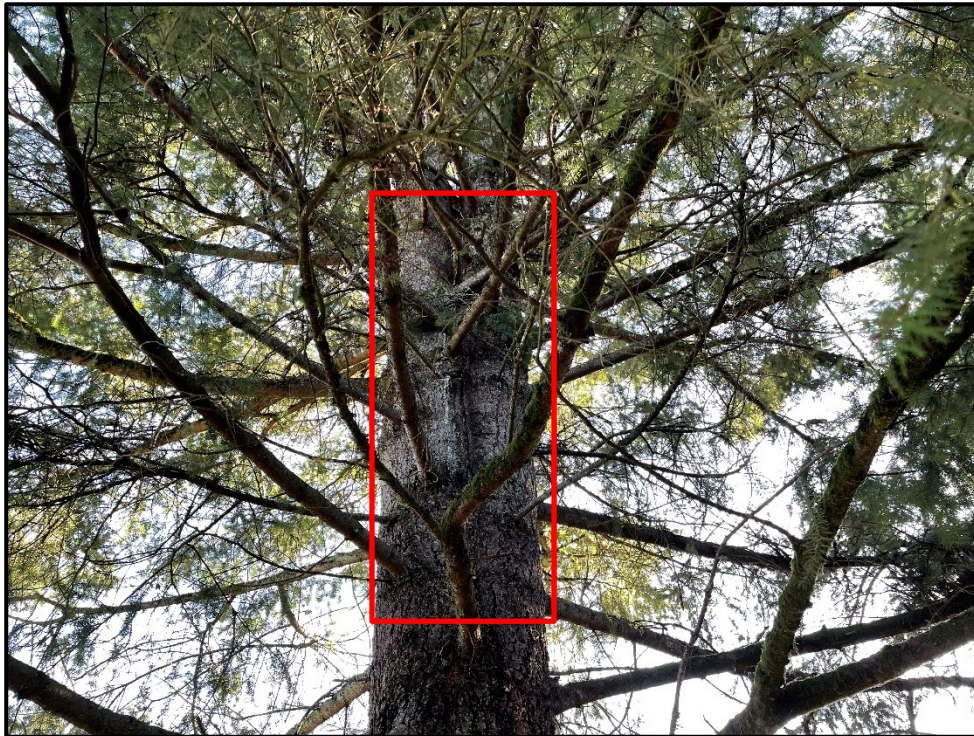
Tree 13-1 is a Douglas-fir (*Pseudotsuga menziesii*) tree in the northeast corner of the site growing in a lawn. This tree has surface roots indicating shallow compacted soils. There is also a narrow codominant union at approximately 10 feet with included bark.

We have rated the retention value of this tree as moderate due to the narrow codominant union, which will likely require monitoring and possible management such as installation of a cable between the trunks as the tree matures.

Photo 3. Narrow codominant union with included bark of tree 13-1.

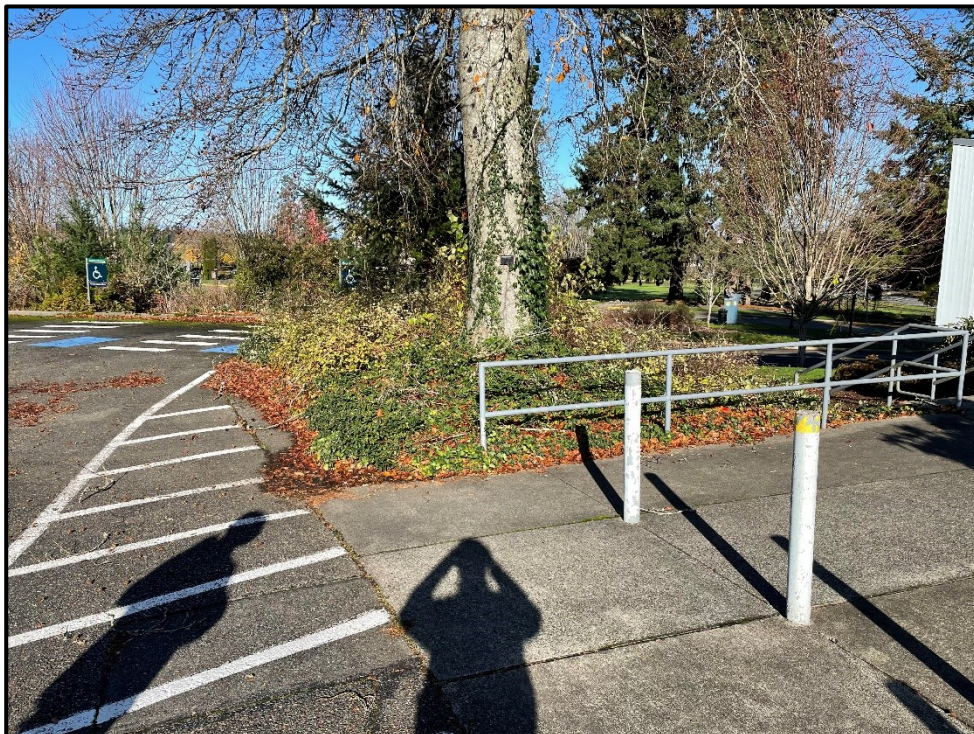
Tree 13-22 is a European beech (*Fagus sylvatica*) tree growing adjacent to the parking lot on the east half of the site. This tree is in good health and structural condition and has a high retention value.

Photo 4. The hardscape surrounding tree 13-22.

If this tree is retained the existing hardscape within the TPZ must be demolished carefully, working away from the tree to make sure that no machinery traverses exposed soils. There is also a small Douglas-fir tree to the northwest of tree 13-22 which could also be retained as part of the TPZ of this tree.

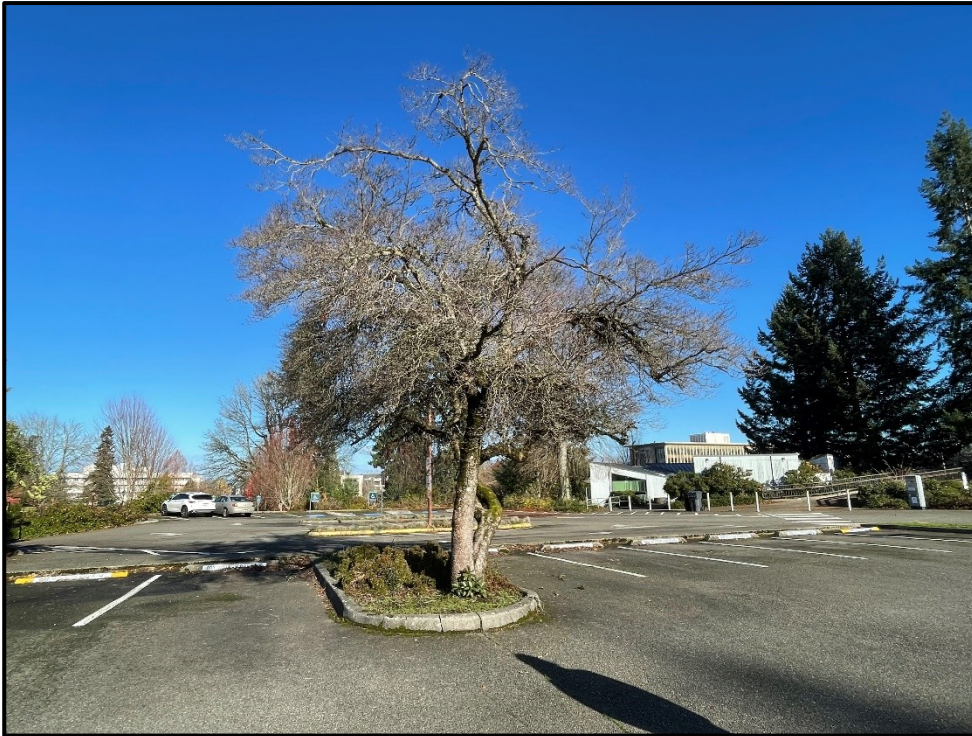
Tree 13-32 is an eastern dogwood (*Cornus florida*) tree growing in a small planting space in a parking lot. This tree is in fair health and structural condition with little shoot extension and a codominant union at the base.

Photo 5. Tree 13-32 located in a small planter in the parking lot.

Based on the fair health and structure of this tree and its location in the parking lot we have rated the retention value of this tree as moderate. If this tree is retained we recommend careful removal of the asphalt and curb around the tree to minimize disturbance to soils within the TPZ. The planting area surrounding the tree should also be expanded in the final plans to allow for improved access to water and nutrients.

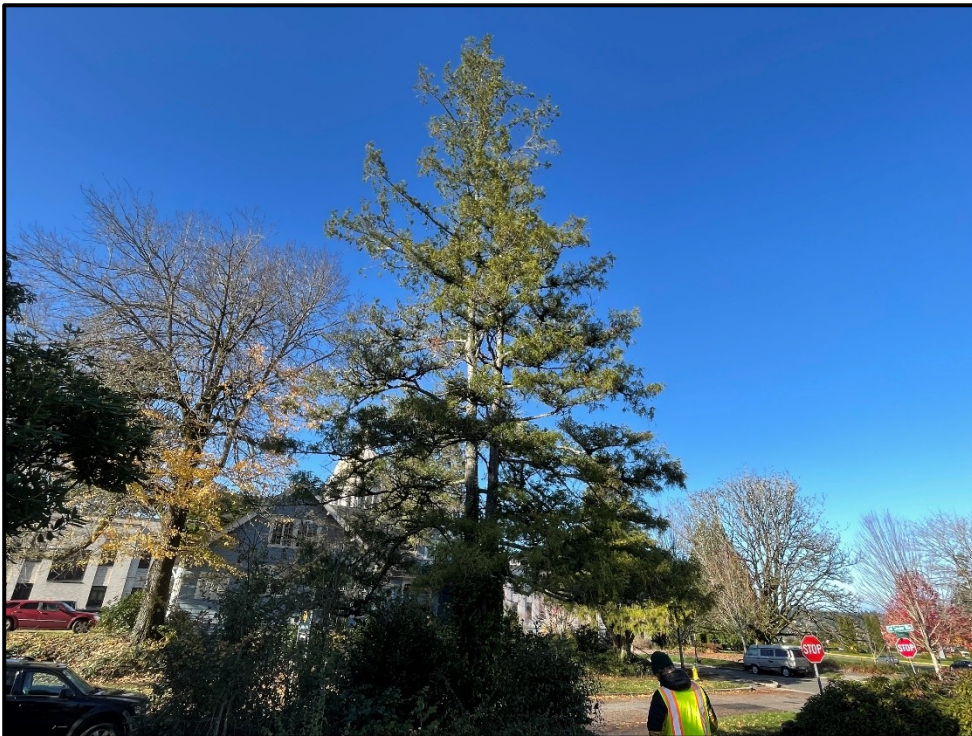
Tree 13-100 is a Sawara cypress tree located to the north of tree 13-36 in a small planting area between a parking lot, rock retaining wall, and a set of concrete stairs. The canopy of this tree is slightly sparse, and the trunk has a narrow codominant union at approximately 4-feet with included bark. We rated the retention value of this tree as moderate based on the tree's condition and the amount of hardscape surrounding the tree which will likely require demolition.

Photo 6. Tree 13-100 in a small planting area with a codominant trunk.

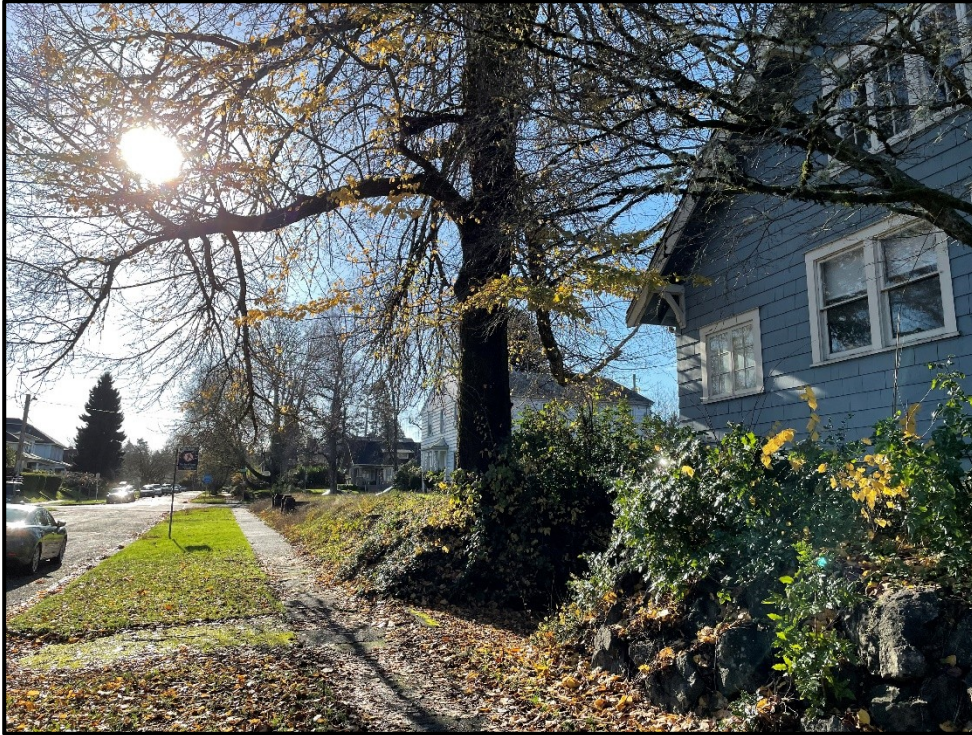
Tree 13-41 is an elm (*Ulmus* sp.) tree with a DSH of 36.5-inches and in good health and good structural condition. This tree is located at the top corner of a rock retaining wall above a sidewalk along Columbia Way SW and a driveway to the adjacent building. At this time Dutch elm disease (*Ophiostoma ulmi*) is not prevalent in the area, but is currently spreading in our region. Due to the condition of the tree and its location at the top of the rock retaining wall we rated the retention value as moderate. In determining the retention status of this tree the presence of Dutch elm disease in the region should be considered.

Photo 7. Tree 13-41 growing at the top corner of a rock retaining wall along Columbia Way SW.

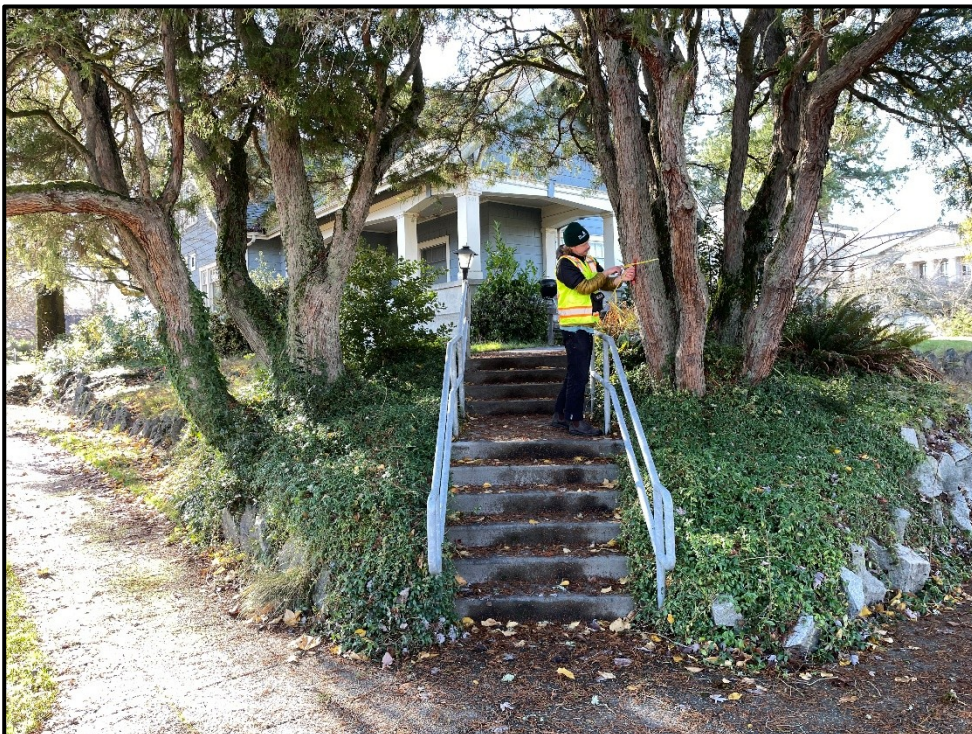
Trees 13-6 and 13-7 are tagged in the field as 34-102 and 34-103 respectively. These trees are both Sawara cypress (*Chamaecyparis pisifera* 'Filifera') trees growing at the top of rock retaining walls at the corner of Columbia St SW and Sid Snyder Ave SW. There is also a concrete stairway between the two trees.

We have rated the retention value of these trees as high due to their good health and good structural condition as well as their large single-stem equivalent diameters for the cultivar.

Photo 8. Trees 13-6 (left) and 13-7 (right) growing above rock retaining walls and with concrete steps between.

If these trees are retained the rock retaining walls within the recommended limits of disturbance must be left in place. The stairs between the trees should also either remain in place, or be removed carefully

taking care not to disturb the surrounding soils. Additionally, no grading may occur within the recommended limits of disturbance. If the grade will be lowered around the trees a retaining wall should be considered at the edge of the TPZ to maintain the current elevation within the TPZ.

When designing and locating any new retaining walls around the trees any over excavation necessary for forms and drainage must be accounted for in the plans.

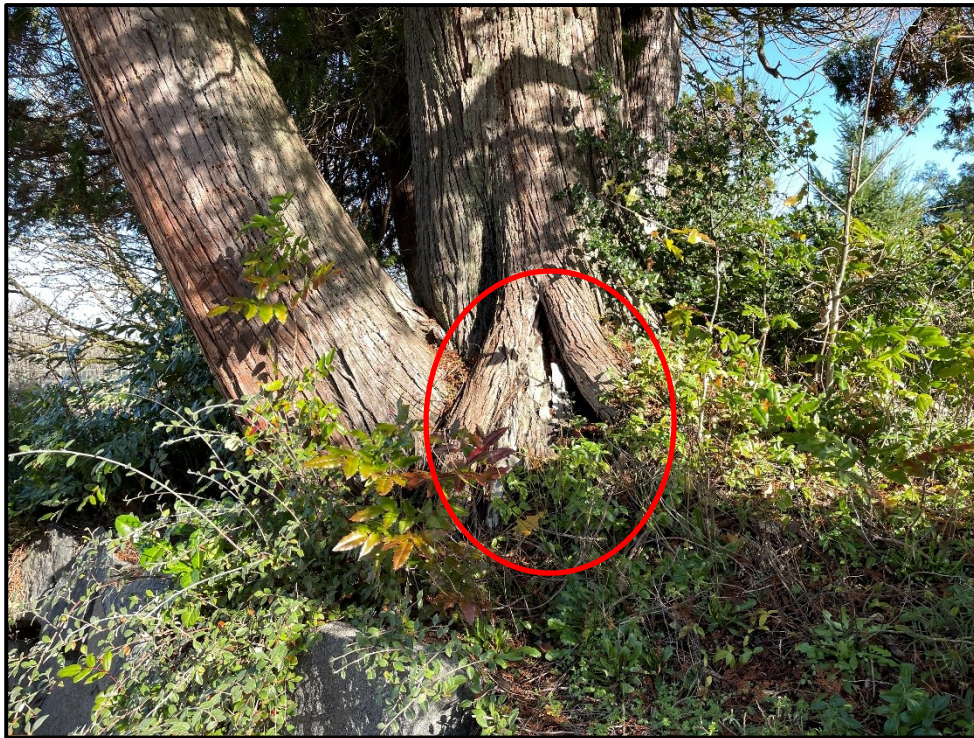
Tree 13-105 is a Sawara cypress tree growing immediately adjacent to tree 13-104 at the top of a rock wall. This tree has a single-stem equivalent diameter of 39.8-inches and is in fair health and fair structural condition. The canopy is slightly sparse, and the eastern trunk likely has a decay cavity from the base to approximately 3-feet in height originating from a large wound at the base on the southwest side. Based on the tree's location and the likely decay we rated the retention value of this tree as low.

Photo 9. Wound with decay at the base of tree 13-105.

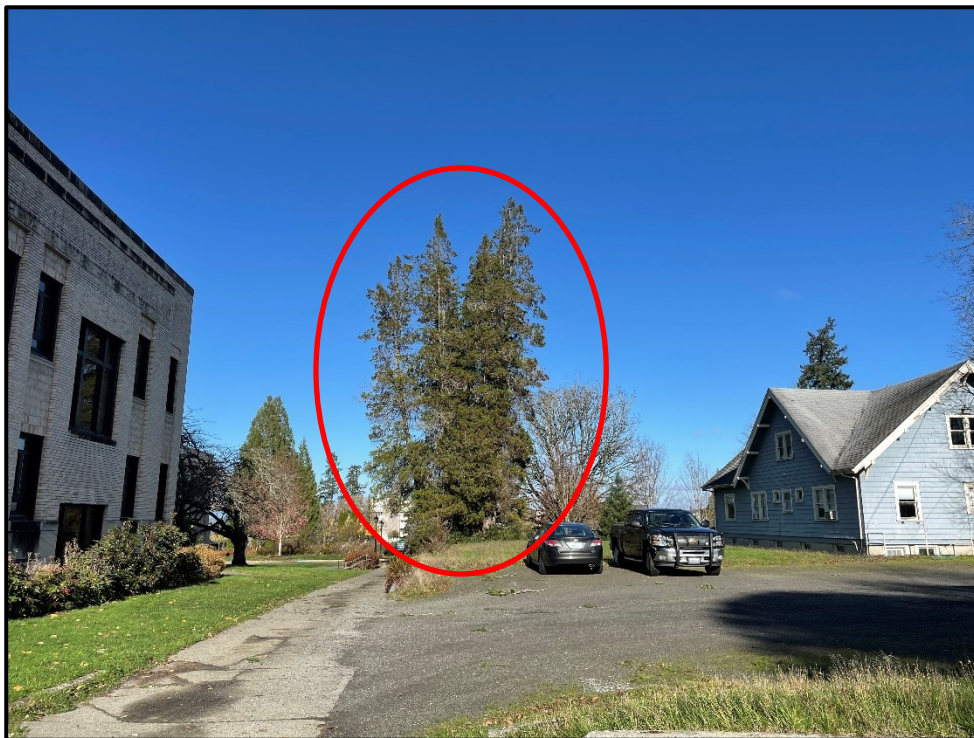
Tree 13-104 is a Sawara cypress tree growing at the top of a rock wall south of Sid Snyder Ave SW. This tree has a single-stem equivalent diameter of 41.6-inches and is in good health and fair structural condition. The trunk is codominant at the base, and the canopy is slightly sparse in locations. Based on the trees location at the top of a rock wall and the condition we have rated the retention value of this tree as moderate.

Photo 10. Canopies of trees 13-104 (roughly left half of circled canopy) and 13-105 (roughly right half of circled canopy), and surrounding area.

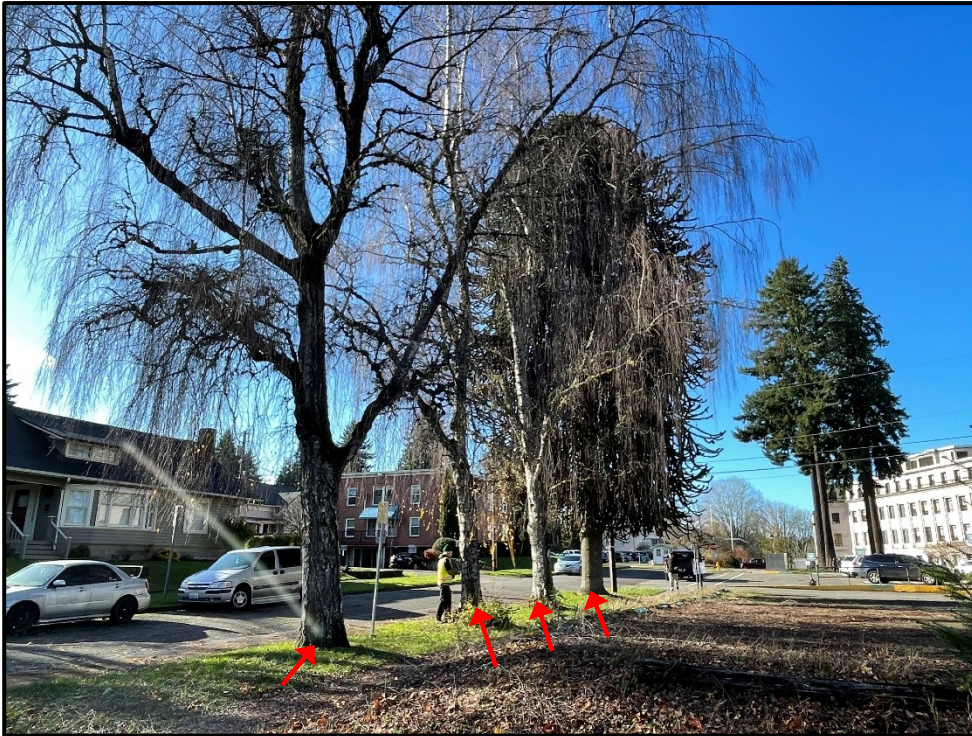
These trees are all European white birch (*Betula pendula*) trees growing north of 15th Ave SW west of Columbia Way SW. These trees are in good health and good structural condition and have diameters at standard height from 17.7-inches to 29-inches. At this time bronze birch borer (*Agrilus anxius*) is not prevalent in the area, but is currently spreading in our region. We rated the retention value of these

trees as high due to their good condition and location at the edge of the site. In determining the retention status of these trees the presence of bronze birch borer in the region should be considered.

Tree 13-47 is a monkey puzzle (*Araucaria araucana*) tree growing to the west of the row of trees 13-44 to 13-46. This tree is in good health and structural condition and is located at the edge of the site. Due to the location and condition we rated the retention value of this tree as high. Hardscape removal and replacement within the TPZ of this tree must be performed to minimize disturbance to soils.

Photo 11. From left to right trees 13-44, 16-45, 13-46, and 13-47, and surrounding area.

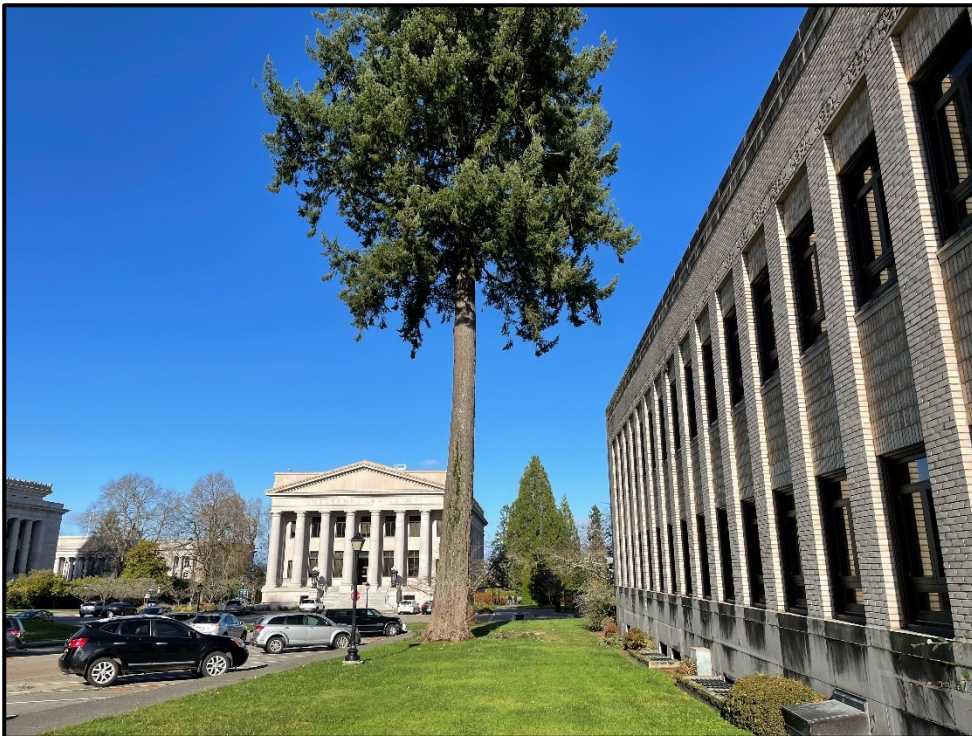
Tree 13-15 is a Douglas-fir tree growing in a lawn to the west of the existing Newhouse Building. This tree has a DSH of 57.6-inches and is in good health and structural condition. There is a codominant union at approximately 100-feet above the base. One of the codominant stems has been reduced to approximately 3 feet above the codominant union leaving one live branch on the stem. The canopy of this tree was raised to above the existing Newhouse Building roof in the past and any pruning wounds were not visible at the time of our assessment.

Photo 12. Tree 13-15 in relation to the existing Newhouse Building.
