# McNeil Island Repair and Replacement Options 10182200022

Prepared by KPFF Consulting Engineers  
Draft Repair and Replacement Options  
June 30, 2022

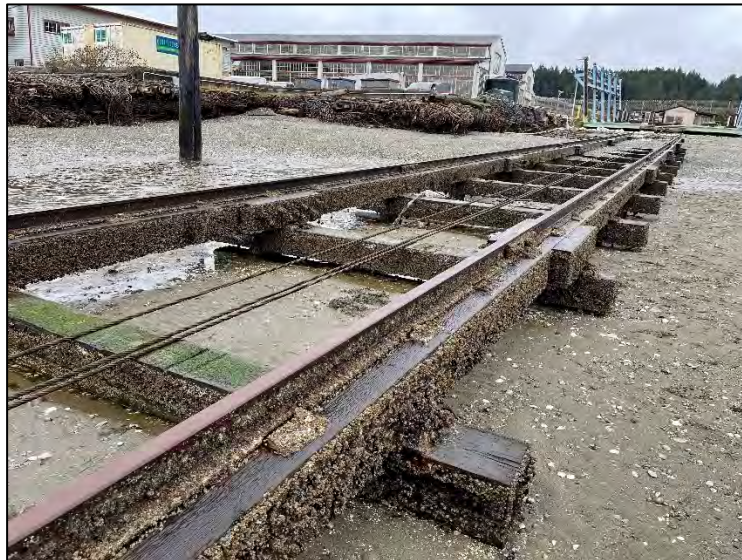
Photo 1A: Marine Railway Dry Dock

Most of the fasteners within the system have heavy marine growth and surface corrosion. Surface corrosion is caused by electrochemical reactions that destroy the structure of the material. These occurrences result in fatigue of the metal and reduce the structural capabilities that they once had. The pile cap brackets and pile fasteners are all heavily corroded. These members are a concern because of the decrease in strength of their structure. The rail

base plates south of the bulkhead are all severely corroded with section loss. This severe corrosion is a typical occurrence when metals of different carbon content are in contact in a saltwater environment. The rails are not fully secured laterally by the rail base plates due to the section loss. This is of high concern because the rails are free to move in unsecured locations and could result in failure of the system during operation. The overall rating of the fasteners in the system is a three and requires immediate action.

The rails north of the bulkhead have minor uniform surface corrosion and pitting in sections. The rails south of the bulkhead have heavy surface corrosion, pitting and marine growth. The rail splice bars are heavily corroded and have heavy marine growth. The conditions gradually worsen down the rail system toward the anchor point at the southern end. If the rails get any worse, they may pose a threat to the operational capabilities of the system. The overall rating of the rails is a 3 and will require immediate action.

The timber rail beams, pile caps, and piles are covered in marine growth, green moss algae, they are hollow in sections along the system, and there is evidence of Teredo ship worm activity. The hollowing of the timber rails, pile caps, and piles is a major concern because the structural capacity of the members is severely degraded. Teredo shipworm activity can result in a major loss of volume in timber members. When the shipworm borers itself into timber, it leaves a small opening for respiration. Once shipworm activity has occurred, the only way to eliminate the issue is to suffocate the borers by covering the member with a plastic material. If a timber rail beam, pile, or pile cap were to fail from any of these issues, the system would be out of operation.

The cradle has sections with surface corrosion and delaminating paint. Areas where welded joints are and exposed elements, have heavier surface corrosion. If this is not dealt with, the cradle system will worsen over time and will require significant repairs rather than typical maintenance. The cradle's wheels and axle retainers are heavily corroded. This is a major concern because the wheels are frozen, and the cradle is not able to function as designed without replacement of the necessary mechanical components.

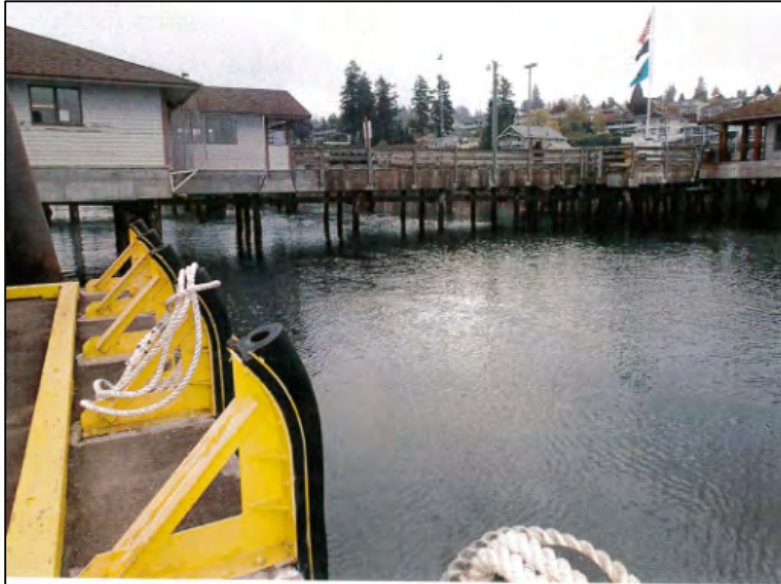
Photo 1B: Steilacoom building trestle

Some of the significant deficiencies include deterioration/marine borer entry of piles supporting the fixed pier, cracking of the welds on the cover plate between the pier and upland entrance, deterioration/splitting of timber curbing, and loose wraps around dolphin piles.

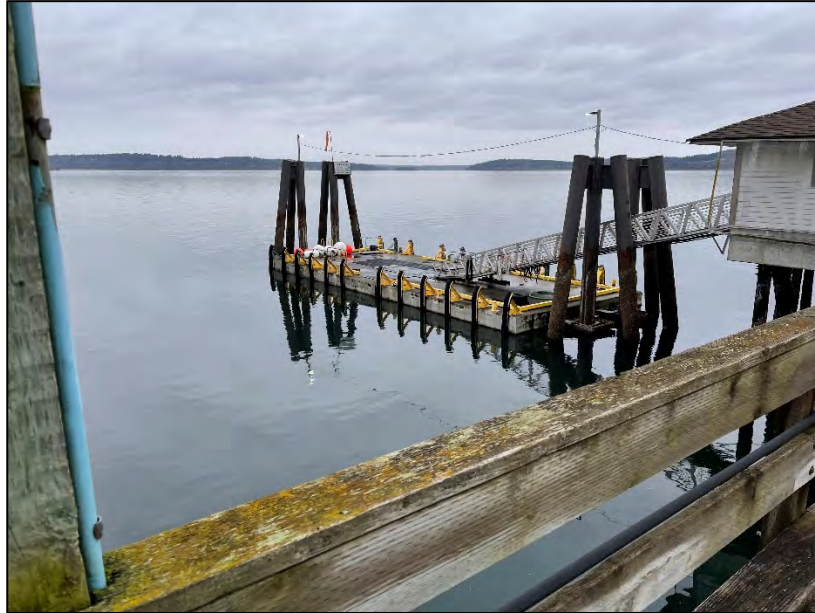
Photo 2: Steilacoom mooring float

Some of the significant deficiencies include water intrusion into the float, broken fenders and fender anchorage, damage from the pile guides on the float due to jamming between the battered piles during extreme high tides, deteriorated piles, the shackle hangers at the upland end of the gangway are deteriorated, and damage to utilities on the bottom of the gangway due to extreme high tides.

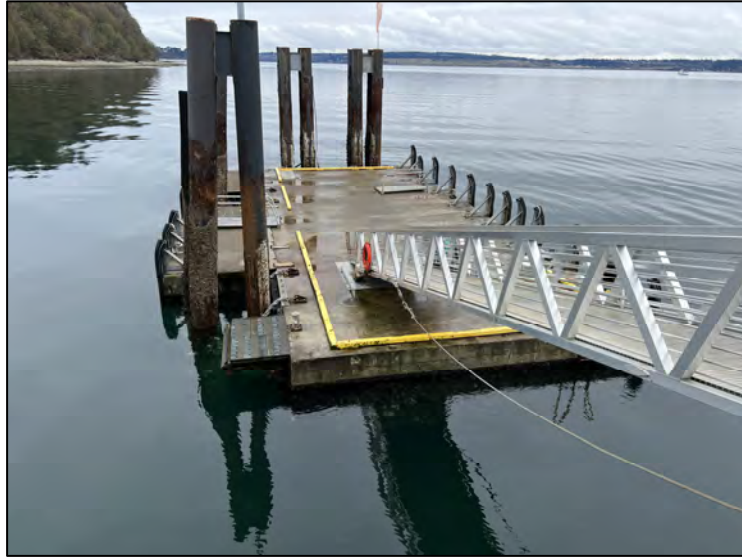
Photo 3: Island Mooring Float

Some of the significant deficiencies include damaged concrete on the floats, deteriorated piles, damaged rub strips on the piles, broken fenders and fender anchorage, damaged connections between floats, deterioration of the hinge at the upland end of the gangway, and deteriorated emergency ladder.

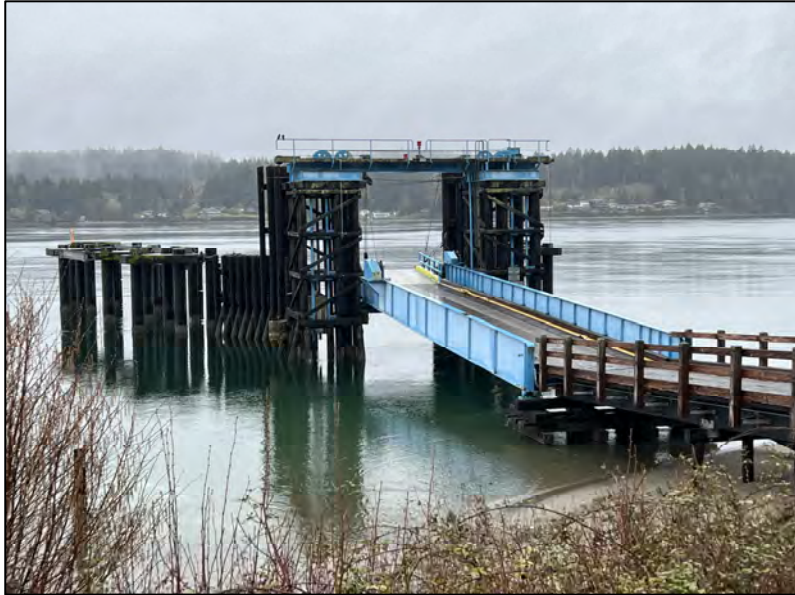
Photo 5: Barge Dock

Some of the significant deficiencies include soft timber decking at the upland end of the trestle, worn deck boards, loose deck bolts, corroded brackets, deterioration at the top of the wing wall piles, deterioration on lower wingwalls, and missing and worn hardware at the waterside end of the apron.

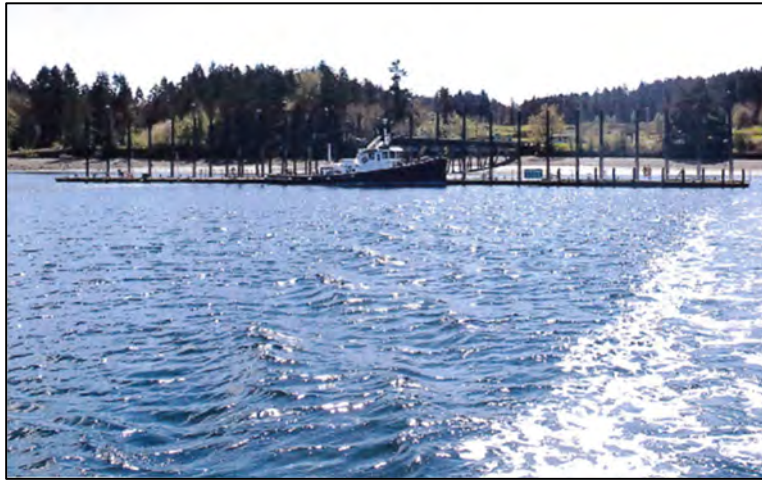
Photo 6: Still Harbor Dock

The Still Harbor Dock is used as the backup ferry landing as well as the primary dock for the emergency vessel and other vessels and barges that are out of service. The dock consists of concrete floats arranged in a T which are held in place by steel guide piles. The floats are accessed by a hinged aluminum gangway supported at the end of a concrete trestle. The trestle is supported by concrete piles. The only issue known at this time is that the steel guide piles have deteriorated.

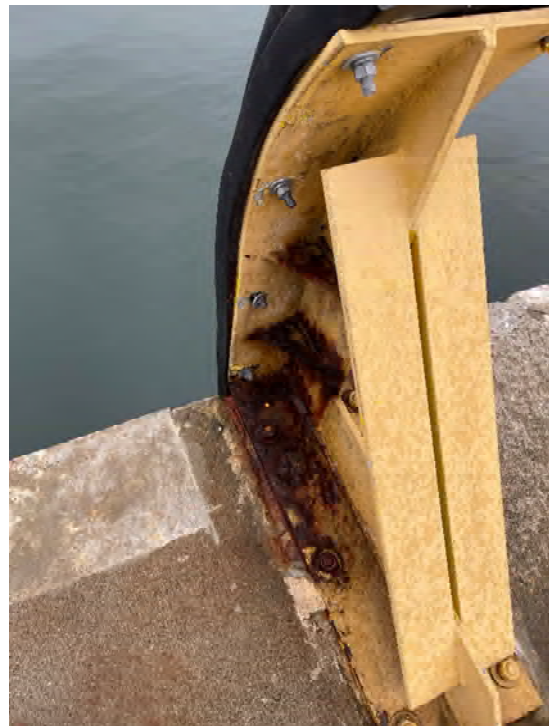
Photo 24: Fender with surface corrosion

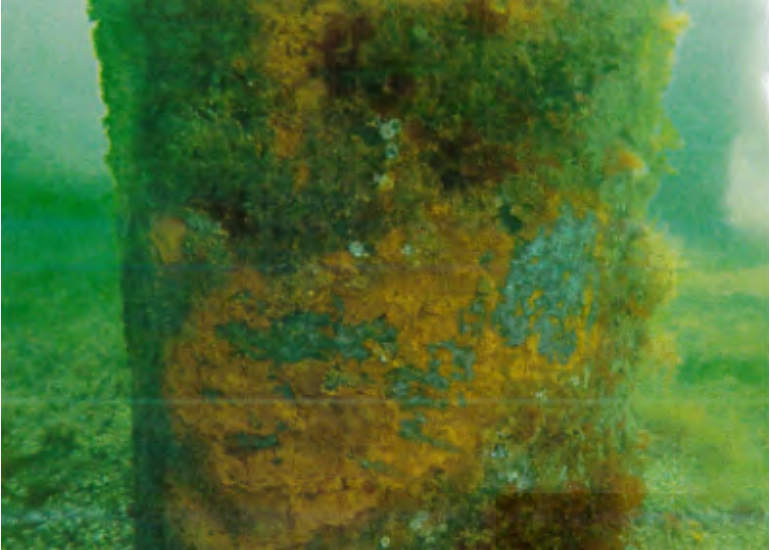
Photo 34: SP4 coating failure and surface corrosion

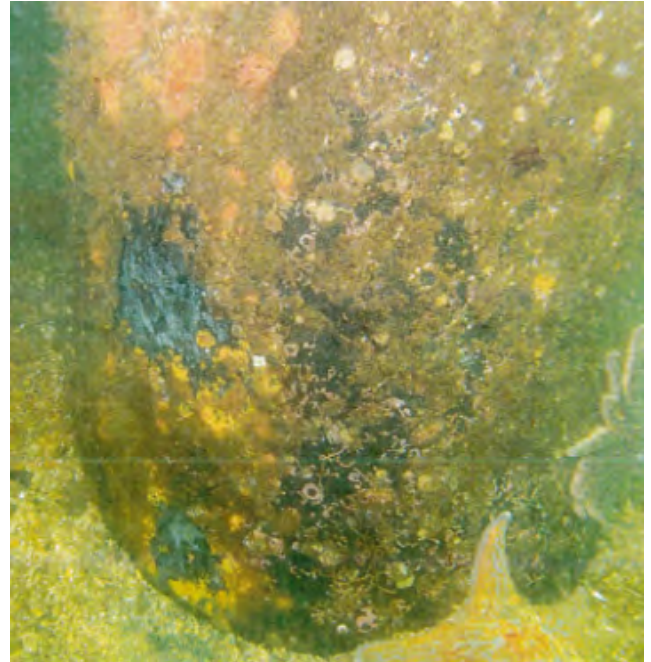
Photo 42: SP4-B typical coating failure and surface corrosion

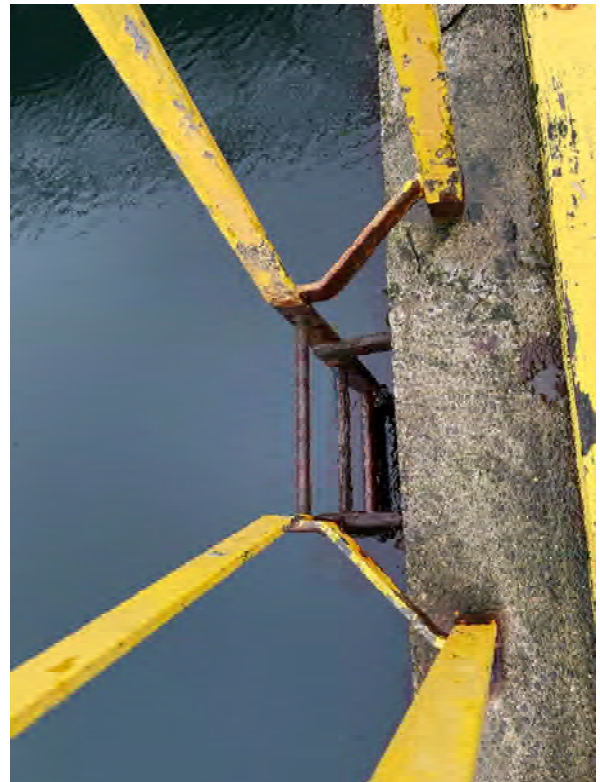
Photo 46: Ladder at Southwestern  
corner of float

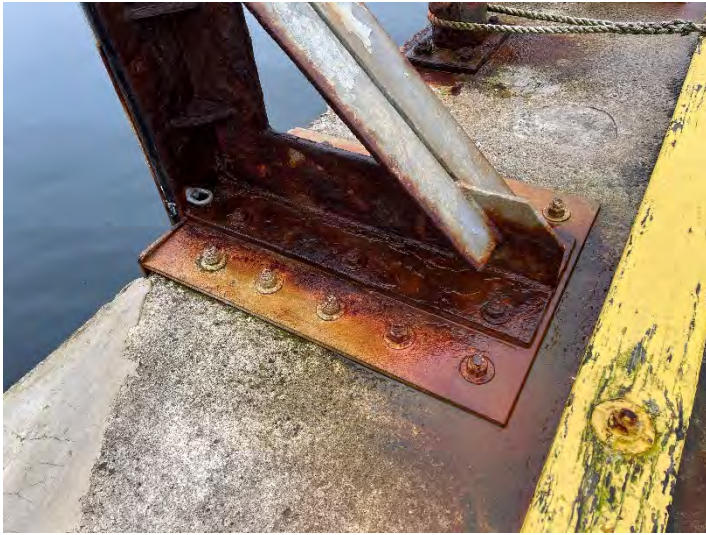
Photo 47: Fender with surface corrosion

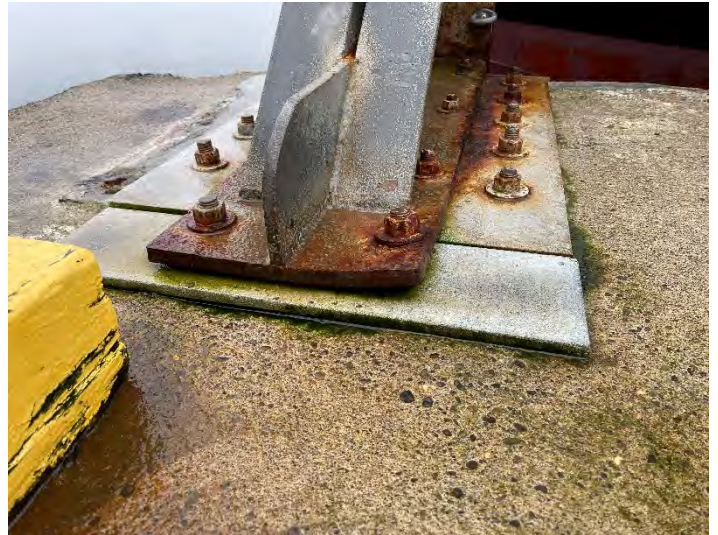
Photo 48: Bent fender with surface corrosion

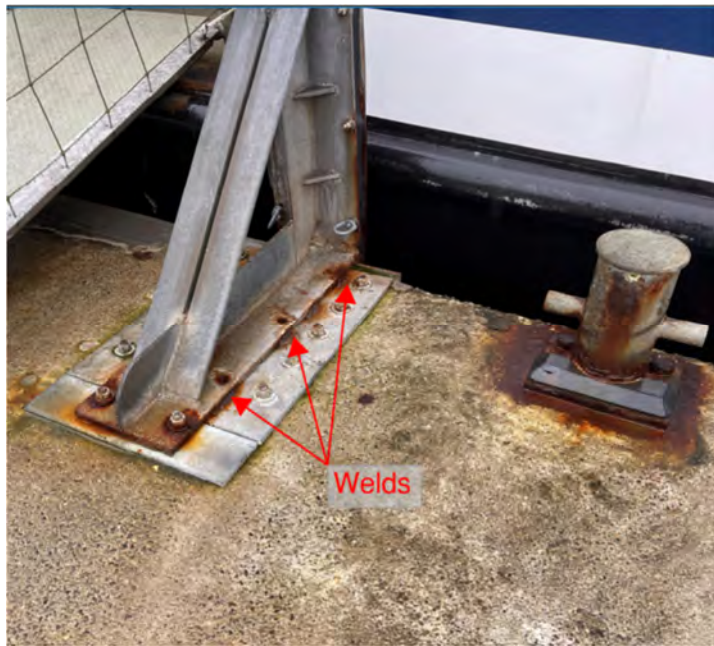
Photo 49: Missing fasteners on fender, secured by welds

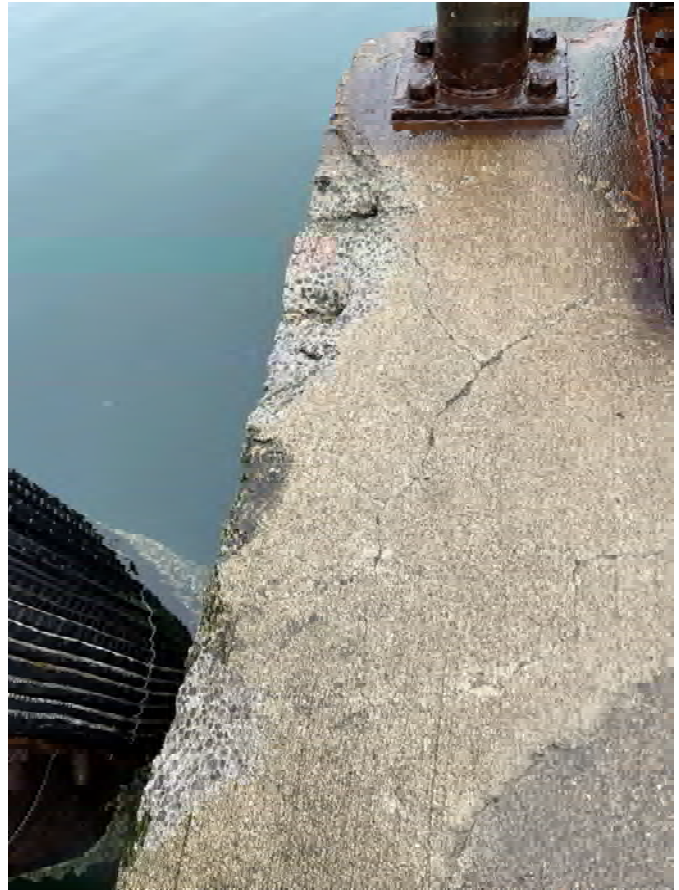
Photo 52: Concrete spalling along edge of float

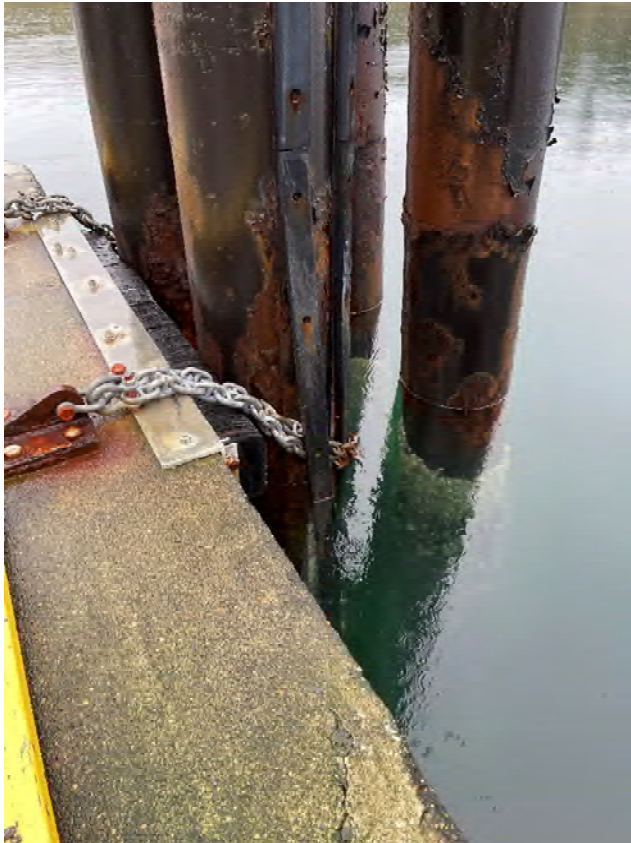
Photo 53: Chain rubbing on pile, UHMW rub rails failing

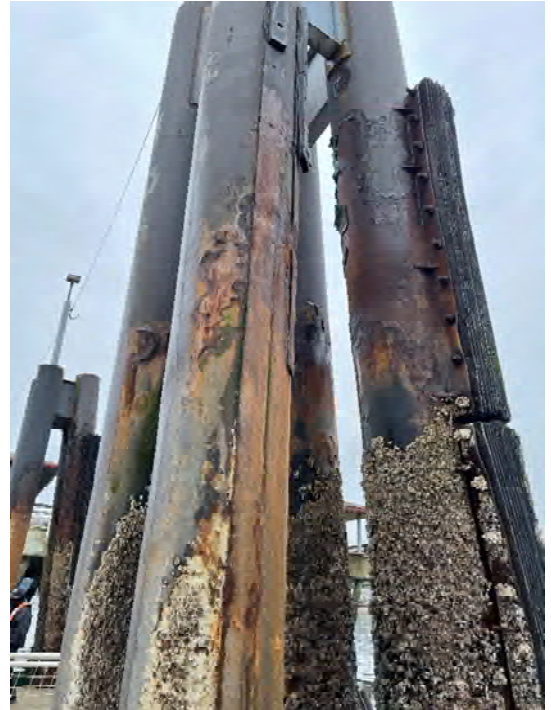
Photo 56: SP2 coating failure, surface corrosion, and heavy marine growth

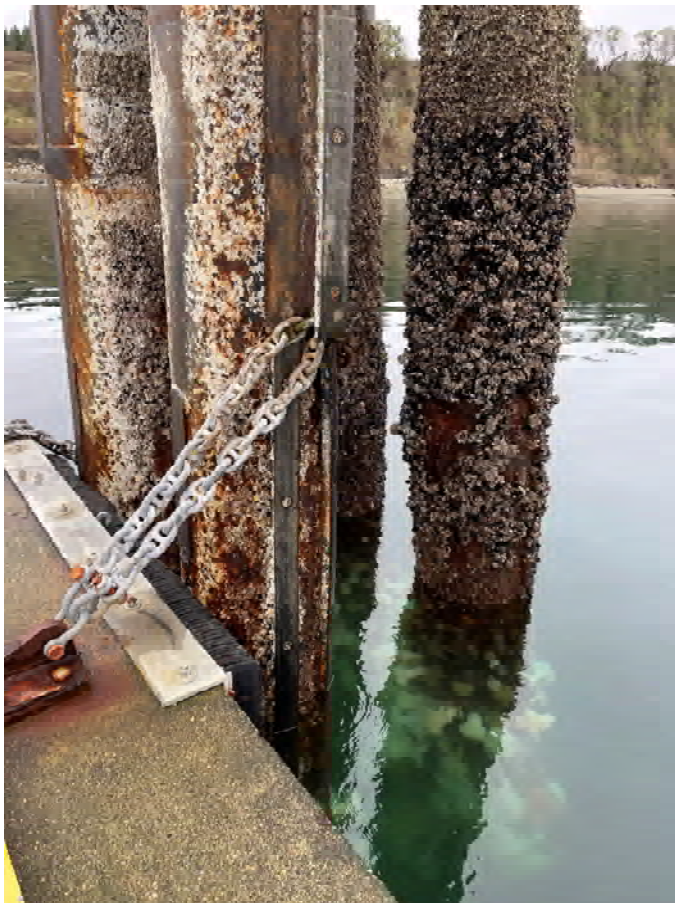
SP3, Pile C	SP3	Delamination, surface corrosion, and section loss	C3	10% coating loss, surface corrosion, 3" dia. hole, 1" (h) x 3" (w) hole, 1" dia. hole	1. Replace pile with new pile or	P3	57	6

Photo 57: SP3 chain catching on UHMW rub rails

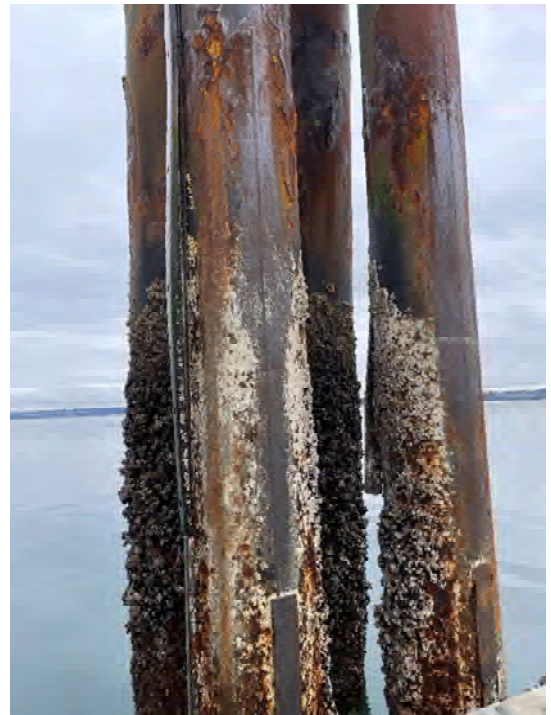
Photo 58: SP4 coating failure, surface corrosion, and heavy marine growth

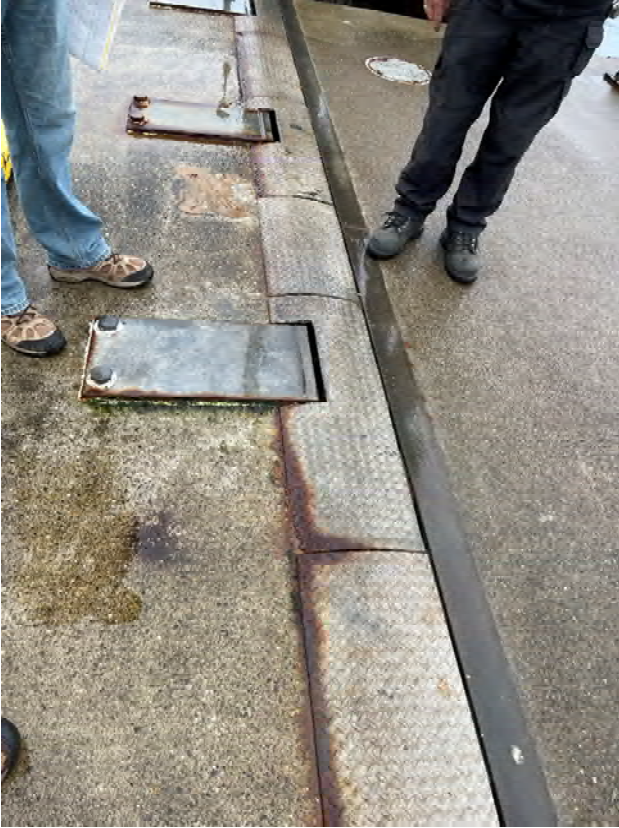
Cover Plates	Between Flanker Pontoons and Float	Surface corrosion	C1	The cover plates and pin assembly are corroded	Disassemble, sandblast and recoat or replace	P2	59, 60	3
--------------	------------------------------------	-------------------	----	--	--	----	--------	---

Photo 59: Surface corrosion on cover plate

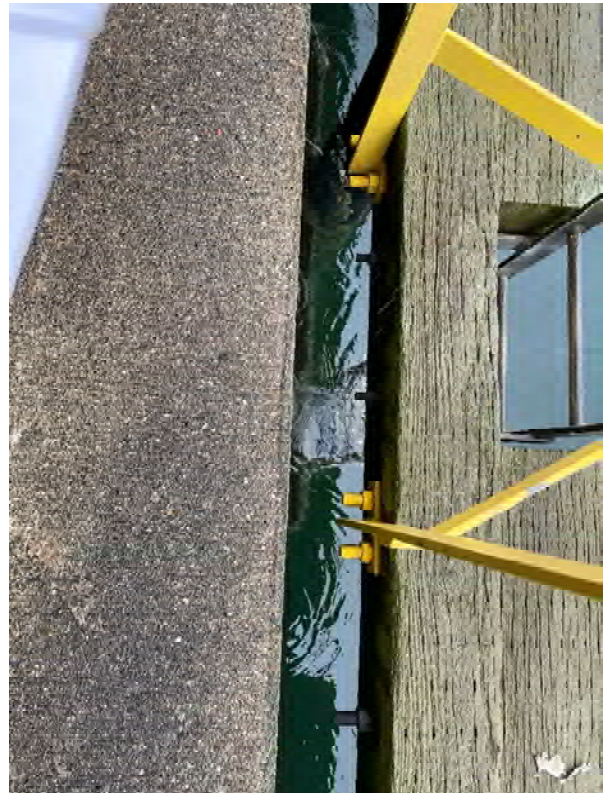
Photo 62: Pile F10 broken, South ladder is unsecured

**Minimum Repairs** – Repair trestle piles F10, D1, D2, D3, and D4. Patch concrete spalling, replace ladders, sandblast and coat mooring float piles, replace UHMW, sandblast and coat fenders, replace balcony loading platform, repair tie back cable attachment, and replace pile collar chain securement.

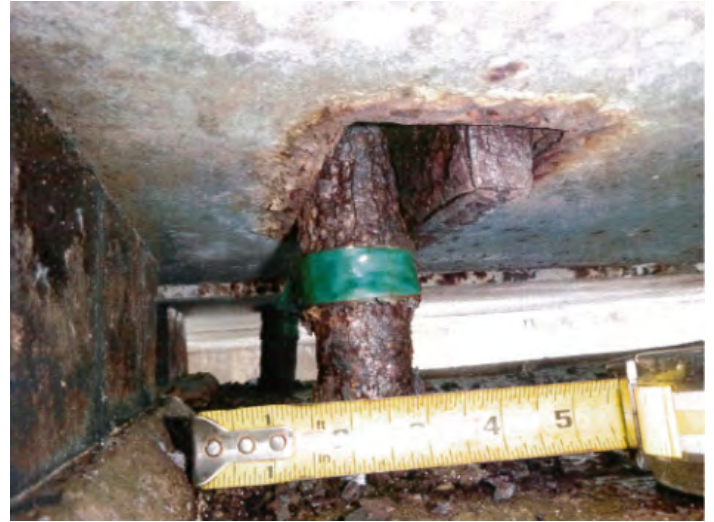
Photo 64: Deck panel 7B hold down bolt is necked down to 1.1875" at pier 7

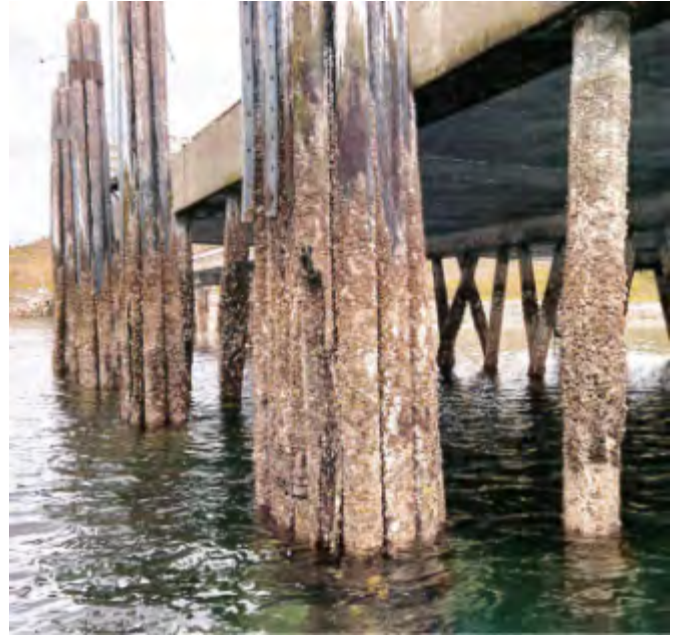
Photo 68: Dolphin D4 with abrasion damage and internal decay

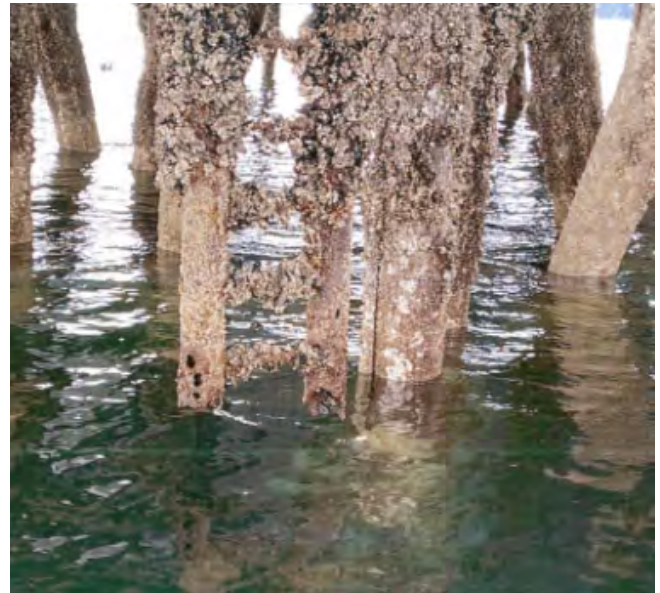
Photo 70: Boat lift access ladder has corroded off in lower intertidal zone.

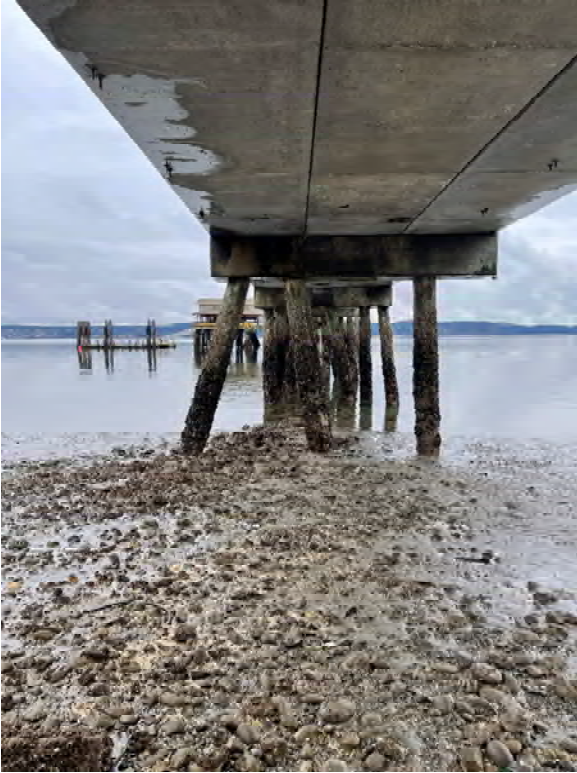
Photo 71: Concrete spalling below trestle

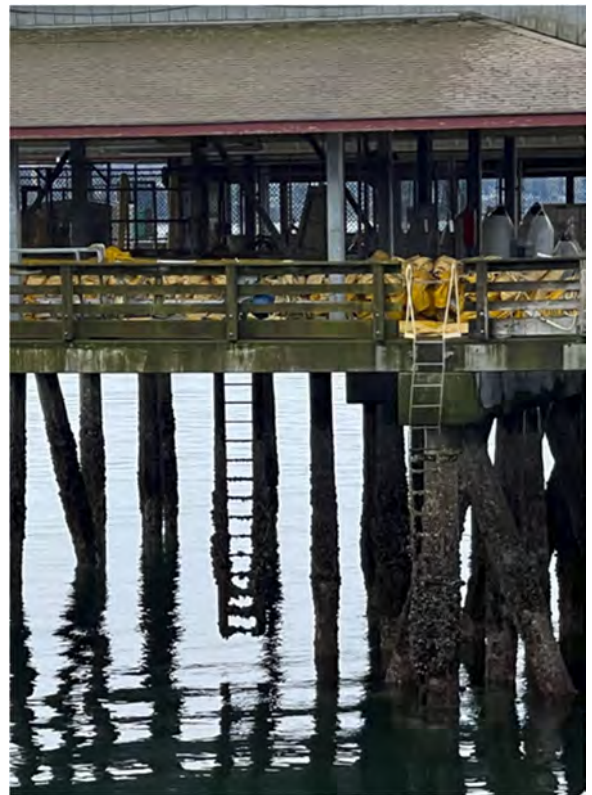
Photo 74: Northern and boat lift access ladders are in very poor condition

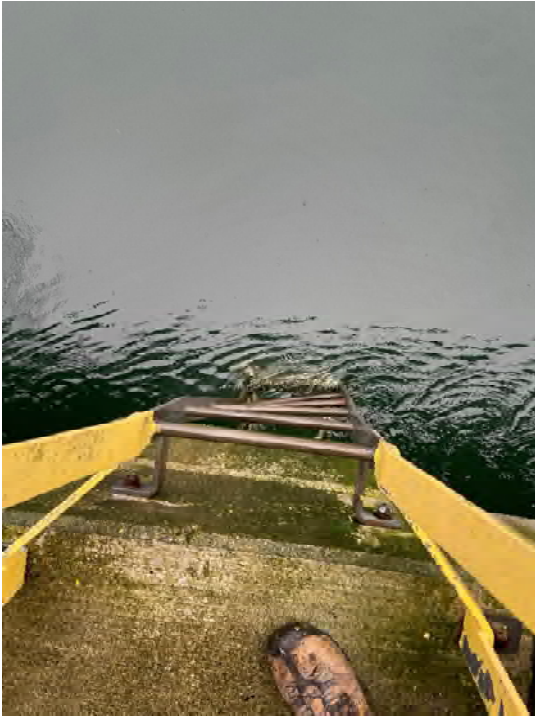
Photo 75: Bent southern ladder

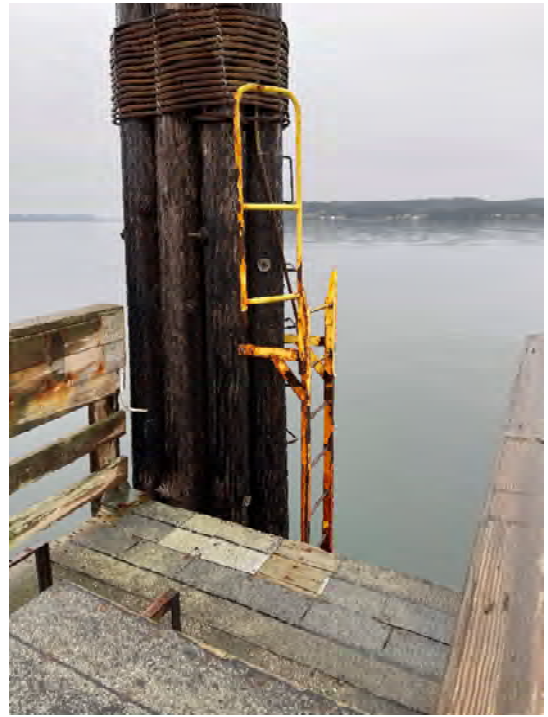
Photo 76: Dolphin ladder broken

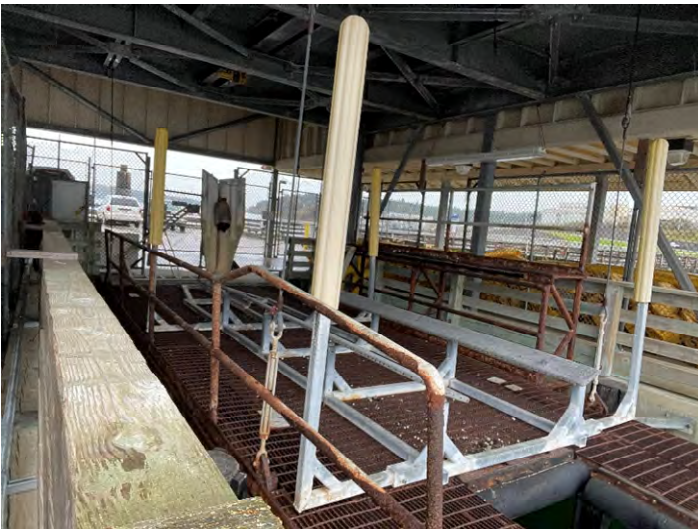
Boat Lift Cover	Eastern section	White rust	C1	The galvanized structural framing members have white rust	Recoat the members	P2	77	3
Fascia on Roof	Eastern section cover roof assembly	Wood rot	C2	The Fascia boards (edge of roof), have significant rot damage along the western side of the cover	Replace the members	P3	79	5

Photo 77: Boat lift

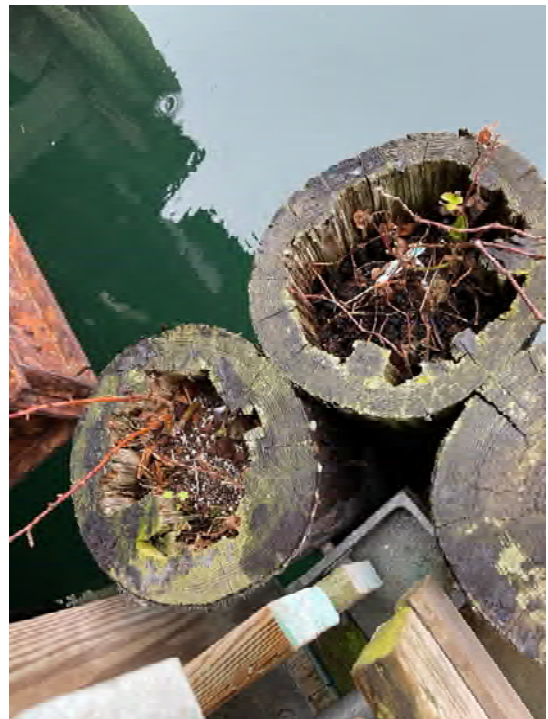
Photo 78: Piles F2A,B,C rot at top of piles

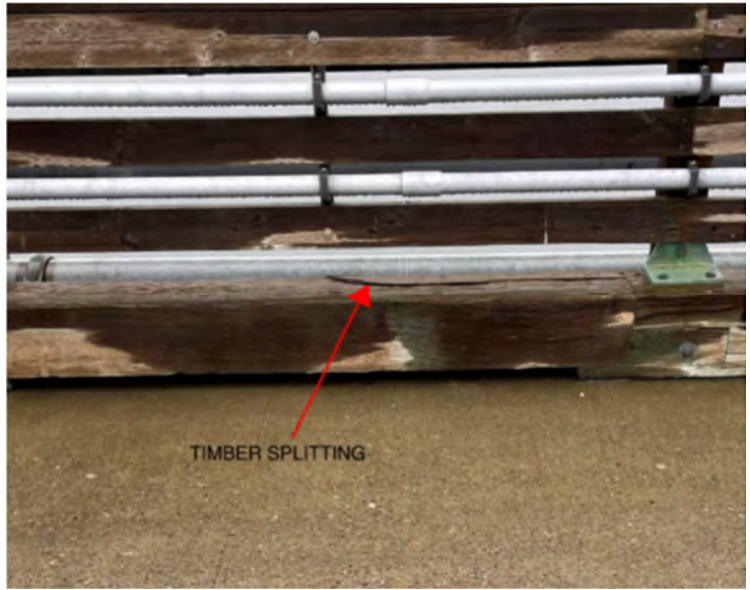
Photo 80: Timber curbing splitting on trestle

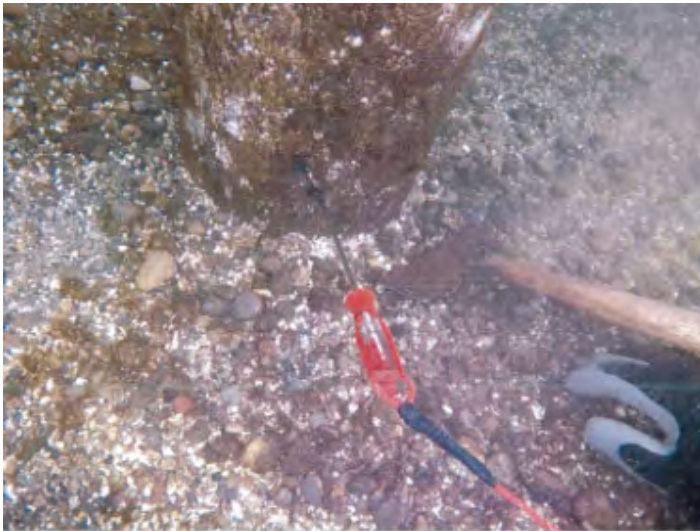
Photo 81: Pile 2C Marine borer entry

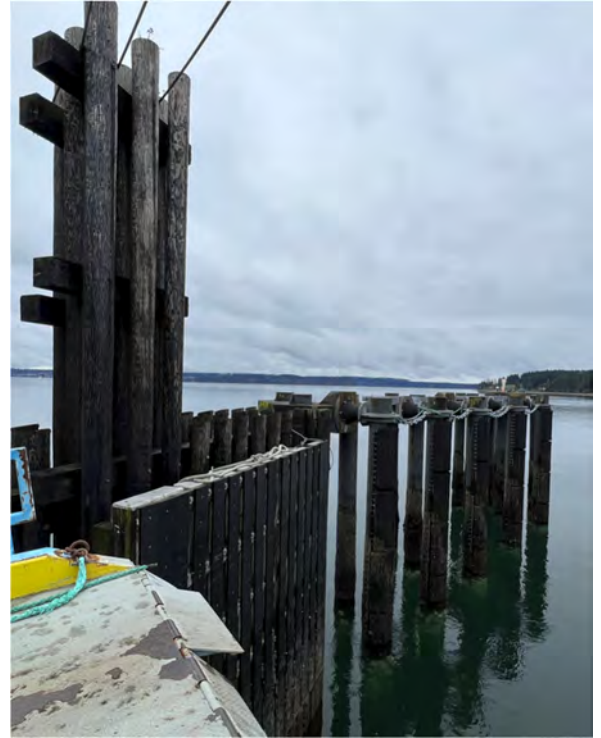
Photo 86: Left wingwall

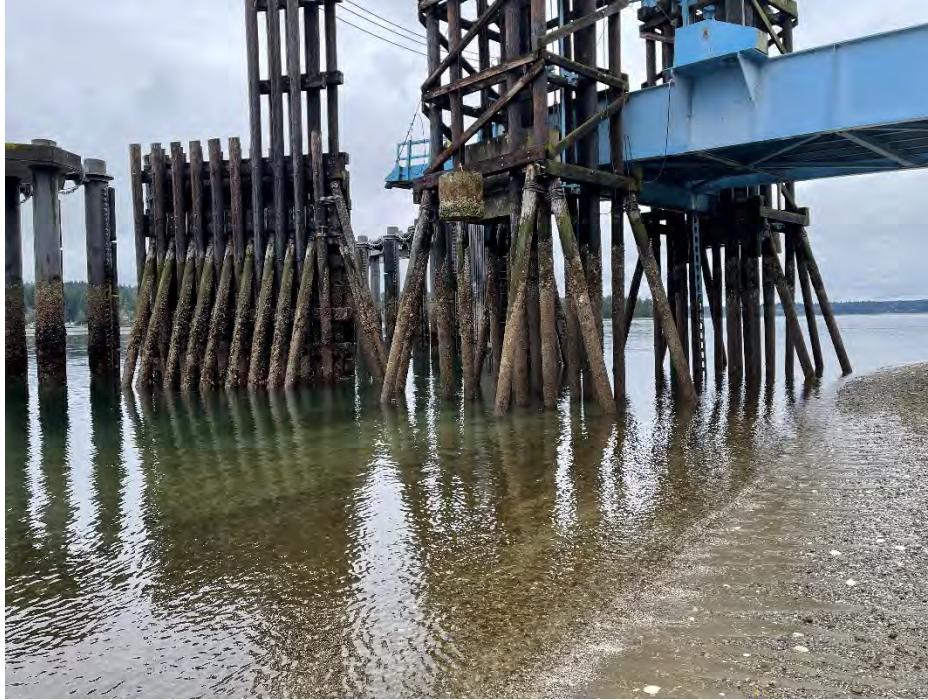
Photo 89: Left wingwall

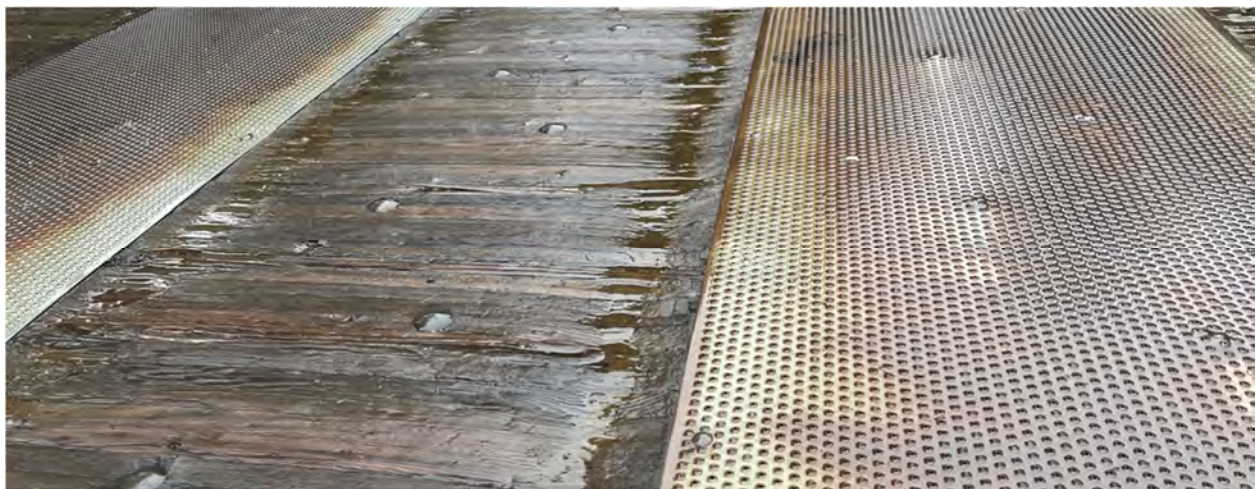
Photo 103: Timber deck is rutting

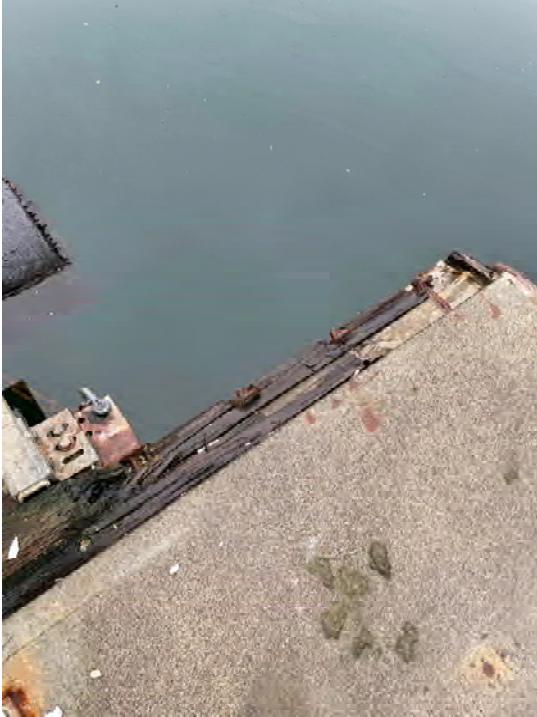
Photo 108: Near Spud Pile A, timber waler is broken and corroding fasteners

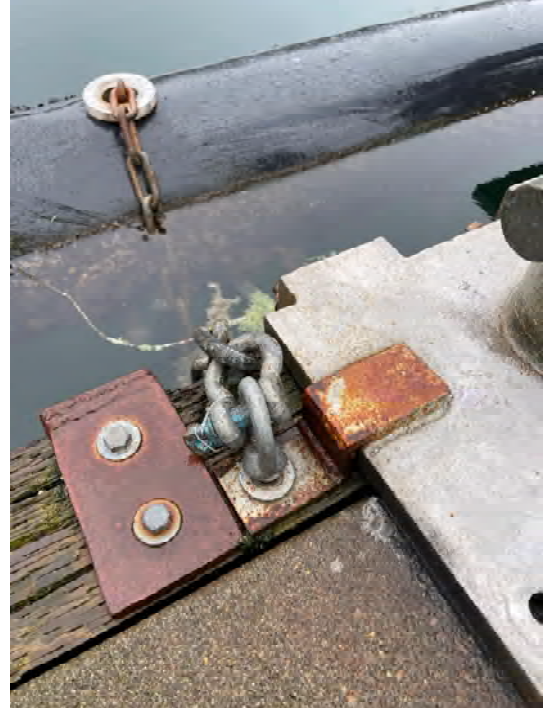
Photo 109: Eyebolts securing log fenders are bent

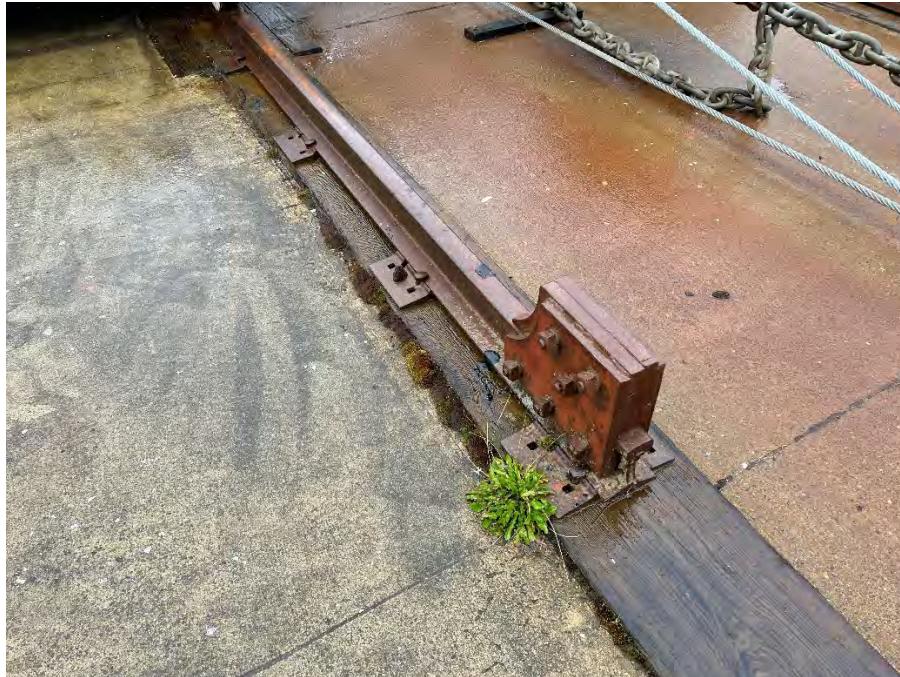
[Photo 126](#): Surface corrosion on rail North of bulkhead

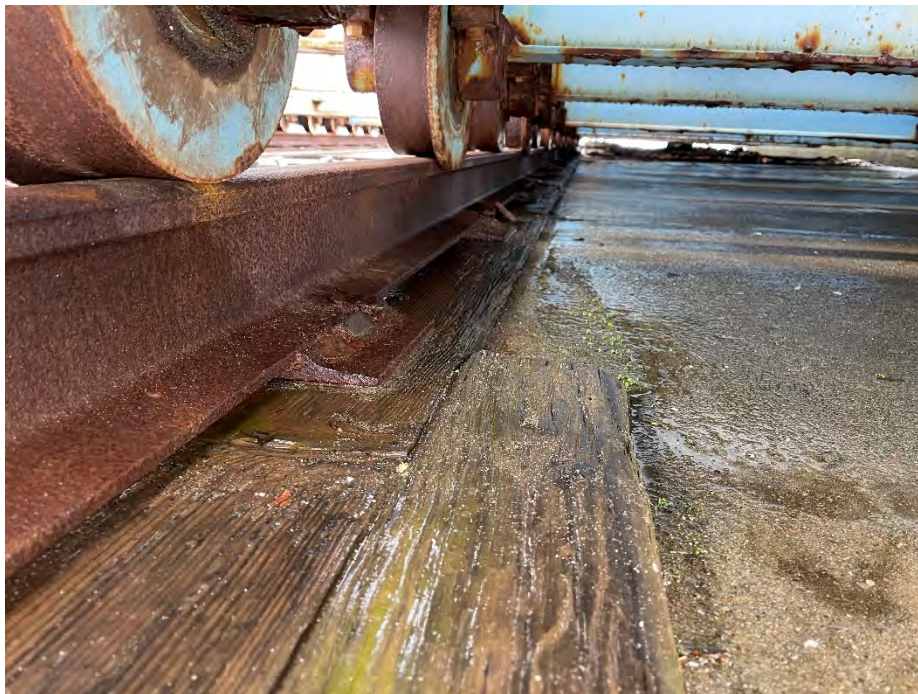
[Photo 127](#): Rail pitting and surface corrosion North of bulkhead

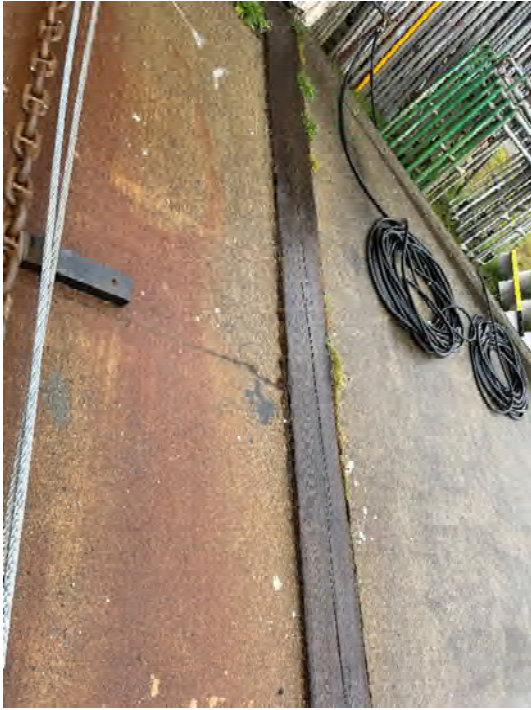
Photo 128: Timber rail beam (A) North of bulkhead

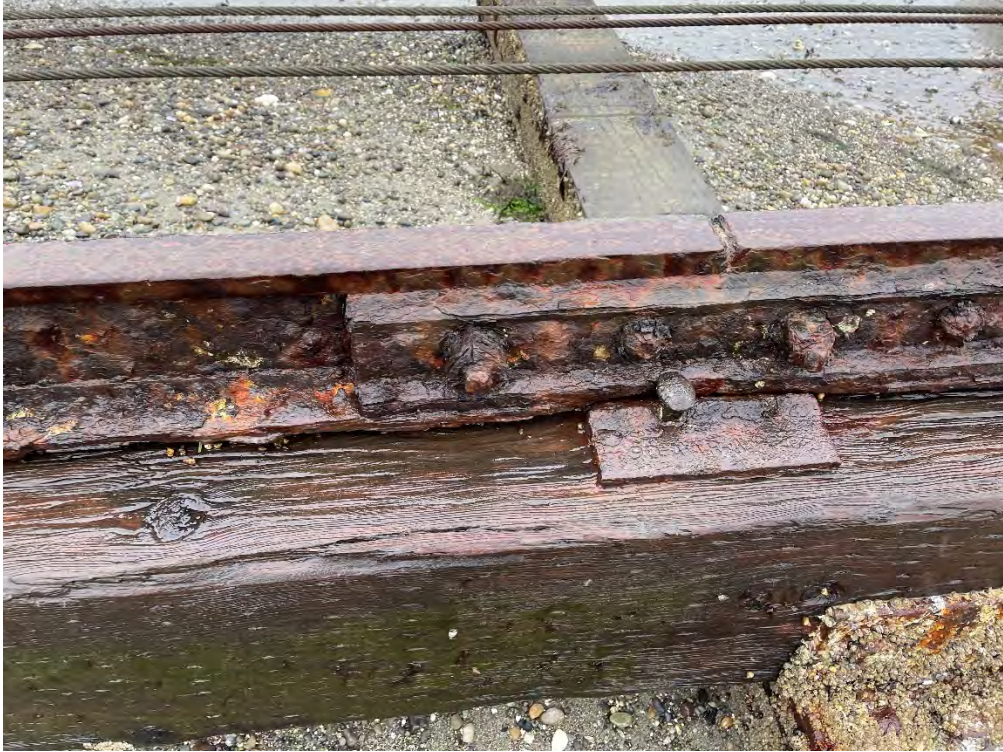
Photo 138: Rail splice plate with heavy surface corrosion

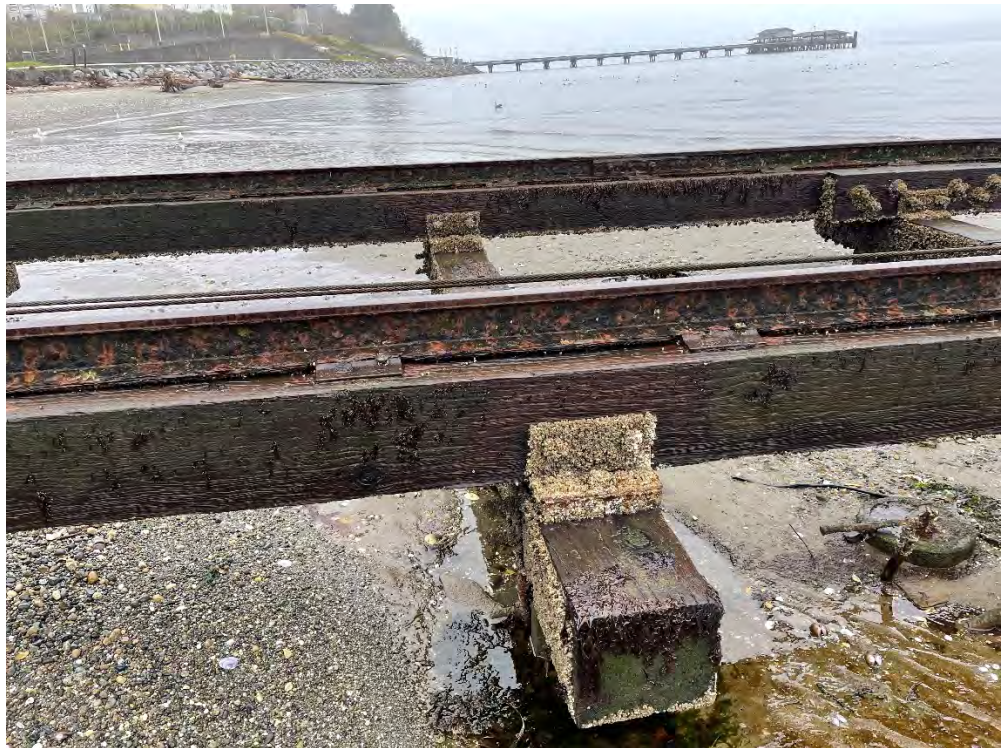
Photo 139: 10<sup>th</sup> pile cap from bulkhead

10	C2	P3	Heavy marine growth, green moss algae, early stages of soft rot, and heavily corroded connection brackets	This member requires action and has a high potential to lose its structural integrity if it gets any worse.	139	5

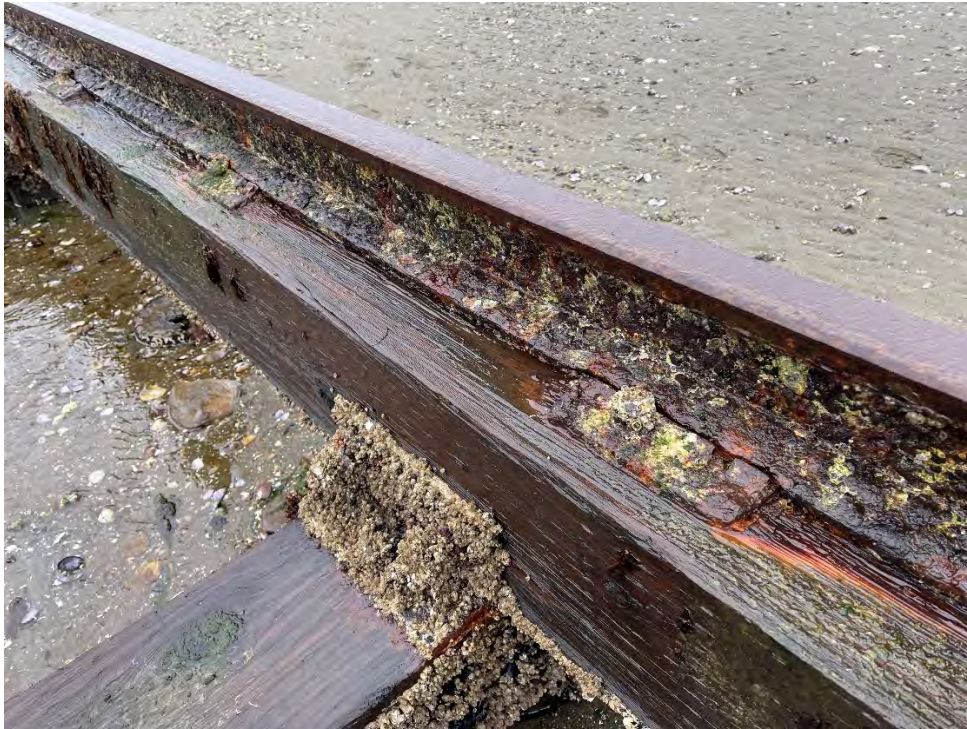
Photo 141: Heavy surface corrosion on rail and pile cap connection bracket

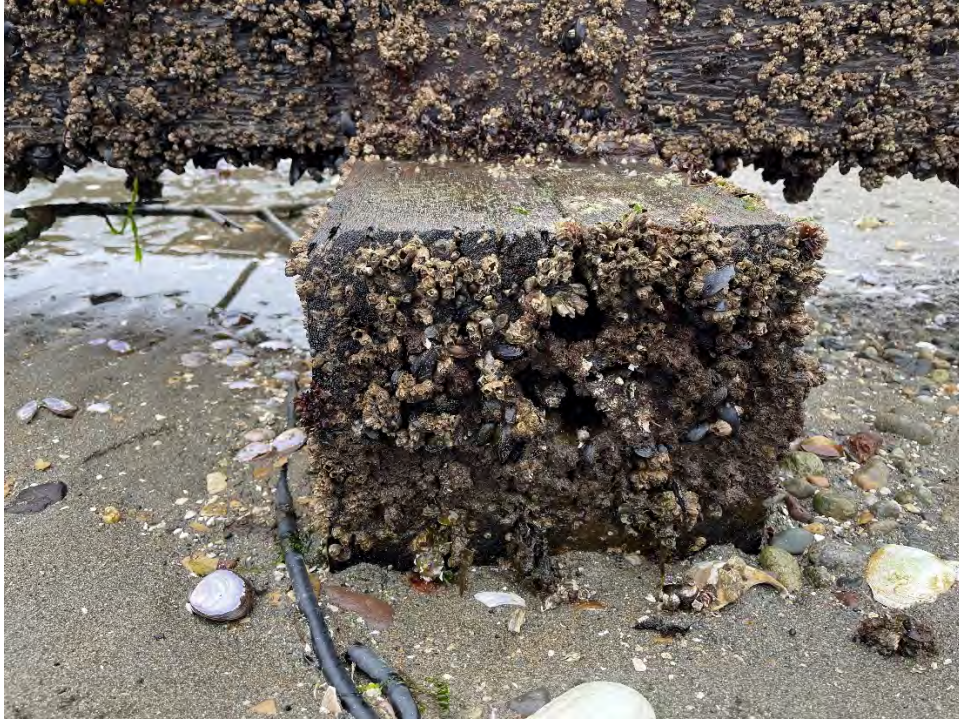
Photo 142: 15<sup>th</sup> pile cap with early stages of hollowing
