# McNeil Island Repair and Replacement Options 10182200022

Prepared by KPFF Consulting Engineers  
Draft Repair and Replacement Options  
June 30, 2022

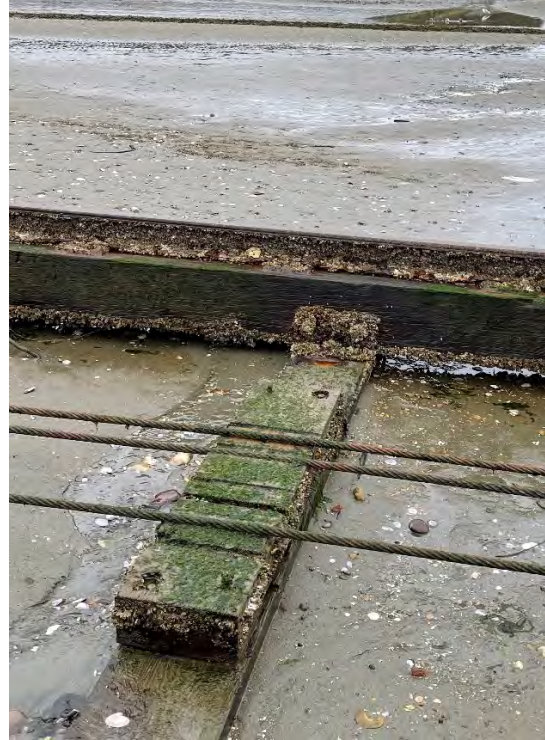
Photo 147: Wire rope wearing on pile cap rub beam

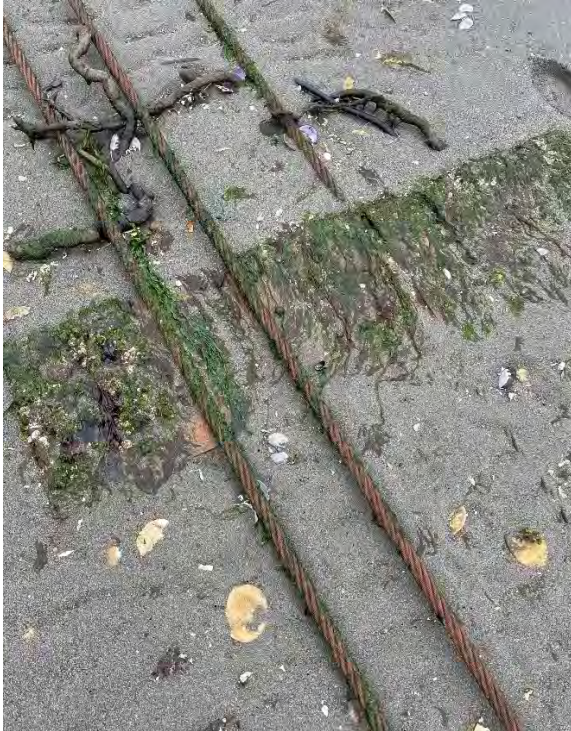
Photo 148: Wire rope wearing on pile cap rub beam
