# Property Evaluation Report

## MODULAR BUILDING ASSESSMENT

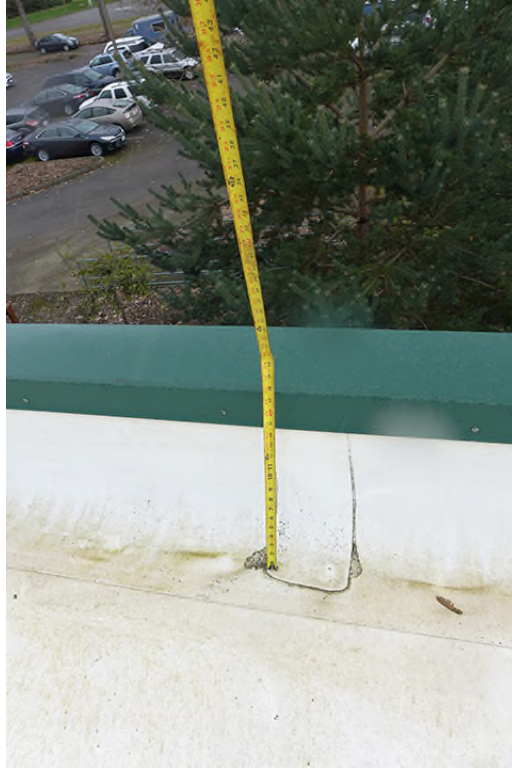
Unsafe Parapet Height  
PHOTOGRAPH 11

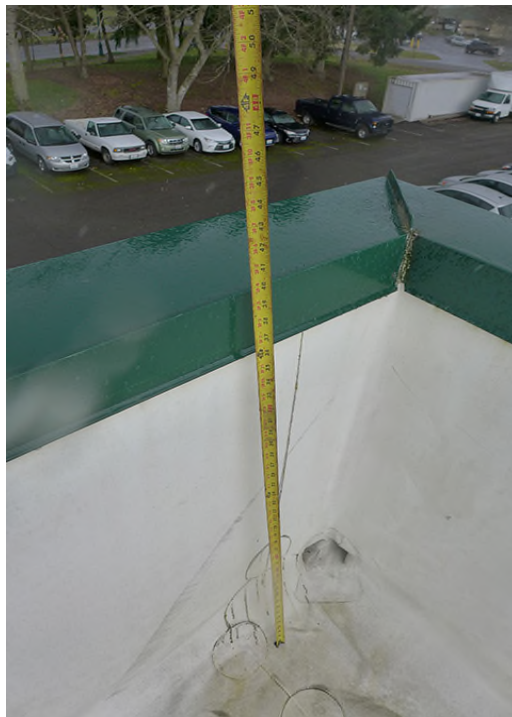
Unsafe Parapet Height  
PHOTOGRAPH 12

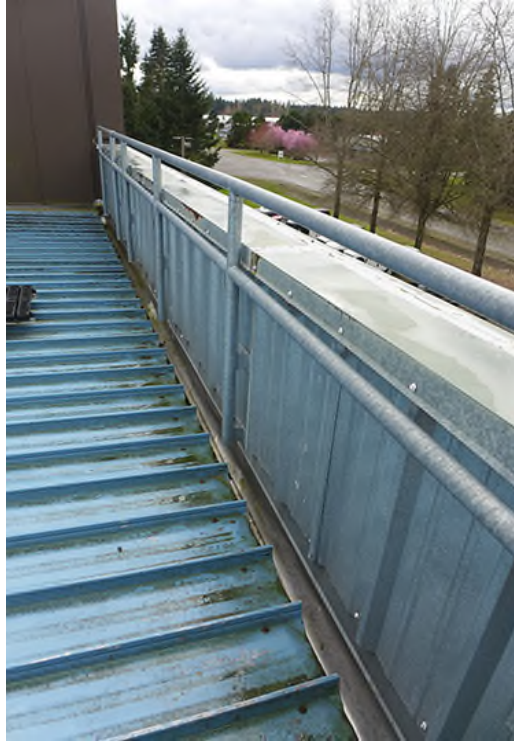
Fall-Protection Guardrail at Adjacent Isabella Bush Building  
PHOTOGRAPH 13

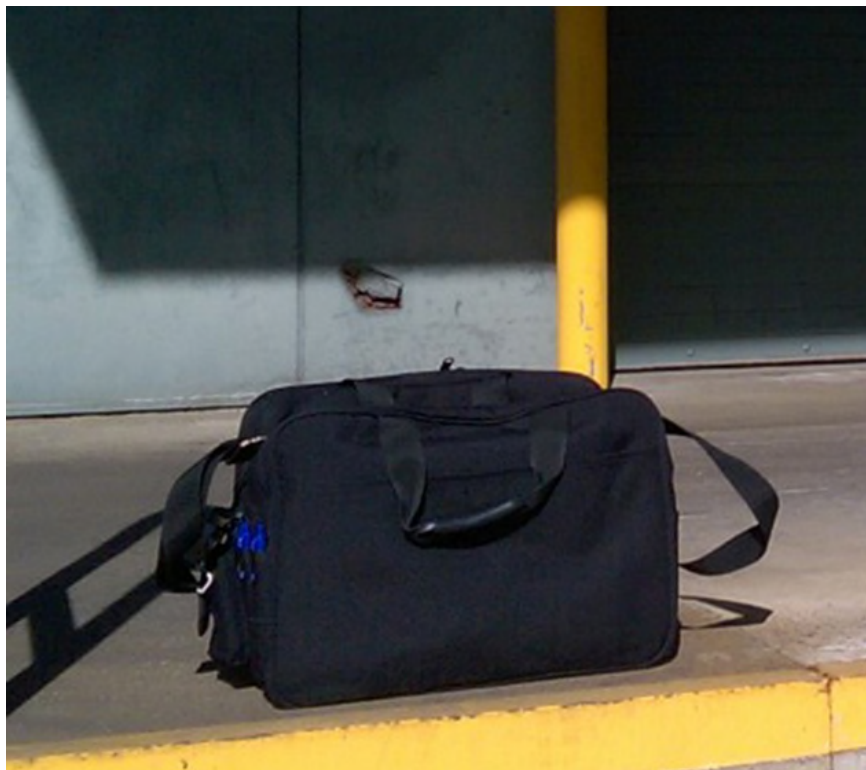
Damaged Panel at Loading Dock  
PHOTOGRAPH 16

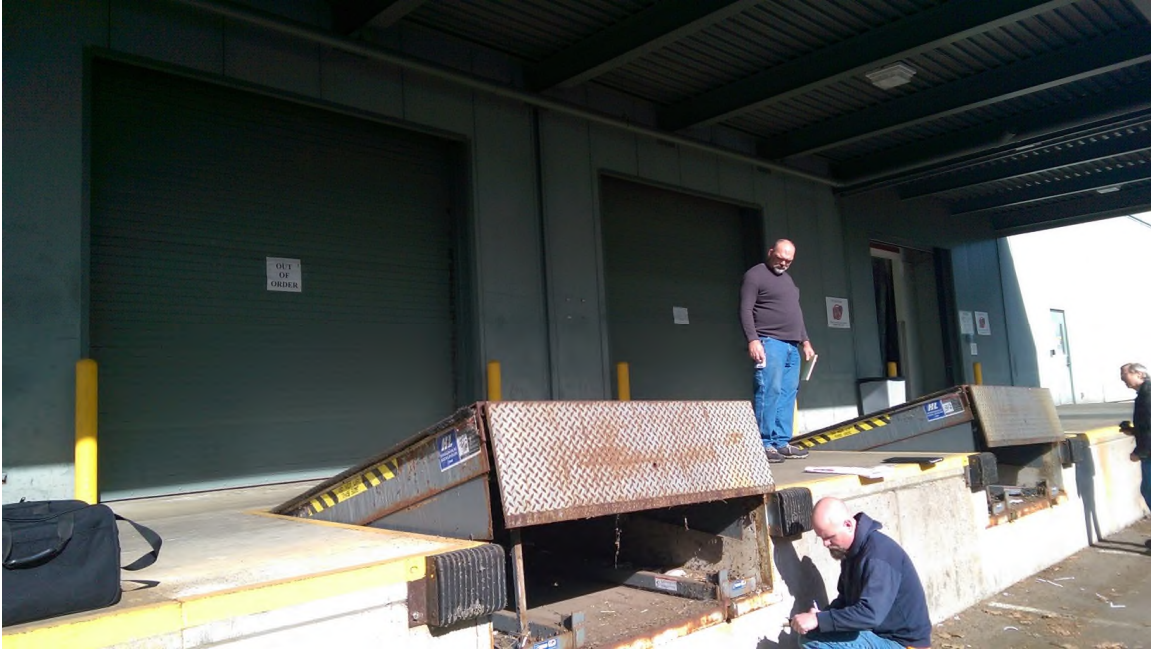
Dock Leveler #2  
PHOTOGRAPH 17

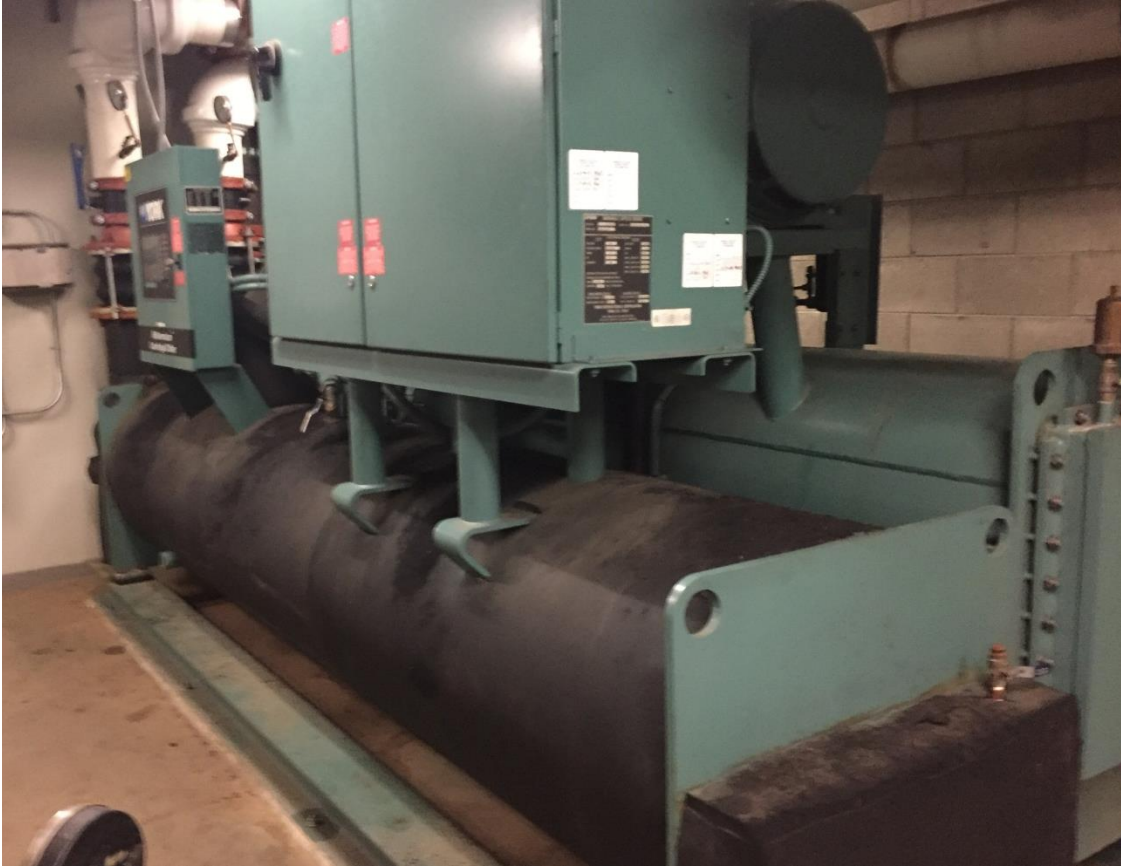
Centrifugal Chiller  
PHOTOGRAPH\_03

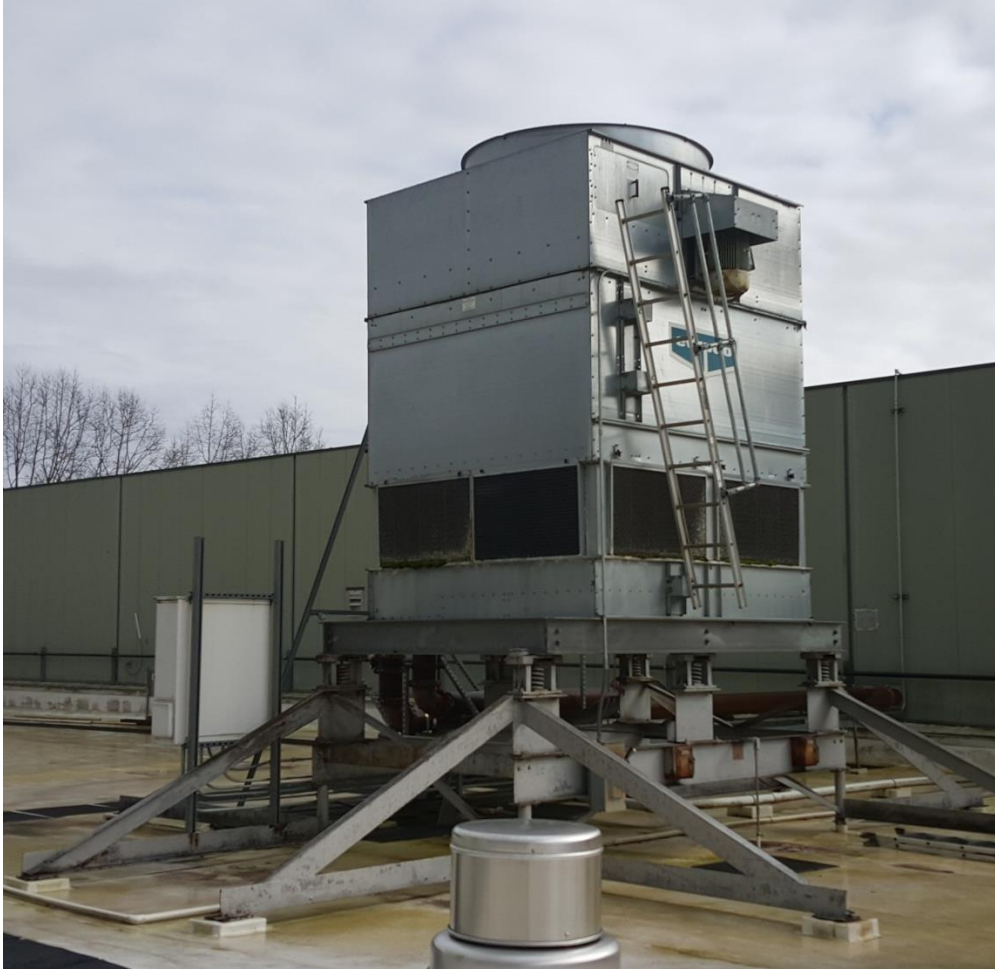
Cooling Tower  
PHOTOGRAPH 04

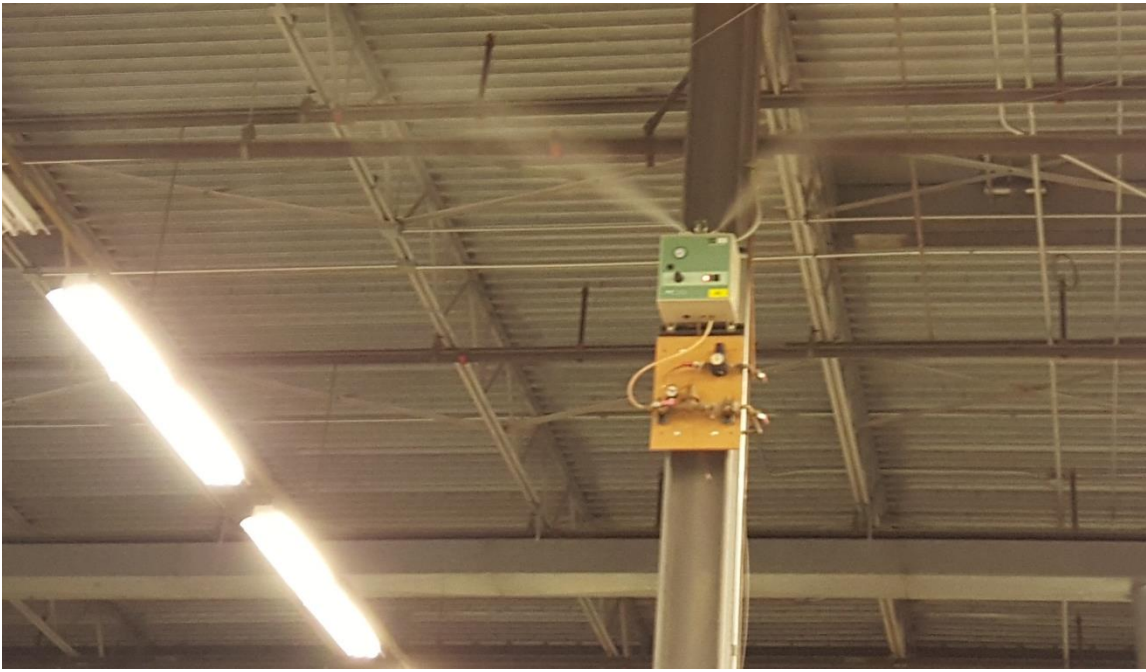
Humidification Unit  
PHOTOGRAPH 19

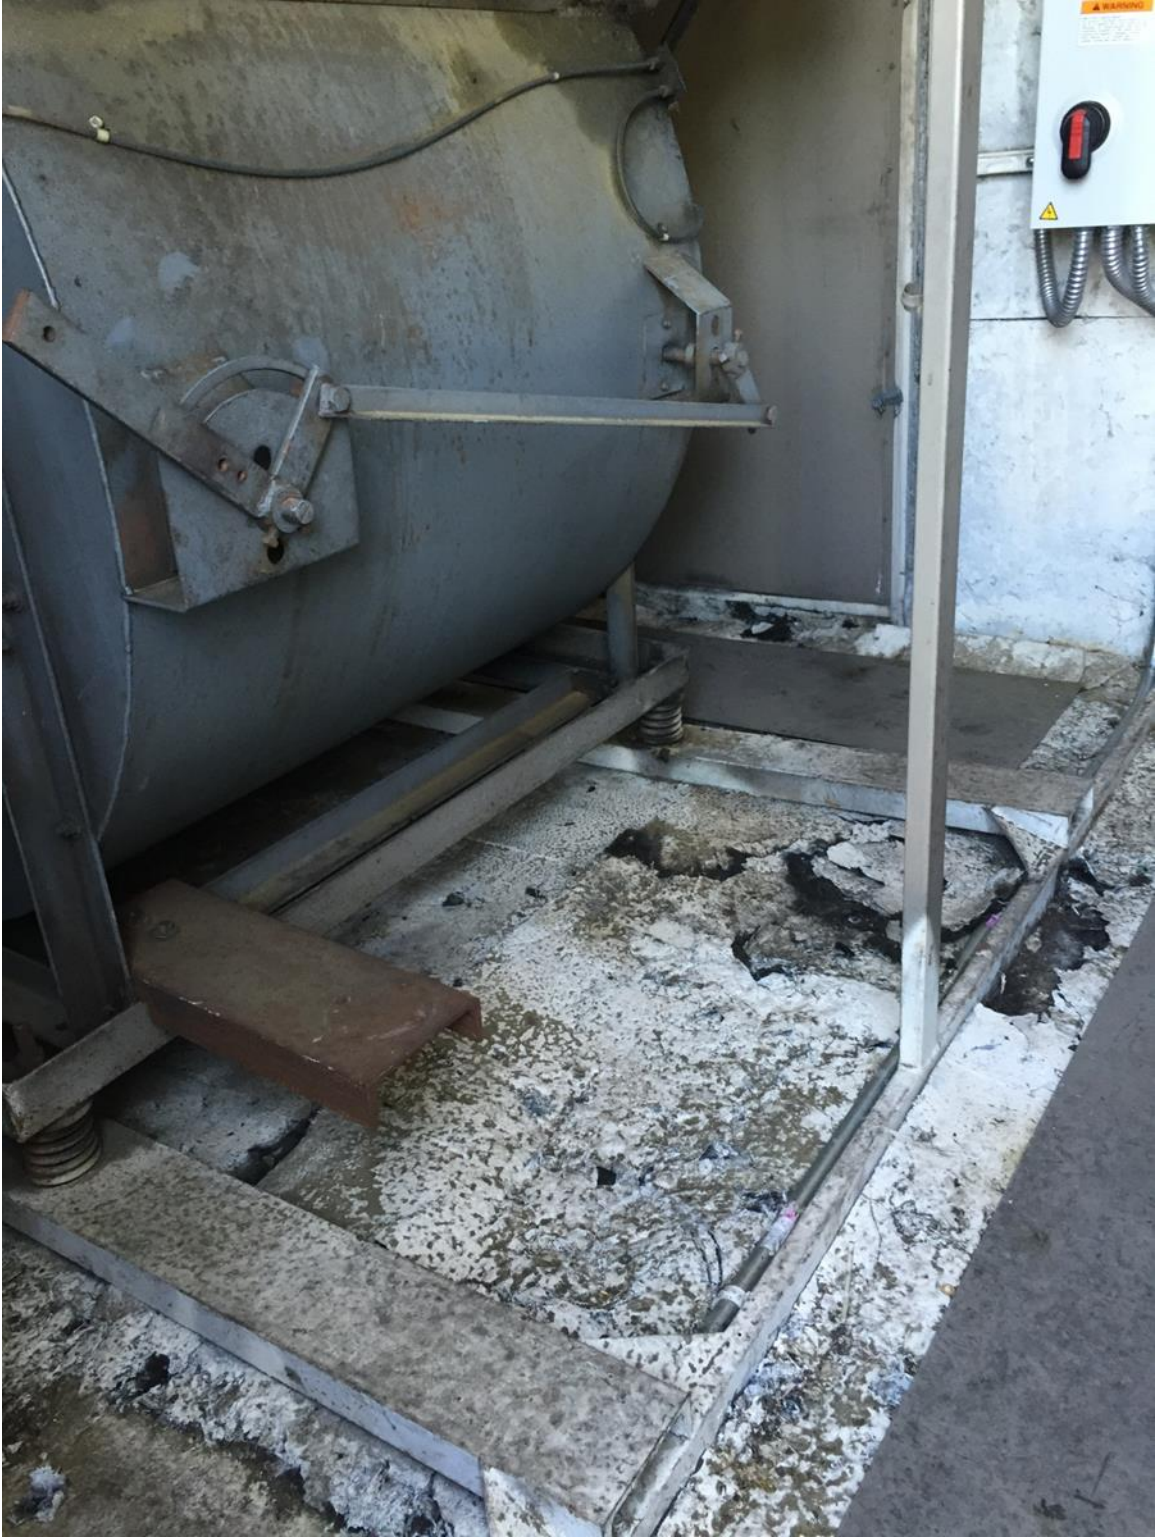
AHU Moisture Damage  
PHOTOGRAPH 20

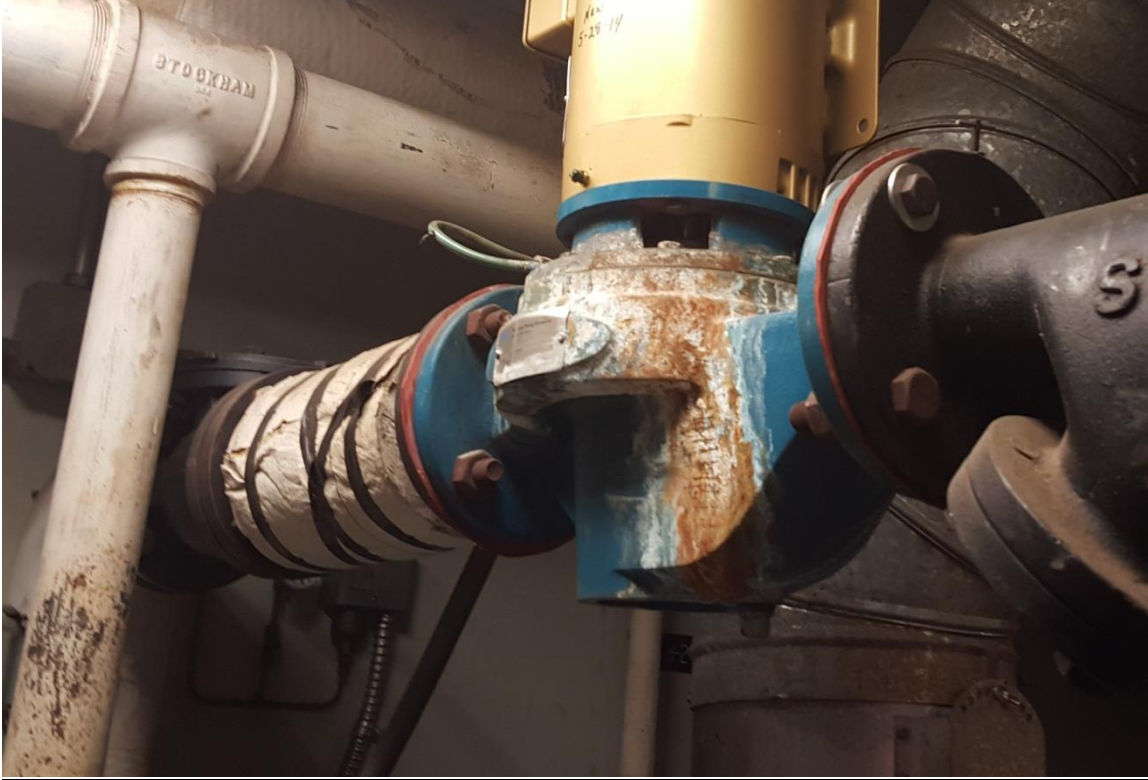
Signs of Rust and Scale in Pipes  
PHOTOGRAPH 21

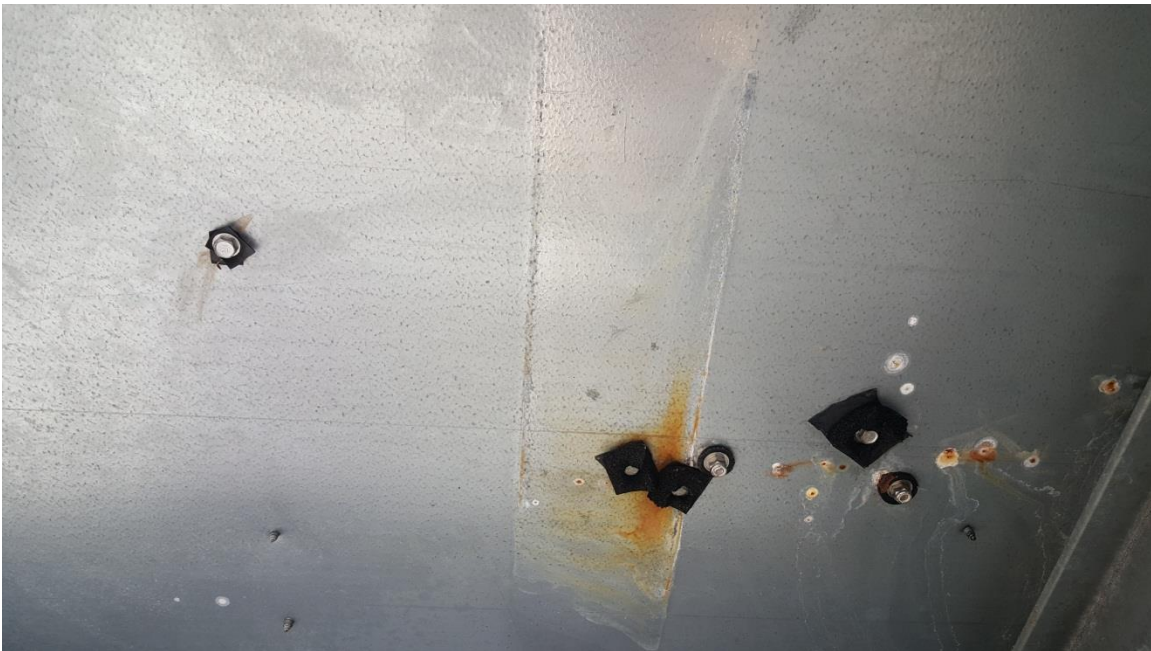
Cooling Tower Leak Damage and Patches (View of Bottom of Tank)  
PHOTOGRAPH 22

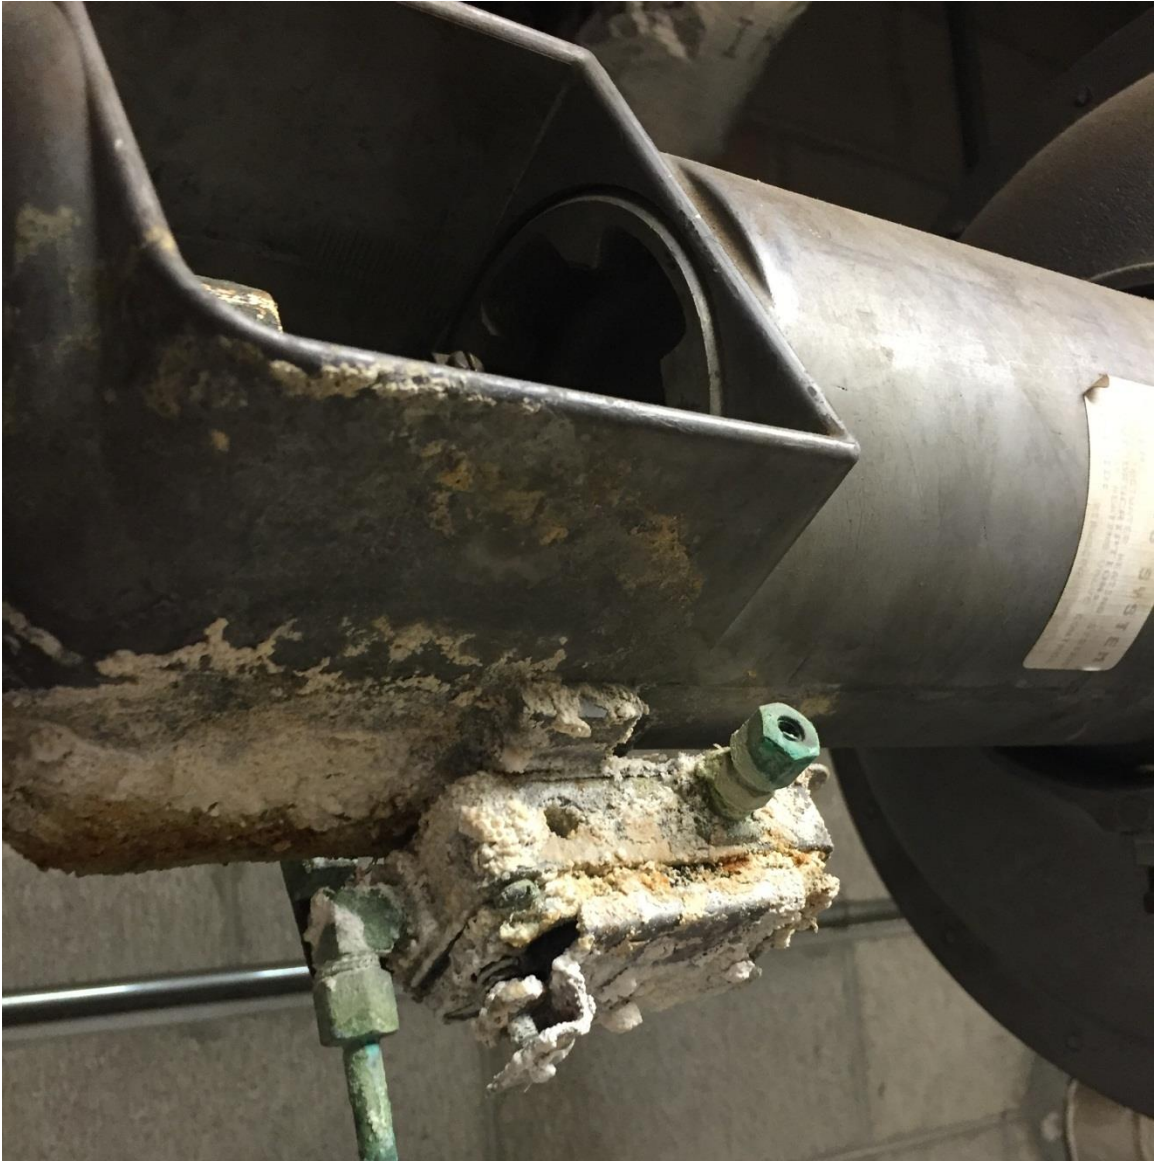
Pneumatic Valve Actuator  
PHOTOGRAPH 23

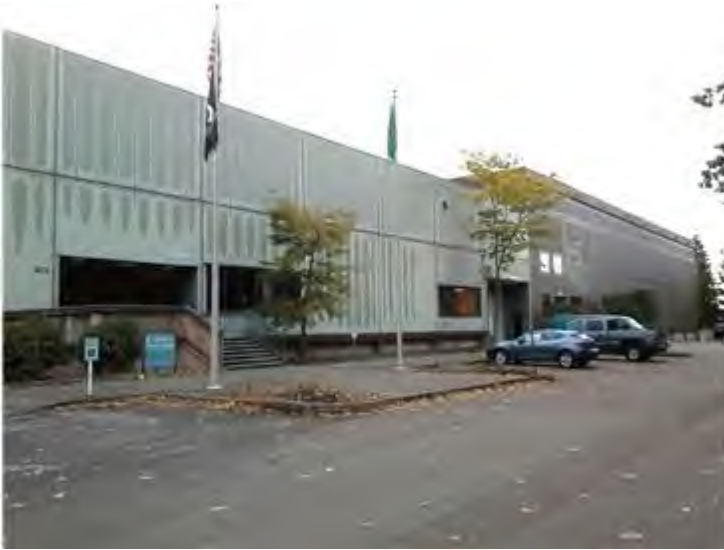
**Facility:** Modular Building High Bay

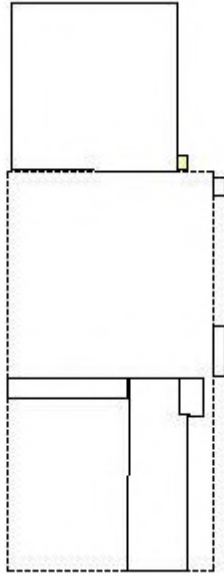
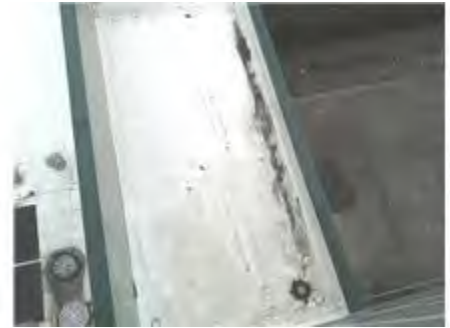
Roof System: White - PVC  
Install Date: 1998 - Estimated  
Roof Deck: Metal  
Roof SF: 170  
Elevation: 15'  
Interior Sensitivity: 0 - None  
Warranty:

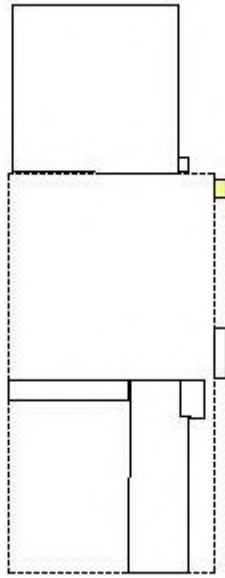
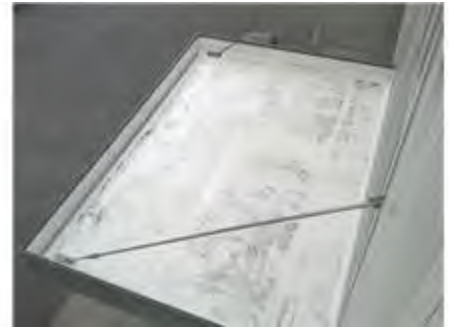
Roof System: White - PVC  
Install Date: 1998 - Estimated  
Roof Deck: Metal  
Roof SF: 304  
Elevation: 15'  
Interior Sensitivity: 0 - None  
Warranty:

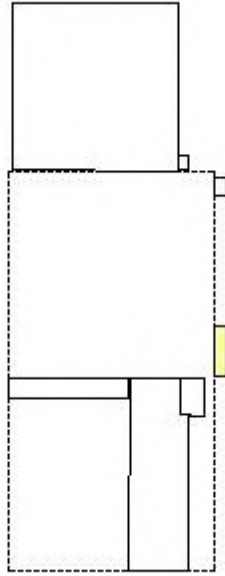
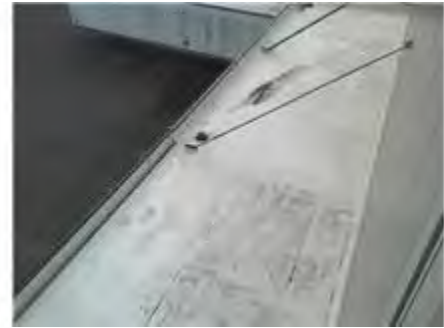
Roof System: White - PVC  
Install Date: 1998 - Estimated  
Roof Deck: Metal  
Roof SF: 885  
Elevation: 18'  
Interior Sensitivity: 0 - None  
Warranty:

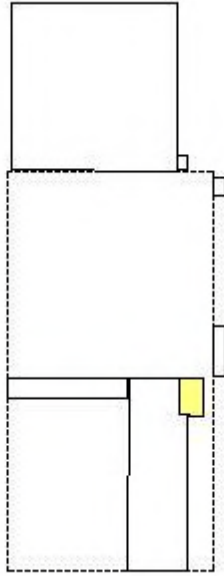
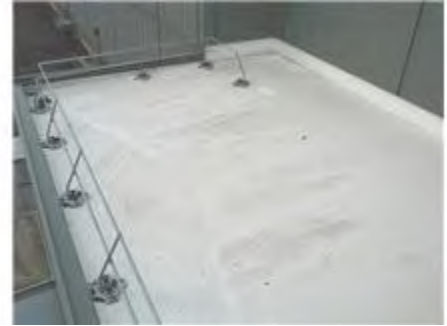
Roof System: White - PVC  
Install Date: 1998 - Estimated  
Roof Deck: Metal  
Roof SF: 1,202  
Elevation: 18'  
Interior Sensitivity: 0 - None  
Warranty:

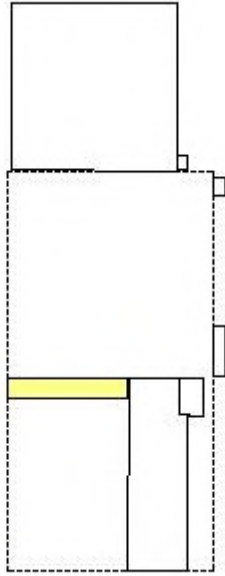
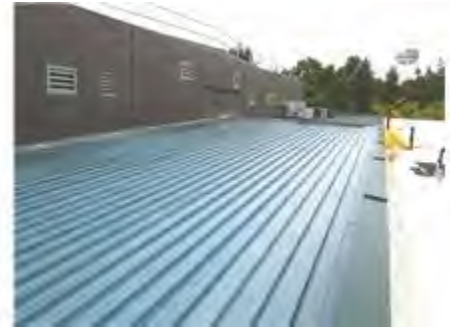
Roof System: Standing Seam - Metal  
Install Date: - Unknown  
Roof Deck: Plywood  
Roof SF: 3,147  
Elevation: 30'  
Interior Sensitivity: 2 - Medium  
Warranty:

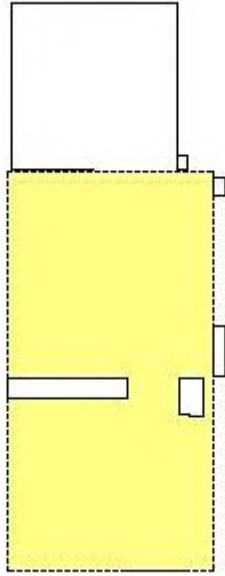
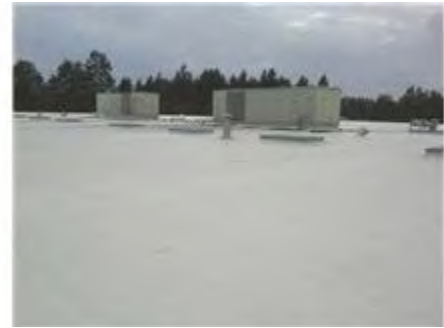
Roof System: White - PVC  
Install Date: 1998 - Estimated  
Roof Deck: Unknown  
Roof SF: 57,840  
Elevation: 32'  
Interior Sensitivity: 2 - Medium  
Warranty:

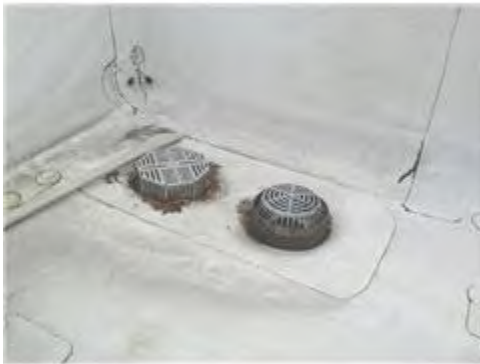
Condition: 004- Debris on roof  
Severity: 2 - Secondary Repair  
Qty: SF: 1 LF: 4 EA: 1

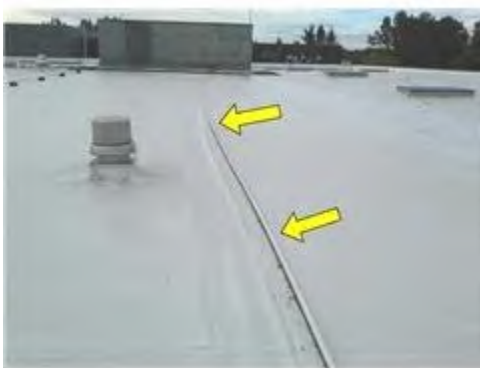
Condition: EG - 204 - Condensation Lines  
Severity: 2 - Secondary Repair  
Qty: SF: 1 LF: 4 EA: 1

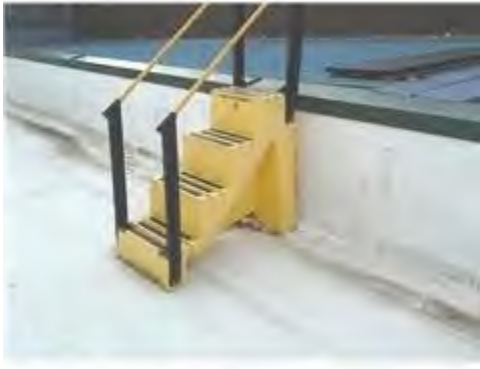
Condition: EG-224 - Improper Installation  
Severity: 2 - Secondary Repair  
Qty: SF: 1 LF: 4 EA: 1

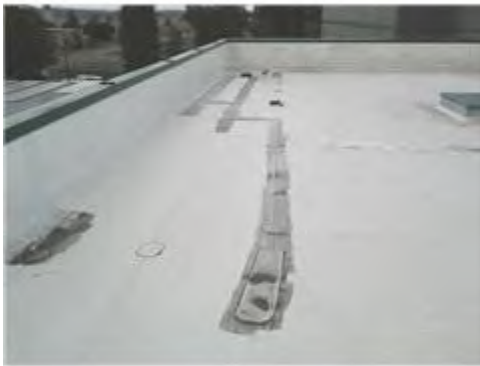
Condition: F-112 Field Membrane- temporary repair  
Severity: 2 - Secondary Repair  
Qty: SF: 1 LF: 4 EA: 1

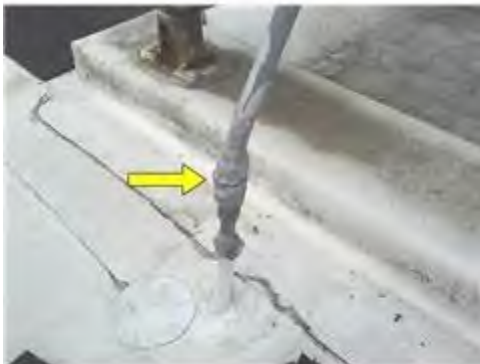
Condition: PP-152 Penetration - Sealant failure  
Severity: 2 - Secondary Repair  
Qty: SF: 1 LF: 4 EA: 1

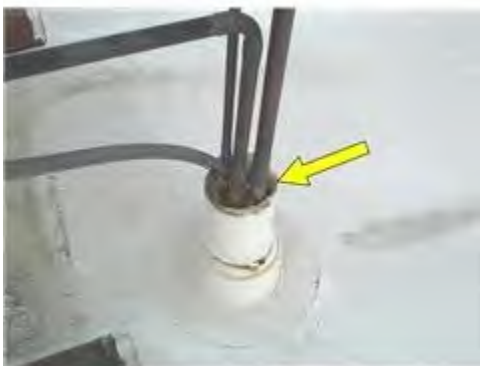
Condition: PP-152 Pitch Pan- Sealant failure  
Severity: 2 - Secondary Repair  
Qty: SF: 1 LF: 4 EA: 1

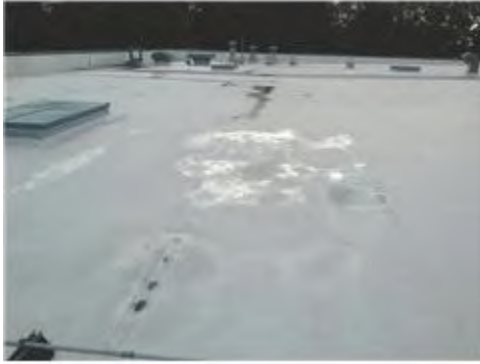
Inspection Date: 10/2/2015  
10:30:00 AM

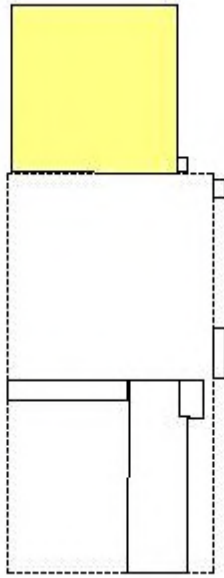
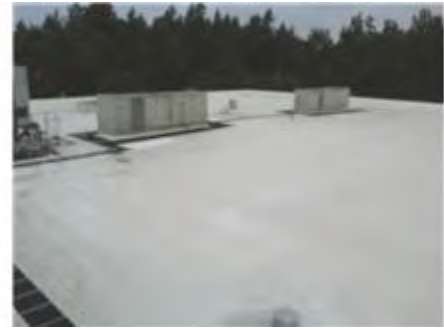
Roof System: White -PVC  
Install Date: 1998 - Estimated  
Roof Deck: Unknown  
Roof SF: 38,104  
Elevation: 25'  
Interior Sensitivity: 2 - Medium  
Warranty:

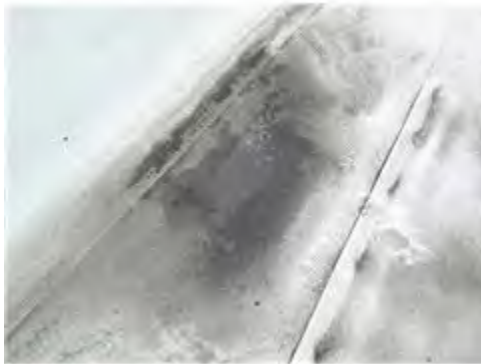
**G-100** Condition: F-100 Field Membrane- deteriorated  
Severity: 3 - Immediate Action  
Qty: SF: 25 LF: 24 EA: 2

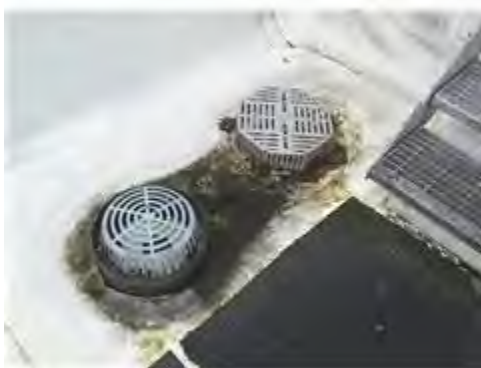
**D-206** Condition: D-206 Drain- vegetation build up  
Severity: 2 - Secondary Repair  
Qty: SF: 1 LF: 4 EA: 1

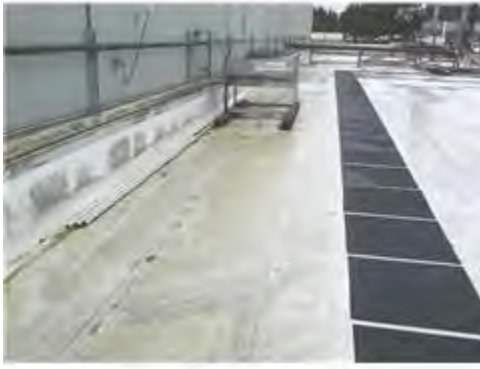
Condition: 026 - Staining  
Severity: 1 - Monitor  
Qty: SF: 2 LF: 8 EA: 2

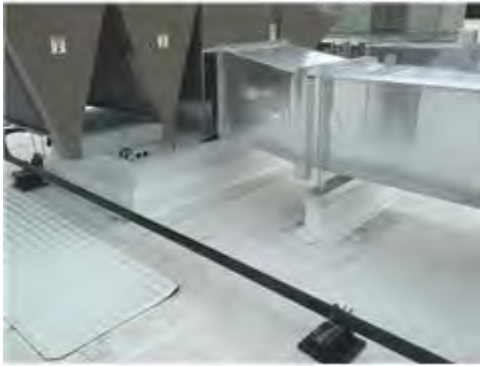
Condition: EG - 212 - New Equipment  
Severity: 1 - Monitor  
Qty: SF: 3 LF: 12 EA: 3

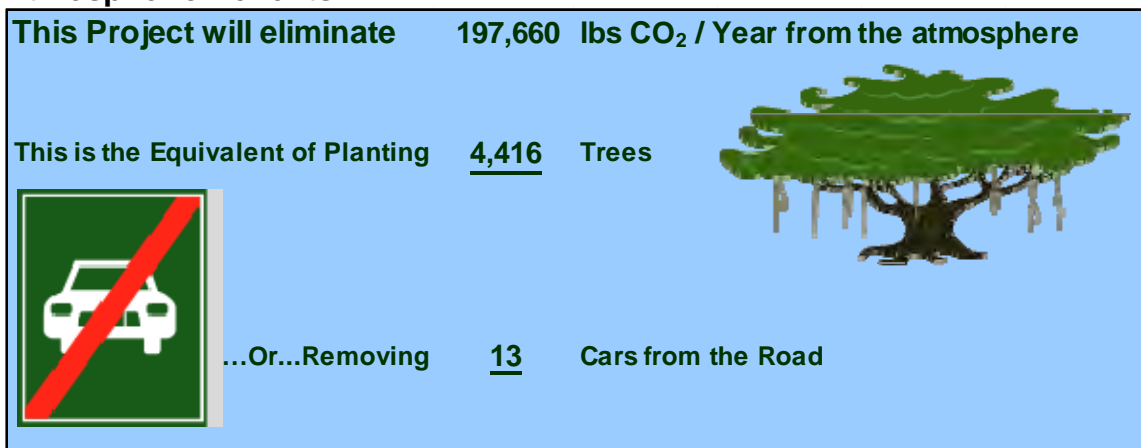
### Facility Infrastructure Benefits:

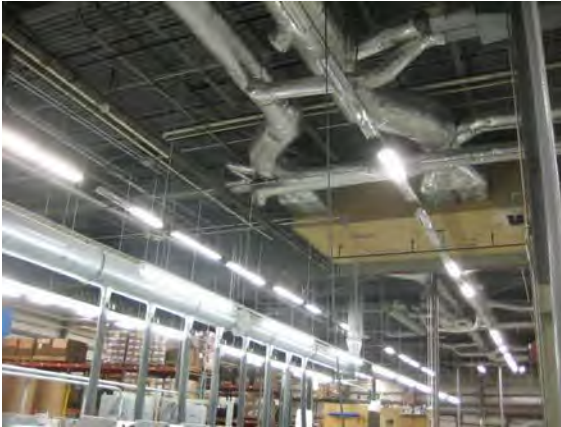
### 2.1 Facility Description & Overview

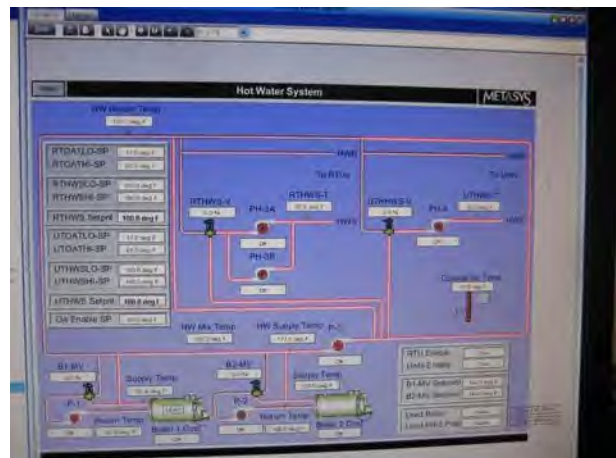
**Chilled Water System:**

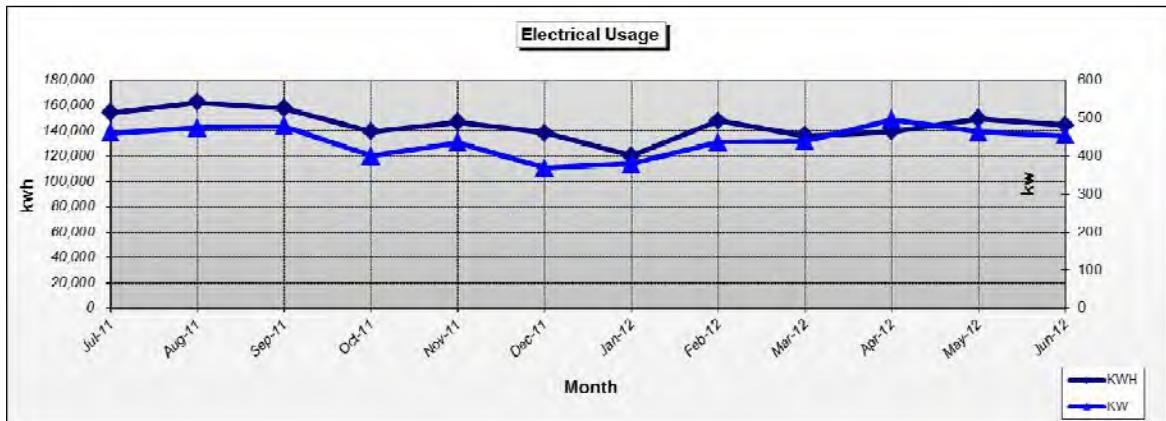
One method, to illustrate the upward or down ward trend of utility usage over a long period of time is through the use of a 12-month rolling average chart (shown below). Each bar on the following charts represents the total kW or kWh for the previous 12 months (including the month noted on the x-axis).

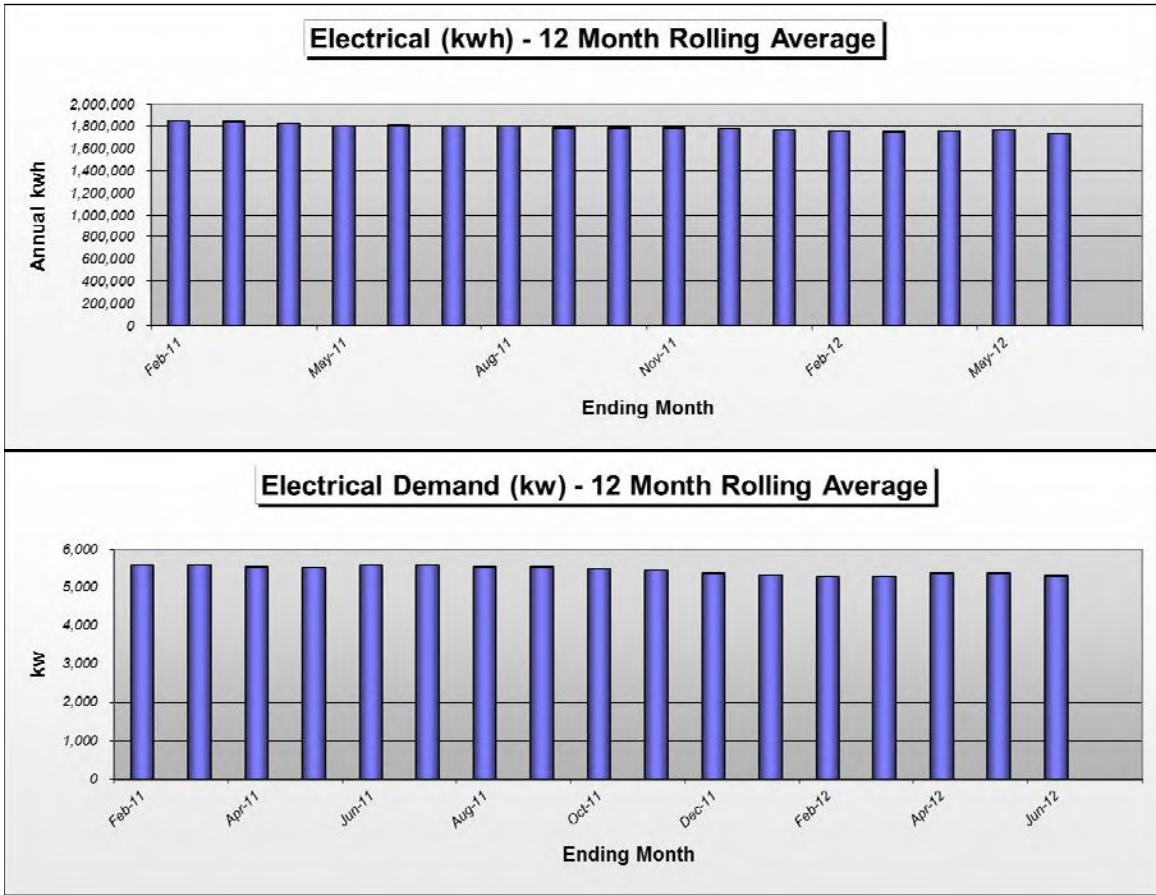
As illustrated in the chart above, the electrical usage and demand have both remained fairly consistent over the recent past. .

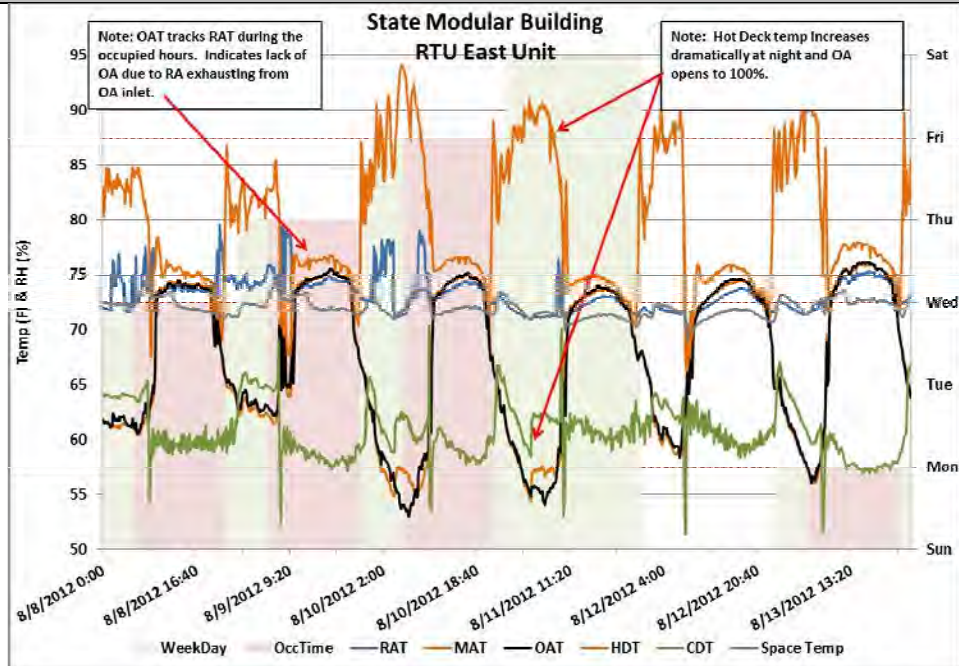
### Supporting Documentation
