RESERVOIR 3 STRUCTURAL REPAIRS

Washington State CPARB PRC Application

Everett Reservoir #3

CG Project No.: 18297.10
October 18, 2019

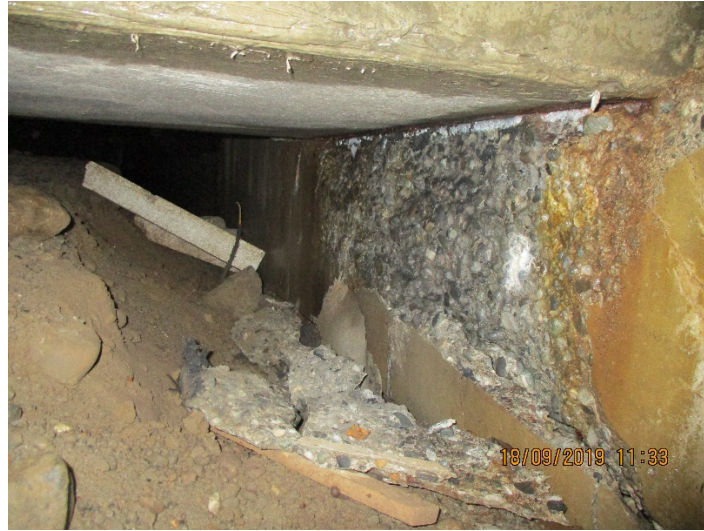
The following is an example that illustrates the type of repair that will be required for this project. Figure 1 shows a pile-supported concrete grade beam that is spalling at the location where it supports a concrete girder. The girder connection supports a large load and the clearance between the ground and the underside of the girder is about 2'-6". All repairs (piles, grade beams, etc.) must be constructed in this small area. Additionally, the repair location is more than 200' away from an opening in the reservoir.

Figure 1 – Typical Girder Support Repair Location

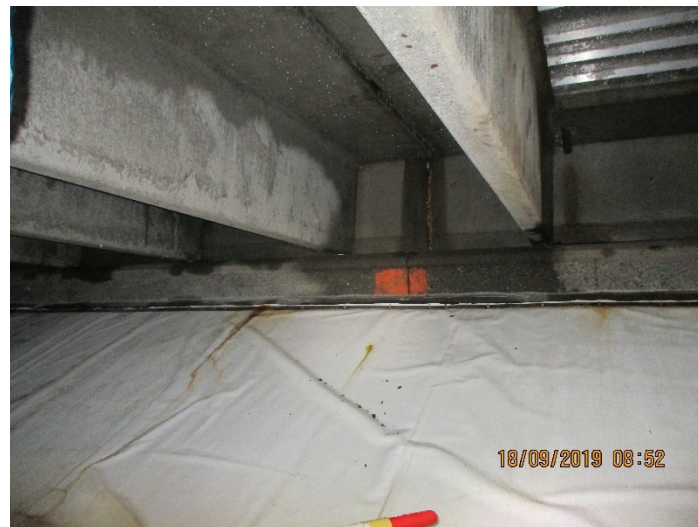
The reservoir floor (including the inclined sides) is covered with an impermeable Hypalon liner that was installed in 2008 (see Figure 2). This liner is a necessary component of the reservoir, as it contains the water inside the reservoir while preventing groundwater from entering the reservoir. The Hypalon liner is watertight, and is inspected regularly for damage. At the completion of the project, the liner must be watertight prior to final acceptance and filling the reservoir.

Figure 2 – Existing Hypalon Liner

Since the liner is relatively new and would cost about \$1.5M to replace in its entirety, a requirement of the project will be that the liner is protected in place or partially removed and repaired. The liner system requires highly specialized means and methods, as well as a thorough assessment of risk involved with working on and around the existing liner system. The construction methodologies are likely to depend on how the contractor decides to handle the reservoir liner system. PDB allows the City to have input to the Contractor's recommended methodology for protecting the liner system – a critical component of the City's water delivery infrastructure.

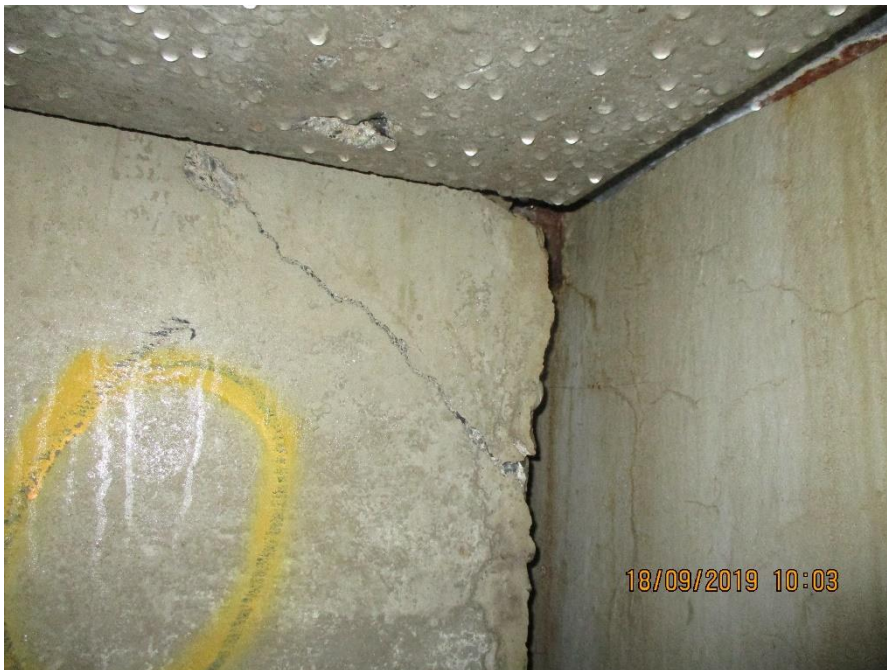
Significant spalling of both the concrete girder ends and their grade beam supports was observed. In general, enough concrete had spalled away to expose the reinforcing steel and steel embedment plates that anchor the girders to the foundation. Additionally, some spalling of the girder end at the center of the structure was observed. Significant corrosion of all the exposed reinforcing steel was observed. Refer to the attached roof plan for a summary of observed girder spalling.

Photo 1 - Spalling at top of girder (typical condition)

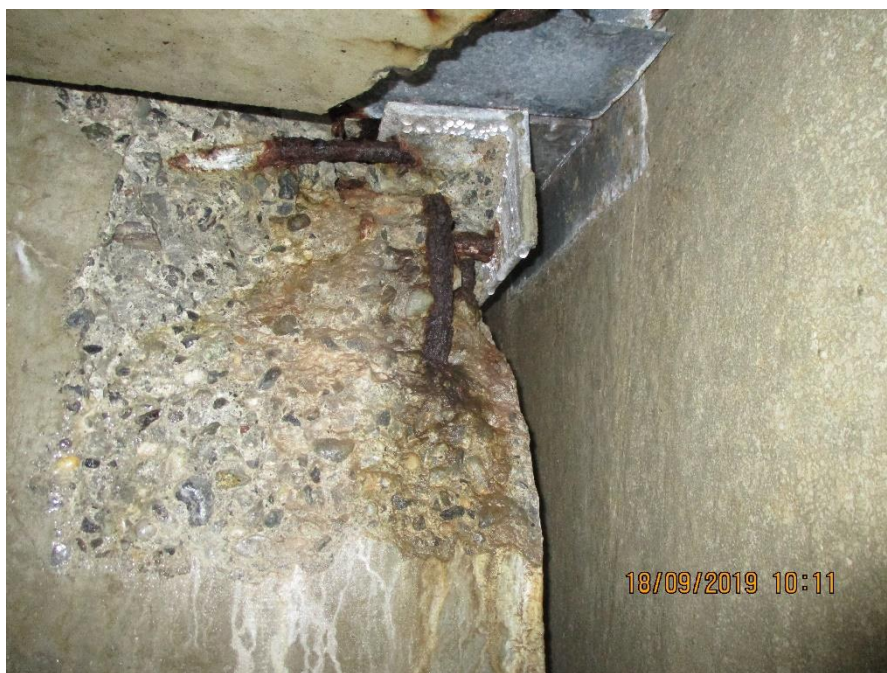
Photo 2 - Spalling at top of girder and exposed reinforcing steel (typical condition)

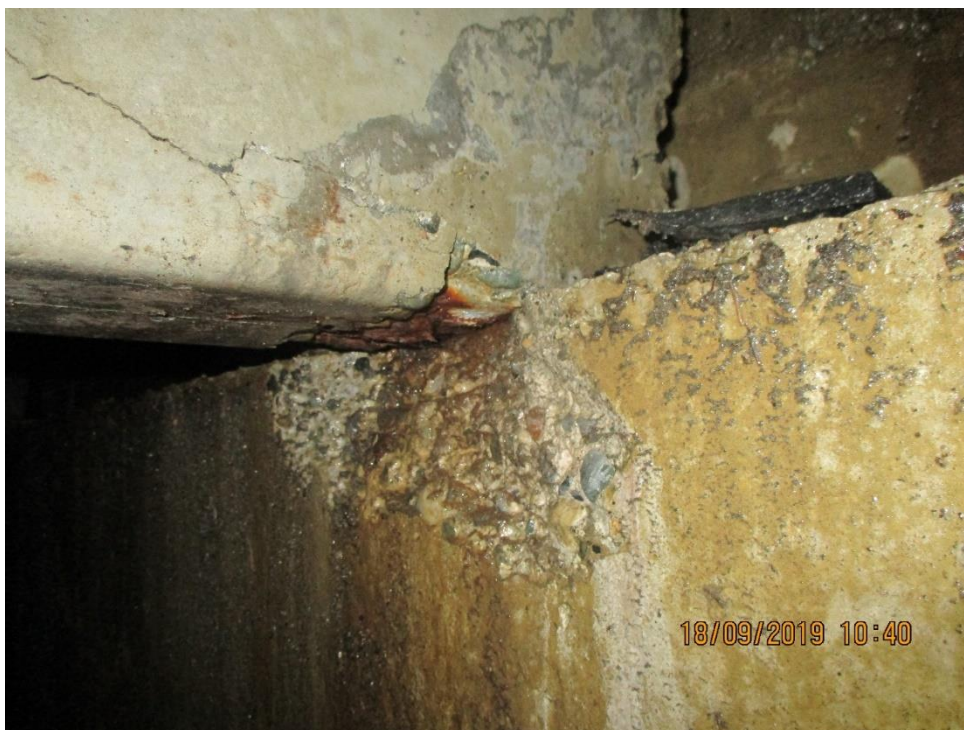
Photo 3 - Spalling of girder and its support (typical condition)

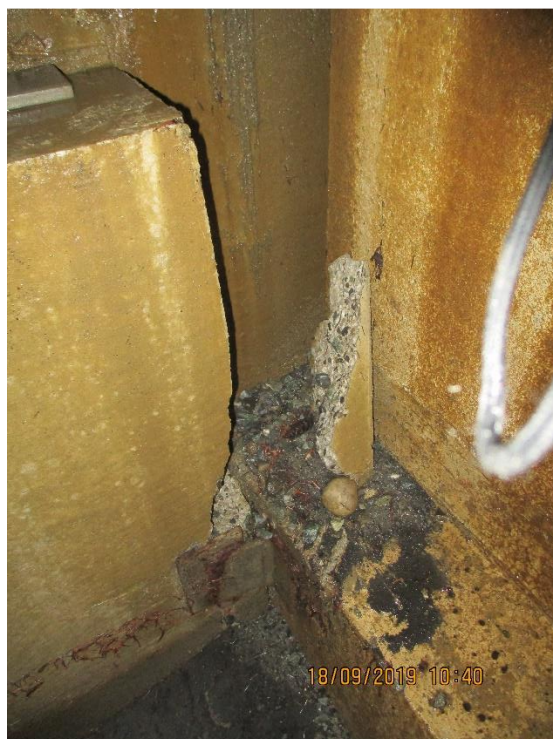
Photo 4- Spalling grade beam connection (typical condition)

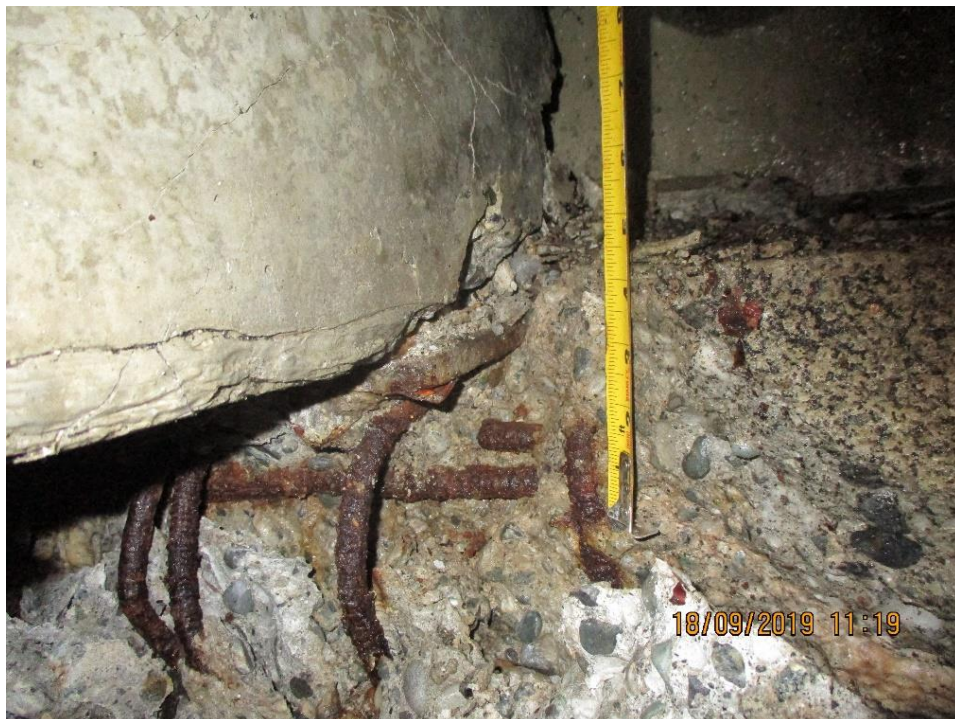
In some cases, the grade beam support had spalled away leaving very little bearing area for the girder. Typical spalling of the supports left 1 inch or less of bearing at some locations. Specifically, the girder support located at Grid A-8 has completely spalled away and the bottom of the girder appears to have settled below the top of the grade beam by ± 2 inches. This location also corresponds to the observed areas of slab cracking above (see previous section).

Photo 5 - Concrete girder support at Grid A-8 and 2" settlement

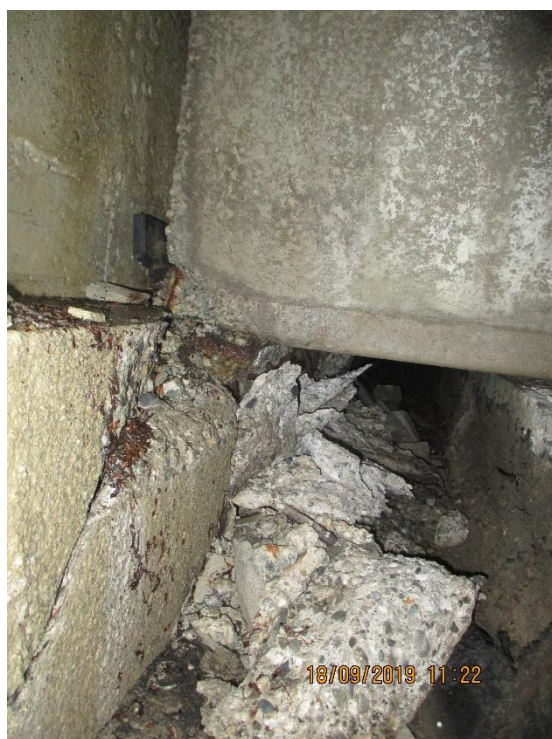
Photo 6 - Concrete girder support at Grid A-8 (opposite side as previous photo)

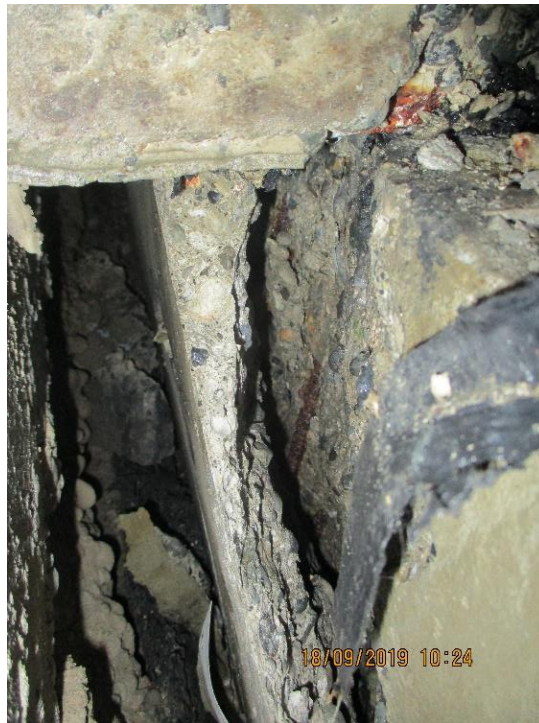
Photo 7 - Spalling at grade beam girder support (typical condition)

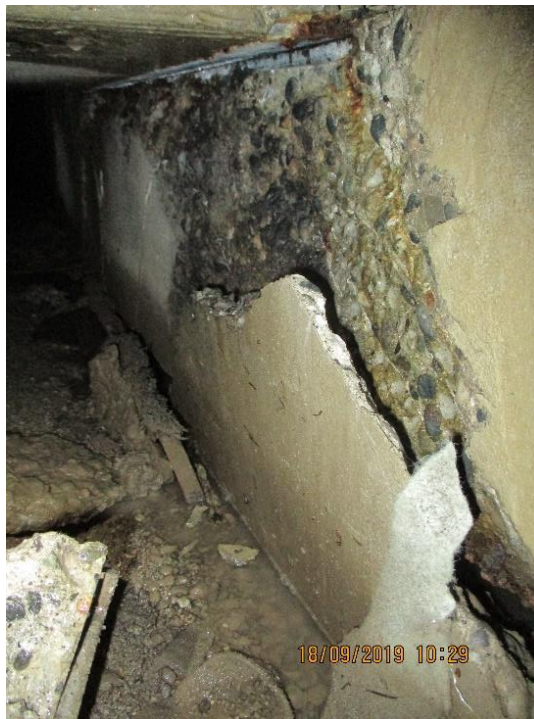
Photo 8 - Spalling at grade beam girder support (typical condition)

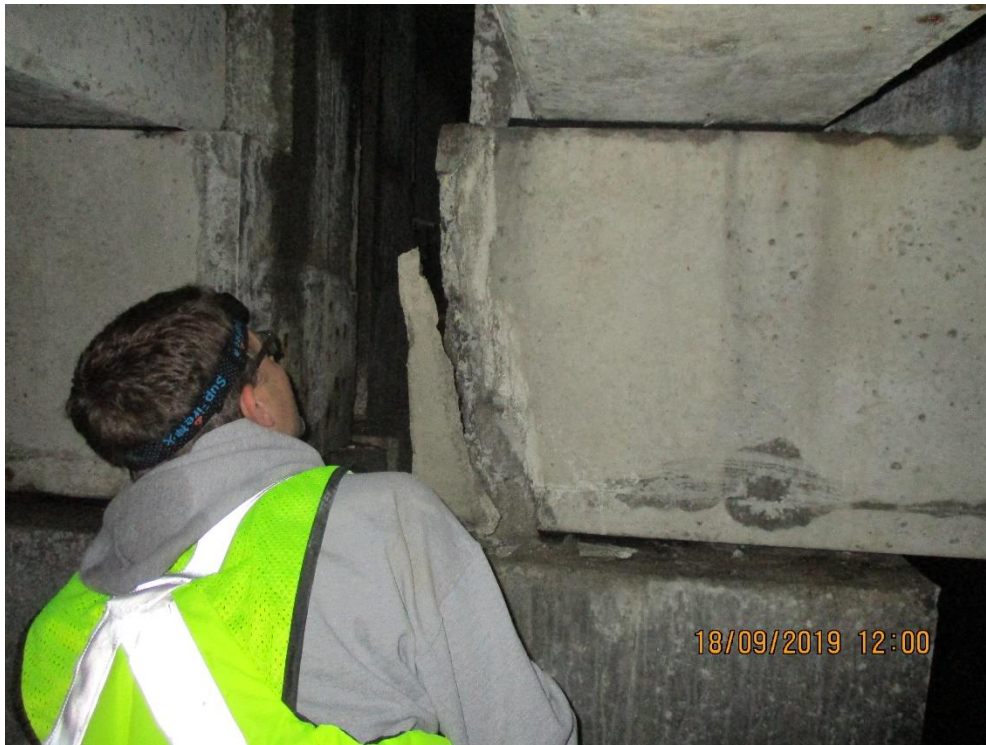
Photo 9 - Spalling of girder at interior support

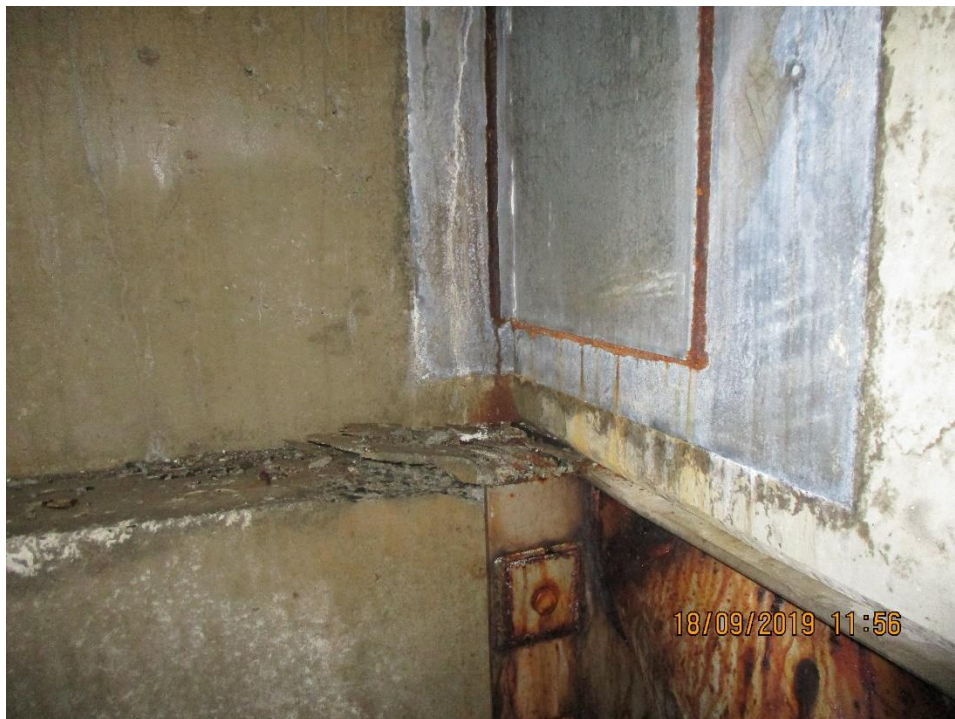
Photo 10 - Spalling of girder at interior support

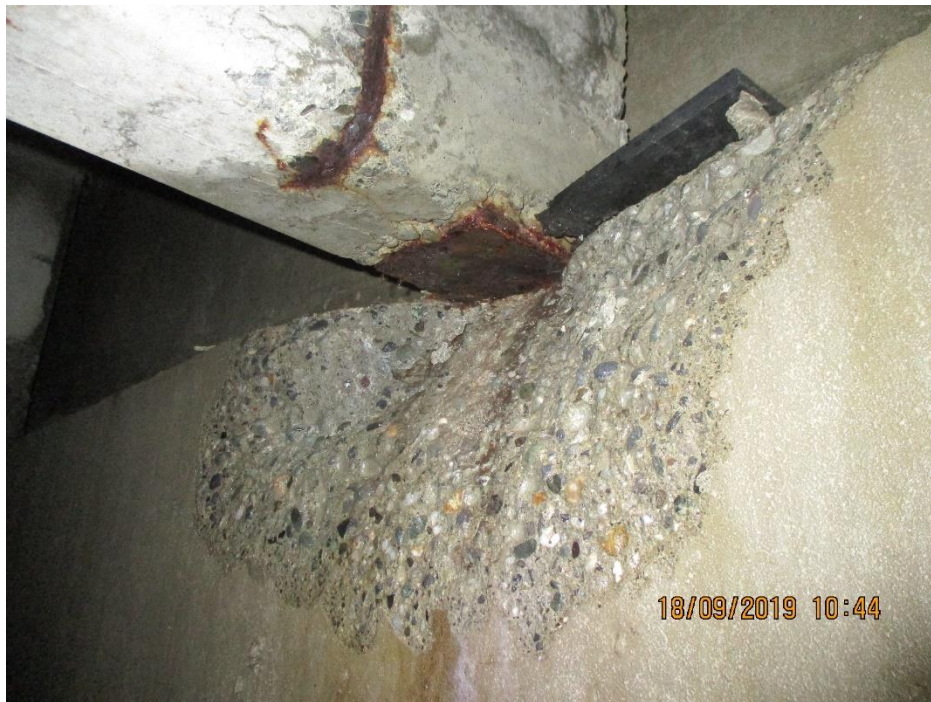
Similar to the concrete girders, several of the double-tee joists had spalling at the end of the members as well as their supports. The spalling exposed the reinforcing steel which was observed to be corroded. The existing concrete cover was observed to have been less than $\frac{1}{4}$ " at some locations.

Photo 11 - Spalling of double-tee joist and its support (typical condition)

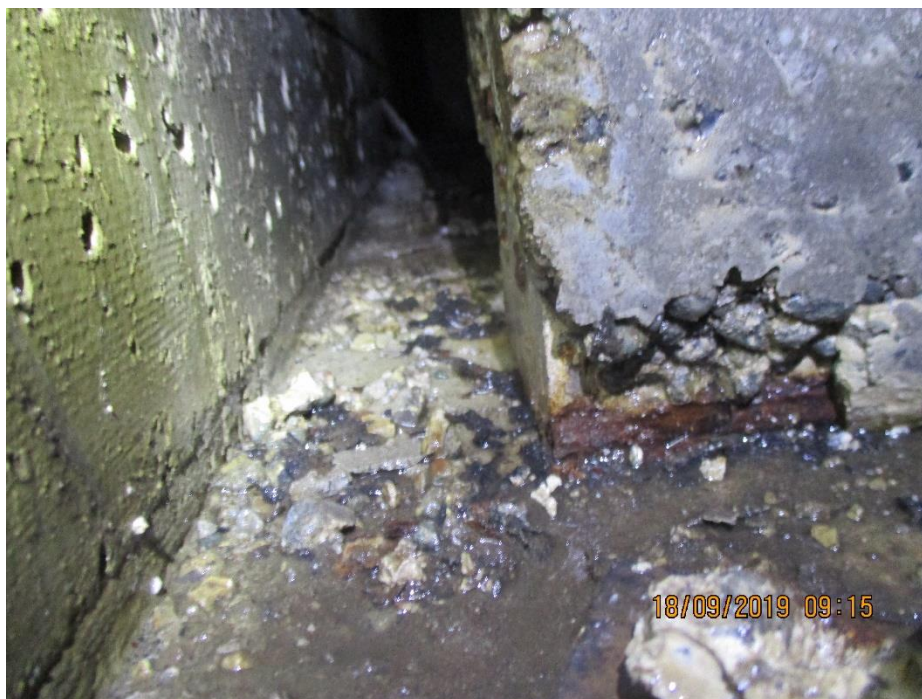
Photo 12 - Spalling of double-tee joist and exposed reinforcing steel

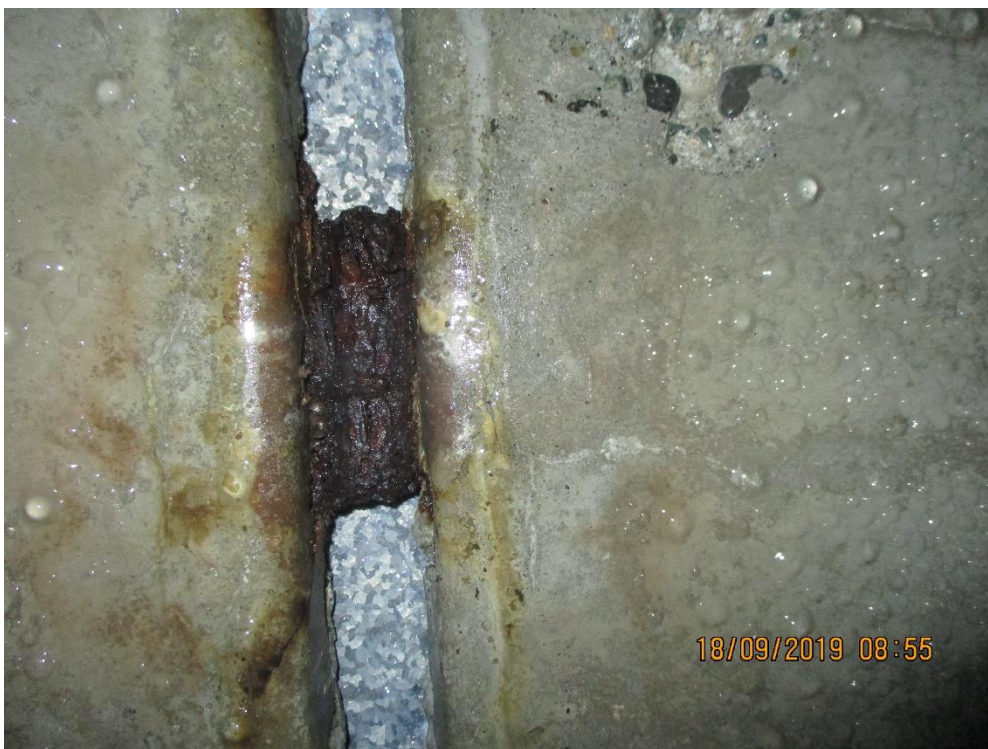
Substantial corrosion or rust was observed at all hairpin connectors between the joist flanges. Additionally, some minor cracking of the concrete was observed at several of these connections. The joists are connected together by welded rebar hairpins spaced at 8'-0" oc. We estimate there are 2,160 joist connectors total.

Photo 13 - Corroded steel rebar connection between joists

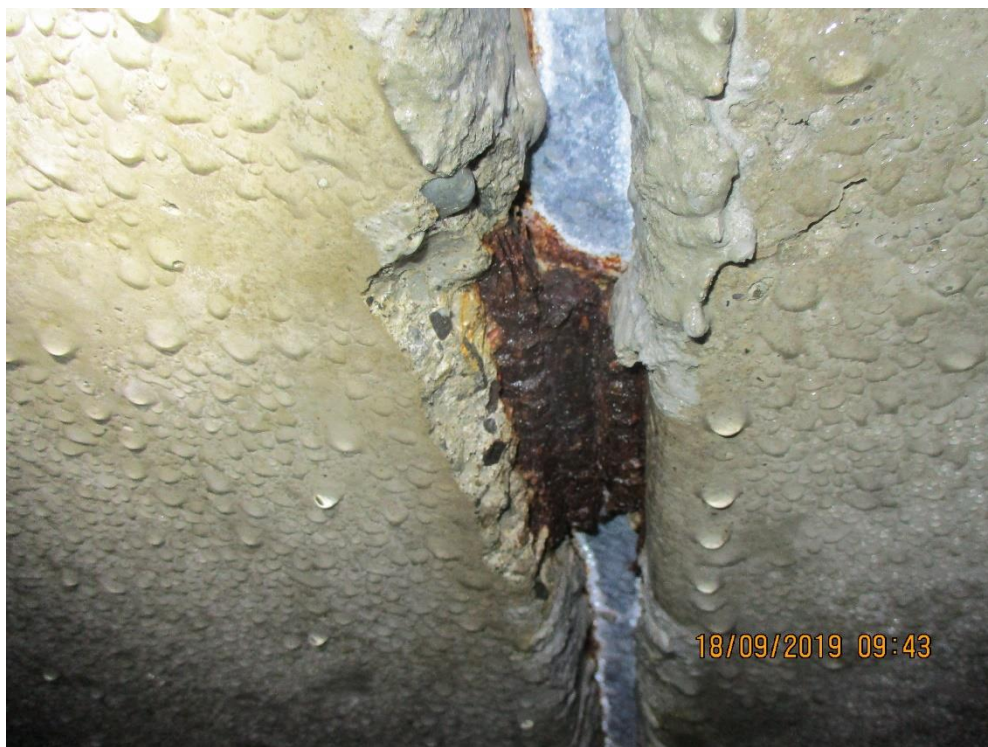
Photo 14 - Corroded steel rebar connection between joists

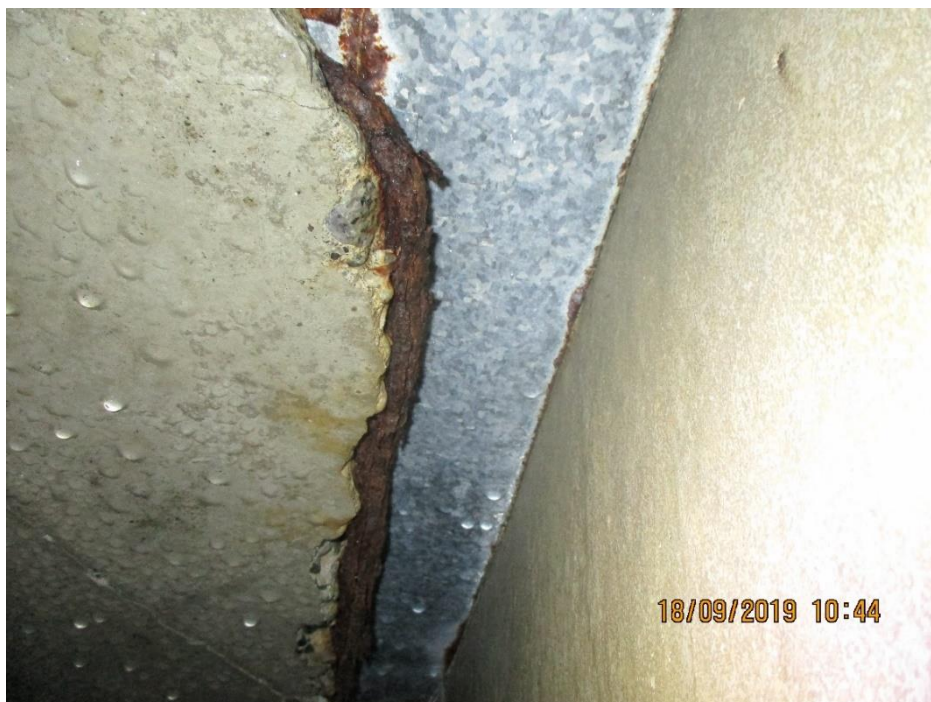
Some spalling was observed around the steel embedment plates that connect the double-tee joists to the exterior wall. The connectors themselves were observed to have substantial corrosion.

Photo 15 - Corroded double-tee joist flange at "non-bearing" wall support

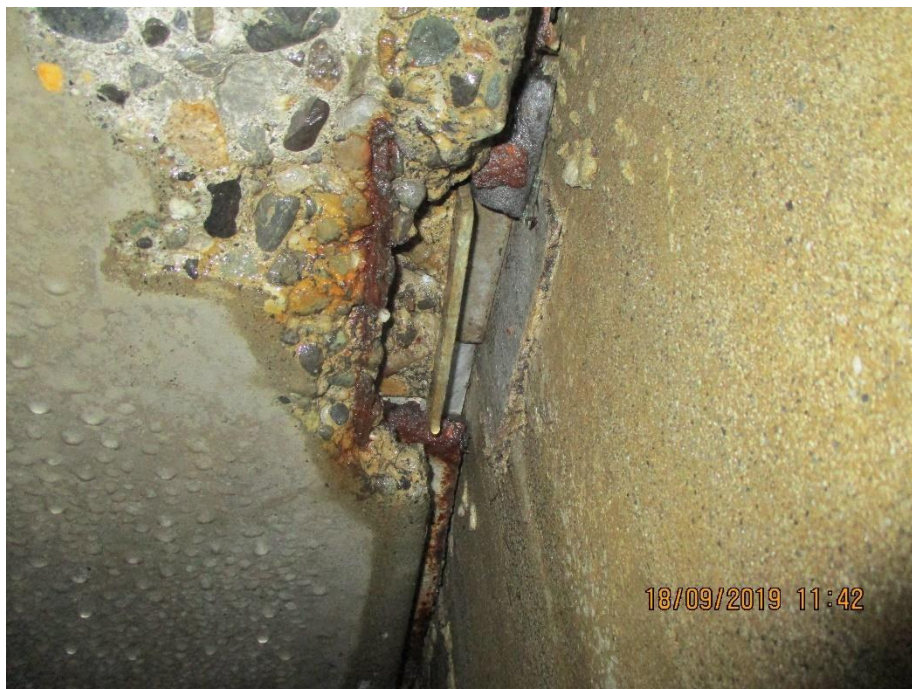
Photo 16 - Corroded double-tee joist connector at "non-bearing" exterior wall support

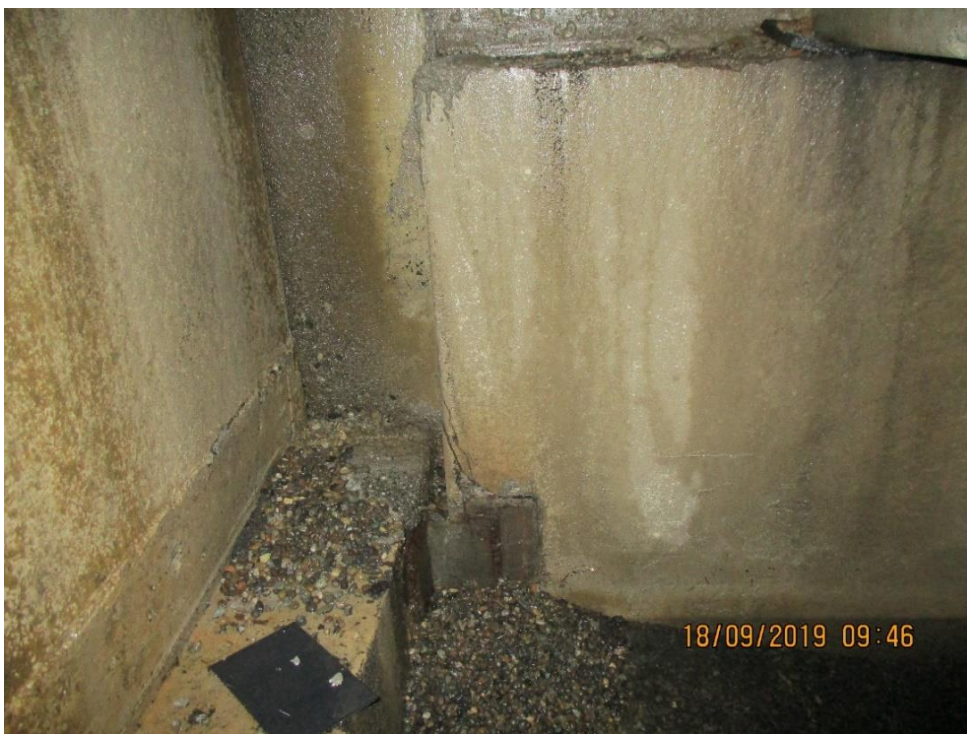
Some minor spalling around the steel embedment plates connecting the precast grade beams at the corners was observed.

Photo 17 - Minor spalling around steel connectors at grade beam corner connection

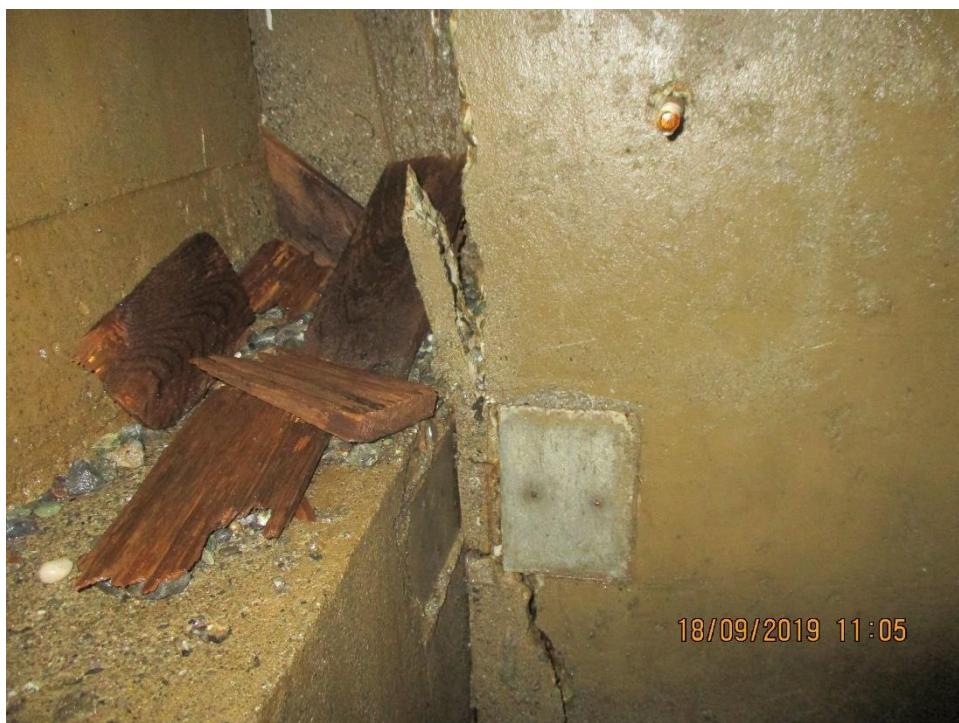
Photo 18 - Spalling around steel connectors at grade beam corner connection

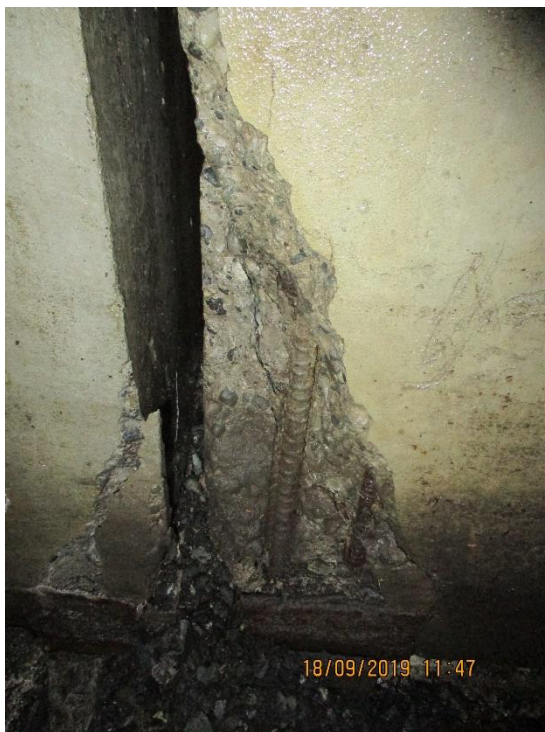
Some concrete edge spalling was observed at the grade beam/wall construction joint in the northwest corner, near Grid A-1. The construction joint appeared to be located directly over a

concrete pile cap. It appeared that the grade beam had some vertical displacement as the double-tee joists was only bearing on one web. It is unclear what caused the differential movement.

Photo 19 - Spalling and exposed reinforcing steel at exterior wall construction joint at northwest corner

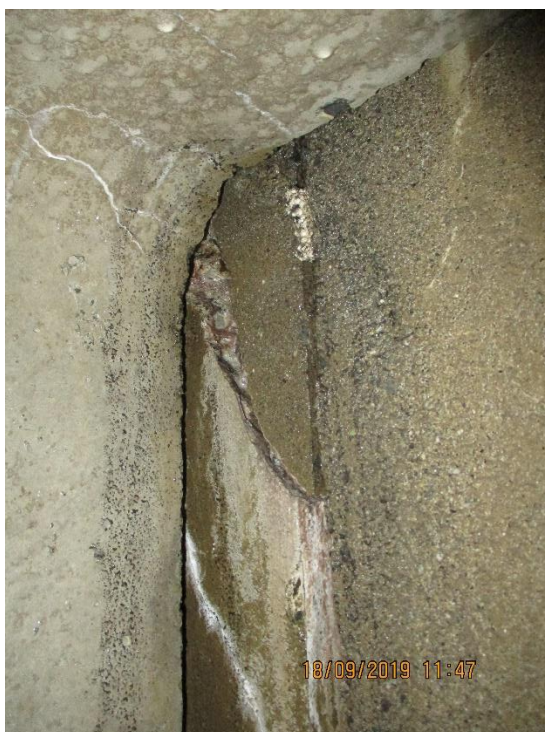
Photo 20 - Spalling and at exterior wall construction joint (same location as previous photo)

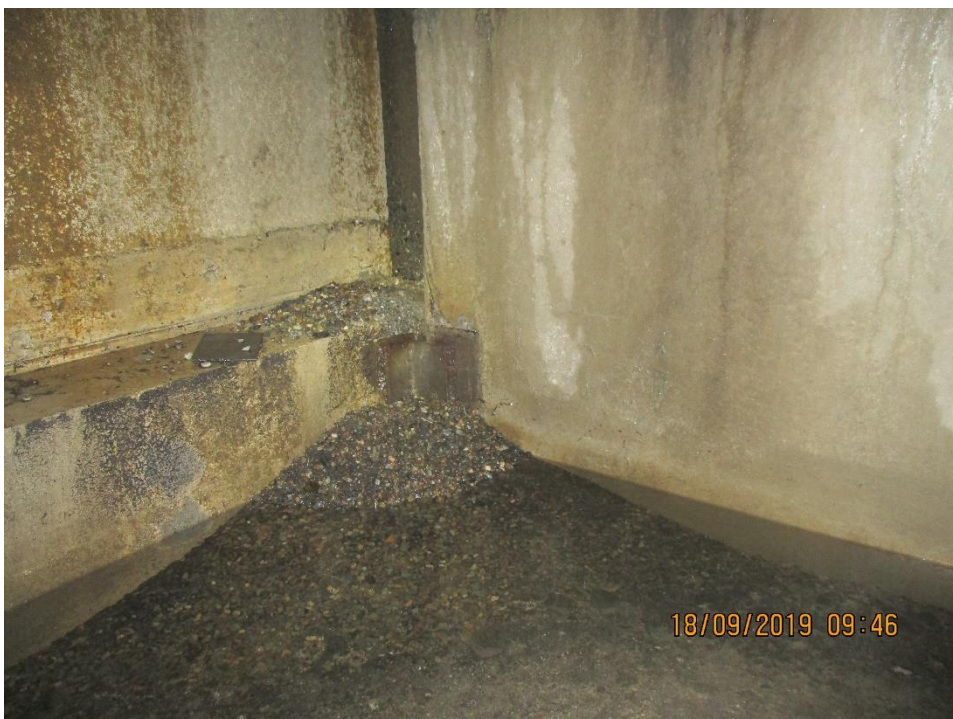
Significant amount of standing water was observed in the crawlspace areas at each corner. In some cases, the depth of the water was several inches. The foundation system utilizes auger-cast piles and it's unlikely the standing water will adversely affect the structural capacity of the system. However, the City may want to consider installing drainage system in these areas to eliminate the standing water.

Photo 21 - Standing water at corner crawlspace (typical condition)

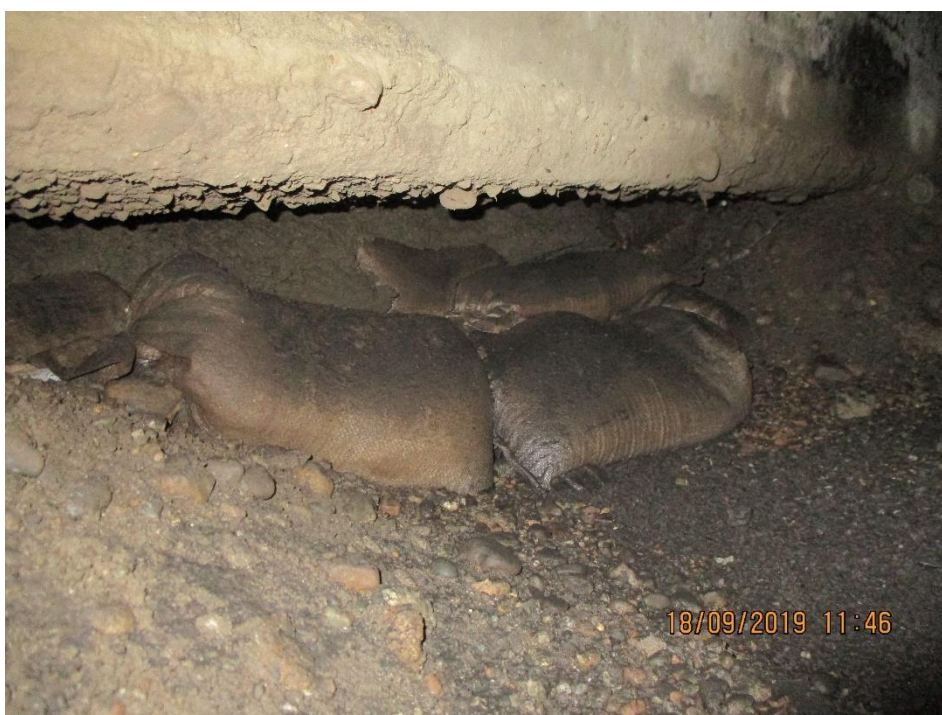
A portion of the grade beam in the northwest corner was observed to be undermined. It was unclear what caused the displacement of the soil.

Photo 22 - Undermined reservoir wall located on west side of structure

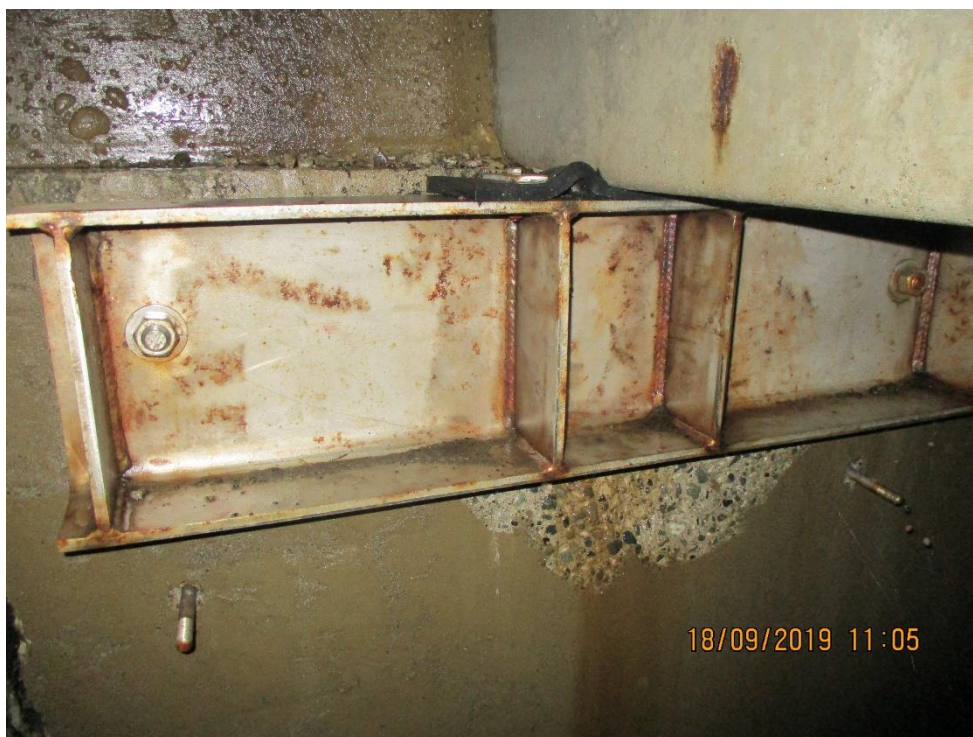
Photo 24 – Previous double-tee support repair near Grid A/B-8

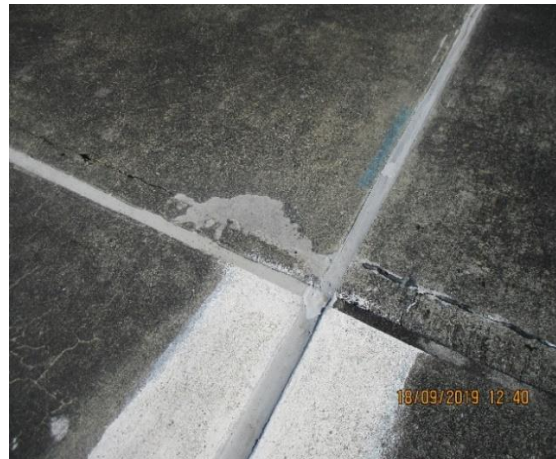
The joint sealant between roof expansion joints, which separate the roof into quarters, was observed to be damaged or missing at the south joint.

26 - Expansion joint at roof center

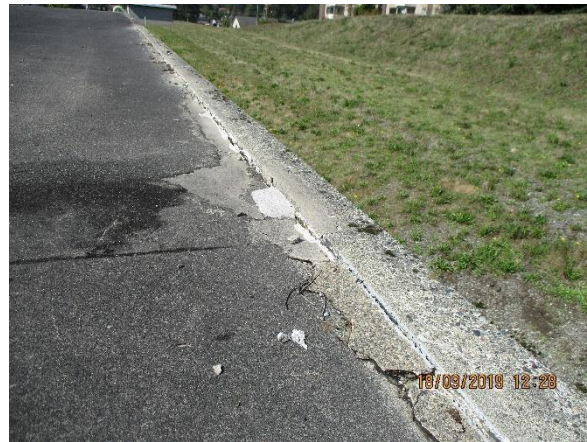
Cracking (and in some cases spalling) of the concrete topping slab at the exterior wall/slab joint was observed in several locations. It appeared that some of the cracking material was a previous repair patch. The cracking suggests differential movement between the supporting structural members and exterior walls. The worst areas of damage were observed in the northeastern quadrant, near Grid A-8.

31 - Cracking of topping slab/wall joint at NE

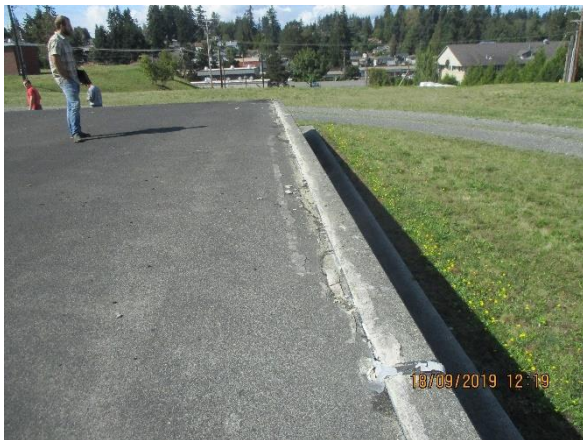
29 - Cracking of topping slab/wall joint at NW corner

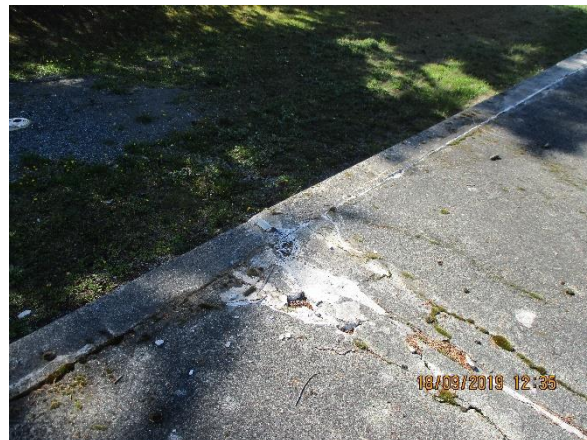
30 - Cracking of topping slab/wall joint at south side
