CAPITOL LAKE

ADAPTIVE
MANAGEMENT PLAN
1999 to 2001

CHAPTER 1

INTRODUCTION & PHASE ONE ACTIVITIES

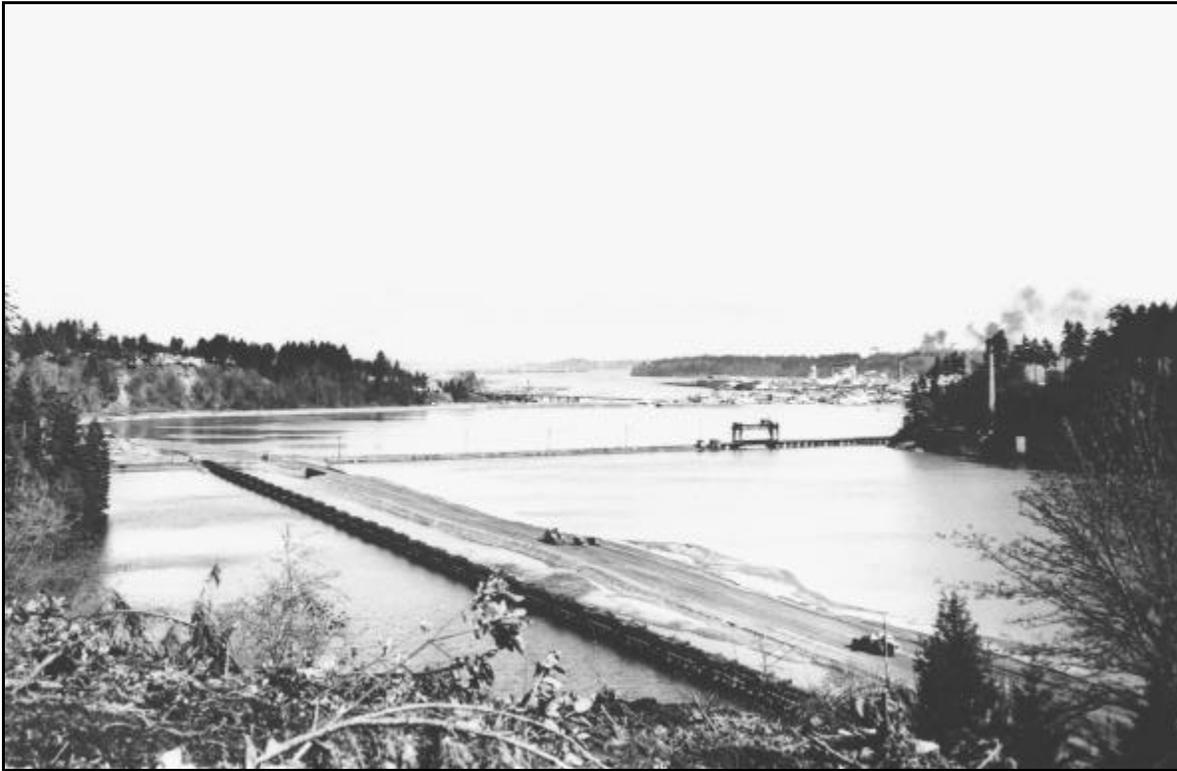
Photo 3-1. Construction of “The Causeway” which created Percival Cove, looking from the Courthouse Hill. c. 1950. Courtesy of the Susan Parish Collection.

Construction records for the Deschutes Basin Project are limited but the following photographs outline what is known. From Percival Landing (Water and 5th Avenue) to the vicinity of Marathon Park, Deschutes Parkway was constructed as a ballast haul road using a point of land to the west of the present park location as the source of the fill material. The Percival Cove crossing (now called "The Causeway") was constructed along the side of the railroad trestle by dumping fill along the east side of the trestle. After the roadway was complete, the trestle was abandoned and dismantled. (Refer to Figure MP-7 in the Map Packet.)

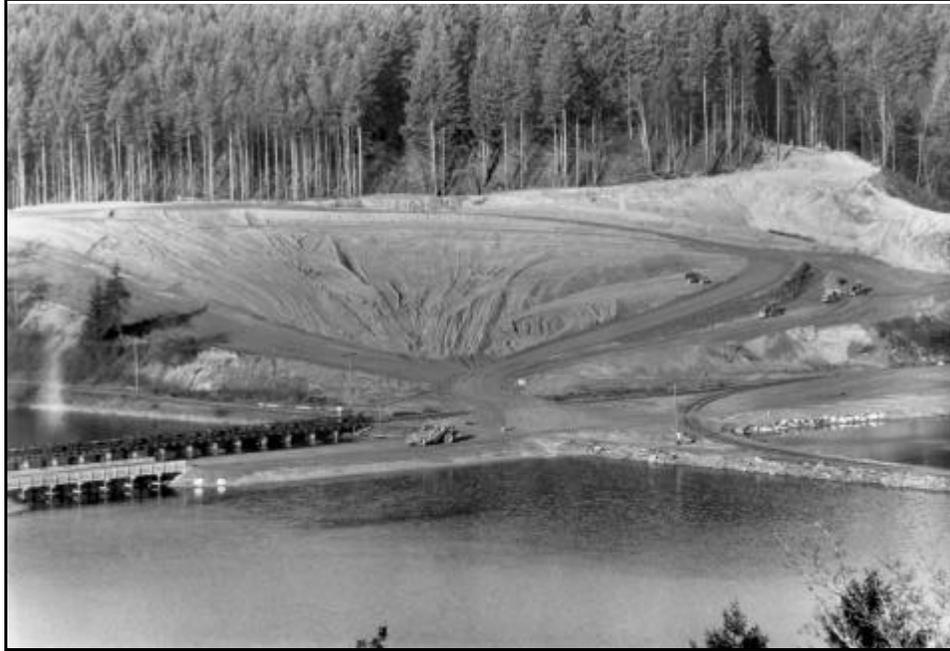
Photo 3-2. Burrow pit for Deschutes Parkway now located west of Marathon Park.
c. 1951. Courtesy of the Susan Parish Collection.

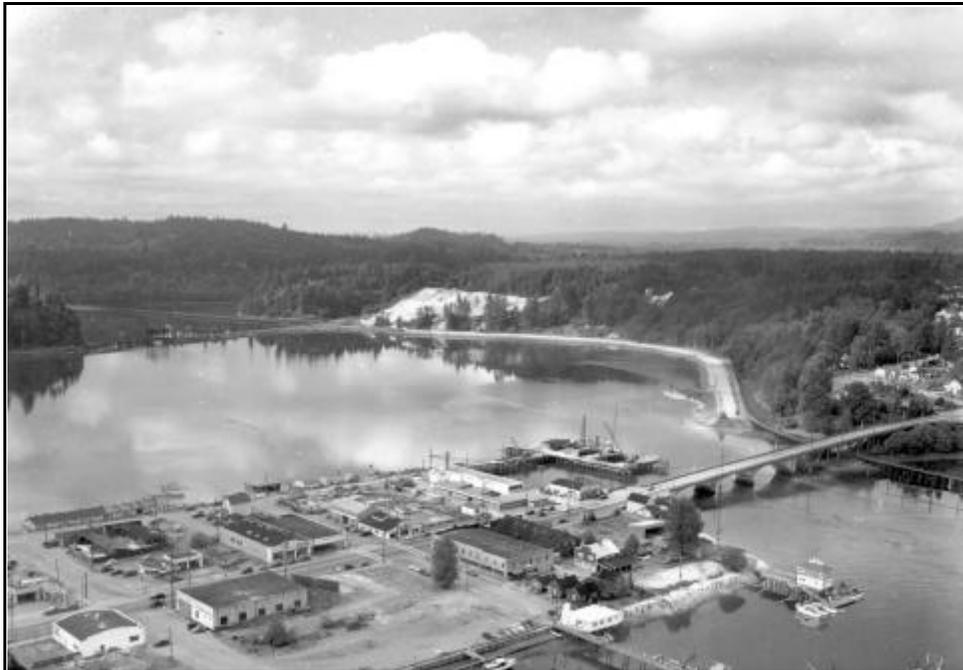
Photo 3-3. Construction of Deschutes Parkway and the North Basin.
c. 1951. Courtesy of the Susan Parish Collection.

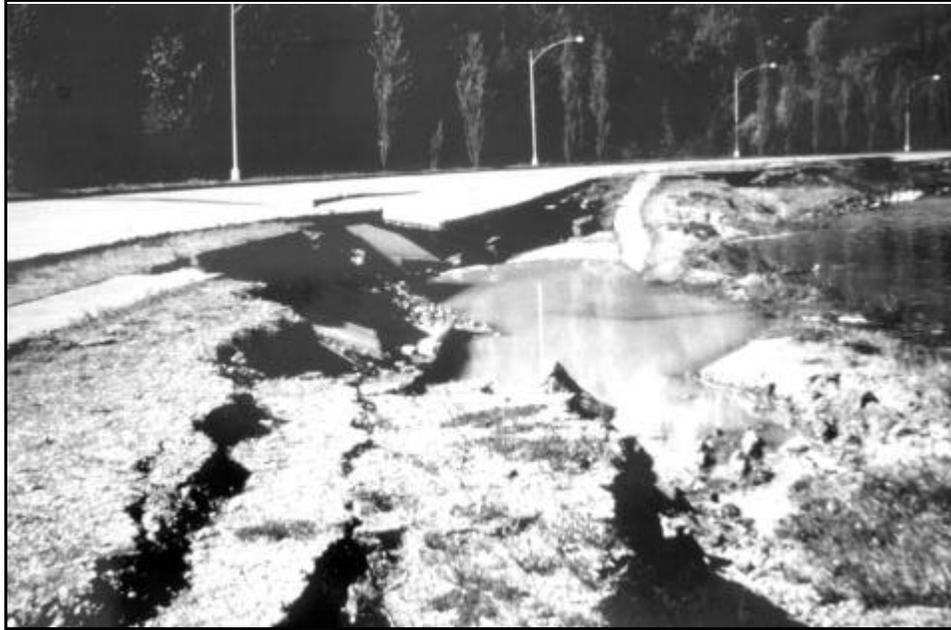
Photo 3-4. Earthquake damage to Deschutes Parkway. c. 1965.
Courtesy of Washington Department of Natural Resources.

Earthquake damage repair drawings were prepared and recorded failure areas showed six slide areas and one settlement area. Slide areas # 1 through 5 (Interpretative Center Area) were located along the southerly lake shore, moderate in size and characterized by steep/high bank upland slope areas and lake bottom mud waves. The slide area located north of Marathon Park was large, extending about 1,400 feet and extended to the Causeway area and fronting Percival Cove. This was the most severe damage to roadway pavement. Considering the type of soil in the failure areas, the probable method of construction and relatively low vertical height of the roadway section, the recorded failures were most likely the result of subgrade liquefaction.

Available geotechnical data confirms the filling process. The fill material used for the roadway generally consisted of uncompacted gravelly fine to course sand, which readily segregates as it settles to the bottom of the inlet. Geotechnical borings indicate fill thicknesses of up to 25 feet in depth with most fill in the 16 feet range. Beneath the fill is naturally loose clayey silt and loose lake (inlet) bottom sediments, which range from a few feet to over 20 feet in thickness. Data gathered on the Causeway in 1996 indicates artesian groundwater with static levels above the ground surface. This suggests that there could be buried springs under this portion of the roadway and that vertical seepage pressure will act to reduce the stability of this embankment. Further, slight slumping to the west of the Causeway may indicate a rising bottom toward the west in Percival Cove. This may indicate a mud wave formation and a deep rotational subgrade failure.

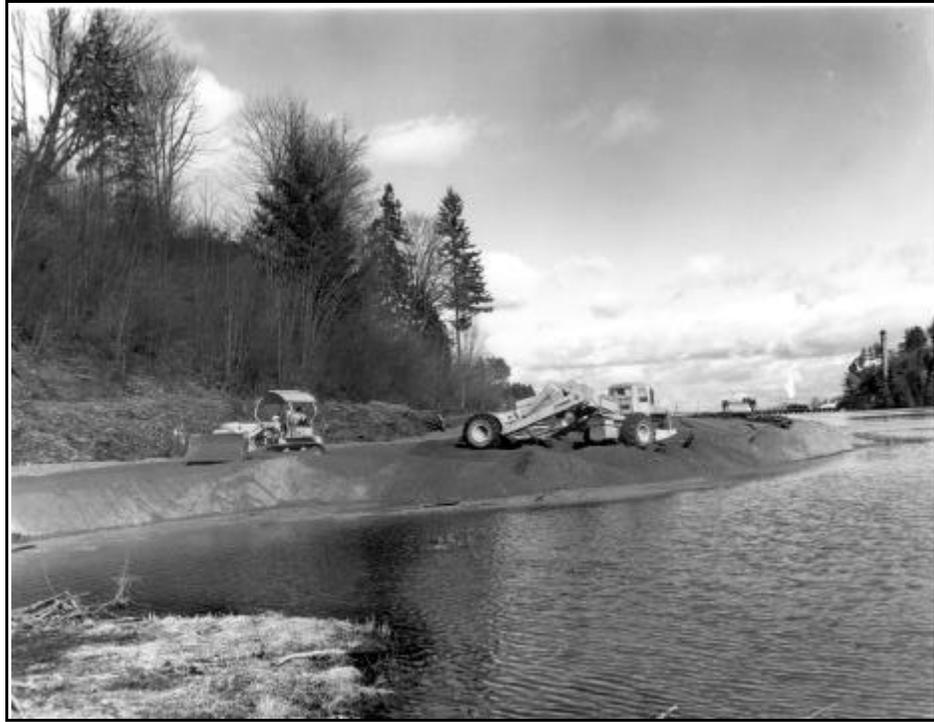
Photo 3-5. Construction of Deschutes Parkway in the Middle Basin.
c. 1951. Courtesy of the Susan Parish Collection.

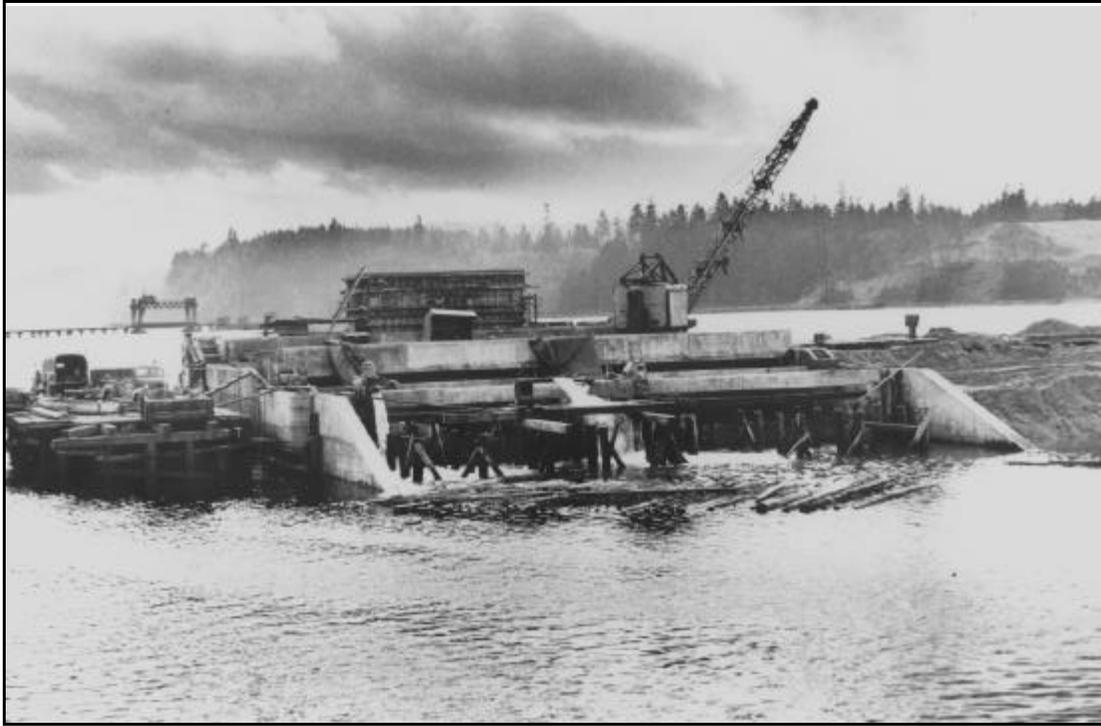
Photo 3-7. Construction of the Capitol Lake Dam.
c. 1951. Courtesy of the Susan Parish Collection.

On June 1, 1948, an application was made to the U.S. Army Corps of Engineers for approval to construct a 230,000 cubic yard earth dam at the north end of the basin (5th Avenue) with an 80 foot concrete spillway structure. Along with the dam, the request was made to construct an earth fill of 186,500 cubic yards along the westerly shore for Deschutes Parkway and an additional earth fill of 375,000 cubic yards at the northeast end of the basin, where Olympia's Capitol Lake Park is at present. This request was subsequently approved by the Corps on February 4, 1949, and construction was completed on October 10, 1951.

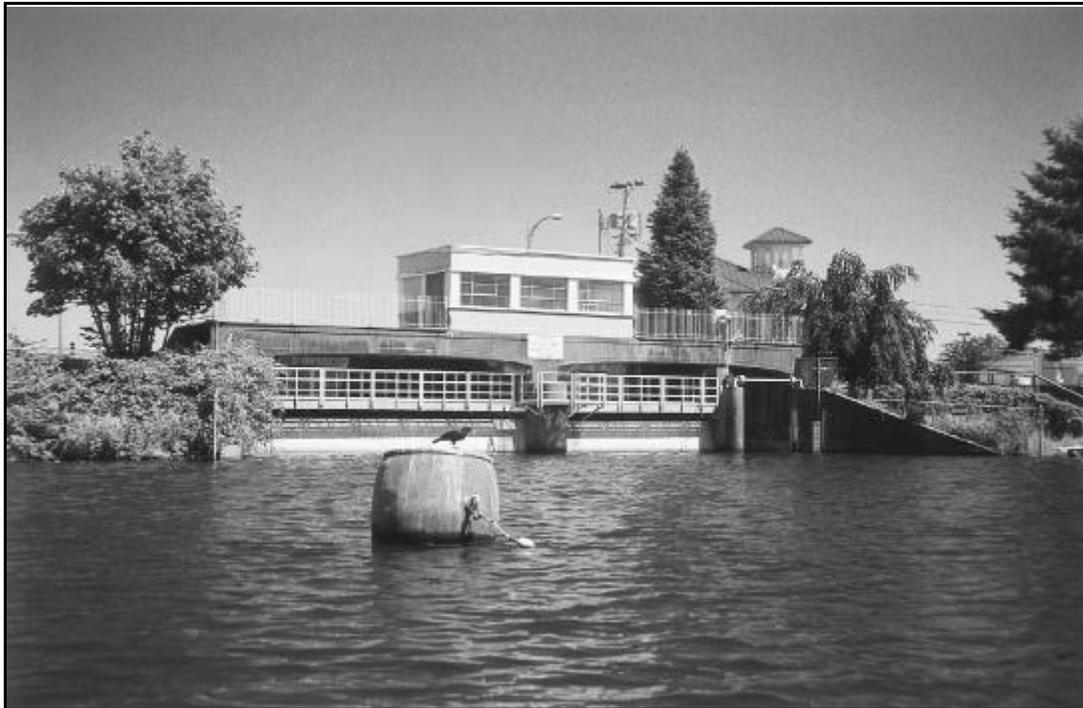
Photo 5-2. Capitol Lake dam from the lake side. c. 1998.
 Courtesy of General Administration.

The sensors in the dam discern differential pressure of the tide level relative to the lake level. An automated system called “Metasys” controls the dam by spilling water or raising the tide gates. The gates rotate up to discharge lake water to Budd Inlet. This control system can be programmed for a variety of variables. These may include the time of year, the predicted tidal elevations, and anticipated flows from the Deschutes River.

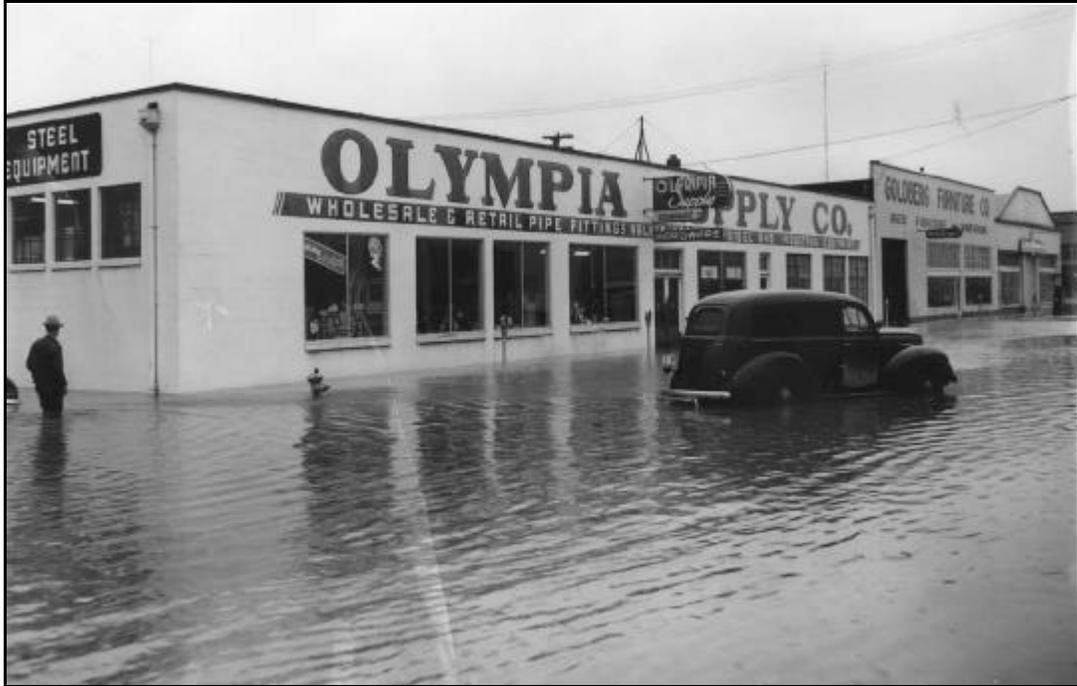
Photo 5-3. Flooding at corner of 7th Avenue and Columbia Street (June 1951).
Courtesy of Susan Parish Collection.

Figures MP-3, 4 and 5 in the Map Packet indicate the chronic flooding problems faced by some downtown businesses adjacent to Capitol Lake and in the vicinity of Water and Columbia Streets. The earliest flood (June of 1951- Photo 5-3) was shortly after the creation of Capitol Lake and local folk lore credits this event to General Administration's first trial and error with operating the new dam. However, the other major flooding events have been during winter months where the combination of high tide and peak river flows cause concerns for downtown flooding. General Administration maintains a normal winter lake elevation one foot lower than the summer lake elevation, which provides approximately 270 acre feet of additional in-lake flood storage.

However, these are minor sources when compared to the discharge and flood threat associated with the 7th Avenue storm sewer which also discharges to Capitol Lake. This storm line drains an area of approximately 16 city blocks. The drainage extends south of 7th Avenue to 10th Avenue and easterly to Adams Street. It even includes the General Administration building on the State Capitol Campus. Street drains along 7th Avenue also flow into this line. Since most all the drainage is at significantly higher elevation than the properties at Water and Columbia Streets, there can be a great hydraulic head in this line which can cause manhole covers to be blow off and water to flow out of street gutters. The lowest elevation in this vicinity is at the corner of 7th Avenue and Columbia Street (Olympia Supply Building). The street gutter at the corner is at an elevation of 8.8 feet MSL and a sidewalk near it is at 9.2 feet MSL. Most photos in this chapter document the problems faced at this location.

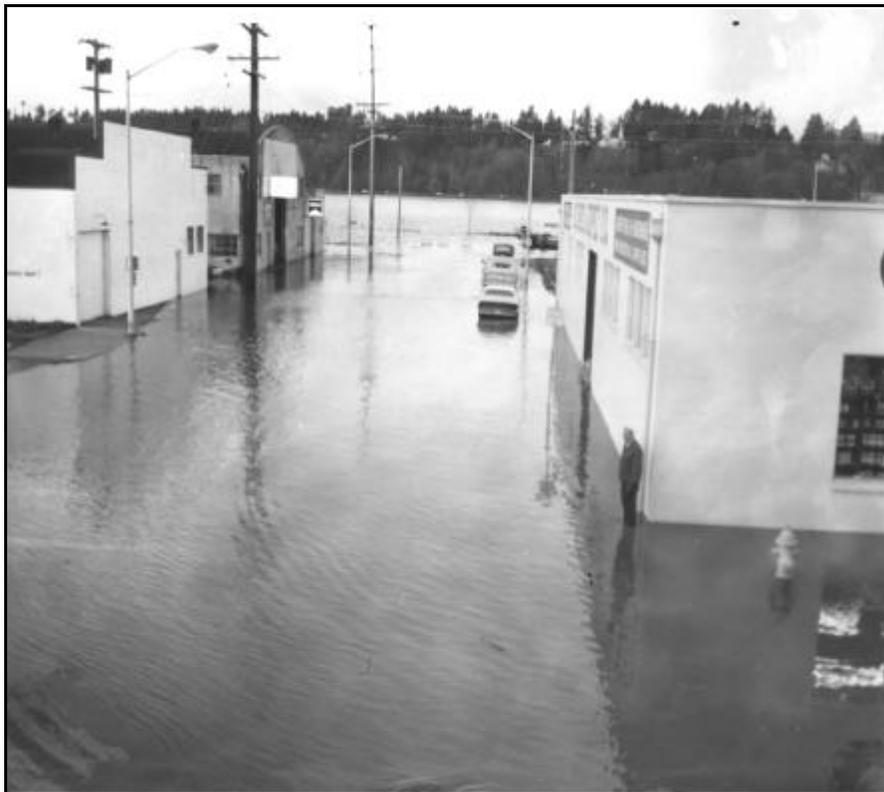
Photo 5-4. Flooding at corner of 7th Avenue and Columbia Street (December 1975).
Courtesy of Susan Parish Collection.

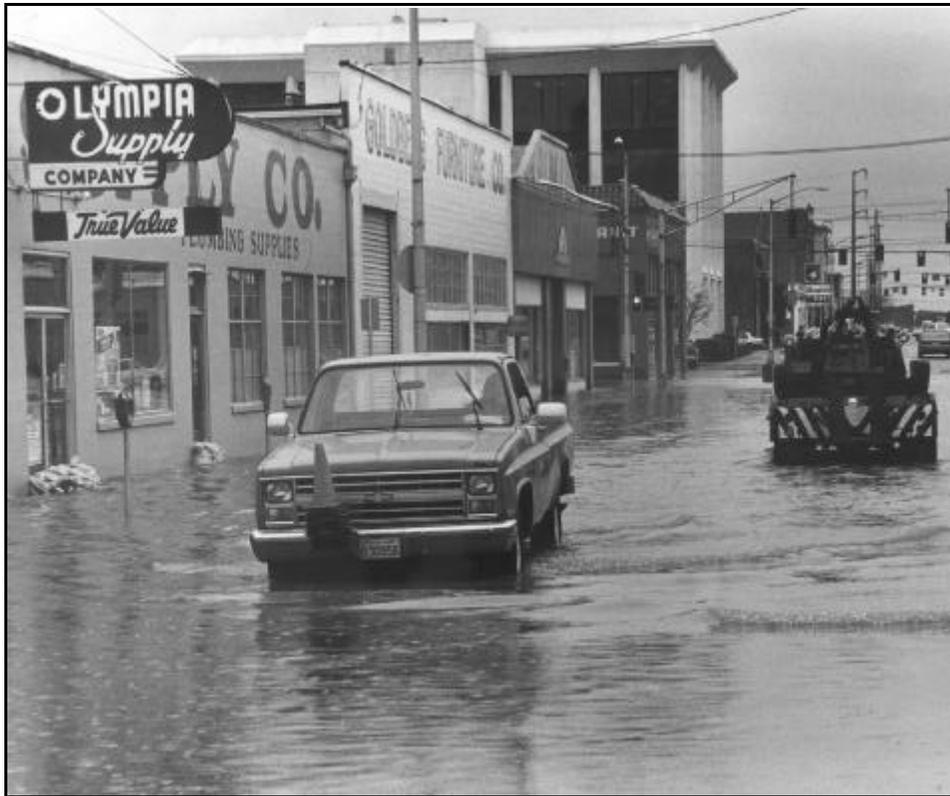
Photo 5-5. Flooding at corner of 7th Avenue and Columbia Street (February 1987).
Courtesy of Susan Parish Collection.

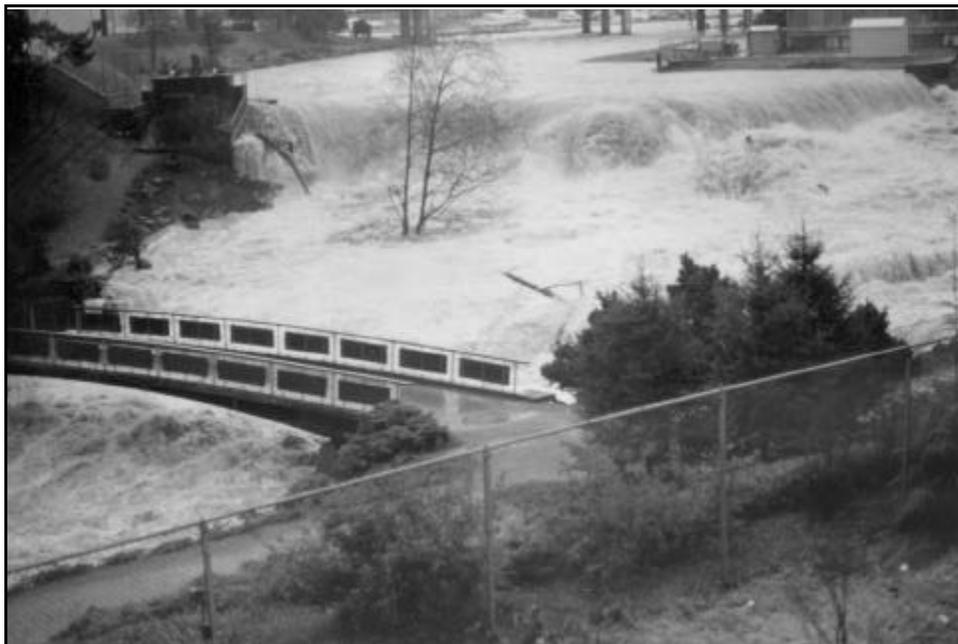
Photo 5-6. Deschutes River flooding. c. December, 1975.
Courtesy of General Administration.

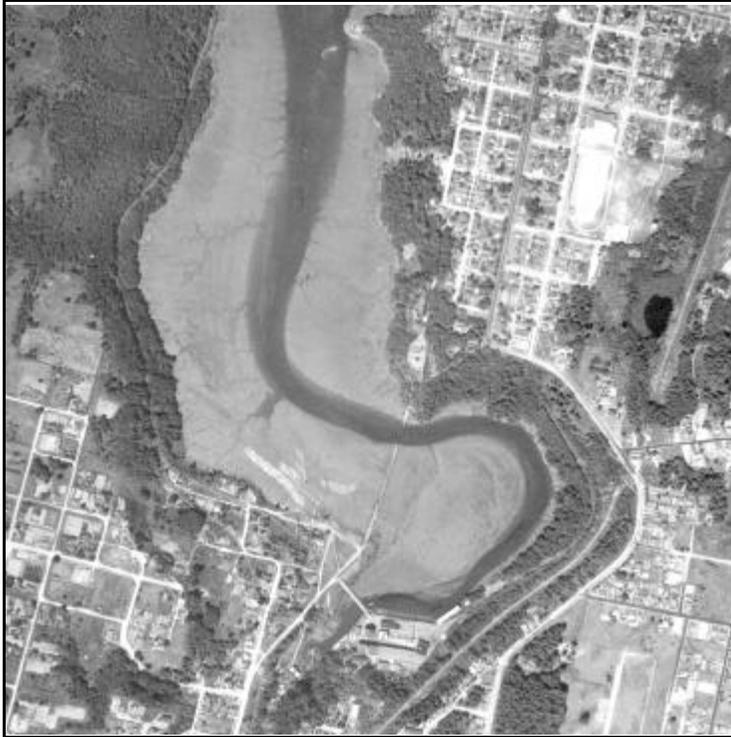
Photo 7-2. Aerial photo of Southern Budd Inlet. c. 1936.
Courtesy of Walker Aerial Surveys and
Thurston County Roads and Transportation Services.

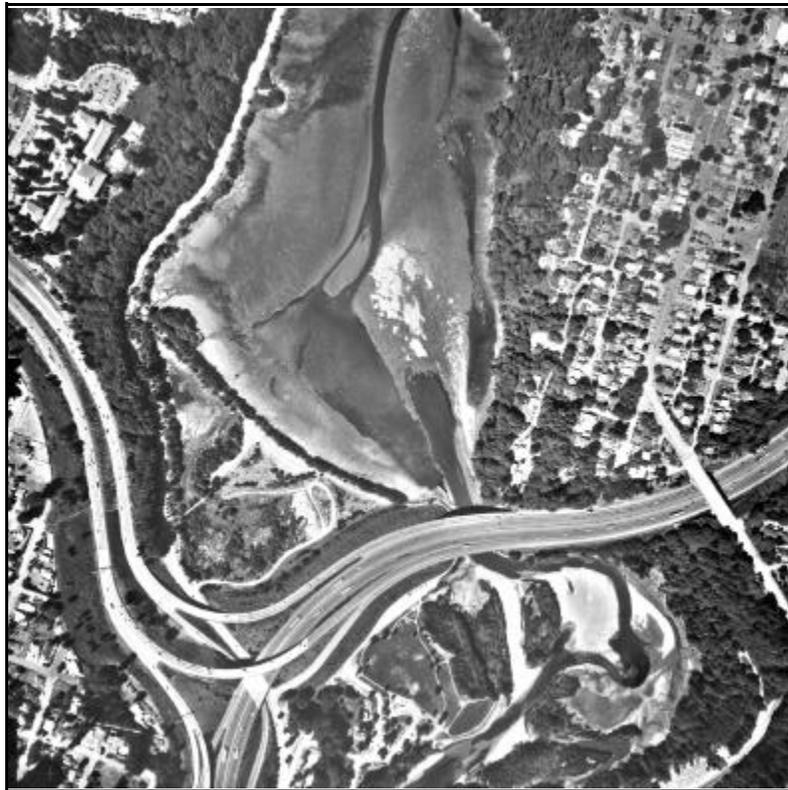
Photo 7-3. Aerial photo of the South Basin
during the summer lake drawdown c. 1996.
Courtesy of NIES Mapping Group Inc.

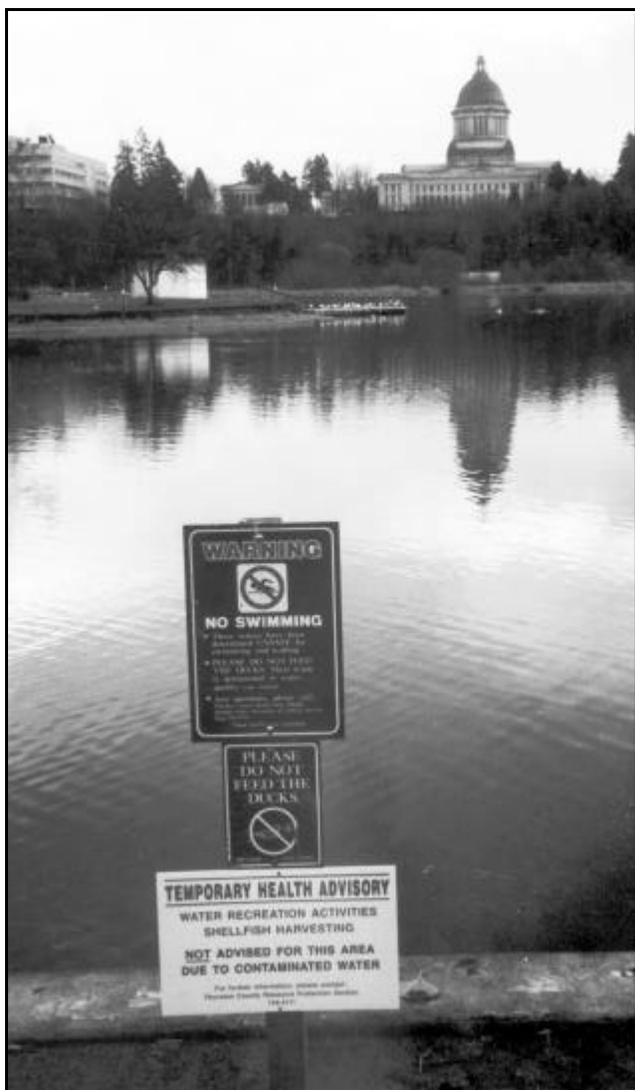
Photo 8-1. Temporary Health Advisory sign at Capitol Lake Park after the sewer line failure. c. February 1995. Courtesy of General Administration.

In 1995, the Tumwater sewer line to the LOTT treatment plant was broken and approximately 15,000 cubic yards of sediment and an estimated 3,000,000 gallons of raw sewage were added to the eastern shore of the South Basin. Although the sewer line was repaired, no sediment

removal or shoreline restoration was undertaken. Due to the mixing of sediment and raw sewage, these nutrients may have contributed to the submerged plant growth found in the 1997 survey.

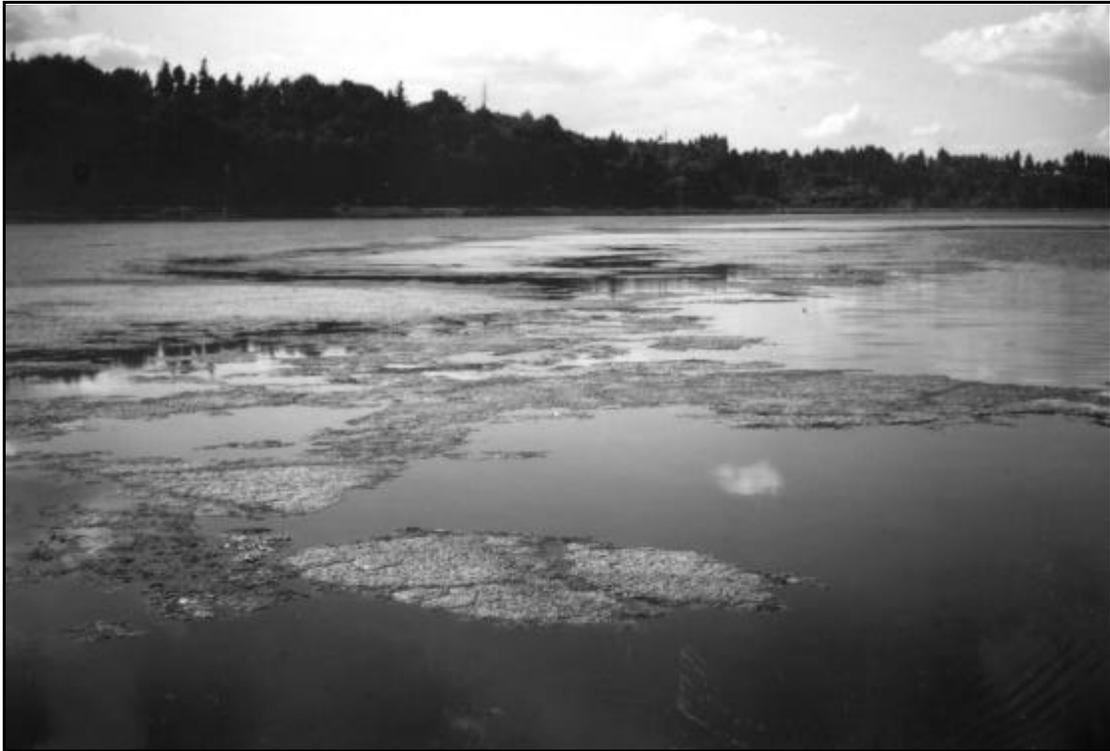
Photo 8-2. Algal mats in the Middle Basin. c. 1969. Courtesy of General Administration.

Localized zones of poor water quality are typically found in backwater areas during low flow periods (June through October), particularly in the South Basin. Because the majority of the flow in the South Basin is restricted to the main river channel during low flow periods, backwater channels can have poor water circulation, elevated temperatures, and reduced dissolved oxygen levels. Another indicator of and contributor to poor water quality are thick algal mats that develop only in these backwater areas.

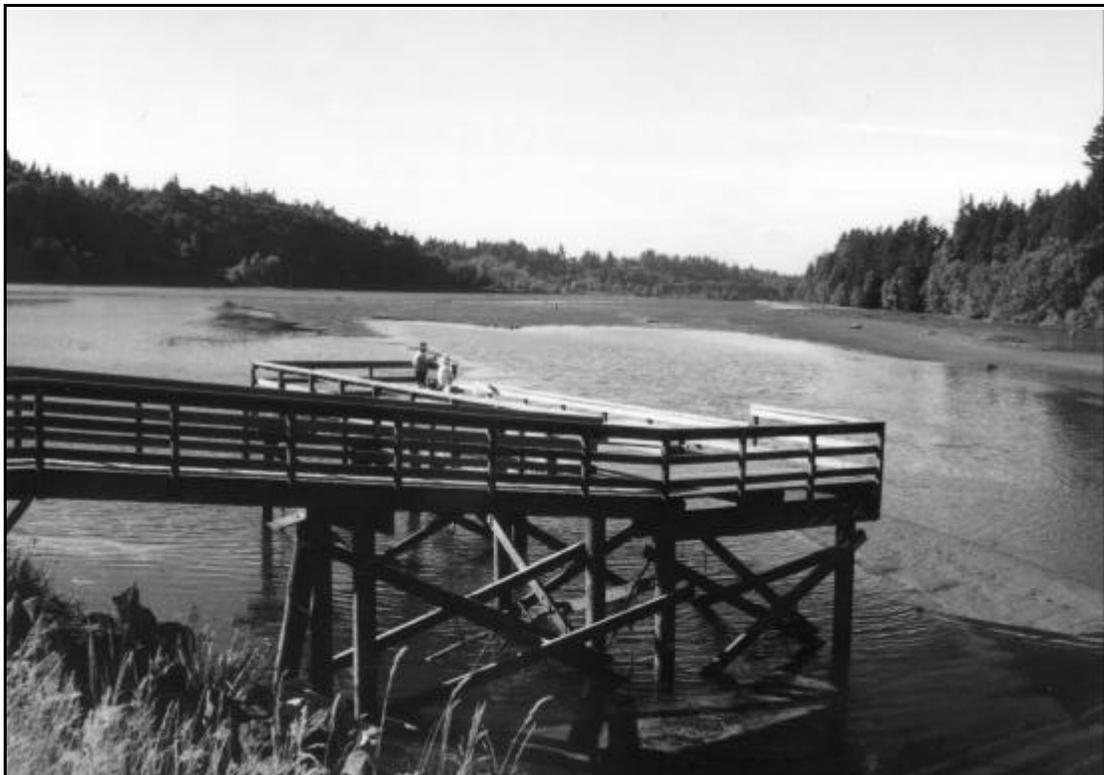
Photo 8-3. Fishing pier in the Middle Basin during a summer drawdown. c. 1996.
Courtesy of General Administration.
