Limited Fungal Investigation

Natural Resources Building

1111 Washington Street SE
Olympia, Washington

PBS Project Number 40535.103
January 2012

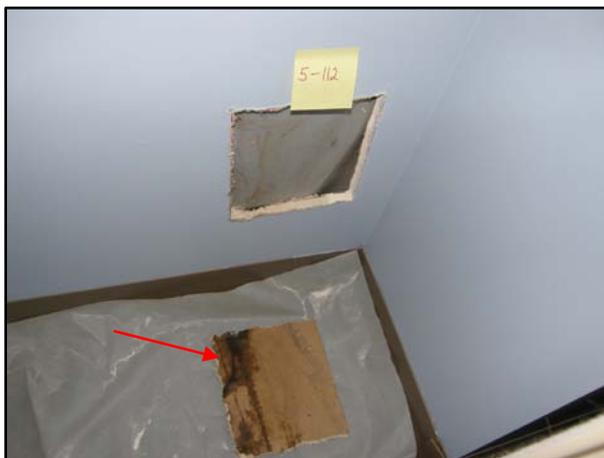
- Significant fungal growth was observed inside the wall cavities on the south elevation of the 5th and 6th Floors on both the interior-face of the gypsum sheathing and the wall cavity-face of the gypsum wallboard (See Figure 1 and 2 below).

Figure 1 - Fungal growth on wall cavity-face of wallboard at Inspection Hole #42 (Column 5-112).

- Significant fungal growth and water-impacted building materials were observed inside the wall cavities on the south elevation of the 5th and 6th Floors. PBS recommends the removal of fungal and water-impacted building materials at the south elevation of the 5th and 6th Floors, including the gypsum sheeting, interior gypsum wallboard, and wall cavity insulation.

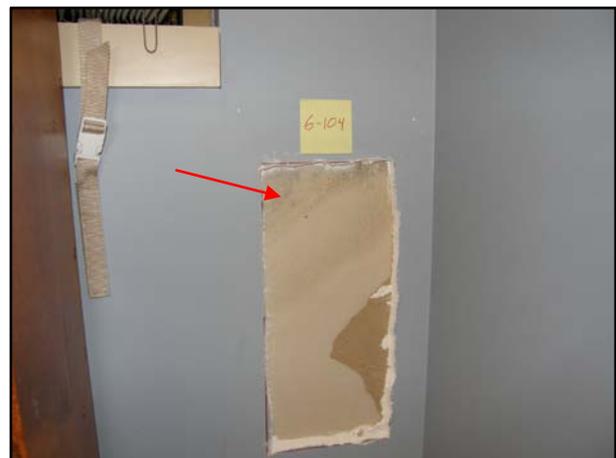
Figure 2 - Fungal growth between 1st and 2nd layer of wallboard at Inspection Hole #49 (Column 6-104).

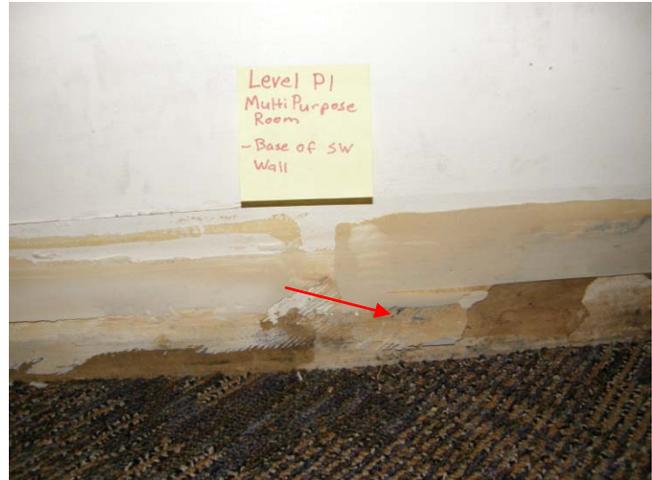
- Minor fungal growth and water-saturated gypsum wallboard and carpet was observed behind the rubber cove base on the S-SW side of the Level P1 Multi-Purpose Room (See Figure 3).

Figure 3 - Fungal growth at base of Level P-1 Multi-Purpose Room.

- Minor fungal growth and water-saturated gypsum wallboard was observed behind the rubber cove base on the S-SW side of the Level P1 Multi-Purpose Room. PBS recommends the removal of the fungal-contaminated wallboard and associated wall cavity insulation and water-impacted carpet from the Multi-Purpose Room.

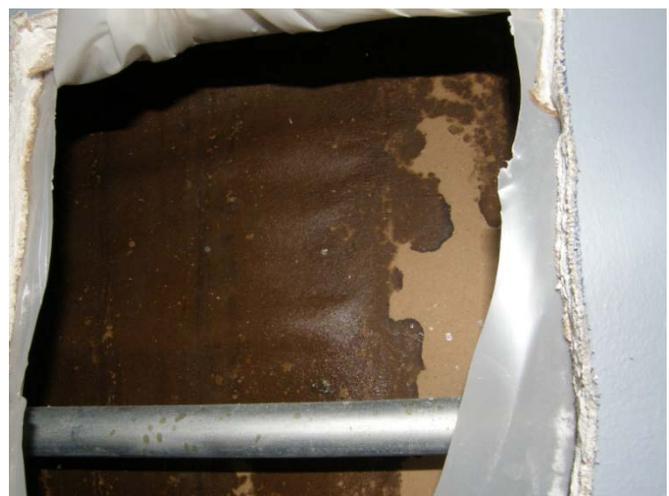
- Significant water damage and active water leakage was observed inside the wall cavities on the south elevation of the 5th and 6th Floors. (See Figure 5).

Figure 5 - Active leaking at Inspection Hole #44 (Column 5-104).

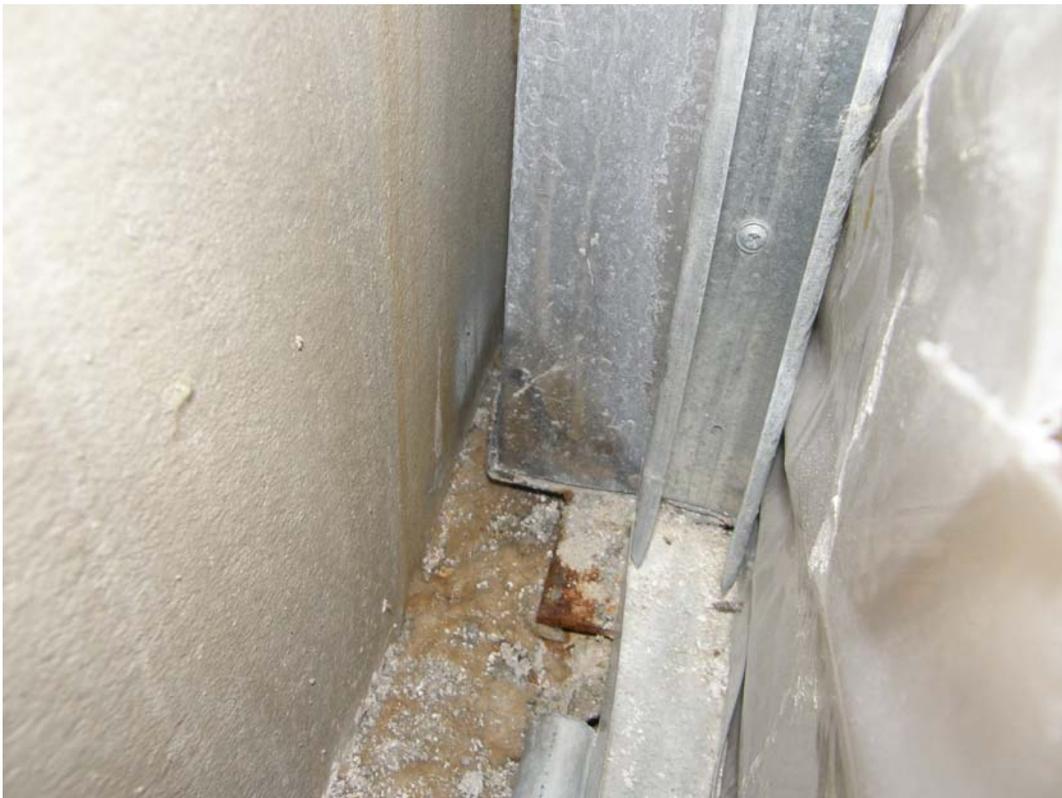
6. View of water staining on concrete wall panel and rust on metal framing at base of wall inside wall cavity at Inspection Hole #14. No fungal growth observed.

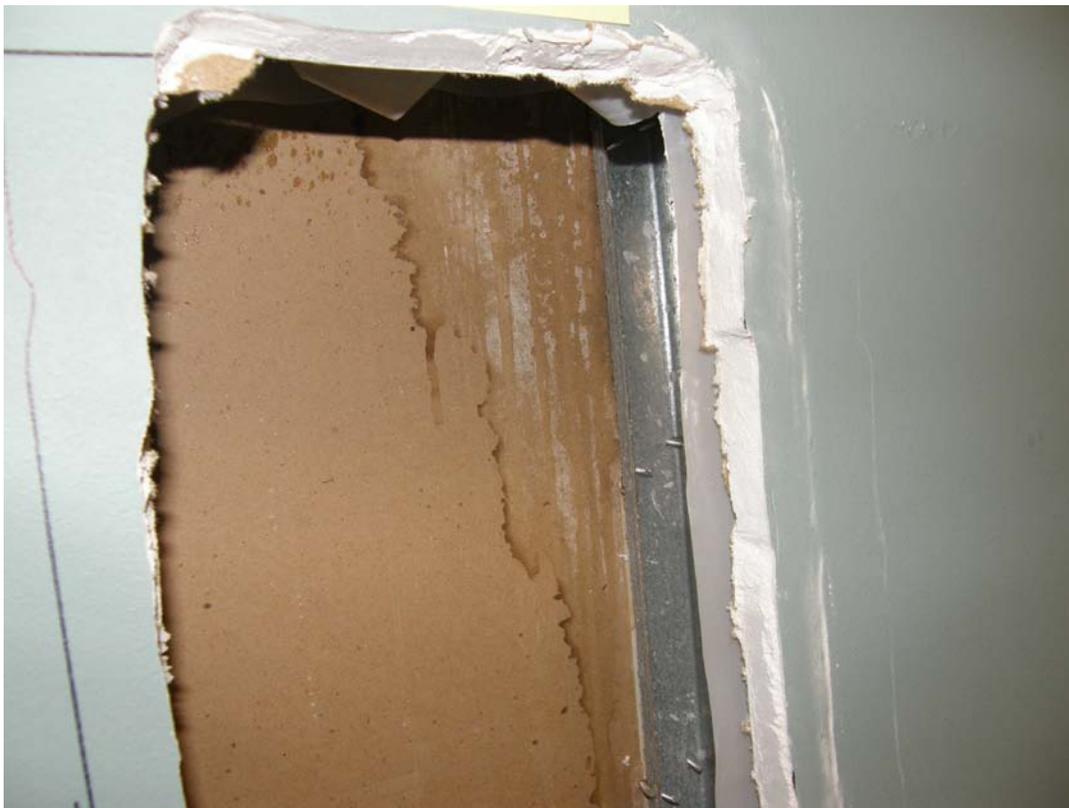
8. Water staining on sheathing under window at Inspection Hole #21 (West of Column 3-82). No fungal growth observed.

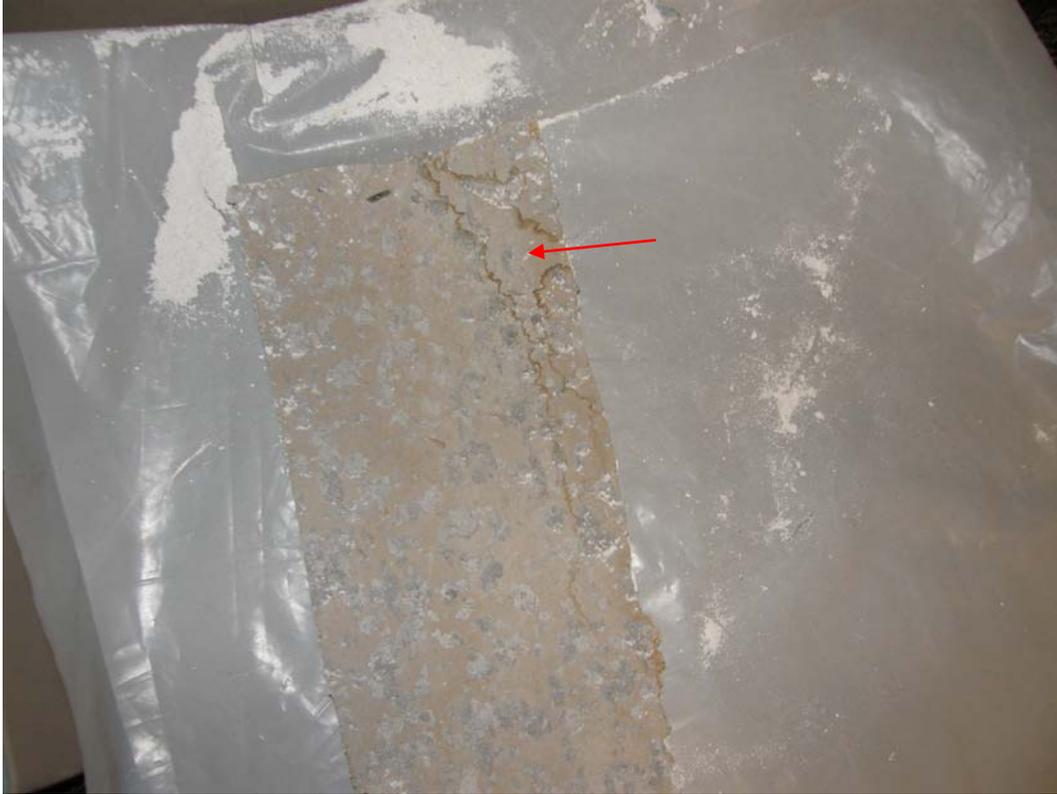
9. Water stained gypsum wallboard at Inspection Hole #21 (West of Column 3-82). Gray fireproofing overspray is also visible on wallboard. No fungal growth observed.

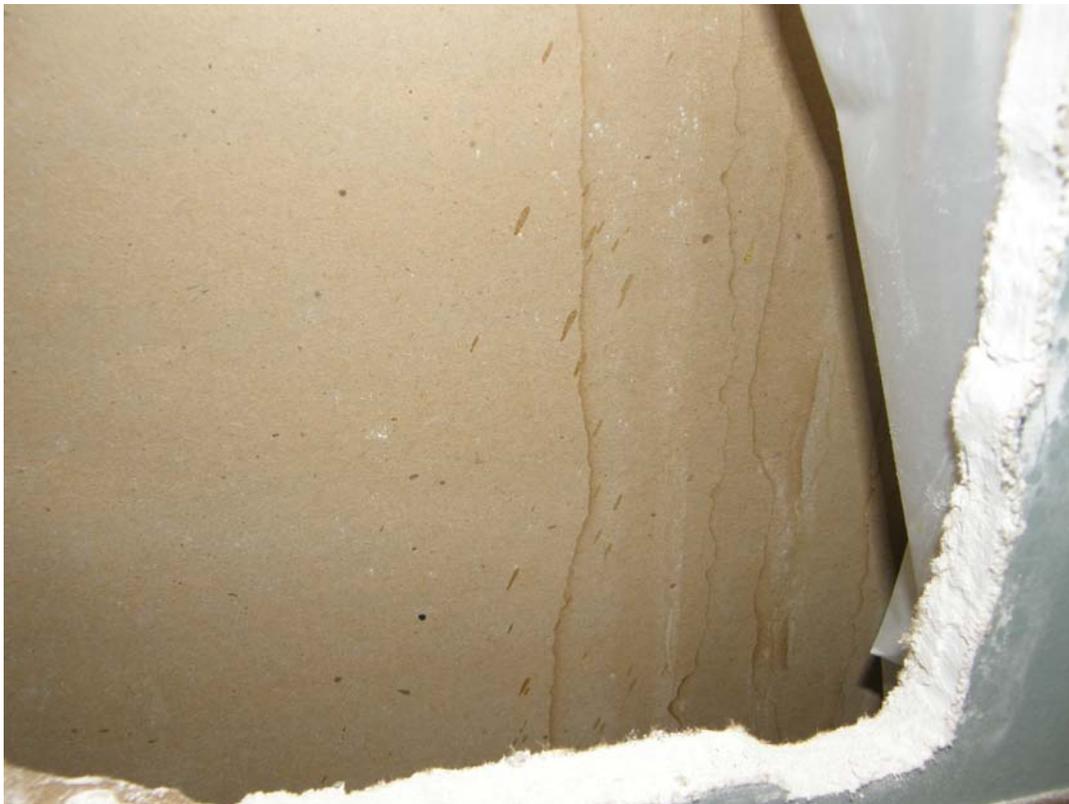
14. View of water staining on sheathing under window at Inspection Hole #30 (East of Column 4-80). No fungal growth observed.

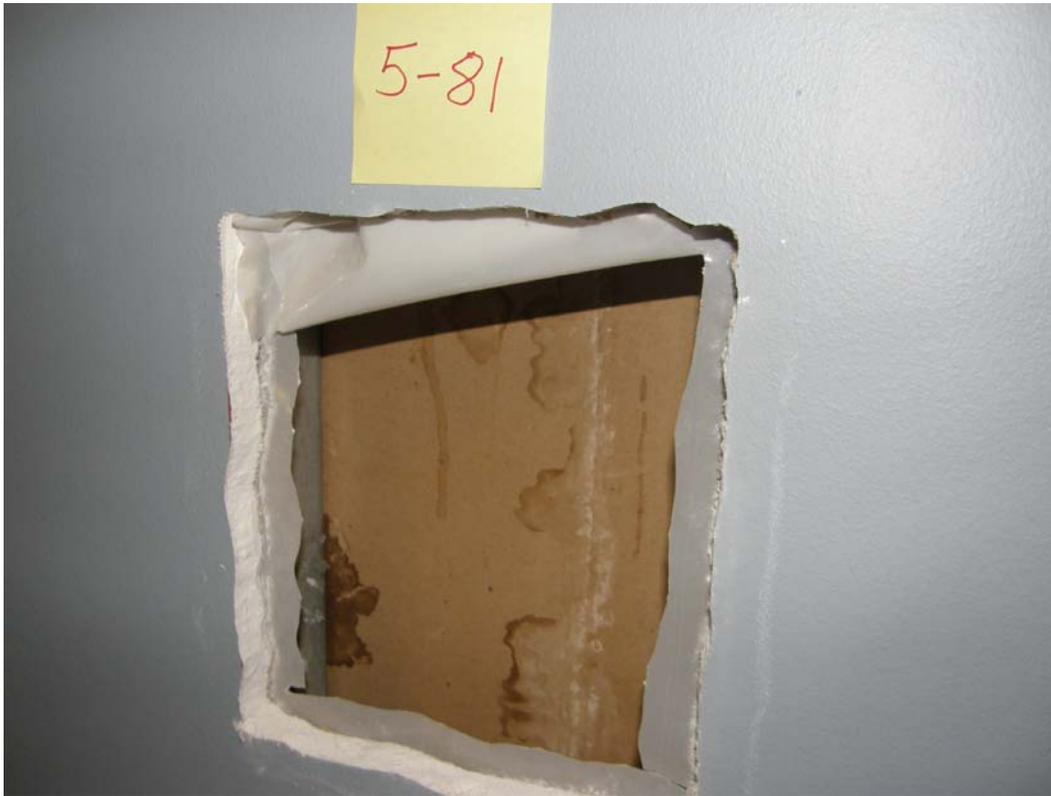
19. Water staining and active wetting on sheathing at Inspection Hole #38 (East of Column 5-81). No fungal growth observed.

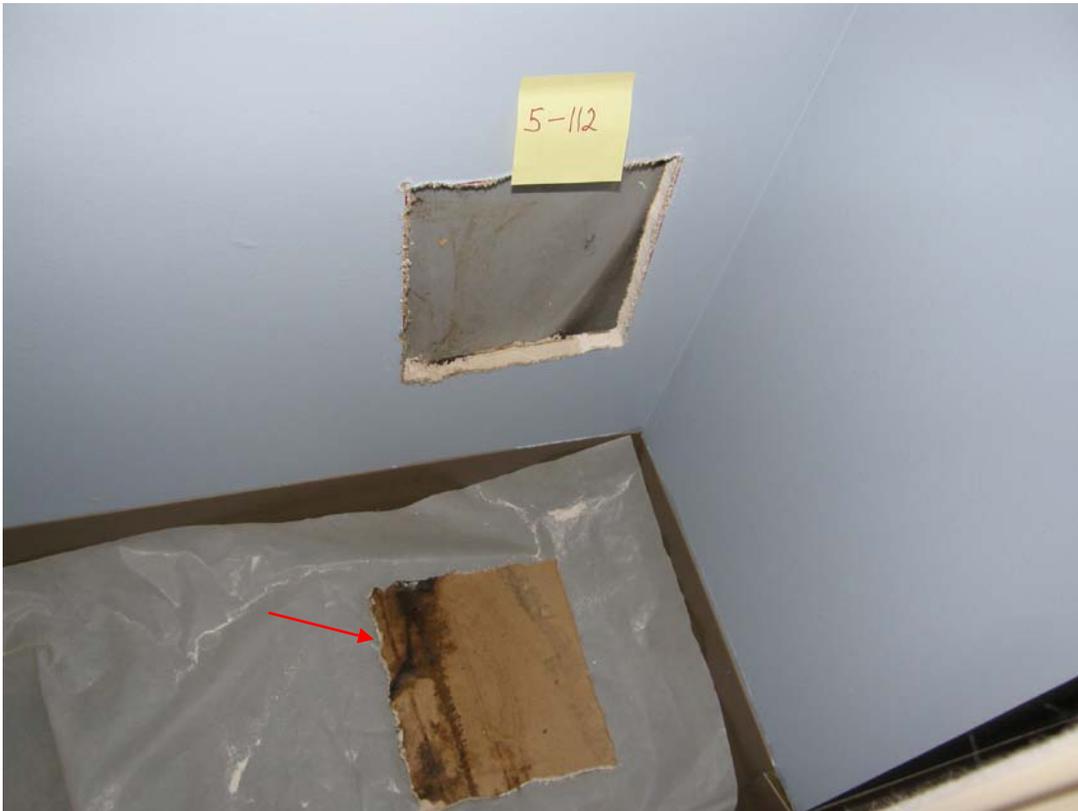
21. Visible fungal growth and active wetting on wallboard at Inspection Hole #42 (East of Column 5-112).

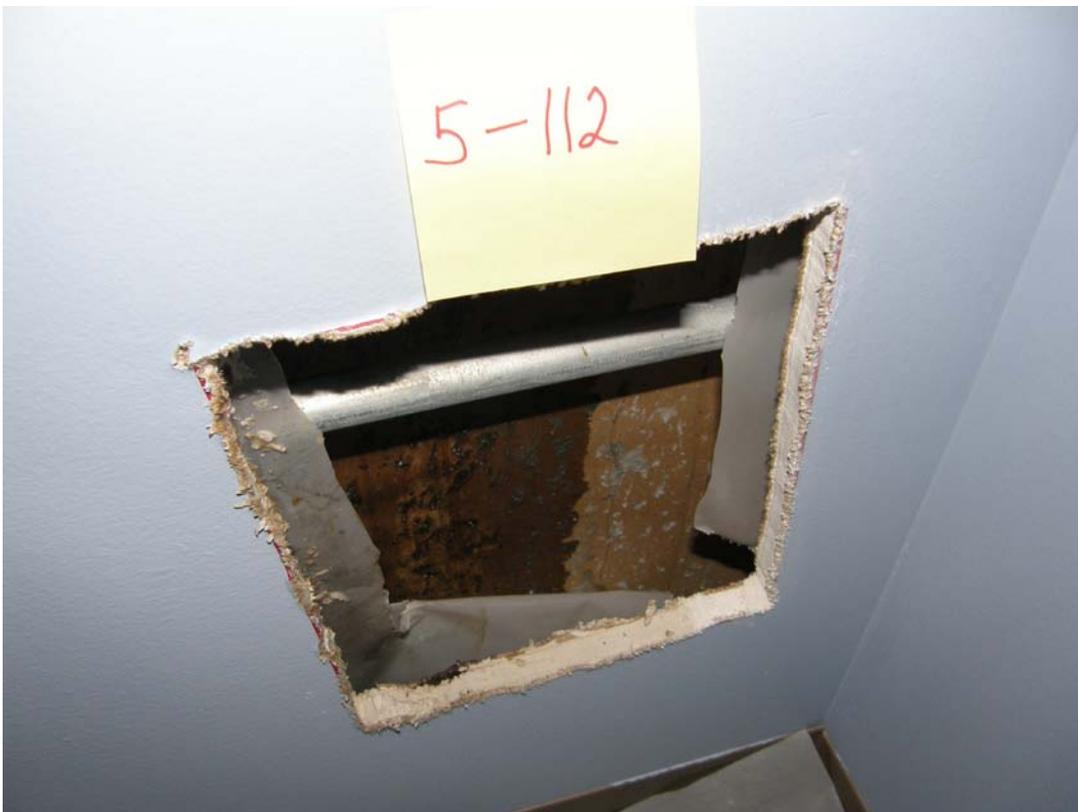
22. Wet sheathing from active water leak at Inspection Hole #42 (East of Column 5-112).

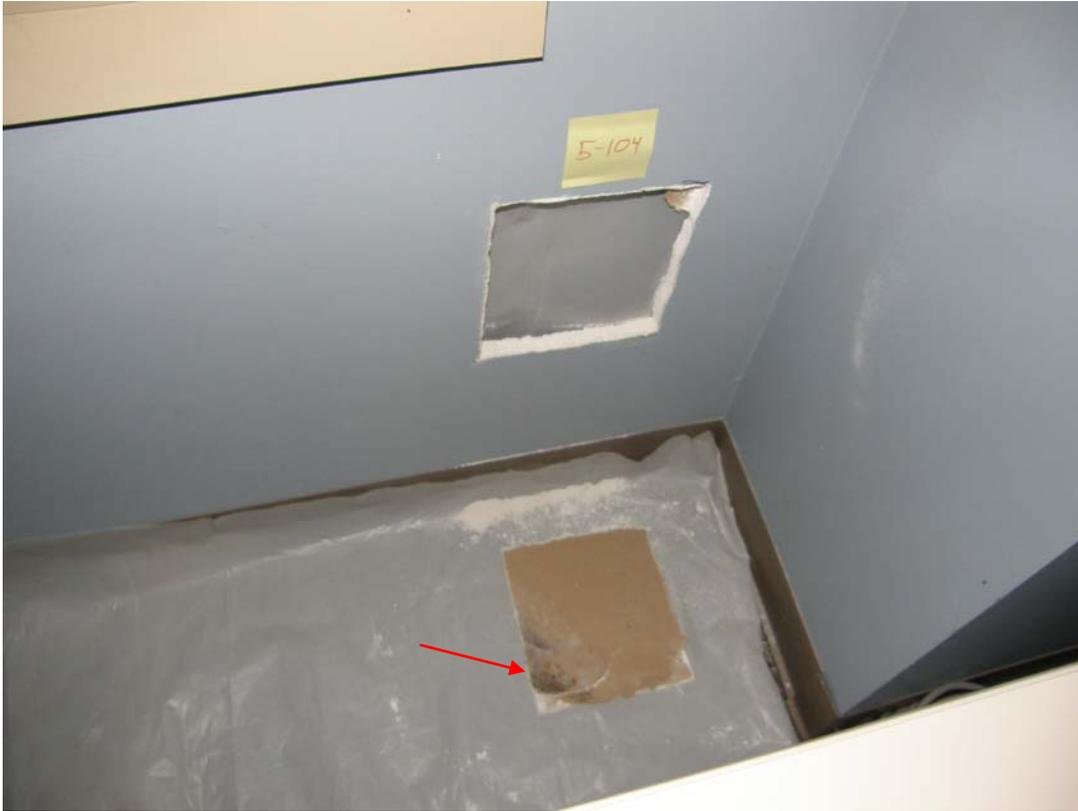
23. Visible fungal growth on wallboard at Inspection Hole #44 (East of Column 5-104).

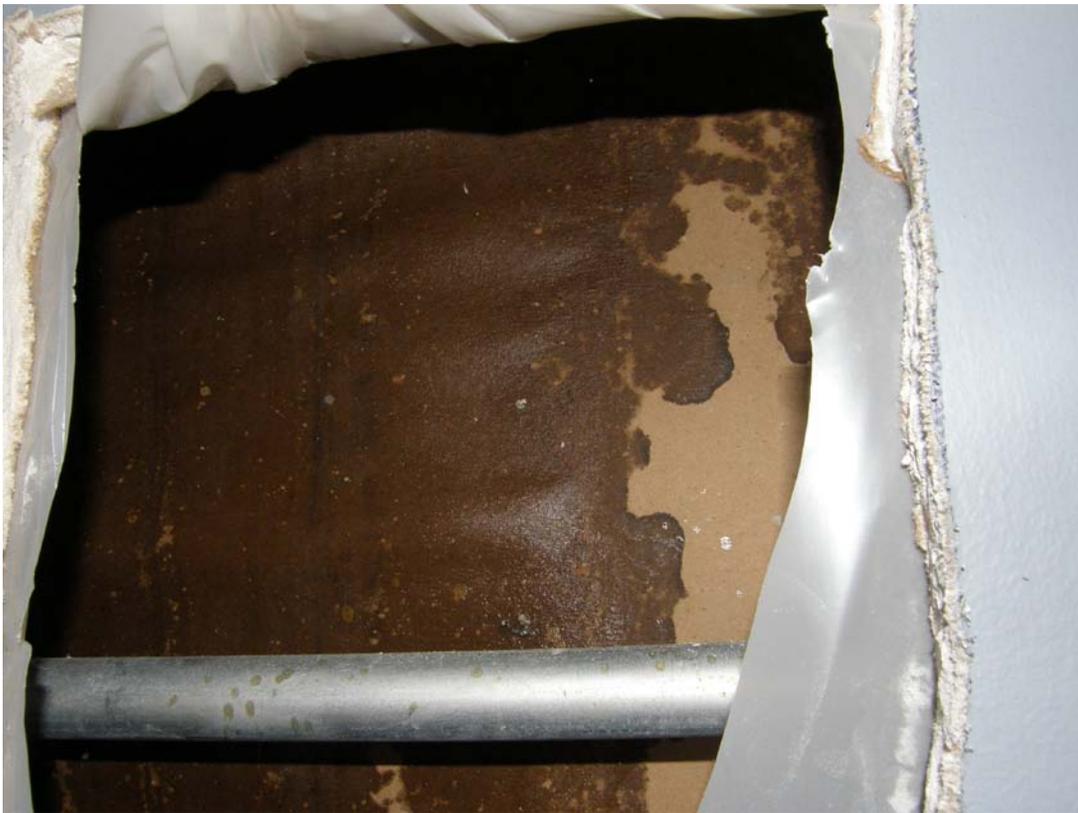
24. Wet sheathing from active water leak at Inspection Hole #44 (East of Column 5-104).

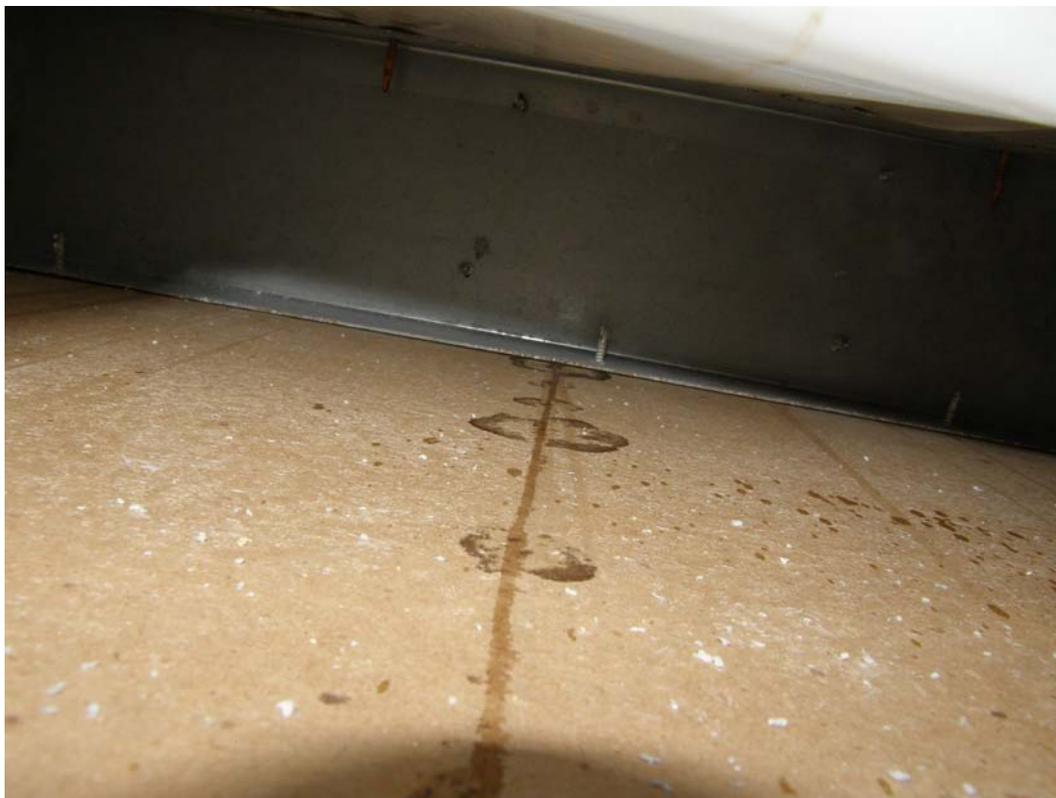
26. View of water running down gypsum sheathing; looking up at horizontal steel framing under window at Inspection Hole #47 (East of Column 6-125). No visible growth observed.

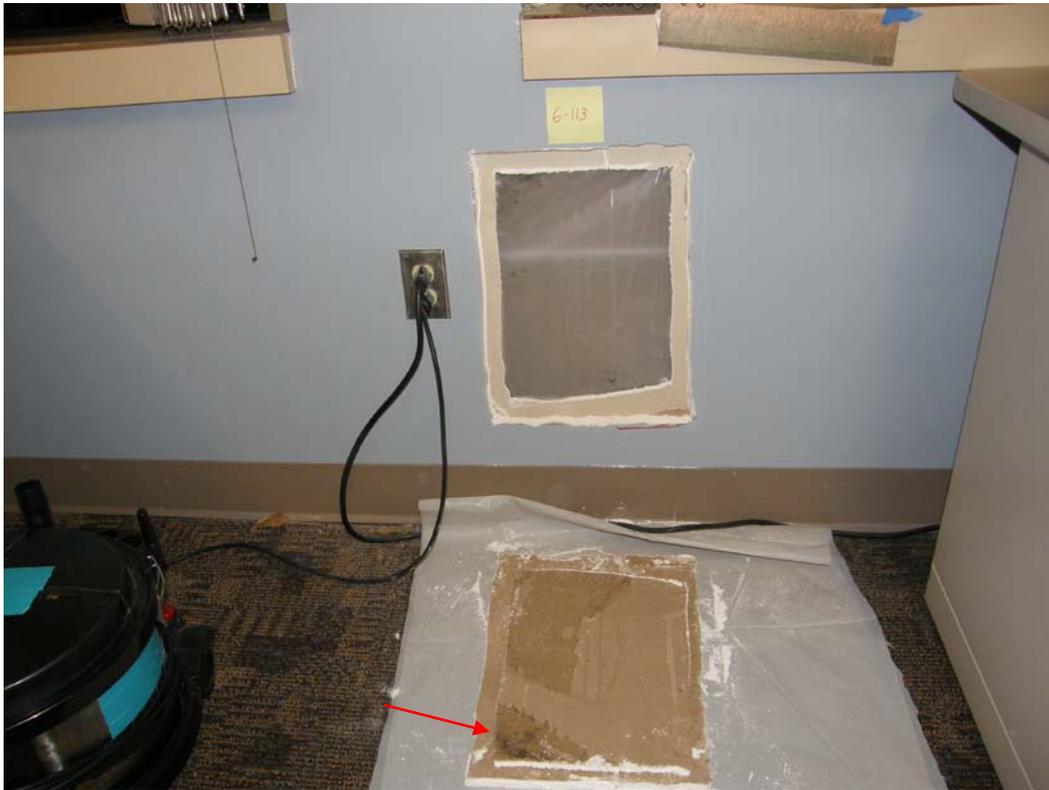
27. Visible fungal growth on 2nd layer of wallboard at Inspection Hole #48 (East of Column 6-113).

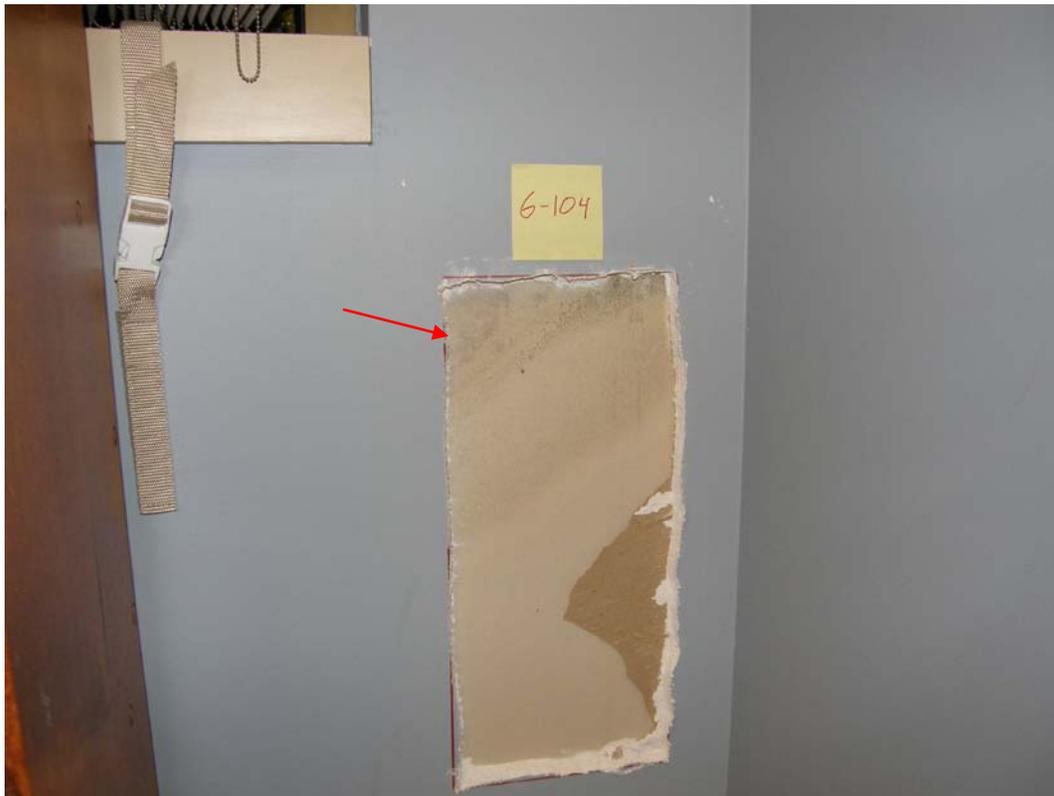
28. Visible fungal growth between the two layers of wallboard at Inspection Hole #49 (East of Column 6-104).

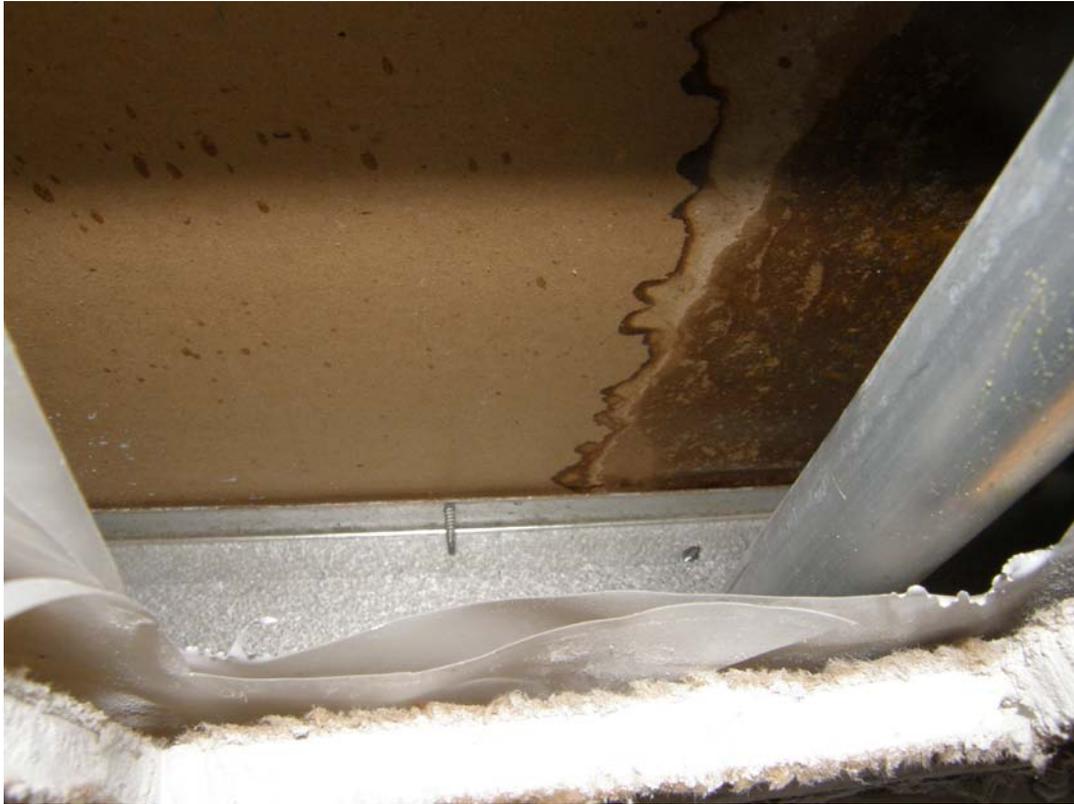
29. Wet sheathing from active water leak at Inspection Hole #49 (East of Column 6-104); looking up at horizontal steel framing under window.

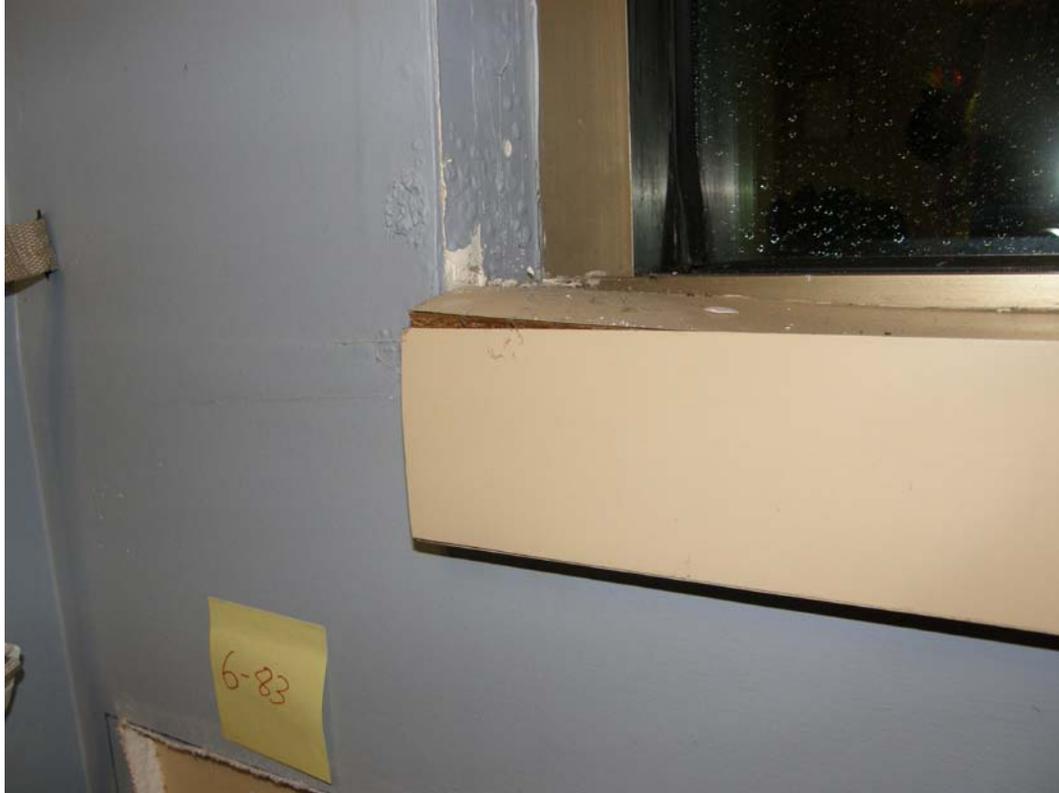
30. Water damaged window sill adjacent to Inspection Hole #50 (West of Column 6-82).

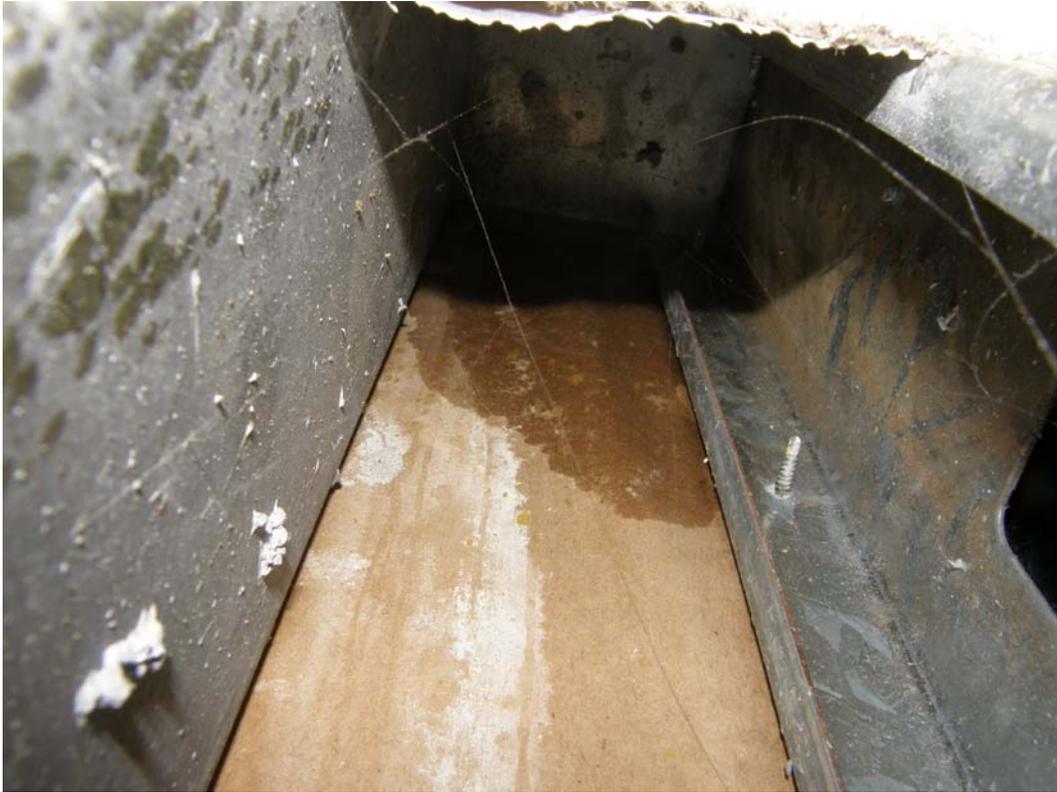
31. Wet sheathing from active water leak at Inspection Hole #50 (West of Column 6-83); looking up at horizontal steel framing under window.

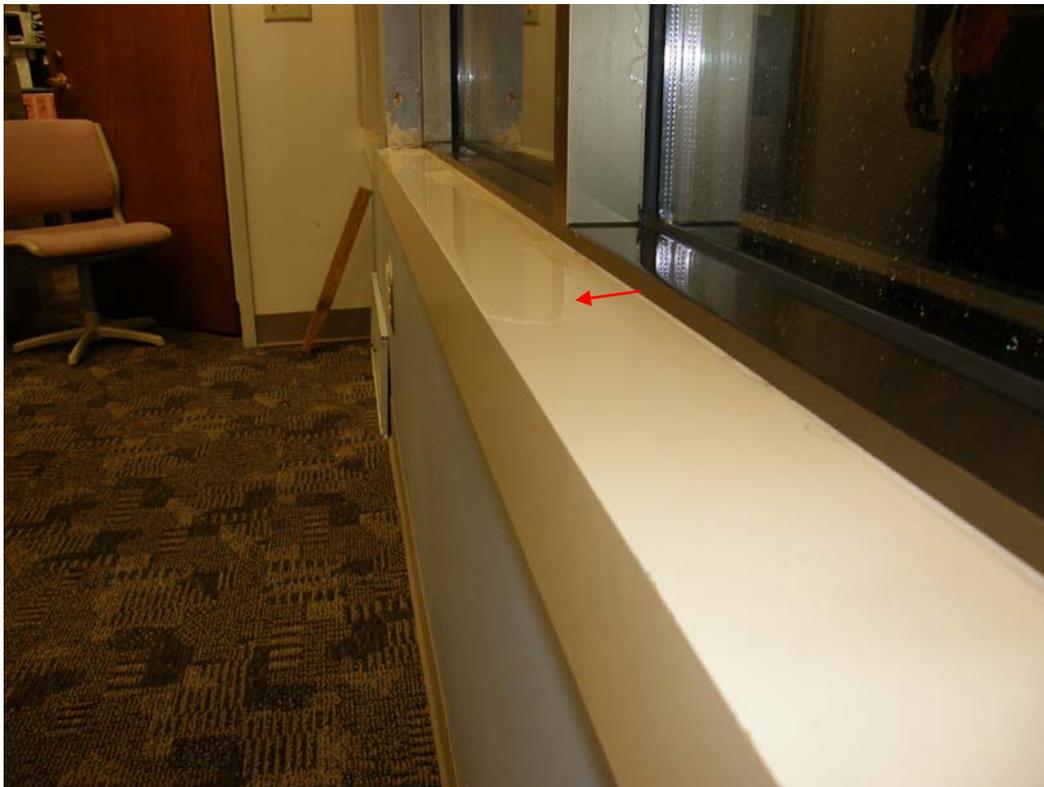
32. Visible water on window sill at Column 6-82 (Room 630A).

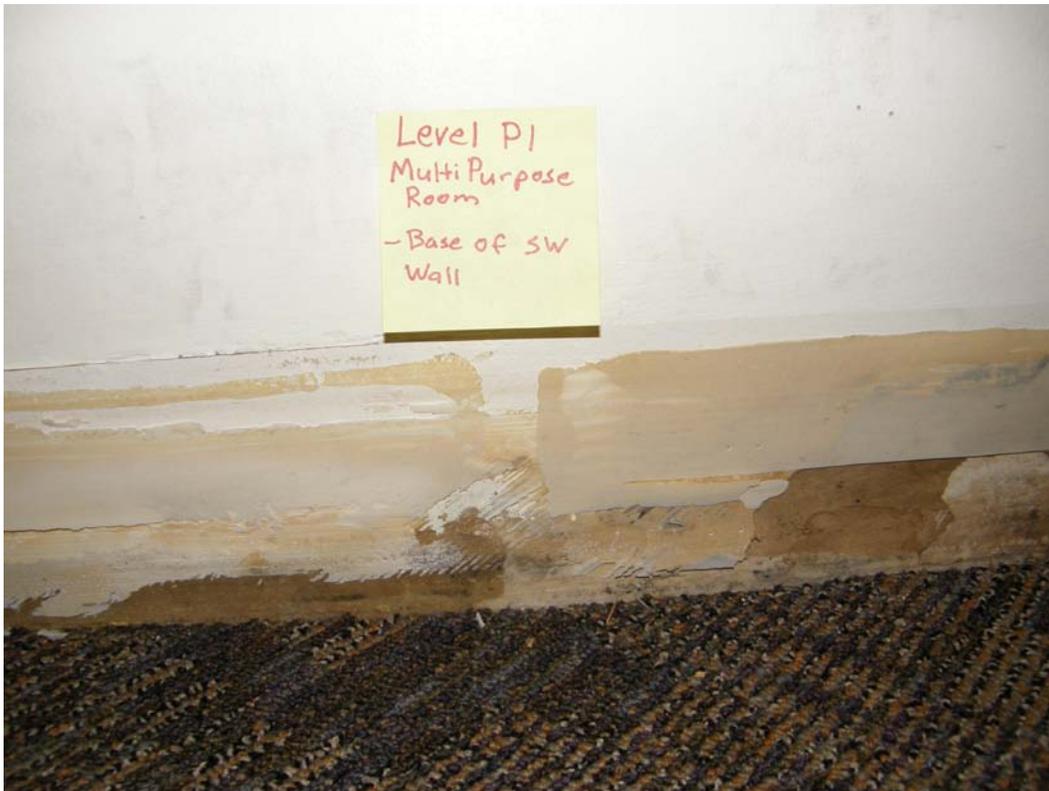
34. Visible fungal growth and saturated wallboard at base of south/southwest wall in Multi-Purpose Room.

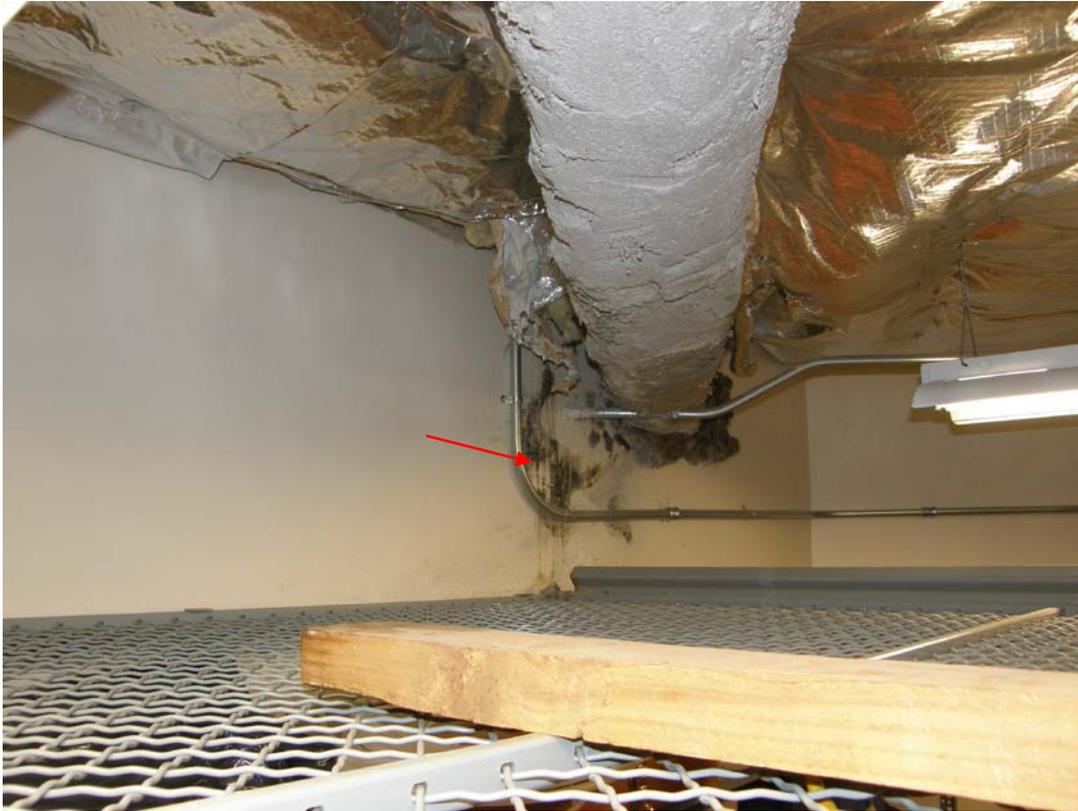
35. Fungal growth on north wall of Room P195.

- Fungal growth was observed on the finished-side of the north wall in Room P195. PBS recommends the removal of the fungal-contaminated wallboard and associated wall cavity insulation from the north wall of Room P-195.

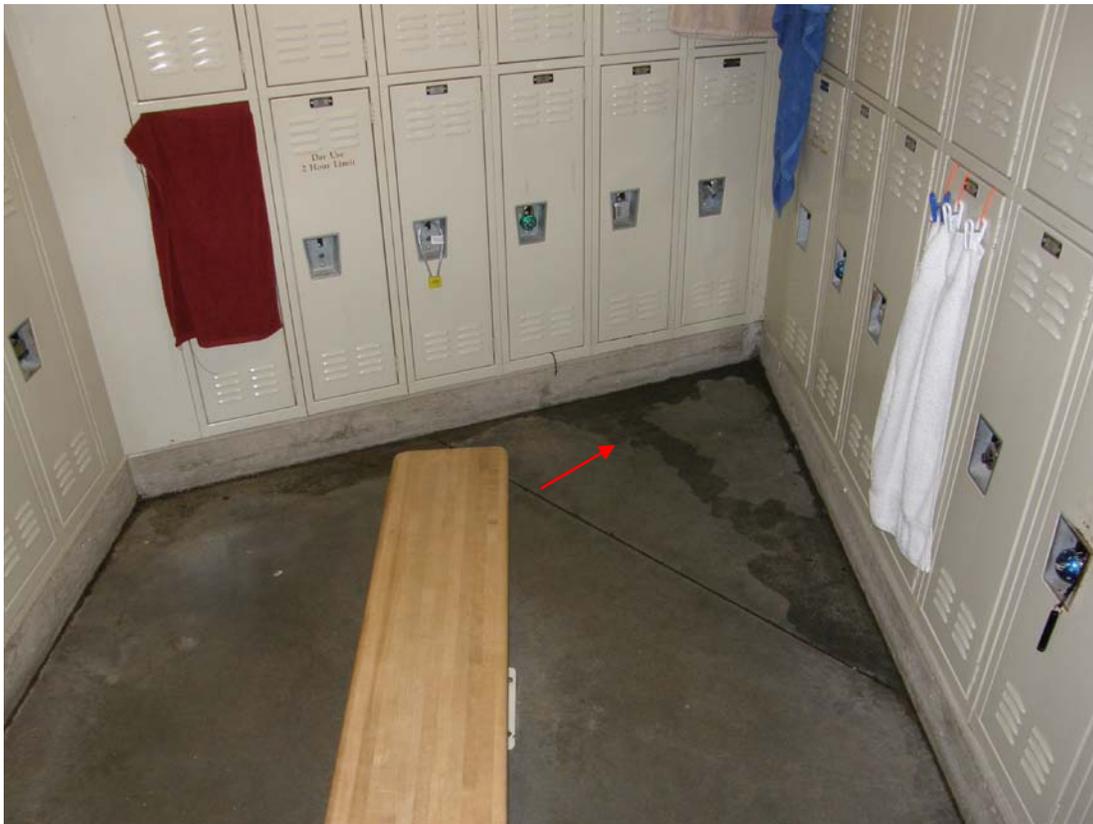
- Standing water was observed on the floor in the locker area of the Level P-1 Men’s Locker Room. PBS was not able to inspect the wall cavity for fungal growth as the walls are obscured by lockers.

36. Water on floor of Level P-1 Men's Locker Room.

- PBS recommends additional investigation to address potential water intrusion sources associated with the Level P-1 Multi-Purpose Room, the Men’s Locker Room, Room P195, Room P-195C and P-199A.
