## DESCRIPTION OF IMPROVEMENTS

National Guard Armory

540 East Main Street  
Pullman, Washington 99163

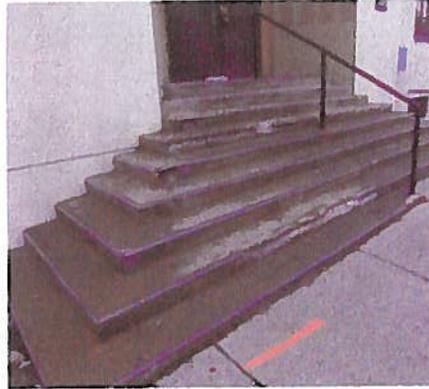
The appraiser noticed chipping of the entry steps. No other significant deferred maintenance items were noted.

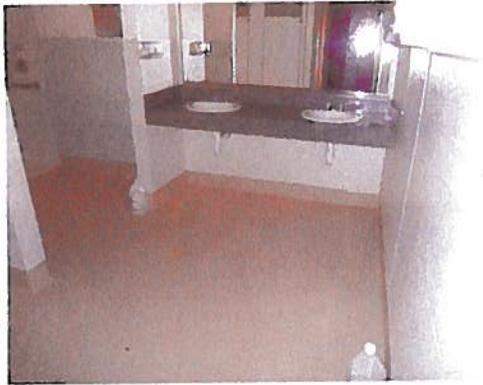
The photo shows the main floor ½ bath.

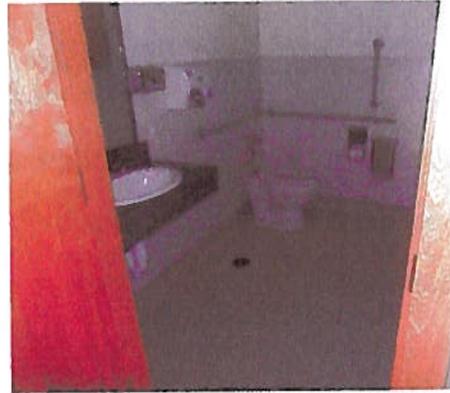
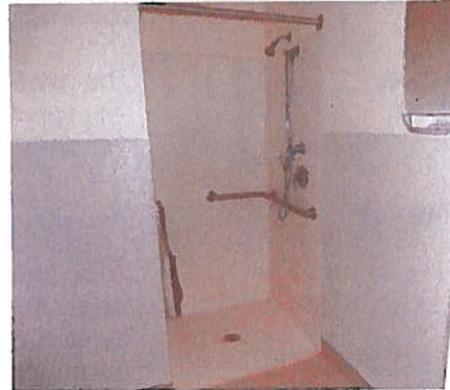
This is one of the basement bathrooms. It contains 2 sinks 2 toilets and a shower. The sec bathroom contains 2 toilets, two urinals, two sinks and three shower stalls. The water was shut but the fixtures appear to be functional and in average condition.

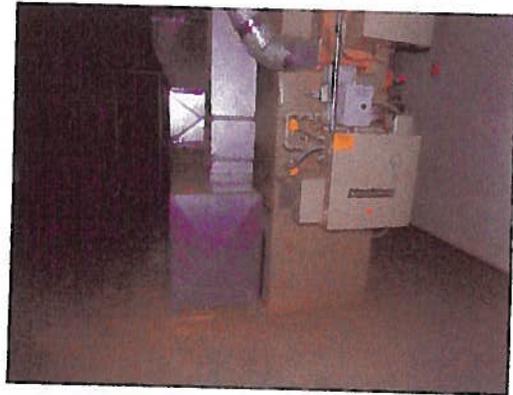
The building has a large forced air gas furnace in the basement and it appears to be in average condition.

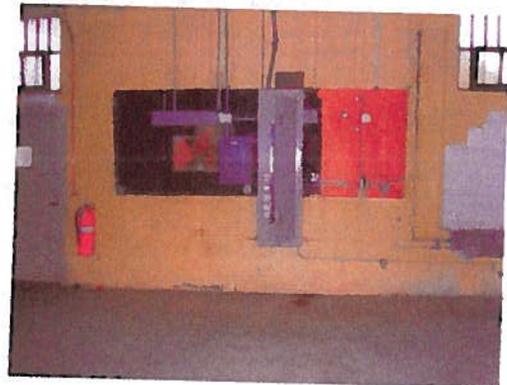
The building has a large power panel and supplies either 220 or 440 volt service. The panel is of modern construction and contains circuit breakers.

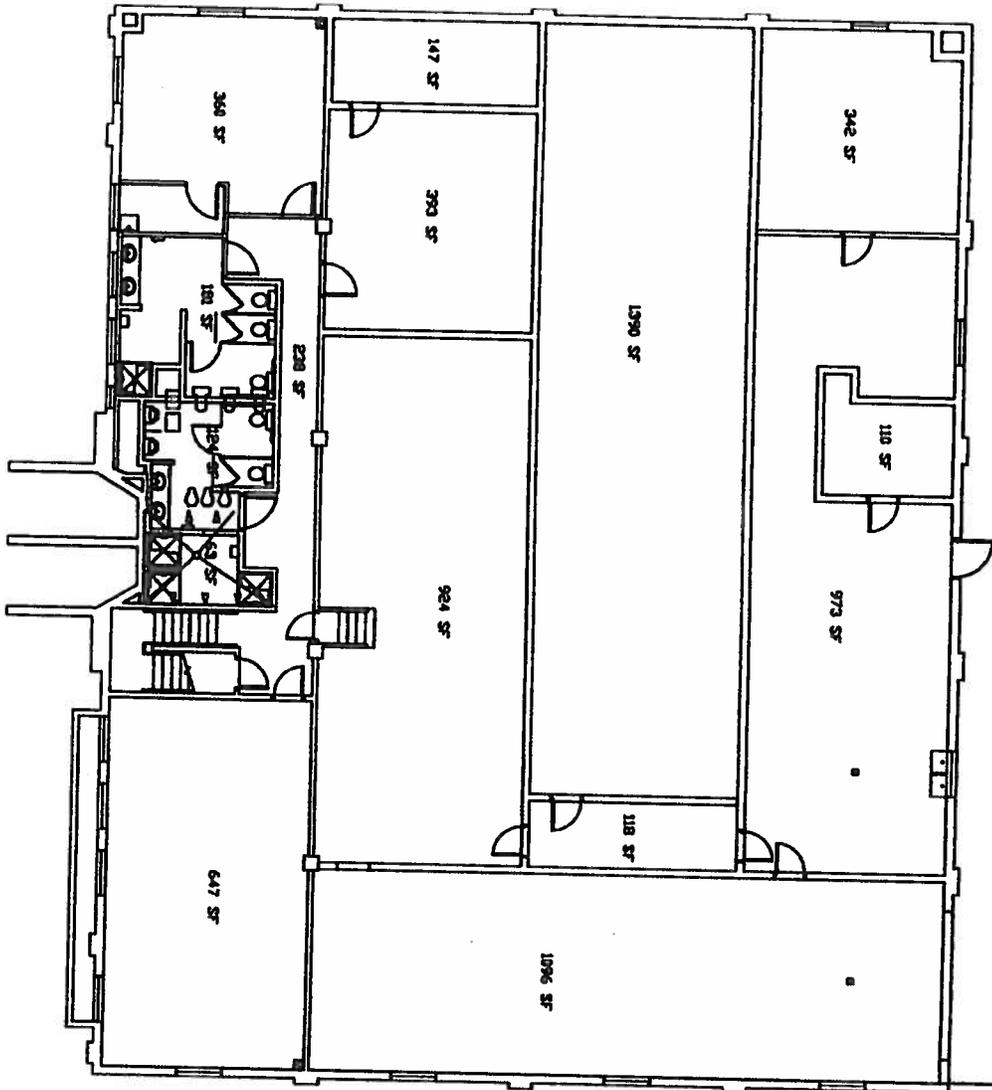
**EXISTING LOWER LEVEL FLOOR PLAN  
8256 SF**

PROJECT NO.	PROJECT TITLE	DRAWING NO. 32810_1_PLAN	REVISED DATE 21-12-21
SHEET NO. 1 OF 3	PULLMAN BUILDING NO. 1 LOWER FLOOR PLAN	FACILITY ENGINEER DIVISION BUILDING 38 - CAMP MURRAY TACOMA, WA 98430-5052	APPROVED: USER: _____ P.M.: _____ F.A.D.: _____ AGENCY DIRECTOR: _____
STATE OF WASHINGTON - MILITARY DEPARTMENT - ARMY NATIONAL GUARD		ISSUED: _____ CHECKED: _____ DATE: 11-9-21

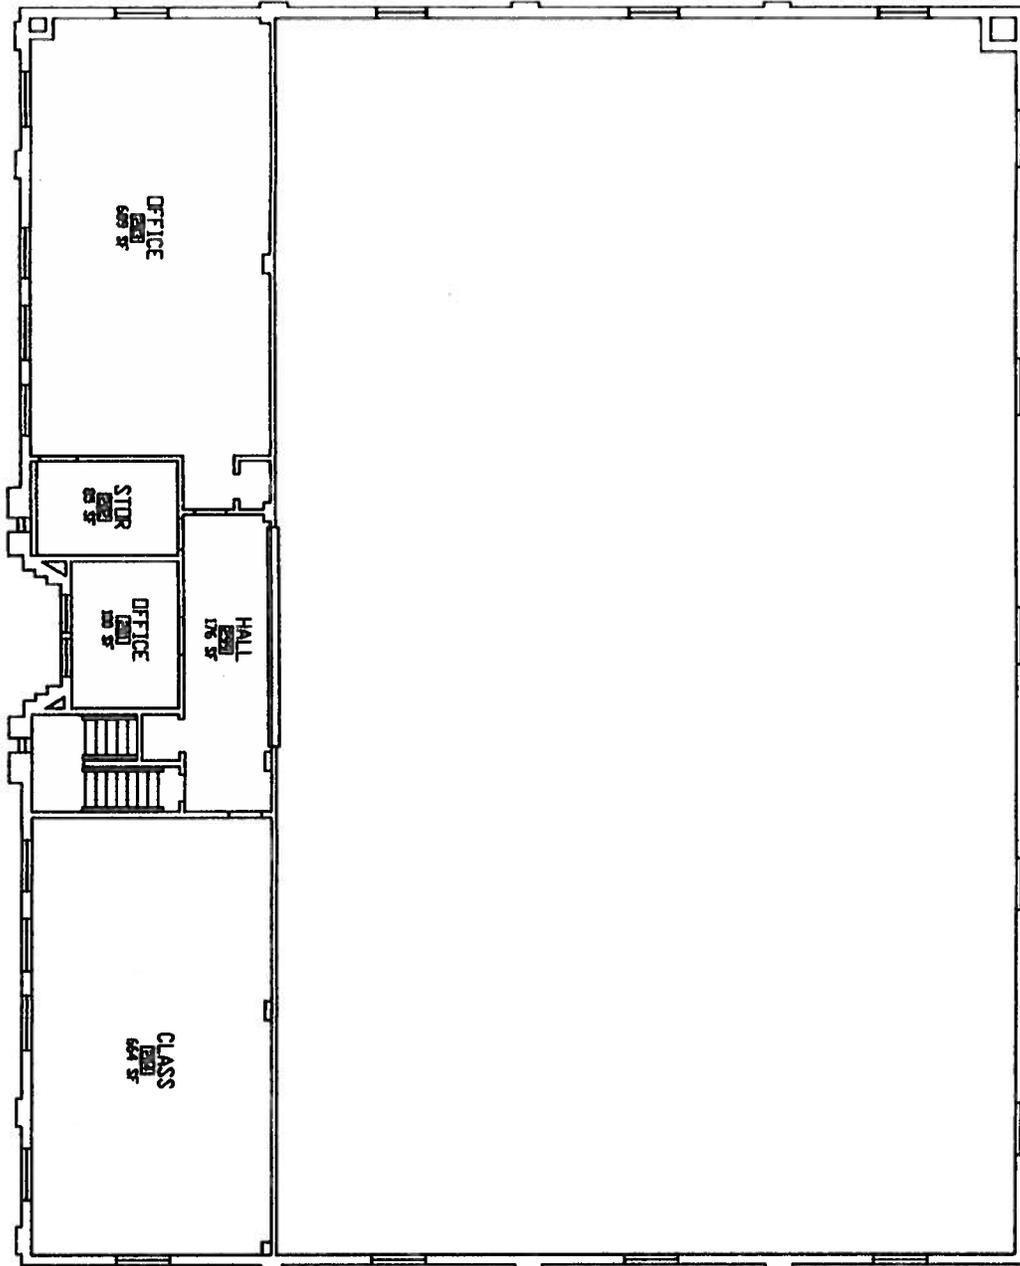
PROJECT NO.	PROJECT TITLE	FACILITY ENGINEER DIVISION BUILDING 36 - CAMP MURRAY TACOMA, WA 98430-6052	DRAWING NO. 53800_1_ENDPLAN	REVISION DATE: 01-02
SHEET NO. 1 OF 1	PULLMAN BUILDING NO. 1 2ND FLOOR PLAN		APPROVALS USER: _____ P&E: _____ FIELD: _____ AGENCY DIRECTOR: _____	DESIGN DRAWN: _____ CHECK: _____ DATE: 03-03-01
<b>STATE OF WASHINGTON - MILITARY DEPARTMENT - ARMY NATIONAL GUARD</b>
