How Energy Escapes

Layers of a Building Envelope

Shoddy construction at Whatcom courthouse prompts call for 'multimillion-dollar' fix

14.0 Building Envelope Design Principles

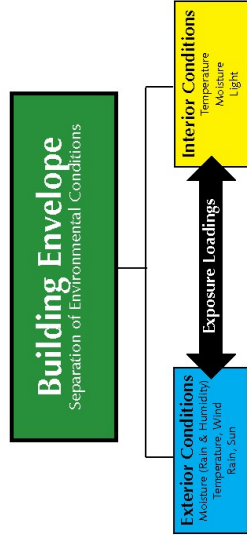
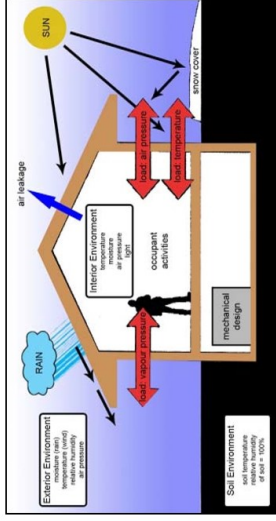
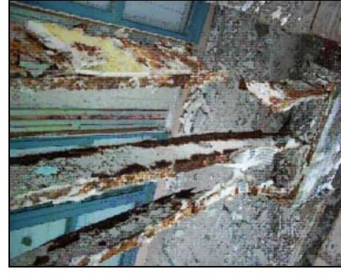
Residential High-Rise Envelope Failure – Steel Stud Corrosion

Environmental Separation

The building envelope failures that have plagued Vancouver's condominium market since the early 1990's illustrate the importance of proper building envelope design and commissioning. The cost for repetitive maintenance, repairs, premature replacement, health effects and occupant disruption has escalated to multibillion-dollar levels. The repairs result in increased embodied energy, which over the expected lifetime of the building will far outweigh that of the originally constructed building. The envelope has obvious impacts on the sustainability of buildings.
