Hazardous Building Materials Survey Report for 90% Design Submittal

General Administrative Building Demo 210 11th Avenue SW, Olympia, WA

HAZARDOUS BUILDING MATERIALS SURVEY REPORT

Project No.: 20230210.0000

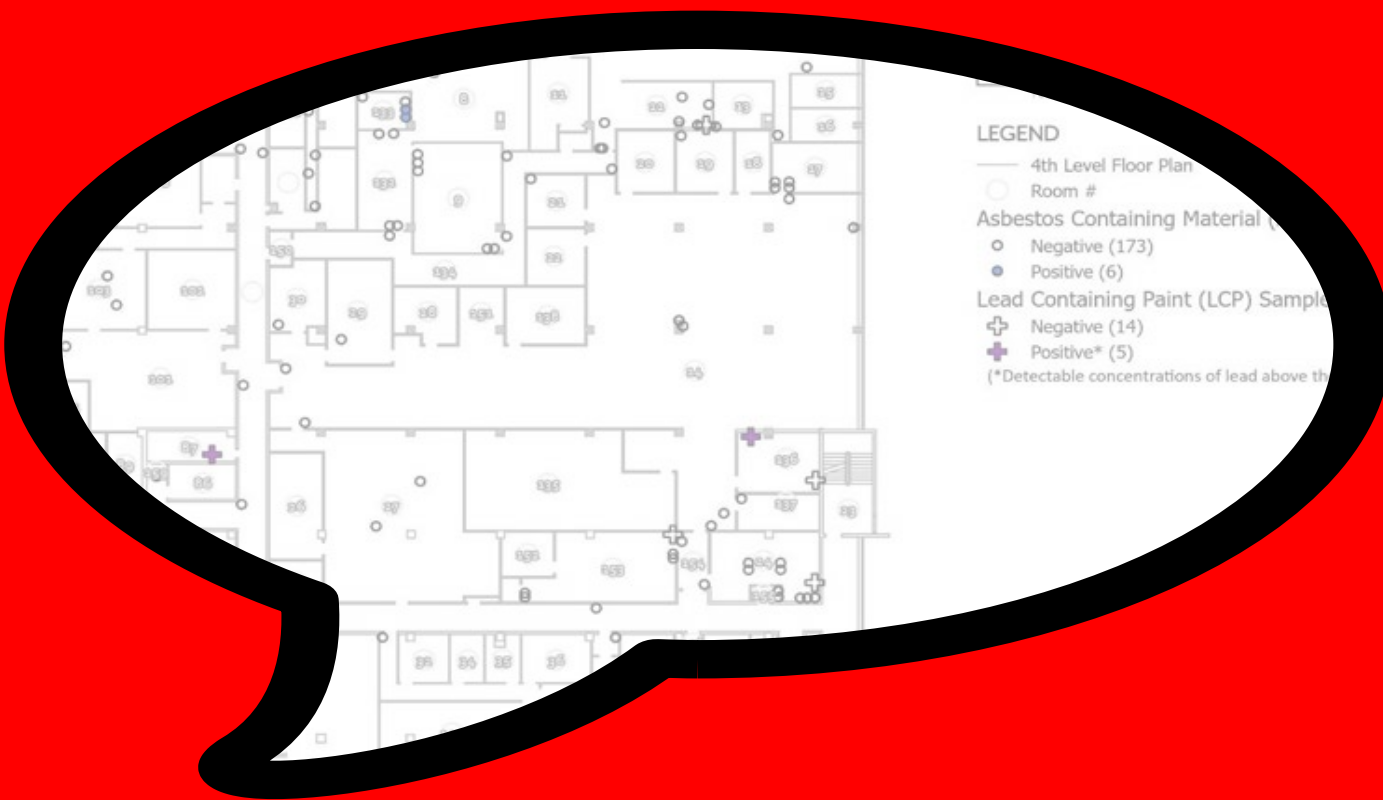
Drawing No.	SP-2
Sheet No.	02
of Total	08

- 4th Level Floor Plan
 - Room #
 - Asbestos Containing Material (ACM)
 - Negative (173)
 - Positive (6)
 - Lead Containing Paint (LCP) Samples
 - ⊕ Negative (14)
 - ⊕ Positive* (5)
- (*Detectable concentrations of lead above the...)

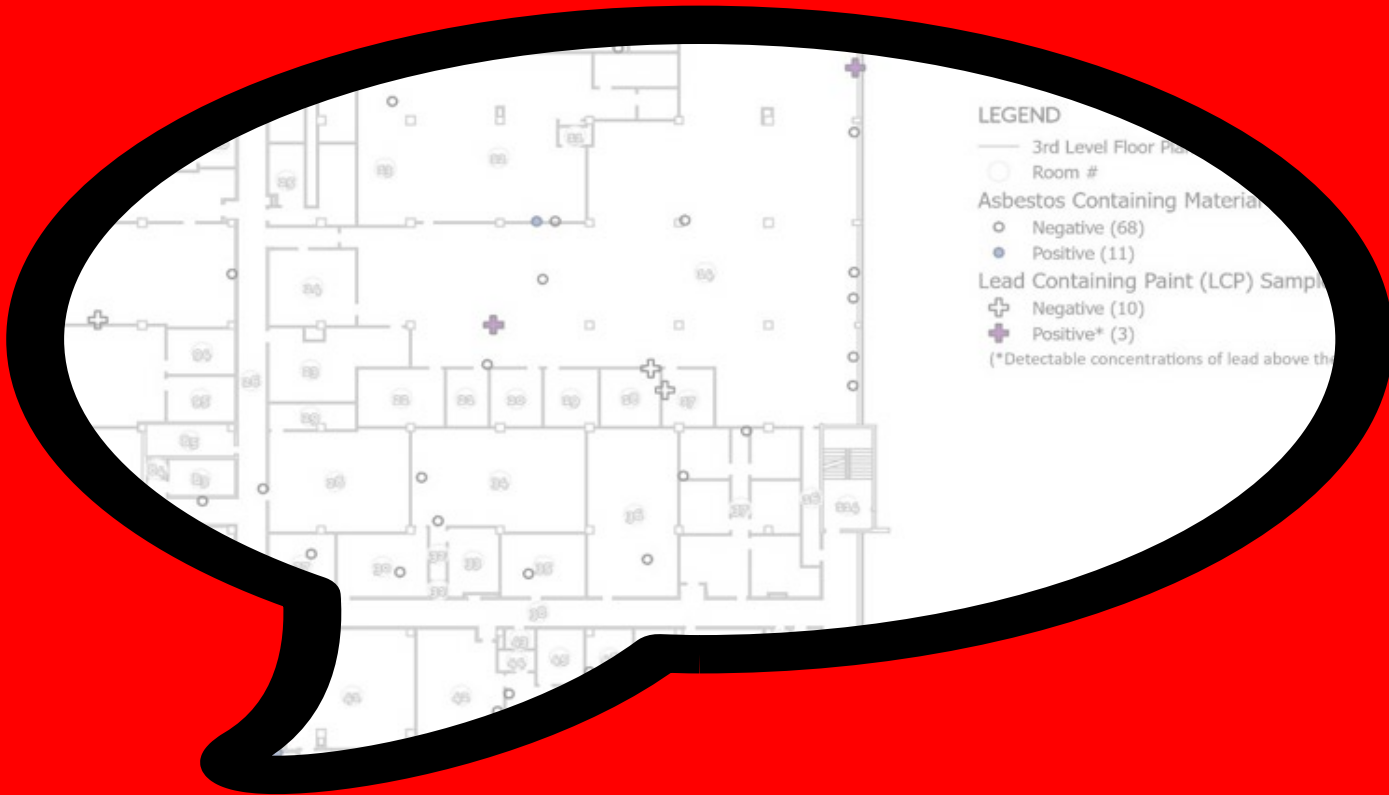
WA STATE DEPT OF ENTERPRISE SERVICES
 GENERAL ADMIN BUILDING DEMO
 ACM & LCP SAMPLE LOCATIONS

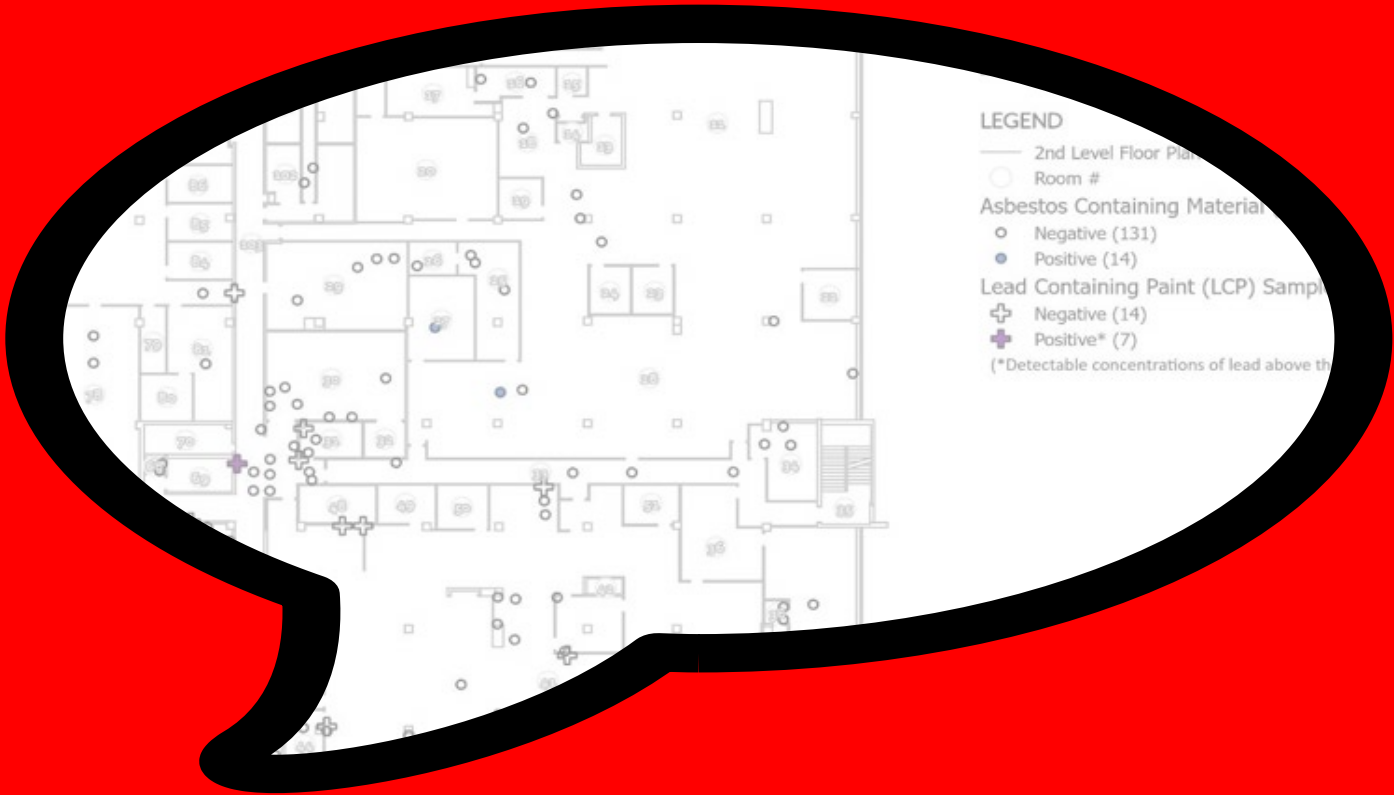
Drawing No. SP-3
 Sheet No. 02 of 08

WA STATE DEPT OF ENTERPRISE SERVICES
 GENERAL ADMIN BUILDING DEMO
 ACM & LCP SAMPLE LOCATIONS

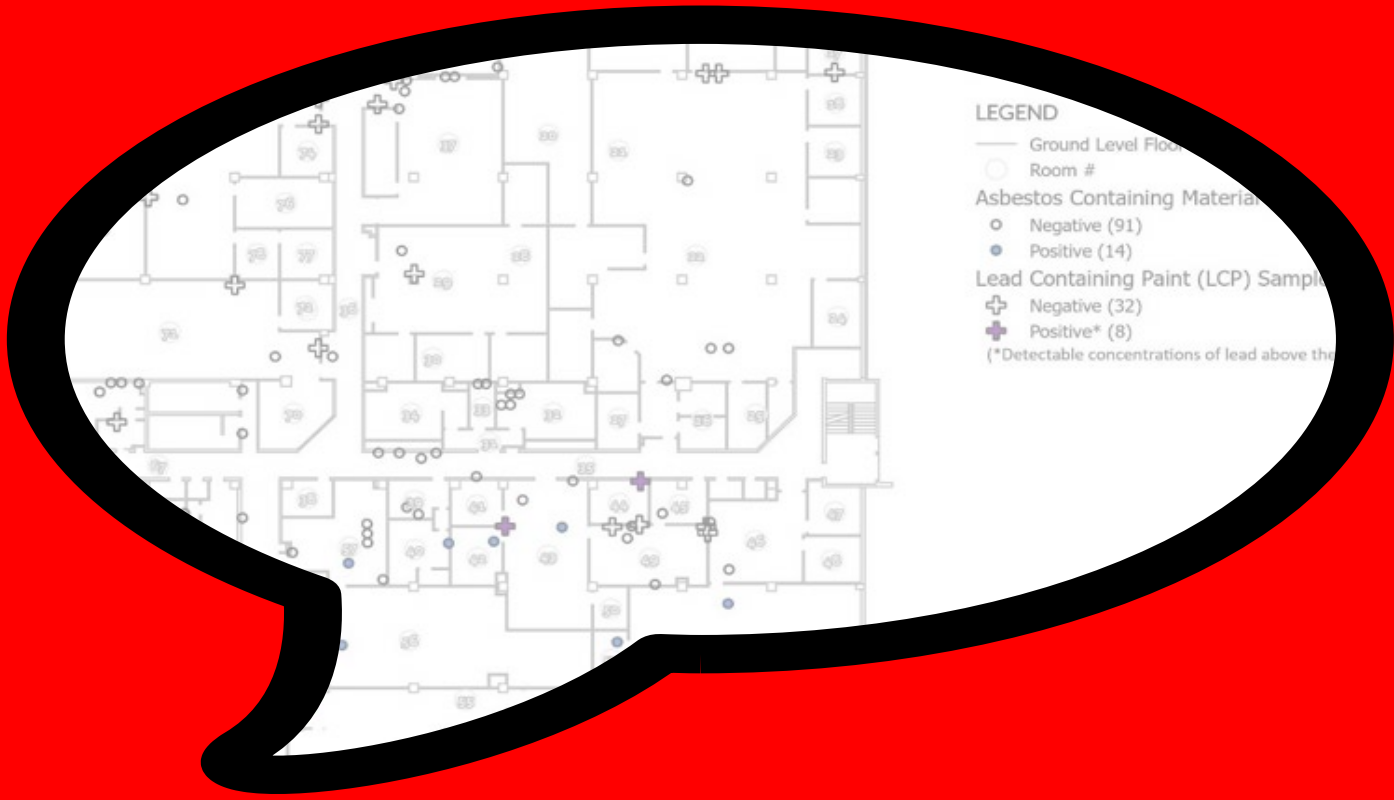
Drawing No. SP-6
 Sheet No. 06
 of Total 08

- Ground Level Floor
- Room #
- Asbestos Containing Material**
 - Negative (91)
 - Positive (14)
- Lead Containing Paint (LCP) Samples**
 - ⊕ Negative (32)
 - ⊕ Positive* (8)

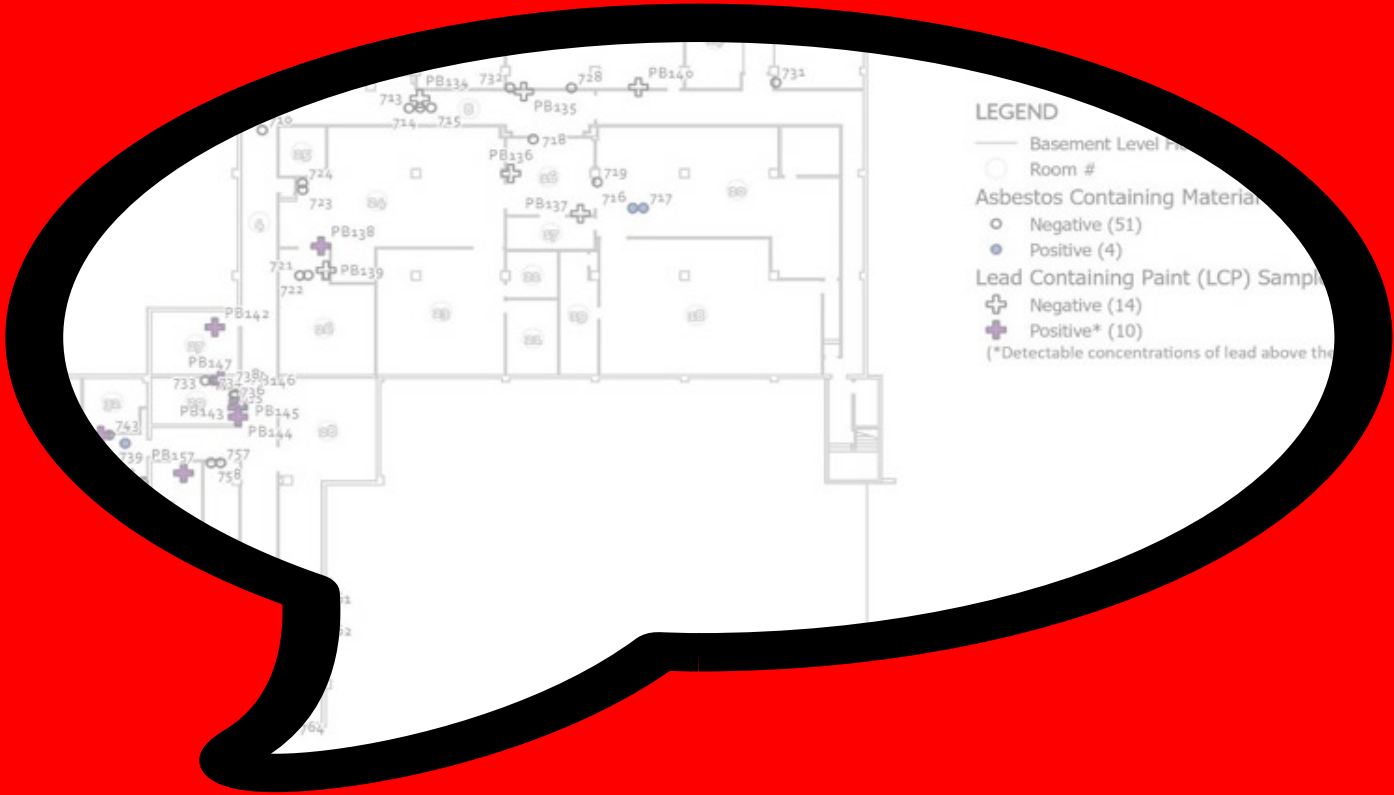
Drawing No. SP-7
 Sheet No. 07 of 08

- Basement Level
- Room #
- Asbestos Containing Material
 - Negative (51)
 - Positive (4)
- Lead Containing Paint (LCP) Samples
 - ⊕ Negative (14)
 - ⊕ Positive* (10)

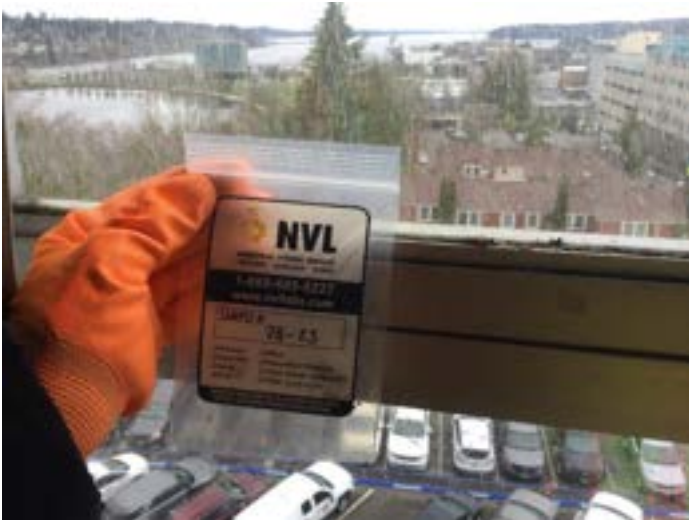
Photo #:	1
Date:	3/6/2024
Sample #	210-23
Material Desc:	Gray window glazing
Location:	4th Floor, Room 6

Planning and coordination of ACM removal should begin prior to demolition activities. The ACM identified in this report should be removed by certified, trained, and protected personnel using appropriate work practices and engineering controls as presented in Specification 02 82 33 prior to disturbance by renovation or demolition, as outlined in WAC 296-62, Part I-1, WAC 296-65, and PSCAA Regulation III, Article 4. The ACM should also be disposed of in accordance with the EPA National Emissions Standards for Hazardous Air Pollutants, 40 CFR 61, Subpart M.

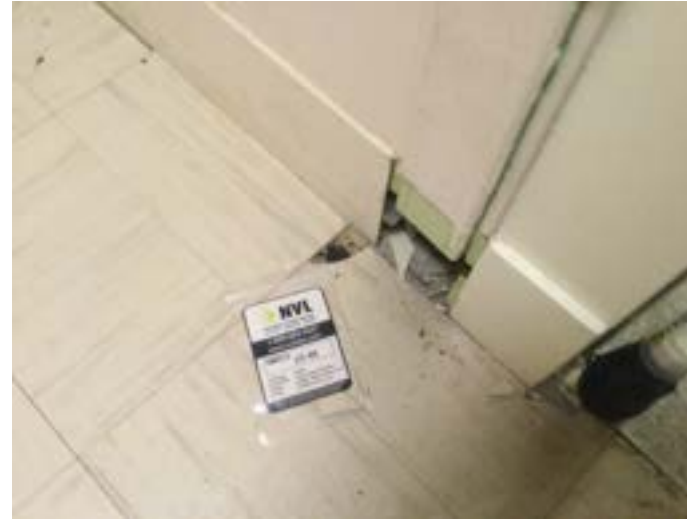
Photo #:	2
Date:	3/7/2024
Sample #	210-49
Material Desc:	Black mastic associated with 12-in tan vinyl floor tile
Location:	4th Floor, Room 133

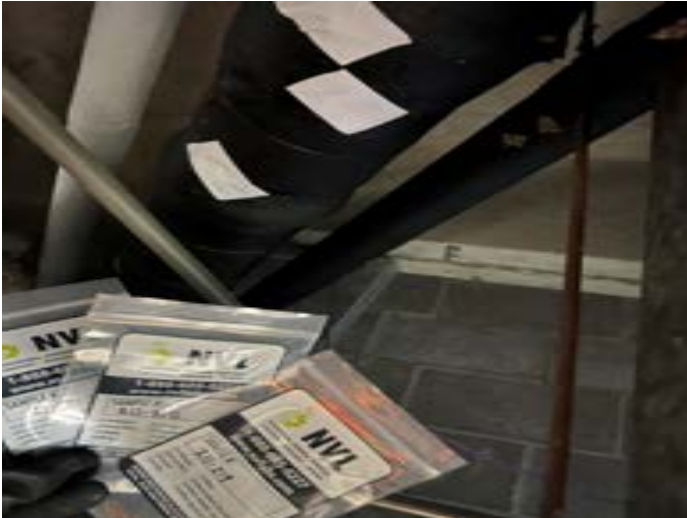
Photo #:	3
Date:	3/15/2024
Sample #	210-217, 218, and 219
Material Desc:	6-in black pipe run wrap and white mesh
Location:	3rd Floor, Room 26, Above suspended ceiling

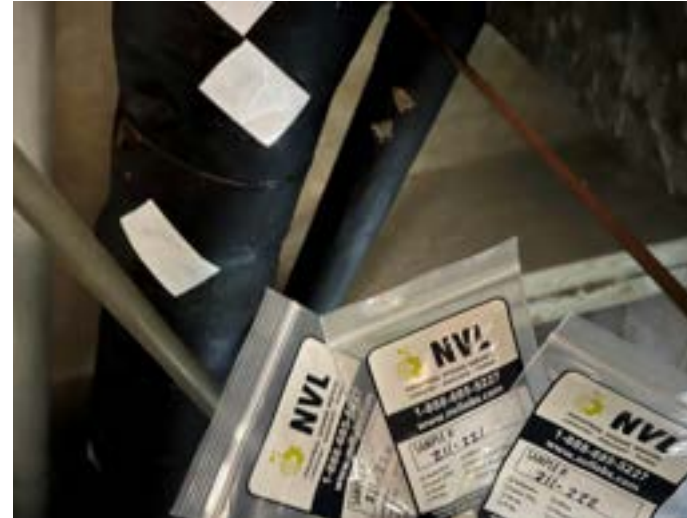
Photo #:	4
Date:	3/7/2024
Sample #	210-220, 221, and 222
Material Desc:	4-in black pipe run wrap and mag insulation
Location:	4th Floor, Room 133

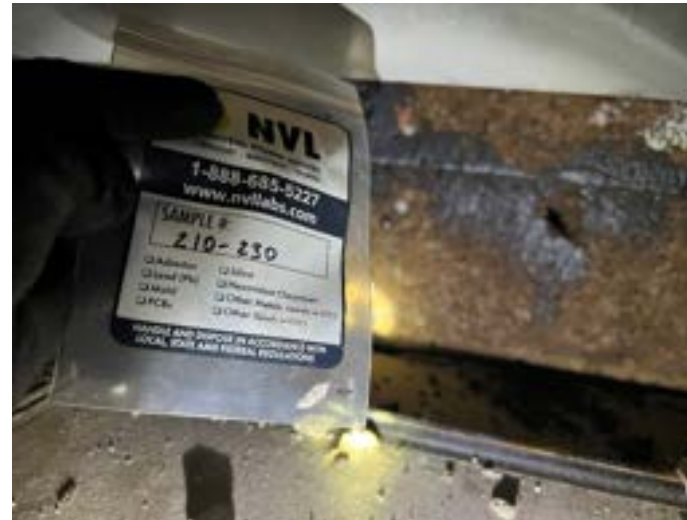
Photo #:	6
Date:	3/20/2024
Sample #:	210-230
Material Desc:	Black mastic on brown corkboard exterior wall
Location:	3rd Floor, Room 79

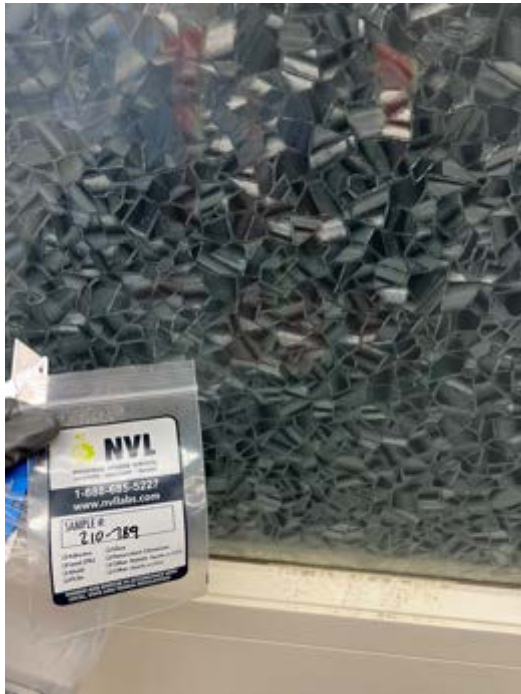
Photo #:	7
Date:	4/12/2024
Sample #	210-789
Material Desc:	Gray window glazing (interior window)
Location:	Floor 3, Room 12, Interior Window Gasket on Houserman Metal Wall Panel

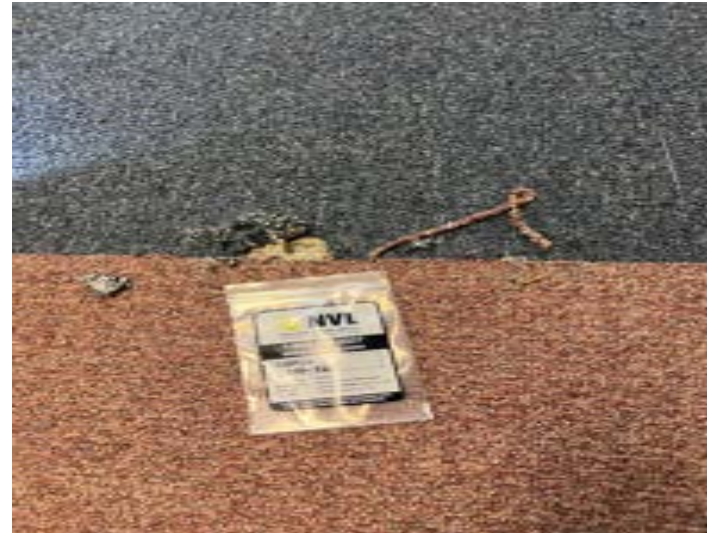
Photo #:	8
Date:	3/21/2024
Sample #	210-265
Material Desc:	Black mastic associated with blue carpet
Location:	2nd Floor, Room 28

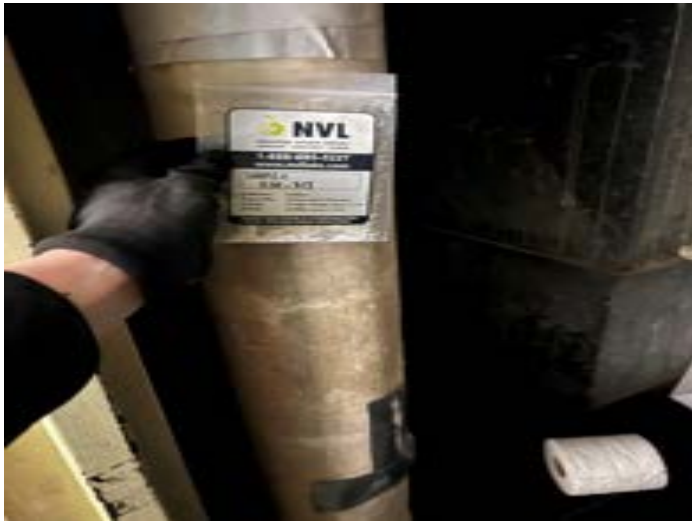
Photo #:	9
Date:	3/22/2024
Sample #	210-313
Material Desc:	6-in white mag pipe insulation
Location:	2nd Floor, Room 55

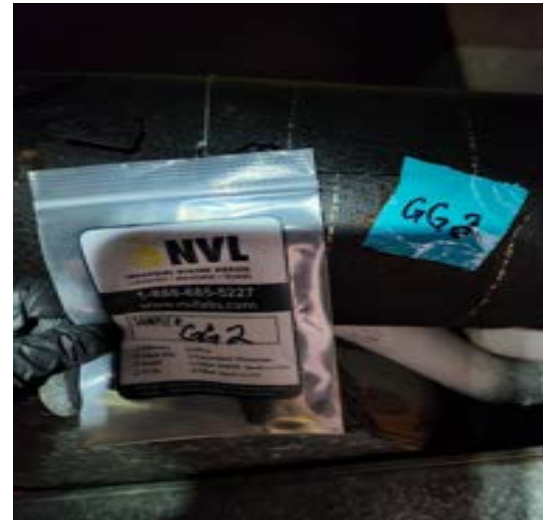
Photo #:	12
Date:	4/2/2024
Sample #	210-633
Material Desc:	Black mastic pipe wrap
Location:	2nd Floor, Room 52 near elevators

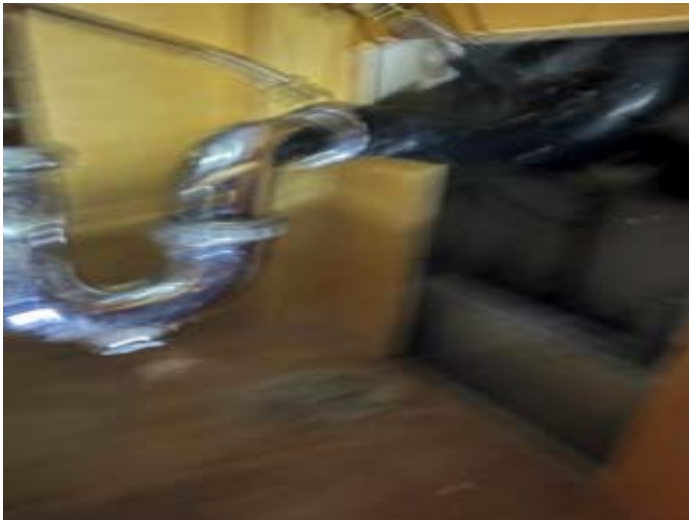
Photo #:	13
Date:	3/28/2024
Sample #	210-407
Material	Black sink
Desc:	undercoating
Location:	1st Floor, Room 28

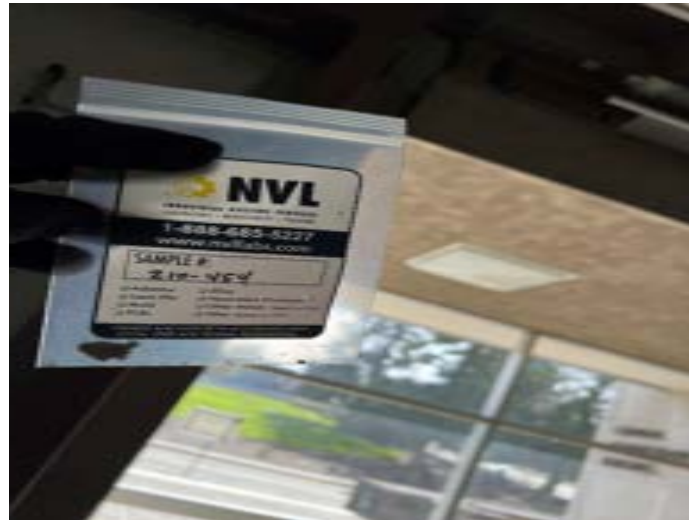
Photo #:	14
Date:	3/29/2024
Sample #	210-454
Material	Tan wall texture
Desc:	
Location:	1st Floor, Lobby

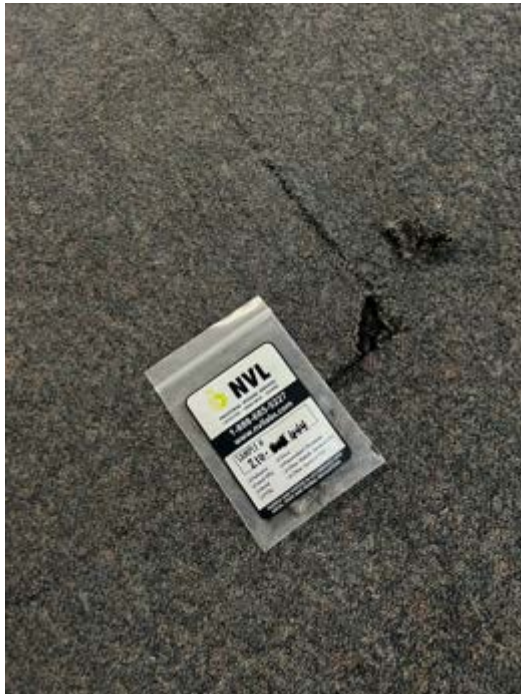
Photo #:	15
Date:	4/4/2024
Sample #	210-644
Material Desc:	Black mastic associated with blue carpet
Location:	Ground Floor, Room 43

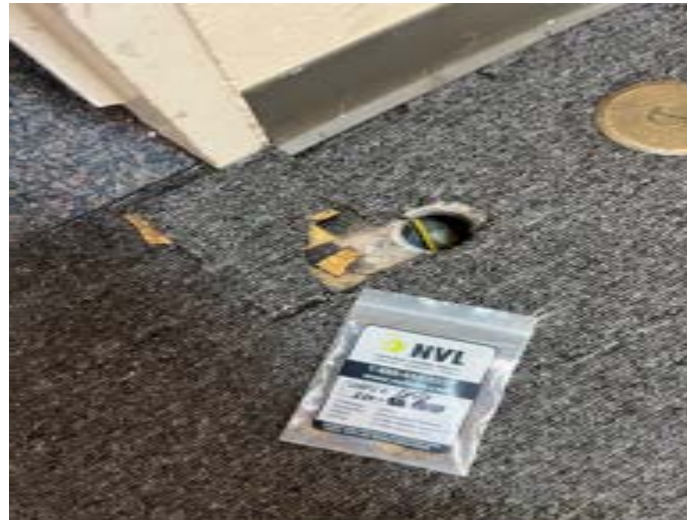
Photo #:	16
Date:	4/4/2024
Sample #	210-656
Material Desc:	9x9-in red and tan vinyl floor tile and black mastic
Location:	Ground Floor, Room 42

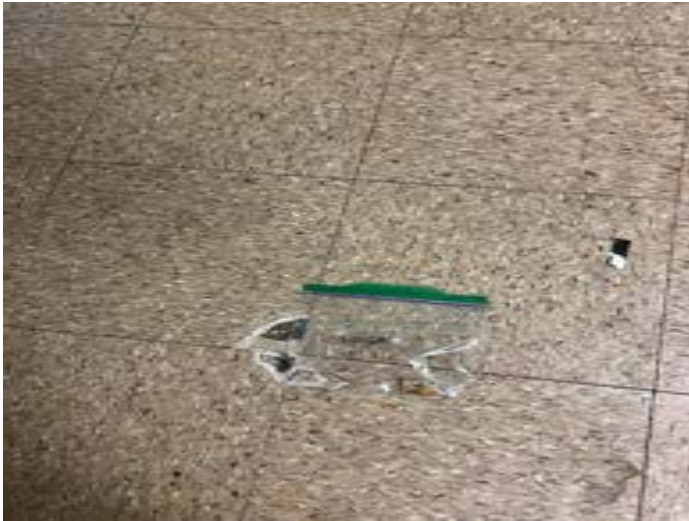
Photo #:	17
Date:	4/9/2024
Sample #	210-681
Material Desc:	Black mastic associated with 12-in tan and brown vinyl floor tile
Location:	Ground Floor, Room 68

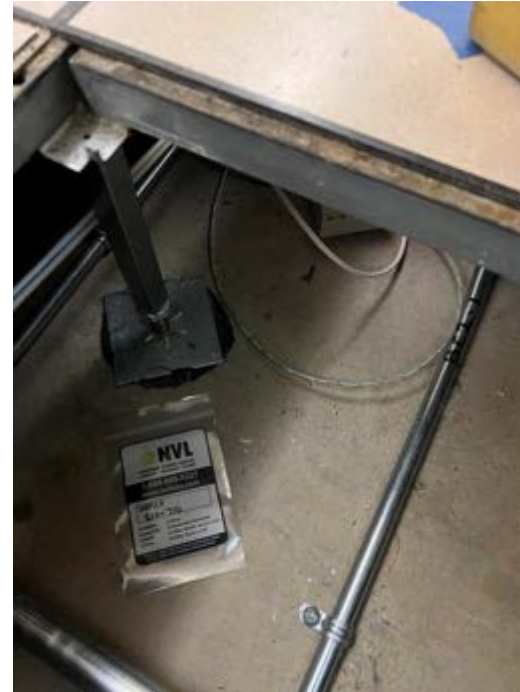
Photo #:	18
Date:	4/10/2024
Sample #	210-716
Material Desc:	Black mastic associated with base of raised floor footings
Location:	Basement, Room 20

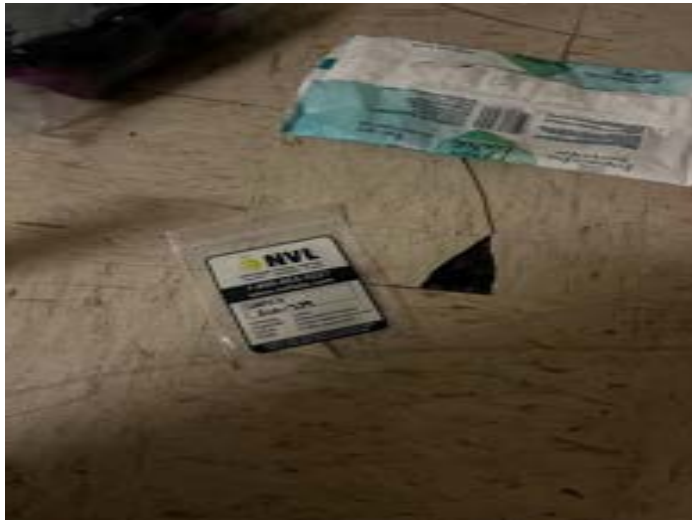
Photo #:	19
Date:	4/11/2024
Sample #	210-739
Material Desc:	Black mastic associated with 9x9-in off white and beige vinyl floor tile
Location:	Basement, Room 34

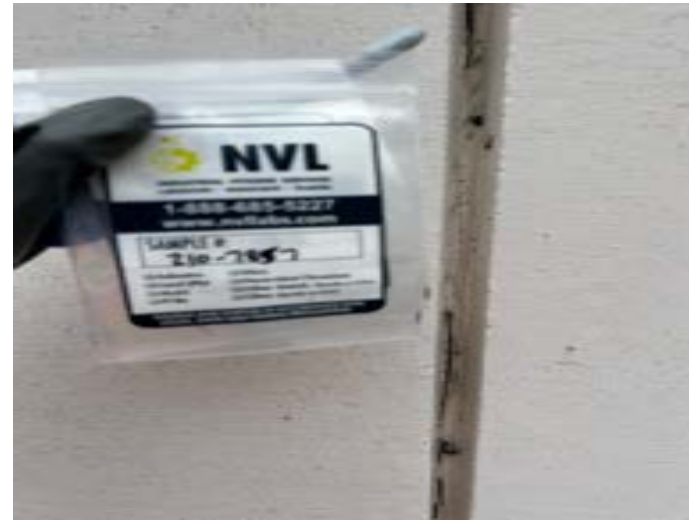
Photo #:	20
Date:	4/12/2024
Sample #	210-787
Material Desc:	Beige caulk in seam between concrete wall panels
Location:	Exterior, West

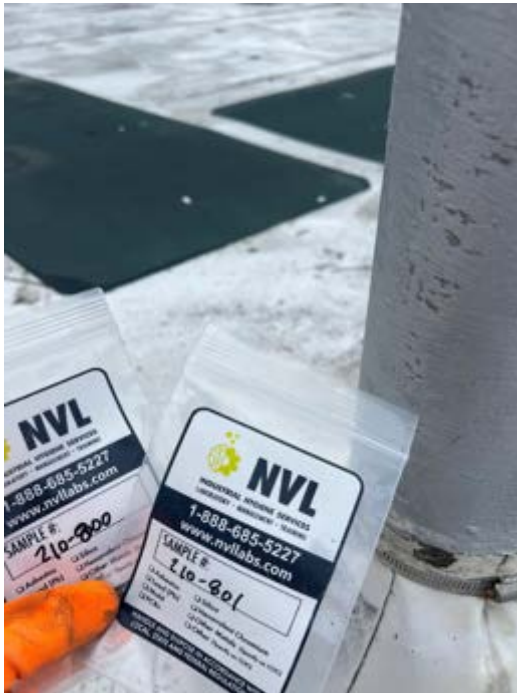
Photo #:	21
Date:	4/30/2024
Sample #	210-800
Material Desc:	Silver paint on fireline standpipe
Location:	Roof, between NE and SE corners

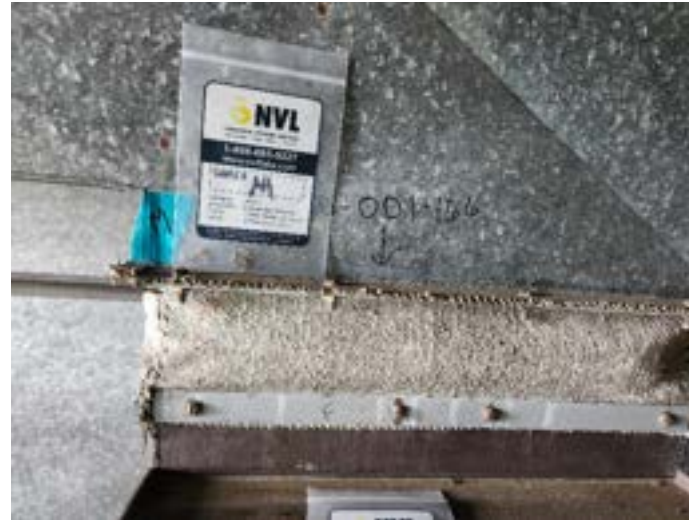
Photo #:	22
Date:	3/29/2024
Sample #	210-488
Material Desc:	White sound dampening material
Location:	Penthouse 1, Room 1 on south HVAC unit

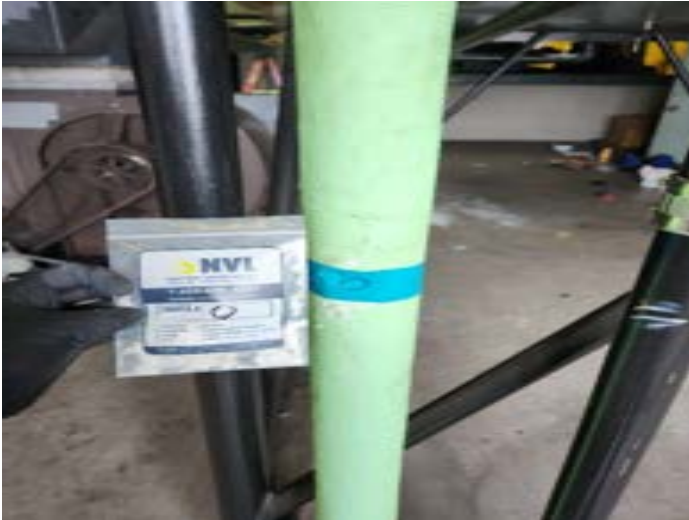
Photo #:	23
Date:	3/29/2024
Sample #	210-490
Material Desc:	4-in Green pipe run mag insulation on bare metal
Location:	Penthouse 1, Room 1 suspended next to south HVAC unit

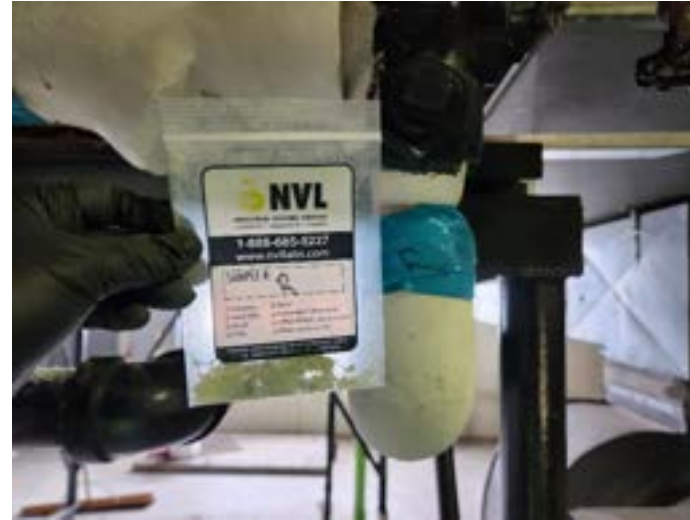
Photo #:	24
Date:	3/29/2024
Sample #	210-493
Material Desc:	4-in Green pipe elbow mag insulation on bare metal
Location:	Penthouse 1, Room 1 elbow of suspend run next to south HVAC unit

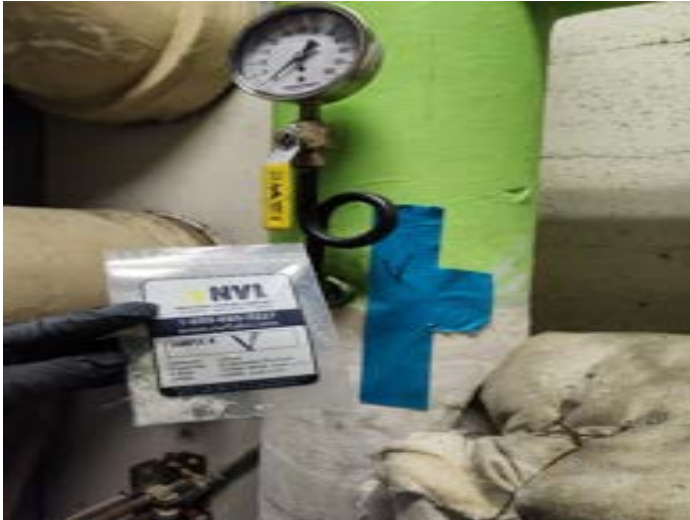
Photo #:	25
Date:	3/29/2024
Sample #	210-497
Material Desc:	Large diameter pipe run mag insulation
Location:	Penthouse 1, Room 1, South Wall

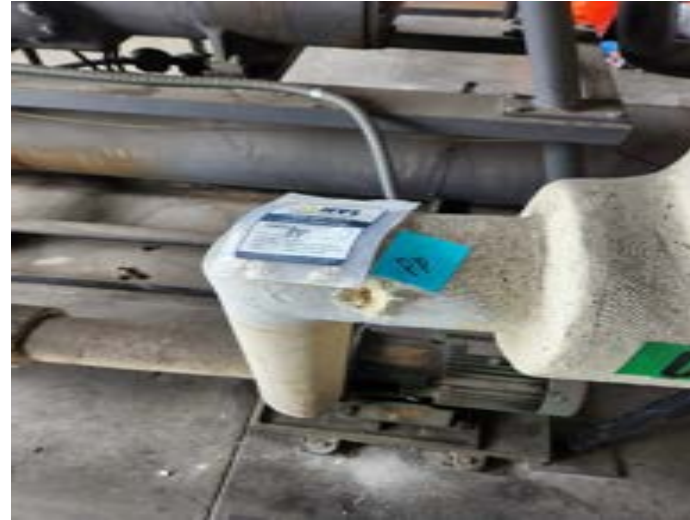
Photo #:	26
Date:	3/29/2024
Sample #	210-517
Material Desc:	Elbow wrap on chilled H2O mag insulation
Location:	Penthouse 2, Room 1

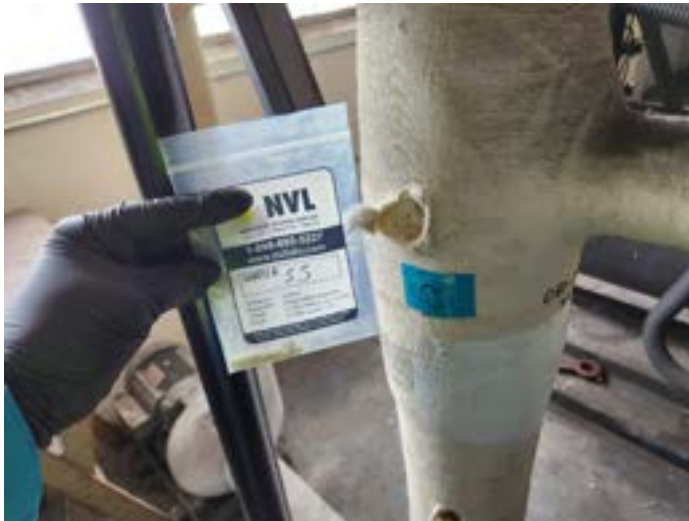
Photo #:	27
Date:	3/29/2024
Sample #	210-520
Material Desc:	Aged mag insulation on pipes
Location:	Penthouse 2, Room 1

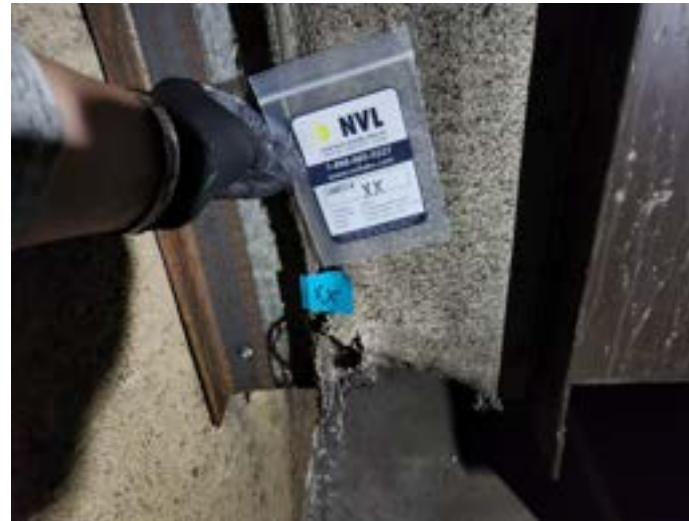
Photo #:	28
Date:	3/29/2024
Sample #	210-526
Material Desc:	Black dampening cloth associated with large HVAC unit
Location:	Penthouse 2, Room 6

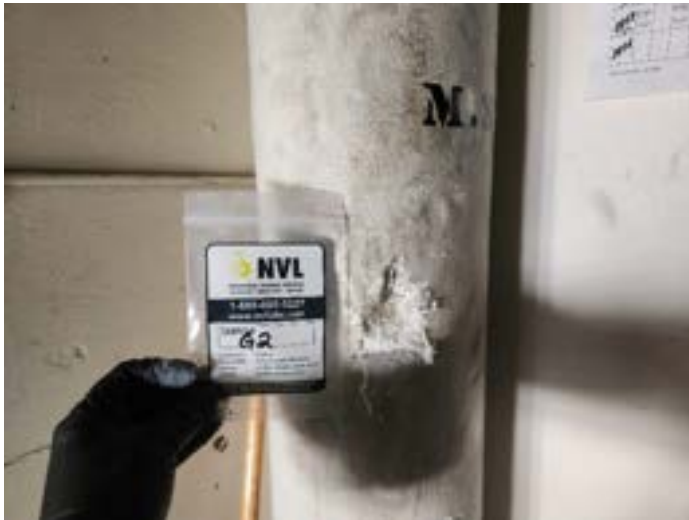
Photo #:	31
Date:	4/2/2024
Sample #	210-607
Material Desc:	Vertical Pipe mag insulation
Location:	Penthouse 2, Room 1, on vertical pipe near door on platform

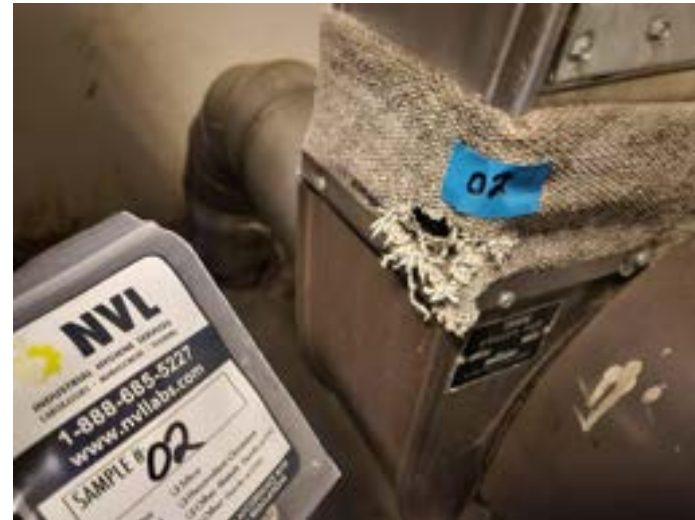
Photo #:	32
Date:	4/2/2024
Sample #	210-615
Material Desc:	White dampening cloth
Location:	Penthouse 2, Room 6, HVAC units in south room

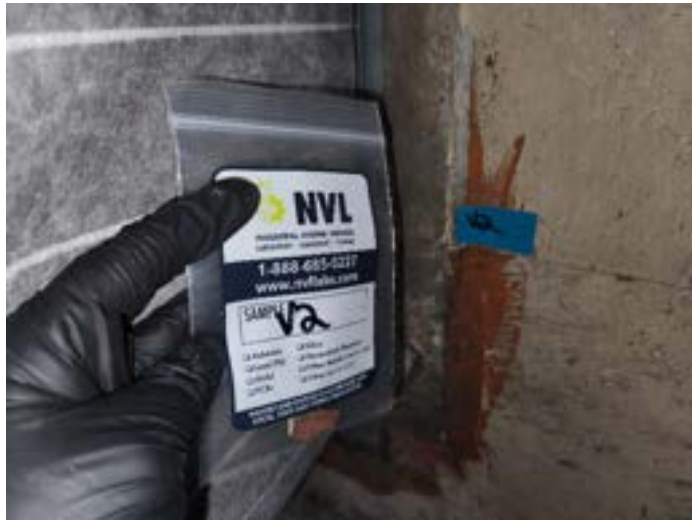
Photo #:	33
Date:	4/2/2024
Sample #	210-622
Material Desc:	Beige caulk along HVAC
Location:	Penthouse 2, Room 5, walls
