Washington State
DEPARTMENT OF
ENTERPRISE SERVICES

LSS Relocation Study Report

Facility Professional Services
Division

Report to the Legislature

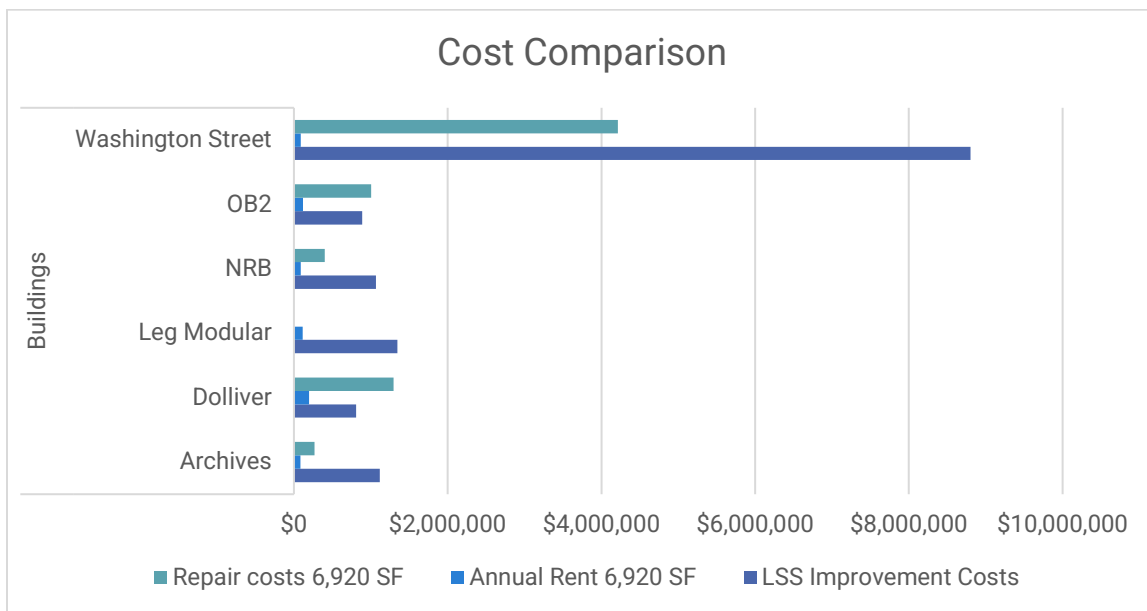
This chart compares the annual rent and Facility Condition Assessment (FCA) repair costs for all locations, using the 6,920 square footage from the modified predesign. Washington Street's improvement costs are based on the total building square footage of 14,580, while the five proposed locations use consultant cost estimates.

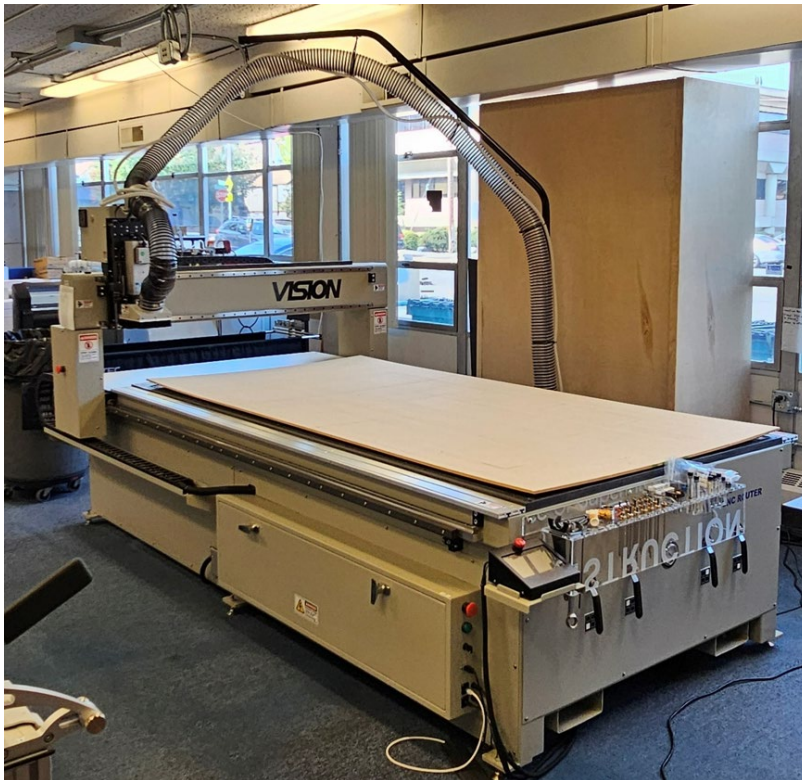
LSS Production and Design create custom items, such as ADA signage, commemorative materials, and other unique specialty objects using equipment such as the machine shown in the image below. This machine, referred to as “S4” in test fit drawings, is a computer numerical control router used to cut different materials. This machine is 10 feet long, 5 feet wide, and weighs 4,000 pounds. It cannot be broken down into smaller parts for moving.

Floor load capacity for this machine requires the structural strength to support 170 pounds per square foot. Typical floors are designed to support a load of weights between 50-125 pounds per square foot, depending on the materials and construction type.

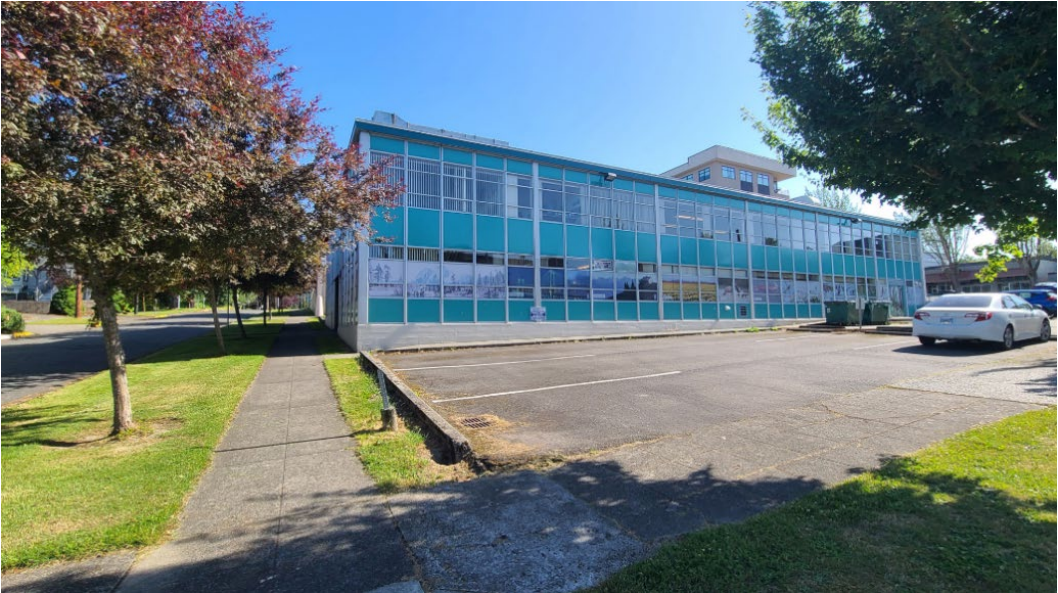
Washington Street, 1959

Two levels, 14,580 gross square feet

The Critical Deficiencies for Washington Street includes the following issues:

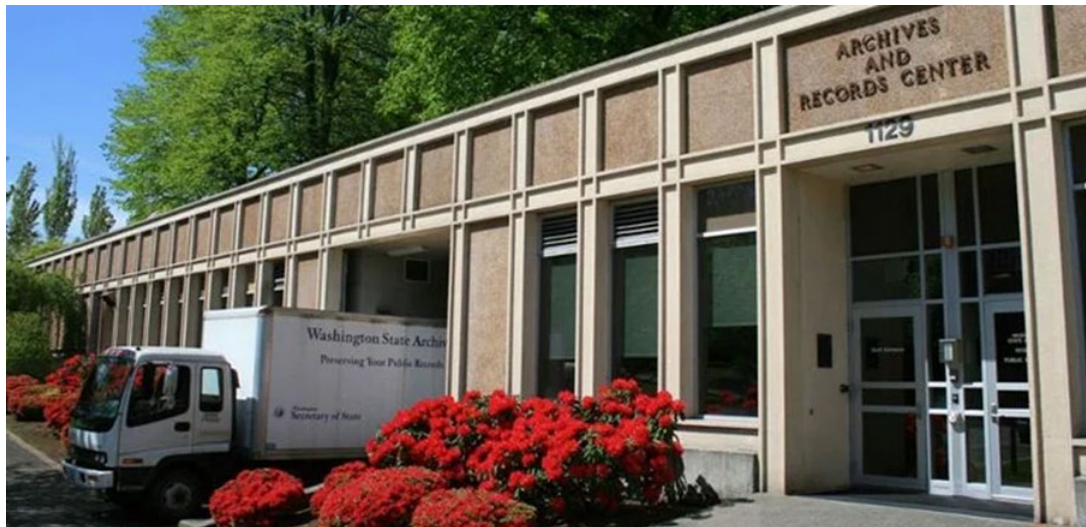
Archives, 1964

Three levels, 51,317 gross square feet

The Archives Building, located on East Capitol Campus, was constructed for the Archives and Records Division of the Office of the Secretary of the State (SOS), and will be fully occupied by SOS until a new building is constructed. Planned construction of a new facility in Tumwater has been delayed due to permitting. Wildlife habitat conservation regulations and financing are constraining construction. The current projection for permitting is 7-10 years.

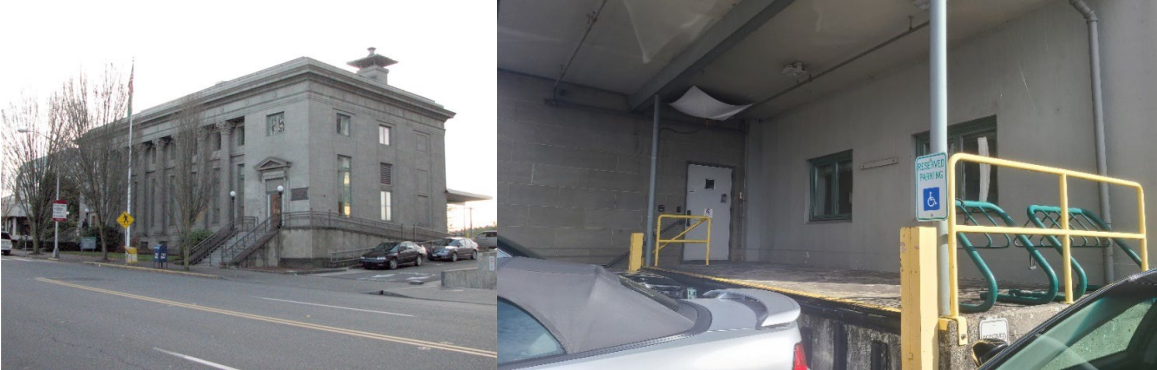
Dolliver, 1914

Four levels, 23,385 gross square feet

The state acquired the Dolliver Building, formerly the Olympia Federal Building, from the U.S. General Services Administration in 1998 for use by the Corporations and Charities Division of the Office of the Secretary of State (SOS). It was initially constructed as a United States Post Office facility. A 1929 addition on the west side created a first-floor area next to the loading dock.

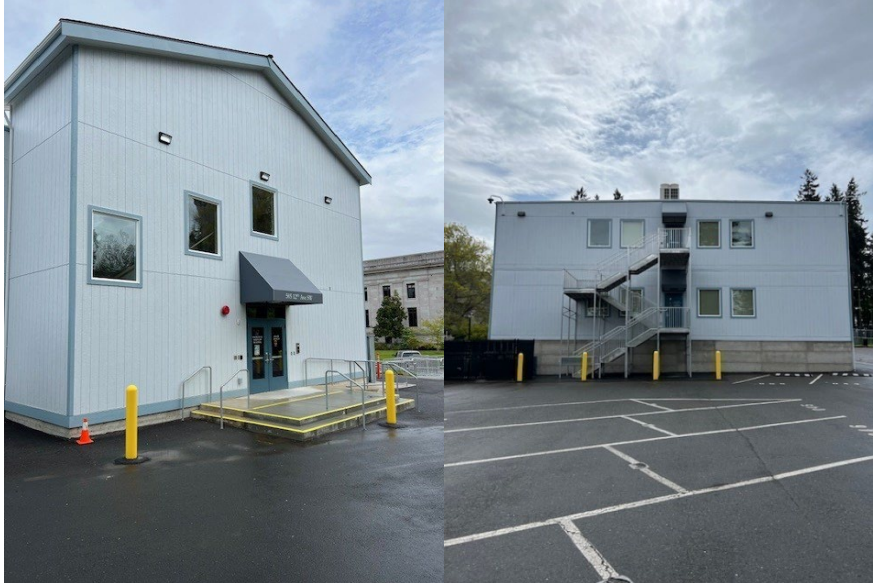
Leg Modular, 2022

Two levels, 14,567 gross square feet

DES built the Leg Modular Building on the Mansion Parking Lot to serve as temporary office space for the impacted occupants of the Legislative Campus Modernization (LCM) Project. The building is fully occupied until the completion of LCM, which is projected to be early winter of 2026.

The building modules were fabricated offsite, then assembled and finished on-site. There are 16 modules plus a circulation area with stairs and an elevator. The building sits on a foundation that slopes downward toward the north. It displaces 49 parking stalls on the Mansion Lot. DES has submitted a capital budget request for the 2025-2027 biennium to surplus the structure and restore the parking.

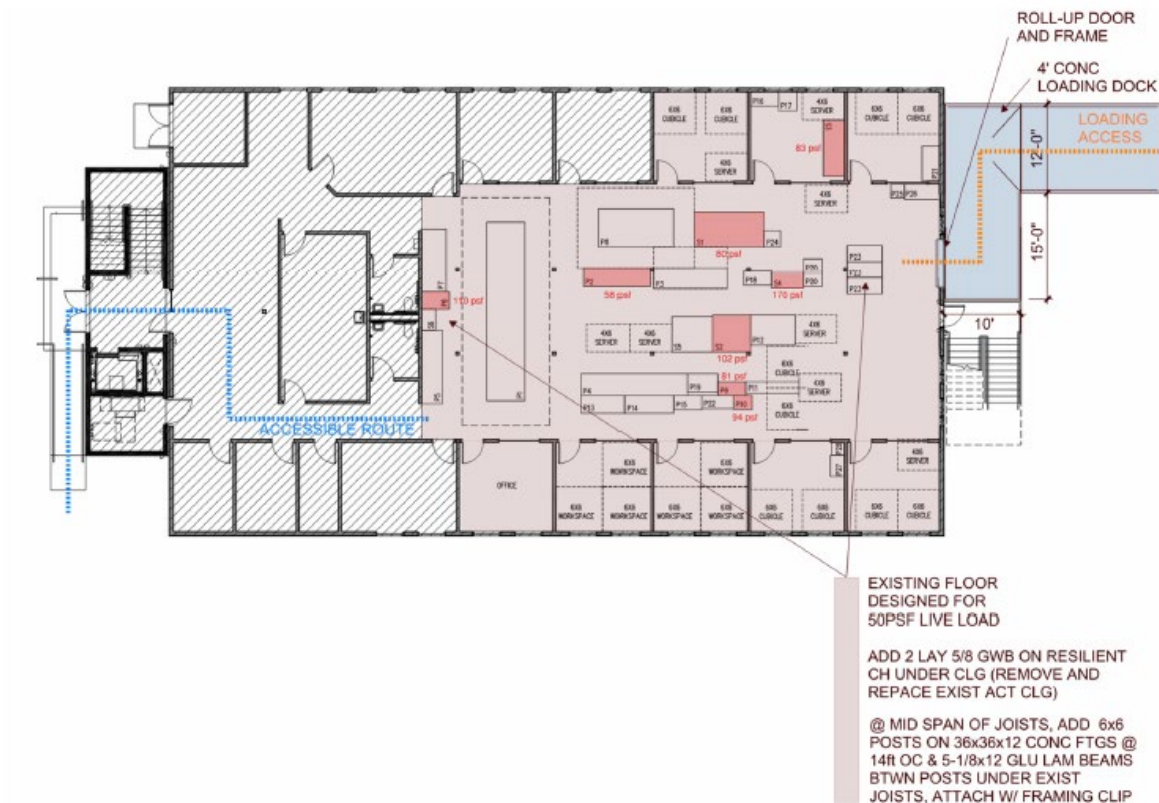
Legislative Modular Building Floor Plan

The north end of the first floor, shown on the architectural test fit drawing, offers the most suitable location for the LSS production equipment. The existing configuration offers natural light, private offices, and an open floorplan. Doorway sizes, floor load capacity, ventilation, and filtration are inadequate. Equipment access is not possible until extensive modifications are made.

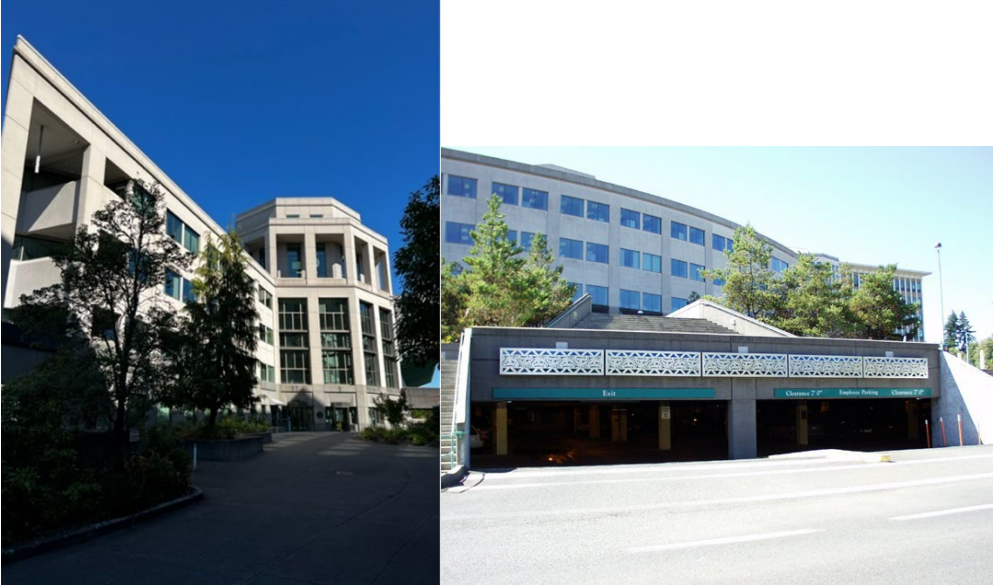
Natural Resources Building, 1992

10 levels, 387,558 gross square feet

The Natural Resources Building (NRB) is the largest building on campus. NRB is a 10-level structure. Levels P-1, P-2, and P-3 are cast-in-place concrete; walls, ceilings, and floors are concrete. The P-1 and P-2 levels house mail rooms, maintenance shops, offices, and parking and mechanical/electrical rooms.

The upper floors of NRB are mostly open office environments with systems furniture workstations. Each floor between the second and sixth has a break room furnished with a microwave, sink, and refrigerator.

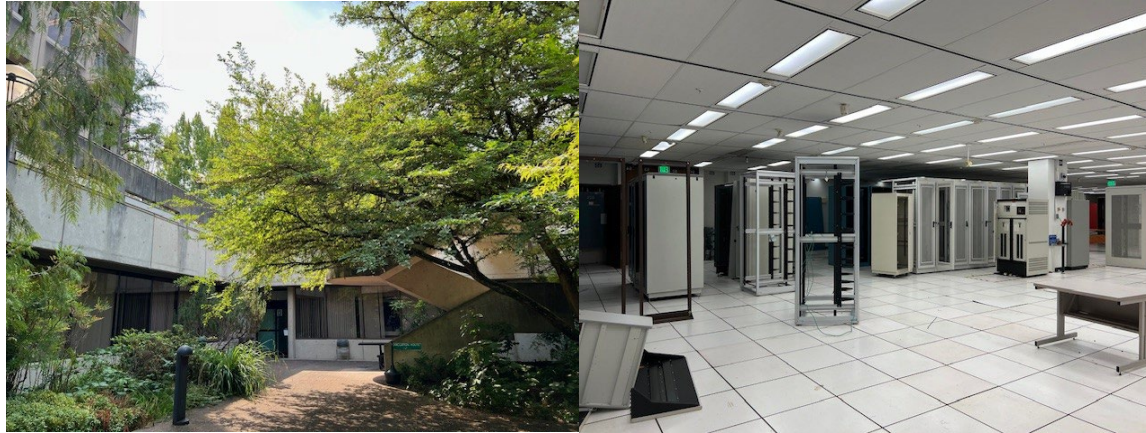
Office Building 2, 1975

Six levels, 379,204 gross square feet

OB2 is the second-largest campus building. The construction of OB2 was an integral part of the East Campus Expansion Project that began in the 1960s to co-locate major state agency headquarters to Olympia, following a State Supreme Court ruling. The East Campus is a 48.5-acre area bounded by 11th Avenue, Jefferson Street, and Maple Park Avenue.

OB2's heavy reinforced concrete construction is typical of an architectural style known as brutalism.
