OCTOBER 2016

# RENTON TECHNICAL COLLEGE

# CAMPUS MASTER PLAN

McGRANAHAN architects

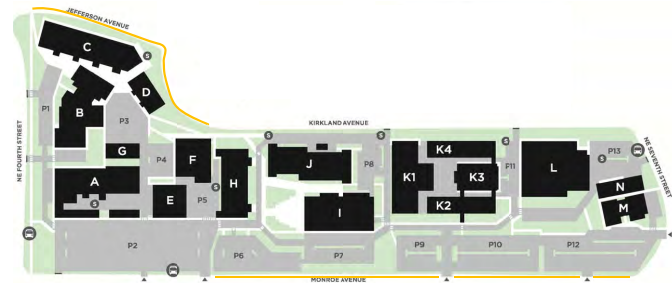
Currently, there are 997 stalls provided on-site at the main RTC campus, including 42 stalls designated as accessible. The Annex supplies an additional 68 stalls. In total, off-street parking supply is approximately 1,065 stalls for RTC programs. In addition to these stalls within parking lots, parallel parking along the street frontages of Jackson Avenue, NE 5th Place/ Kirkland Avenue, and Monroe Avenue were also utilized by the RTC Campus. Including observed off-campus parking, the average peak demand was approximately 1,047 stalls at 11:00 am, resulting in a utilization rate of approximately 98%.

**Parking lot designations on campus**

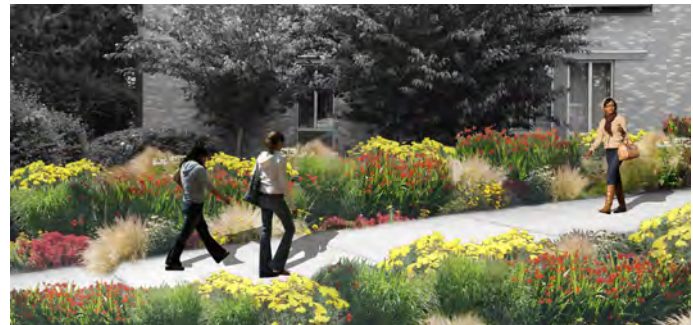
**Proposed concept for pedestrian walkway from 4th Street/Jefferson Avenue Intersection to plaza at Building C**

- Renovation of any program spaces in other buildings that will be located in the new replacement building.
- Improve pedestrian walkway and landscaping between the 4th Street/Jefferson Avenue intersection and existing entry plaza on the east side of Building C.

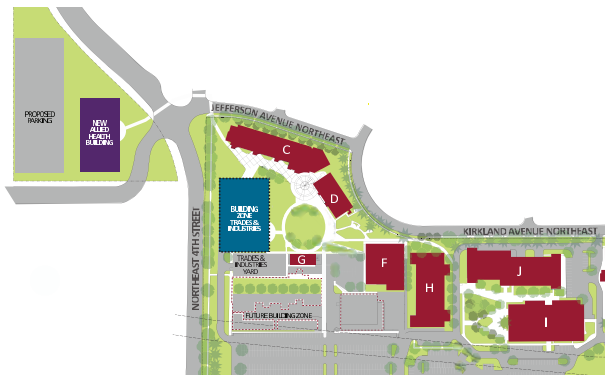
**Proposed location of Capital Project Two - a Trades & Industries Replacement Building - on the current site of Building B. (See full campus plan on page 39.)**

- Proposed site is existing location of Building B, along 4th street.
- With the SBCTC's anticipated revisions to the project funding process, the proposed PRR submittal timelines for Capital Projects Two and Three may need to be adjusted accordingly.

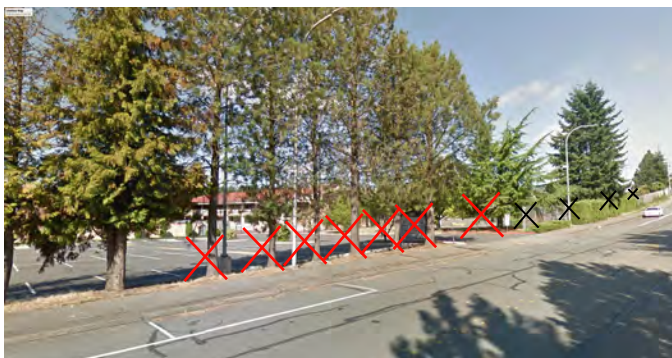
Coniferous trees along Monroe Avenue are over-scaled and planted too close together, blocking sightlines to campus access drives and new entry signage. Consider removing the 7 trees indicated, as well as chain link fence and adjacent shrubs to make this edge of campus more inviting to the public.

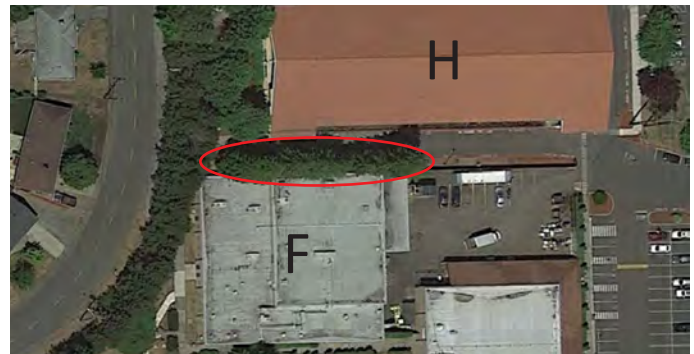
Mature trees, originally planted too close to Building F, are creating problems with roofing and adjacent paving. Consider replacing this row of trees with a lower-growing variety.

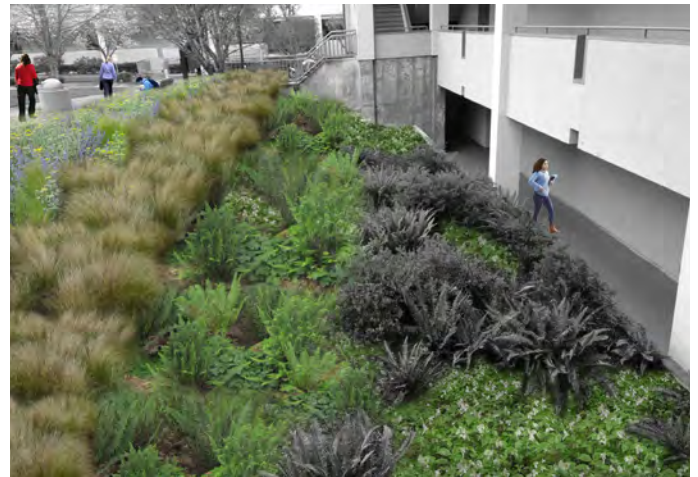
**Proposed Concept: Replace shrubs on the east side of Building J with a variety of grasses and perennials to add color and interest to the adjacent plaza and improve penetration of natural light to the lower level.**

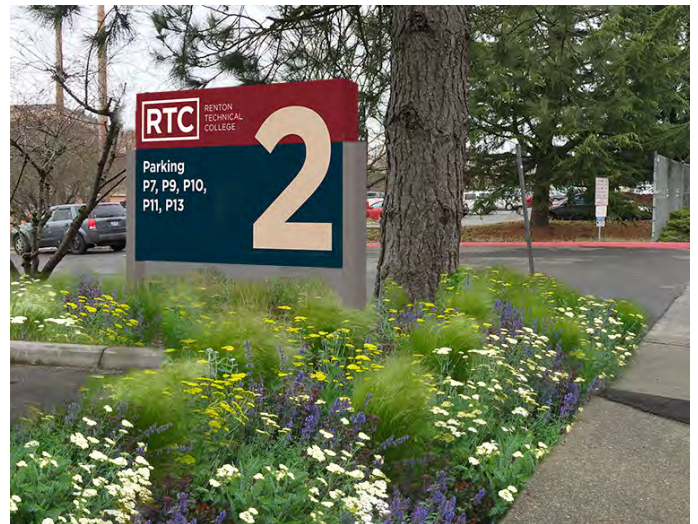
**Concept photos and revegetate the planting beds beneath the new signs selecting a variety of colorful, herbaceous, low-growing species.**

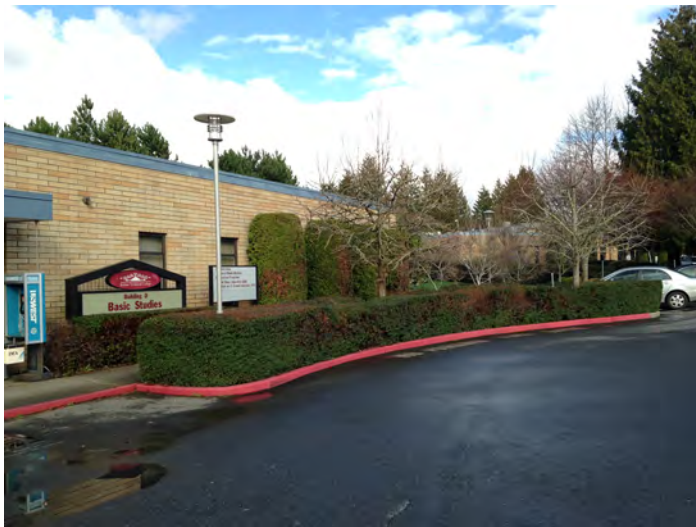
- Restrict vehicles to the edges of campus and dedicate the core to student interaction by creating a casual social, meeting and outdoor learning space in the current location of Parking Lot P3. Plant with Eco-Lawn.

Existing condition

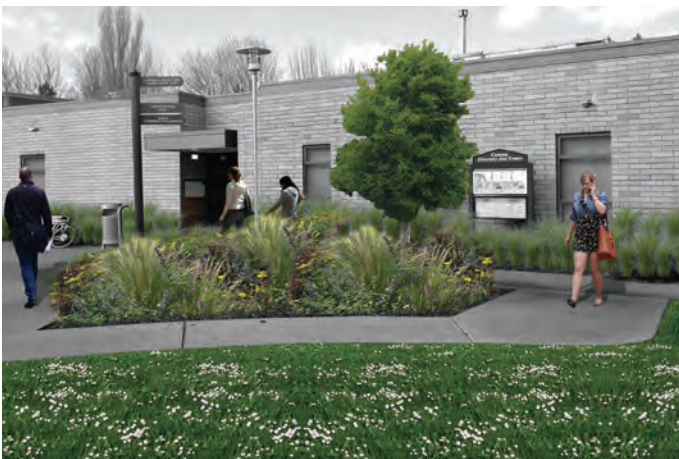
Proposed concept with Eco-Lawn and diverse, herbaceous plants

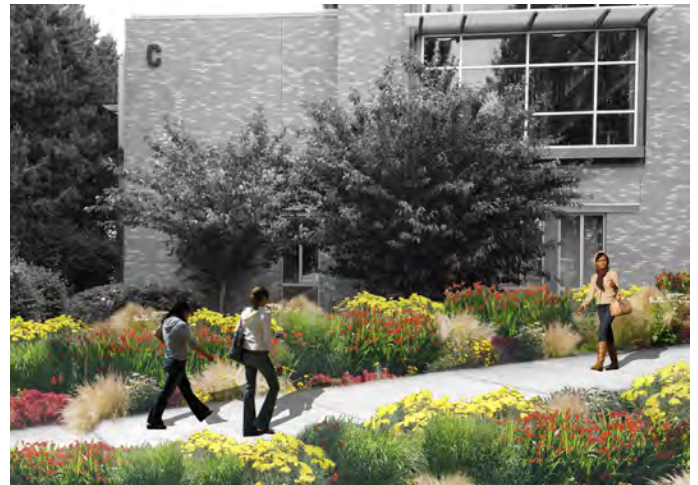
**Proposed concept: A colorful palette of plants lining a pedestrian walkway from the intersection of 4th Street and Jefferson Avenue will provide a welcoming gateway onto campus.**

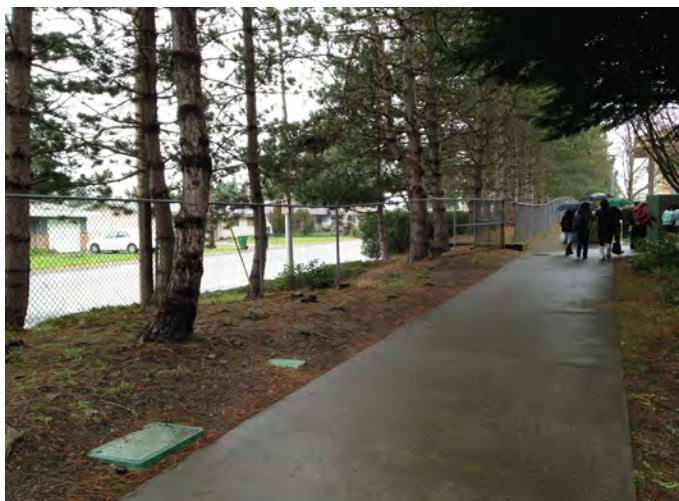
**Existing walkway on campus west edge**

- Create a network of connected pedestrian routes. Add sidewalks to complete the main north/south pedestrian corridor, such as across the parking lot to access the new entry at K1. Establish accessible routes, using interior circulation where necessary to help navigate steep grades. Asphalt in primary pedestrian areas, such as east/west between Buildings H and I gives the impression that vehicles have the right-of-way. Reinforce pedestrian priority by converting this aisle to concrete level with adjacent walkways, even if vehicles must also occasionally access the route.

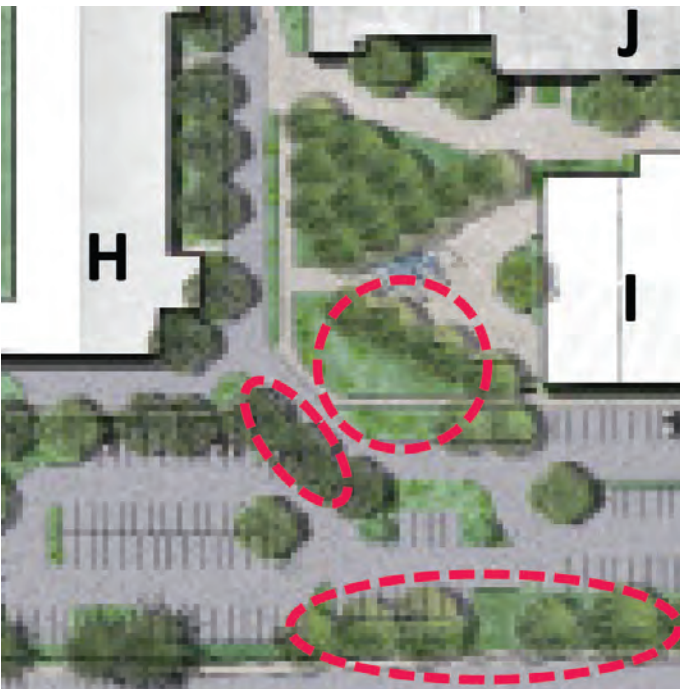
Proposed locations for rain gardens

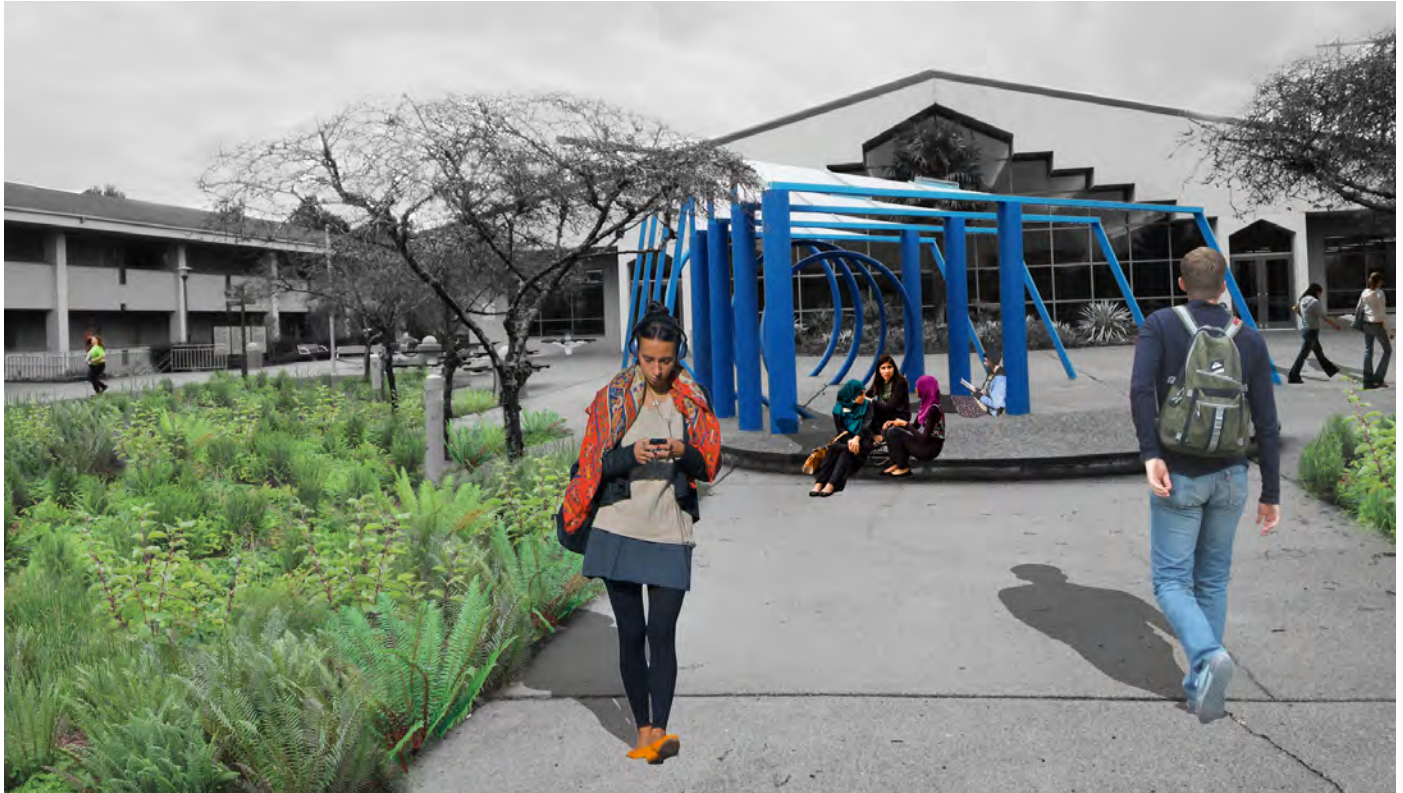
One area to consider for rain garden conversion is in front of Building I since historically it drains very poorly

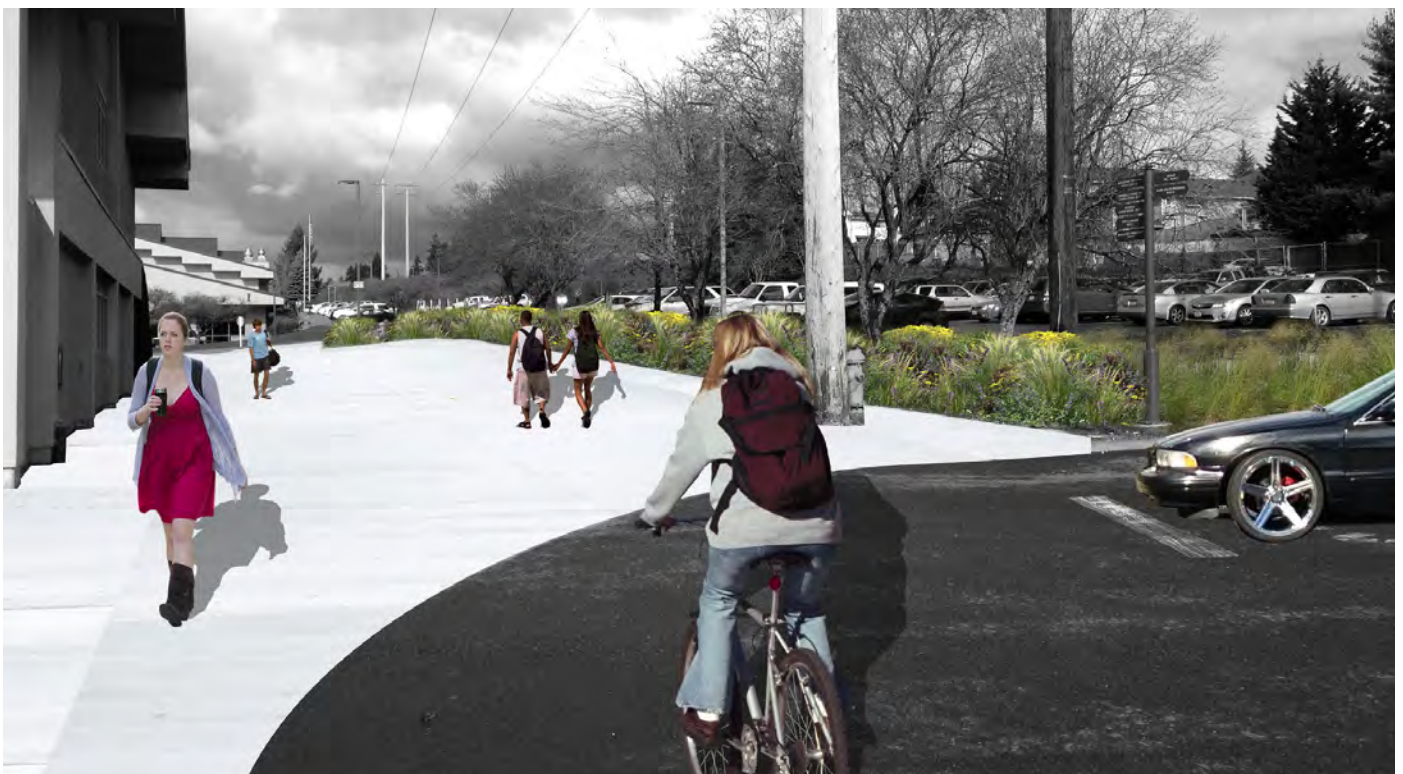
Rain gardens built into the parking islands near the staff parking lot will beautify this highly-public area while adding needed storm water detention capacity

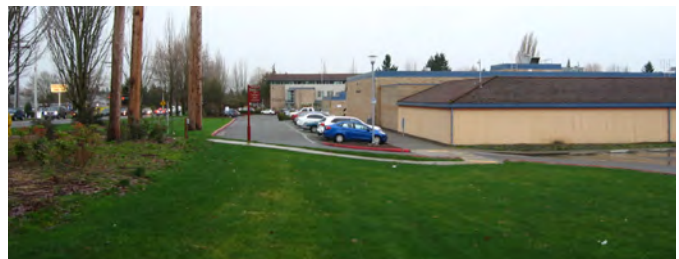
- Following the reconfiguration of PSE power poles on campus, consider simplifying the vehicular drive in front of Building I. Straightening out the drive aisle will increase parking count, allow for a drop-off zone in front of Building I and create additional area for a dedicated pedestrian walkway extending from the east side of Building H south to Building E. See image to left.

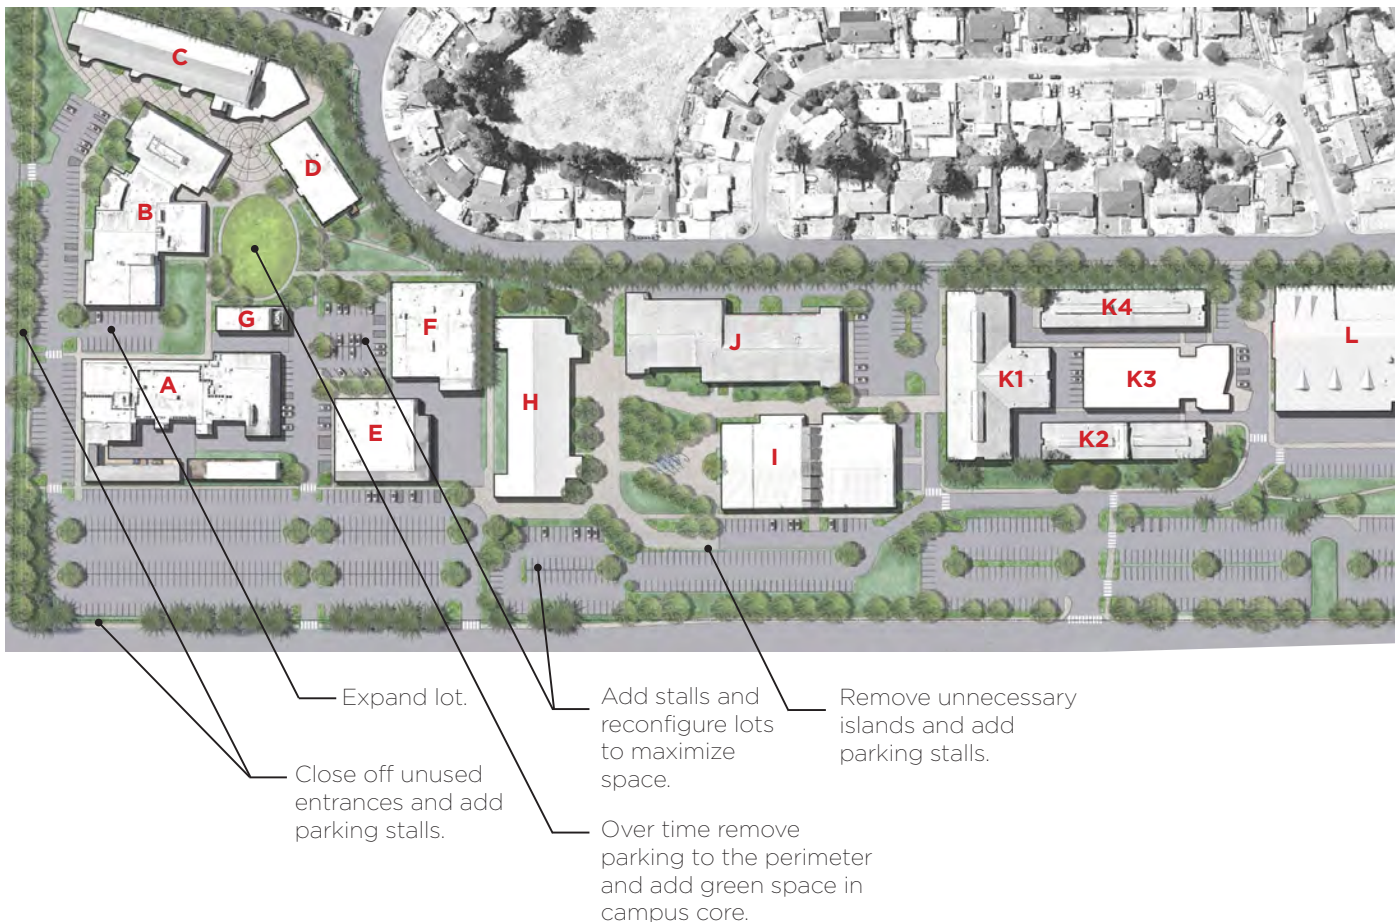
**Proposed concepts for increasing the parking stall count on campus**

- As buildings are replaced/rehabilitated, identify opportunities for efficiency improvement within existing and new parking areas to increase on-site capacity adjacent to classroom buildings, encouraging fewer students to use Monroe Avenue for on-street parking. See image below.
- Locate pockets on campus in which to add stalls, such as along 4th Street, including conversion of permanently blocked driveways into parking, following approval by the city of Renton. See image to left.
- Continue to group primary parking areas outside of the campus core to strengthen pedestrian connectivity and improve overall campus circulation.
- As a part of the Allied Health replacement project on the new south property, provide approximately 160 on-site parking stalls. ADA upgrades to the signalized intersection may be required by the City, with an estimated cost of approximately \$75,000.

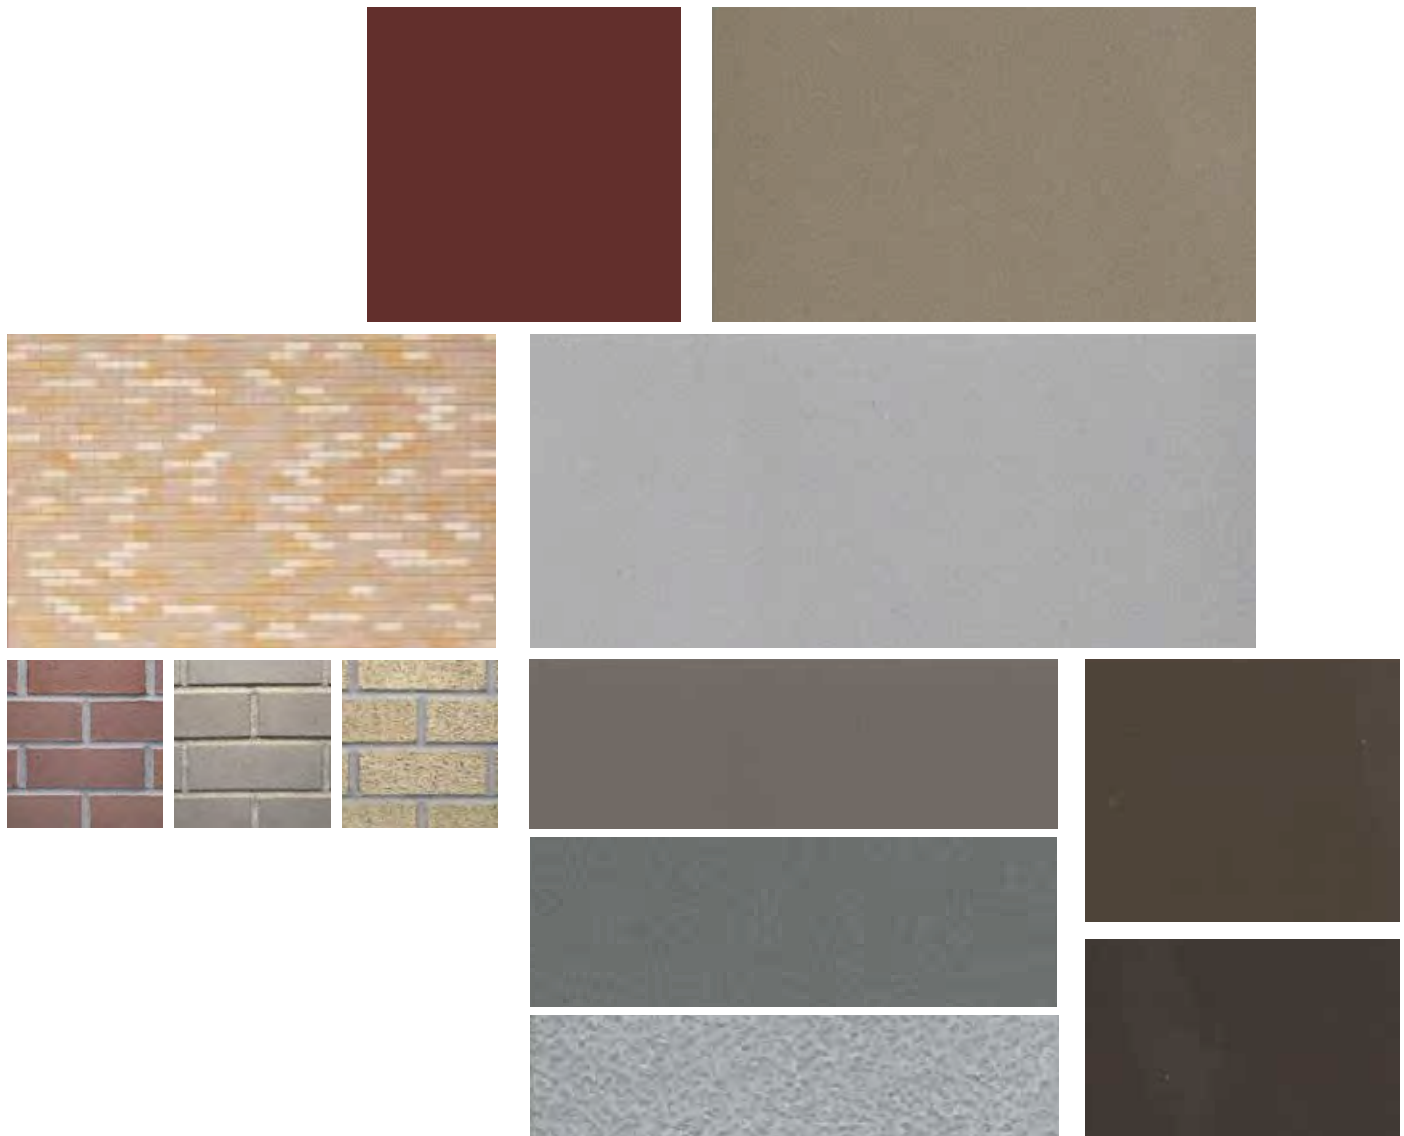
### EXTERIOR MATERIALS & COLOR PALETTE

Siding

Morin S-16 Corrugated Metal Panel Bright Silver

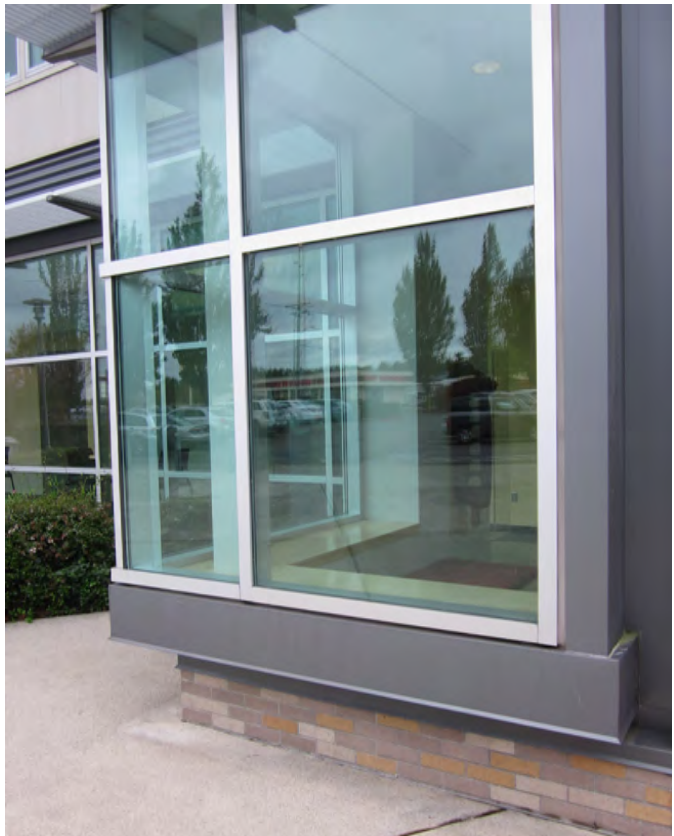
The exterior palette consists of natural, durable materials such as masonry, clear coated metals, and earth tone paint colors.

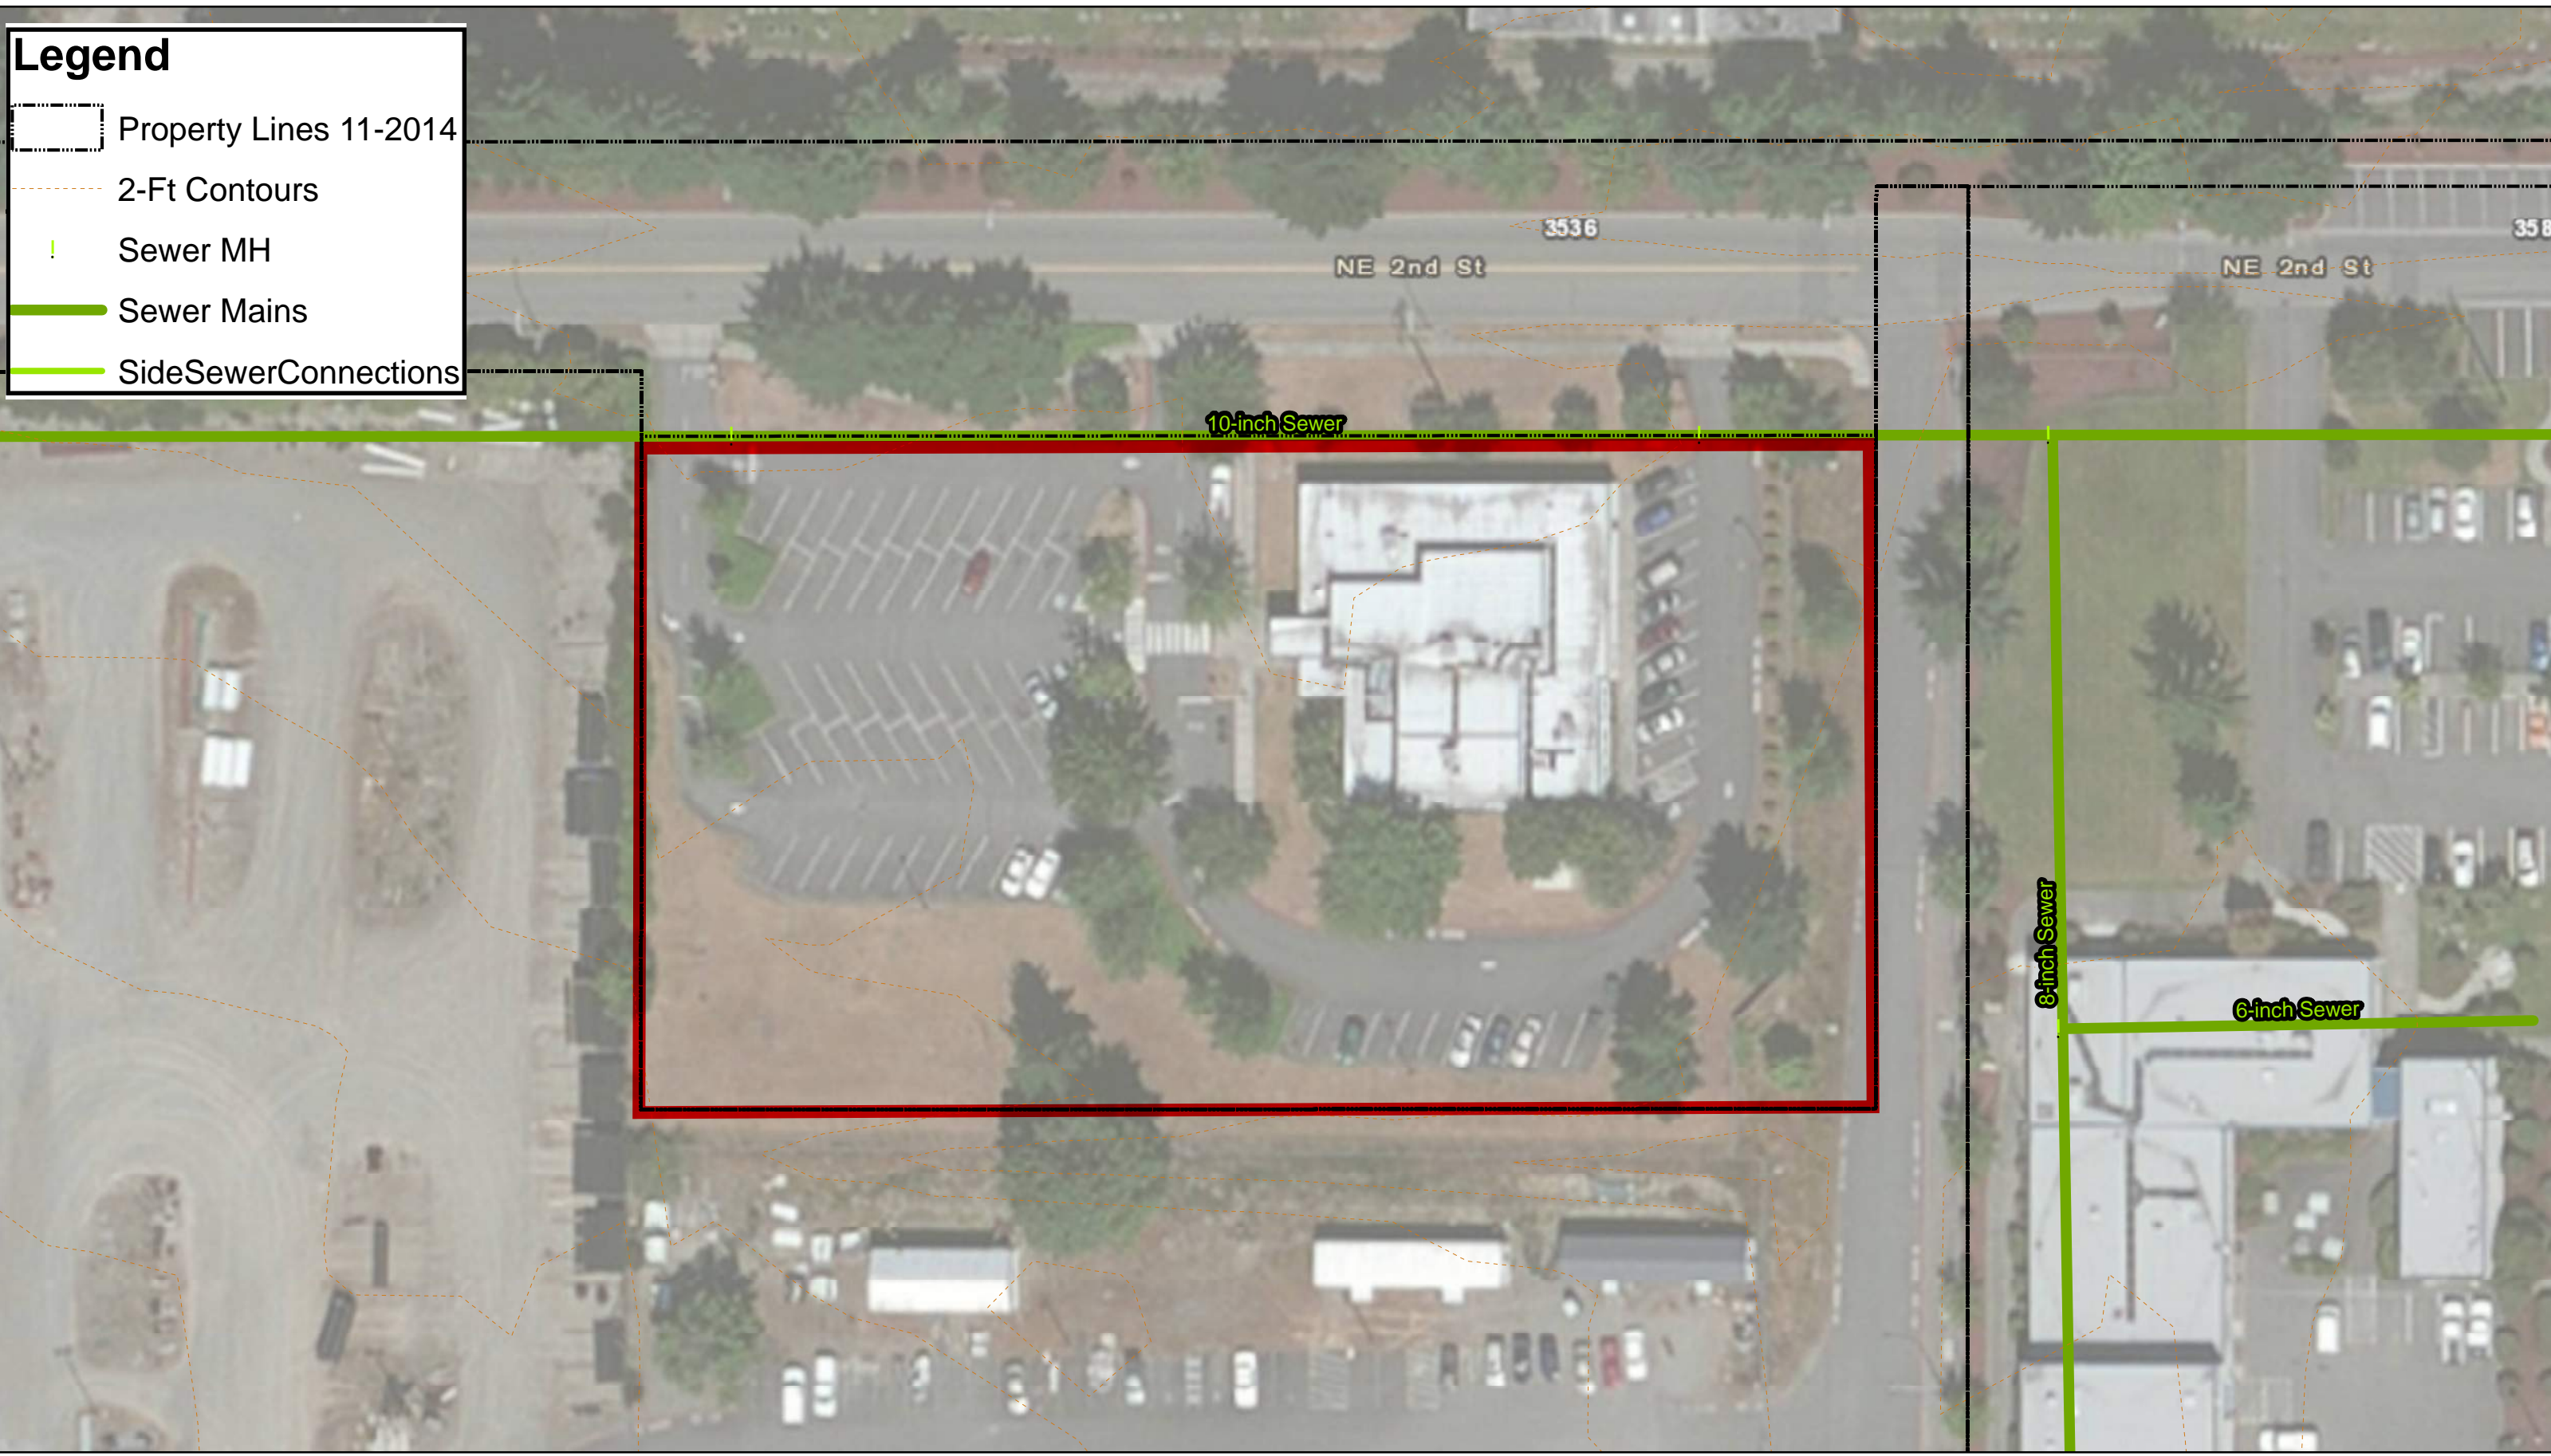
SideSewerConnections

GIS layer provided by  
City of Renton

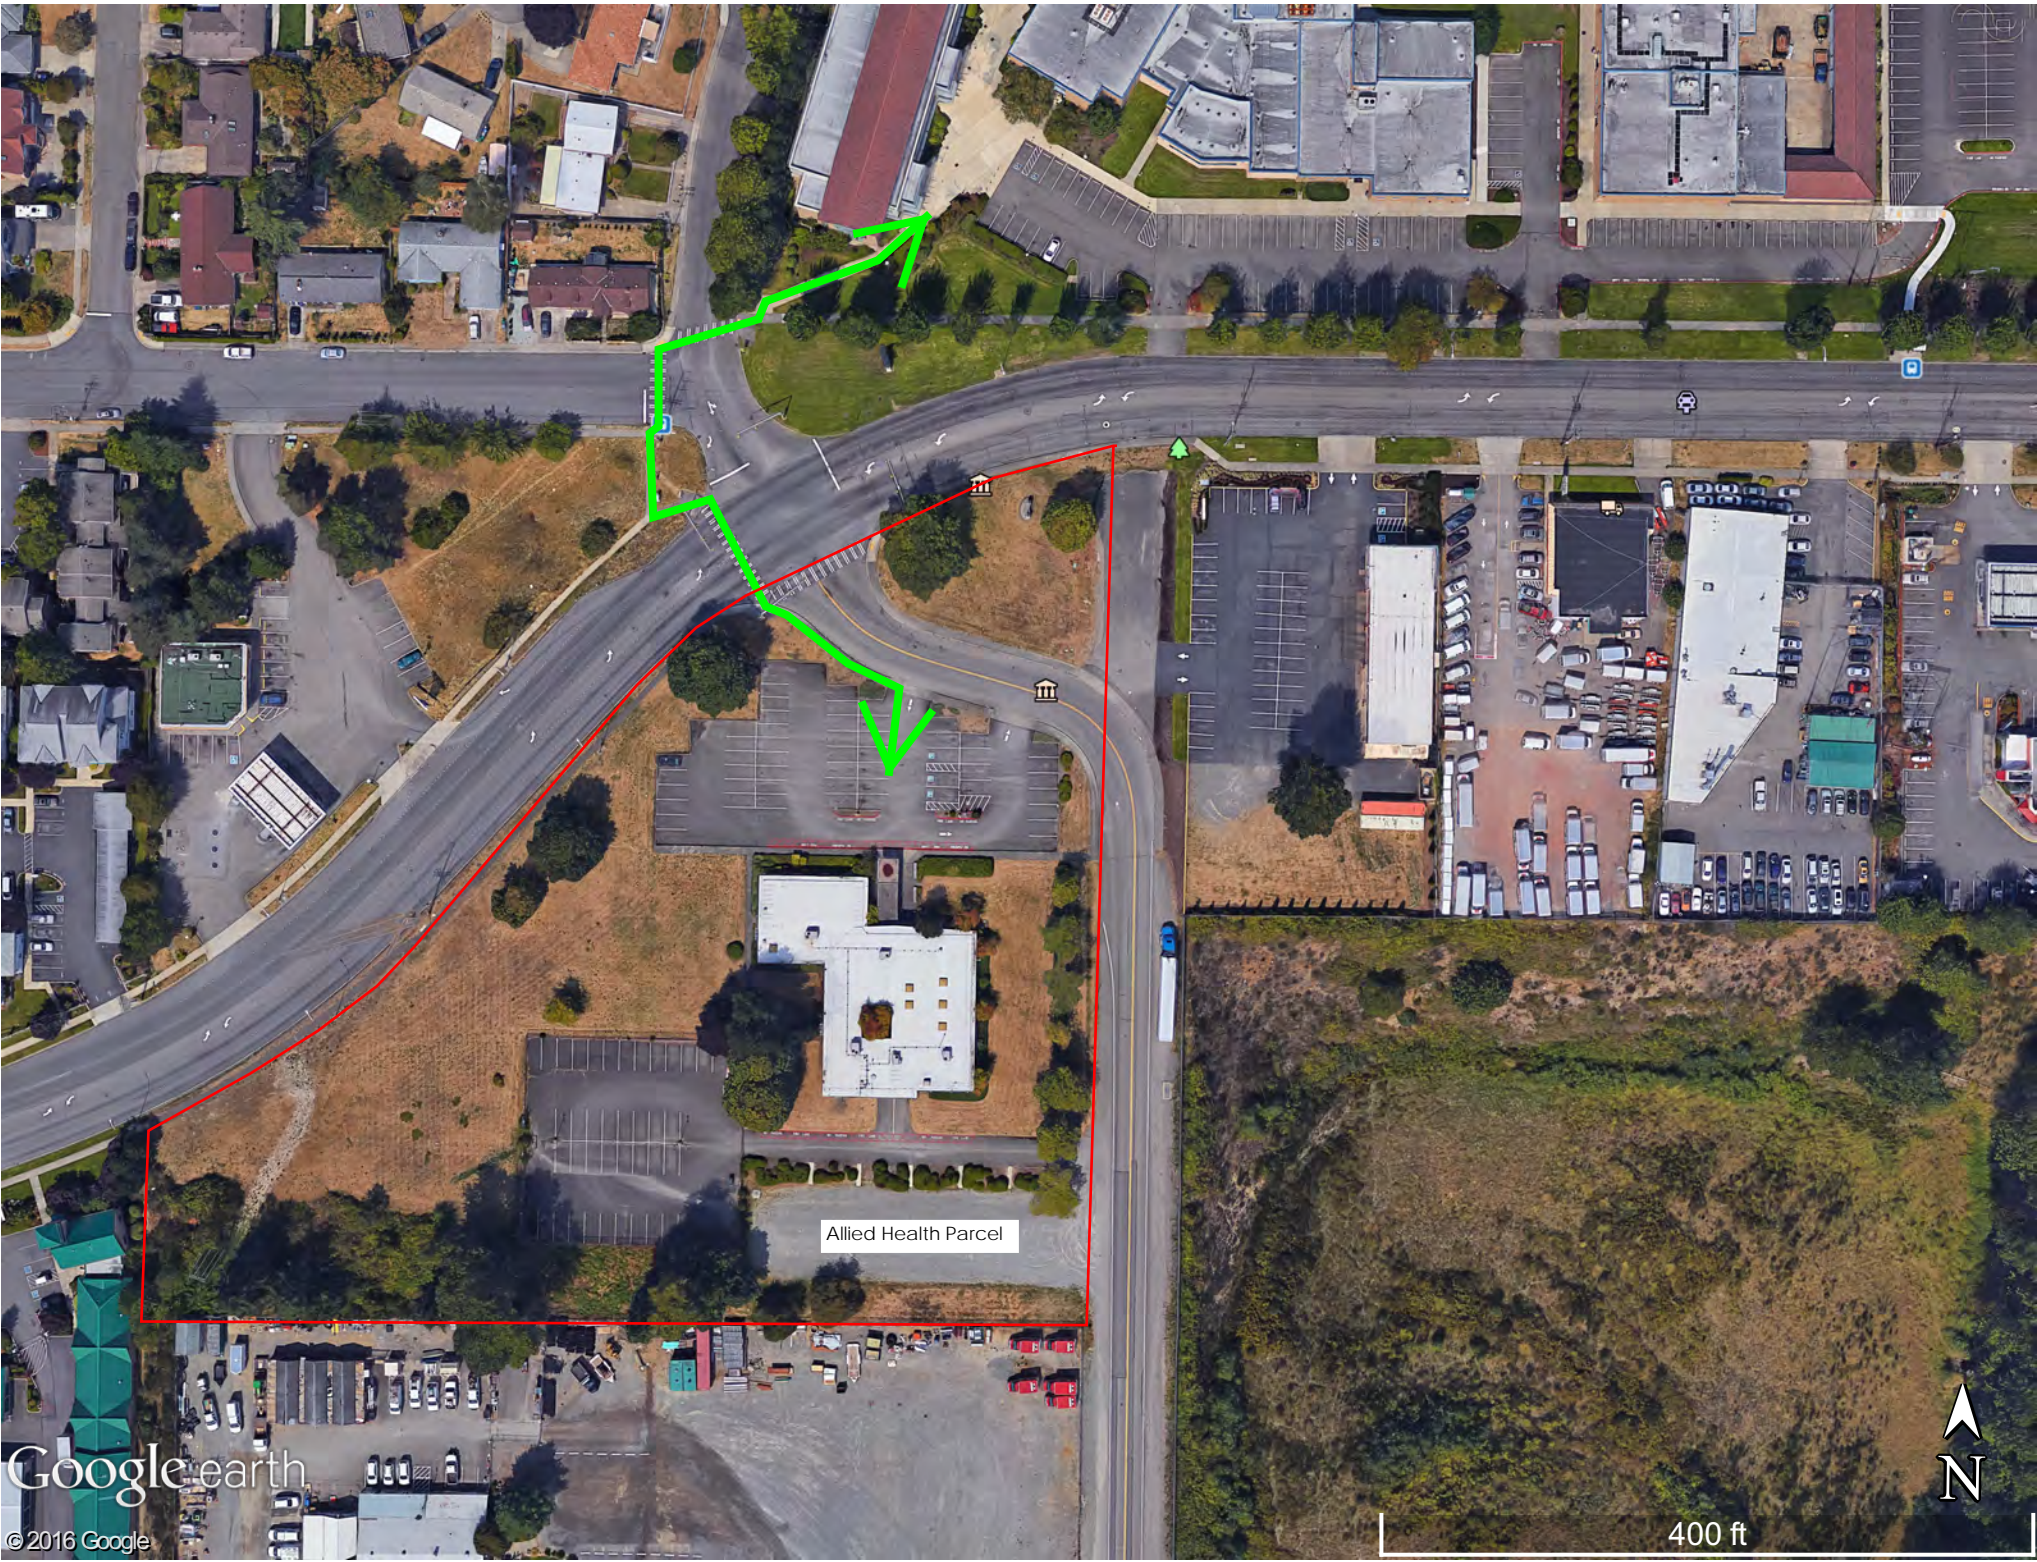
ATTACHMENT C  
*Allied Health Site Pedestrian Connection*

Allied Health Parcel

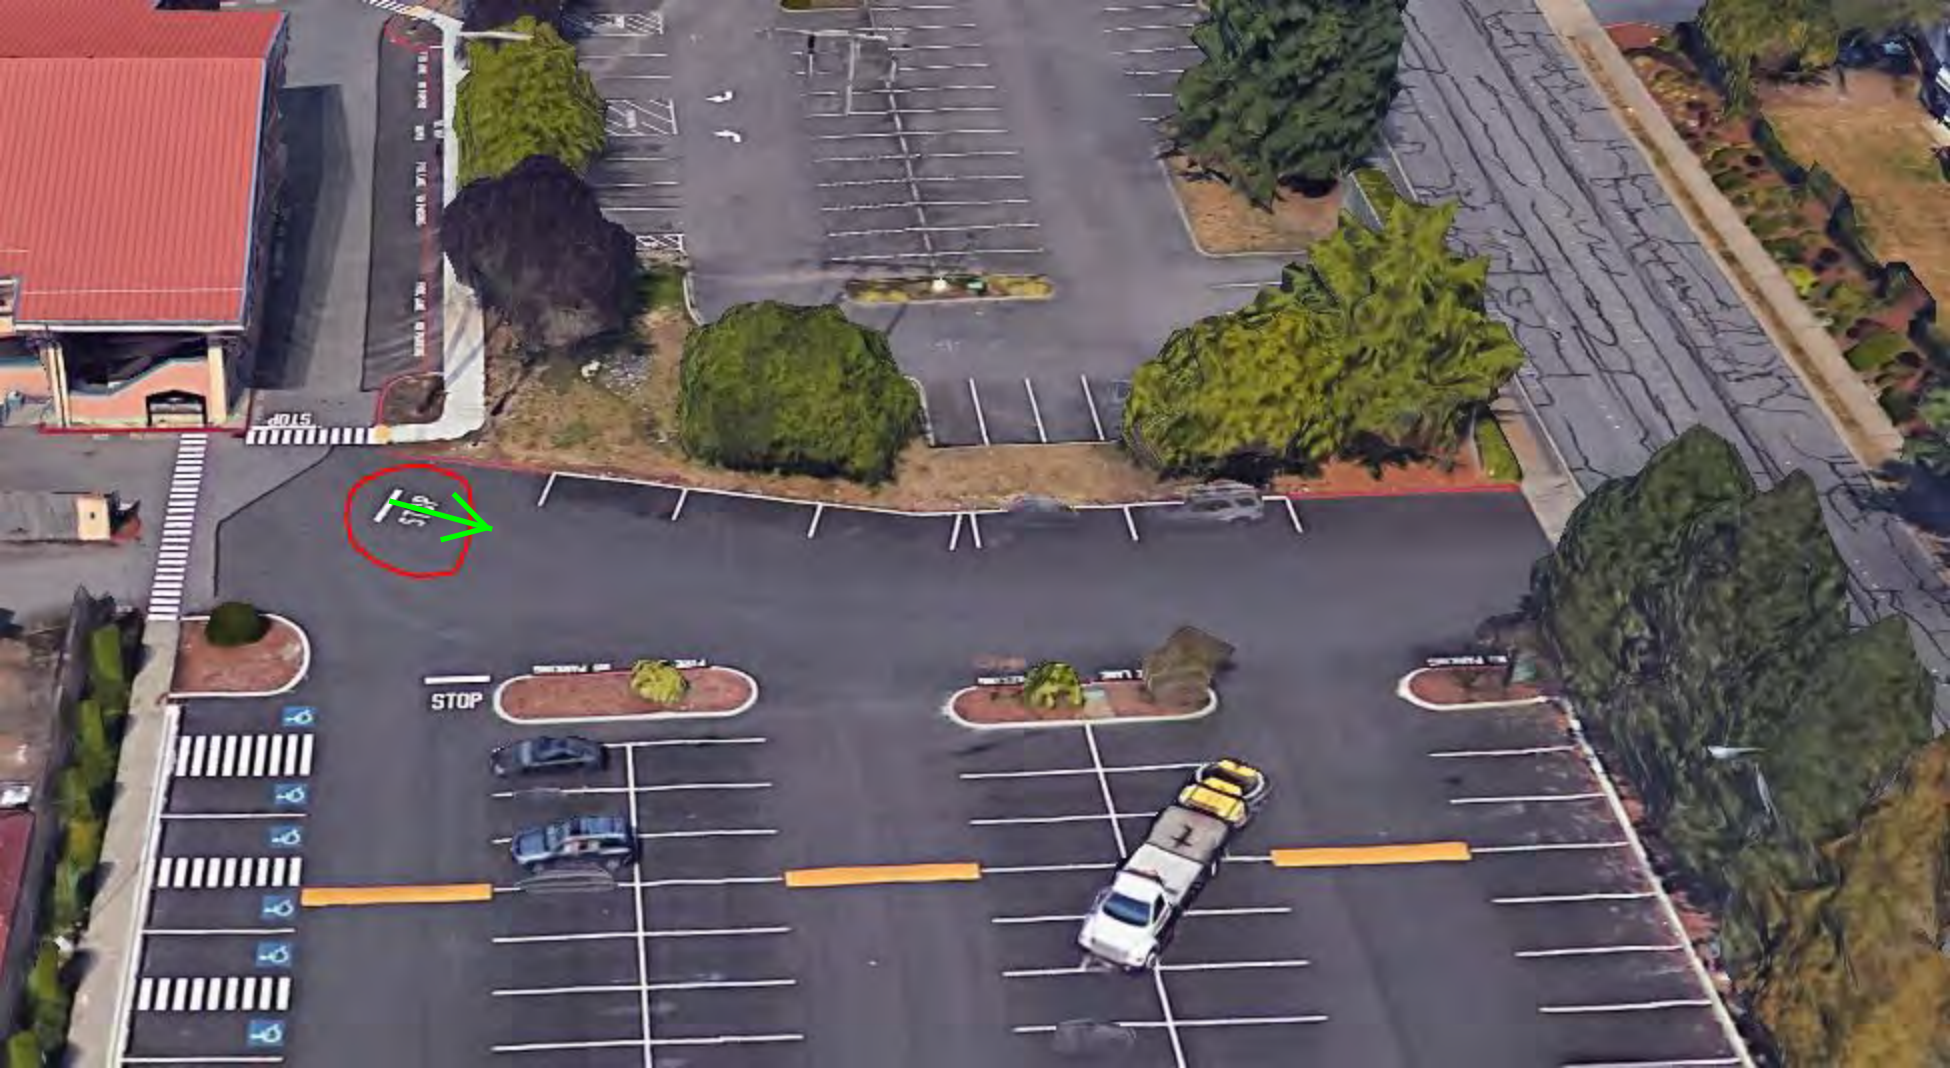
## ATTACHMENT D

### *Interior Campus Circulation Recommendation At Building H*
