# Initial Regulated Building Material Survey

**Irving R. Newhouse Senate Building  
215 Sid Snyder Avenue SW  
Olympia, WA 98504**

**Report Date: 01/28/2022**  
**PacRim#: 17283**

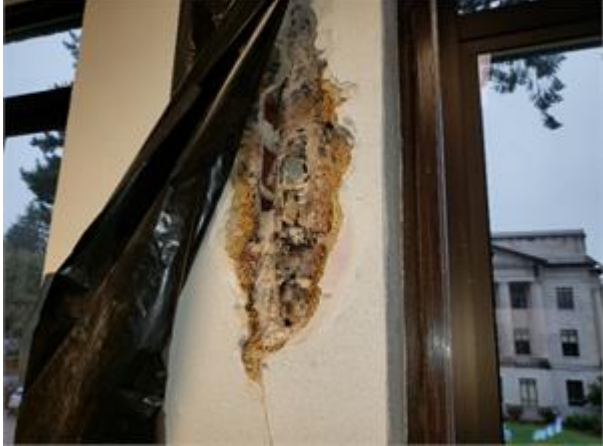
Sample			Sample Date	05-Jan-2022
<b>Project Name</b>	Irving R. Newhouse Senate Building			
<b>Sample Type</b>	Physical Sample	<b>AHERA Category</b>	TSI	
<b>Sample Number</b>	02	<b>Homogenous Material Number</b>	2	
<b>Material Description</b>	Pipe Insulation			
<b>Homogenous Mtl Area</b>	N/A			
<b>Sample Location</b>	Rm 212, West wall.			
<b>Quantity</b>	8	<b>Unit of Measure</b>	Lineal Feet	
<b>Asbestos Type/%</b>	<b>Chrysotile 60-65%</b>			
<b>Sample Photo</b>

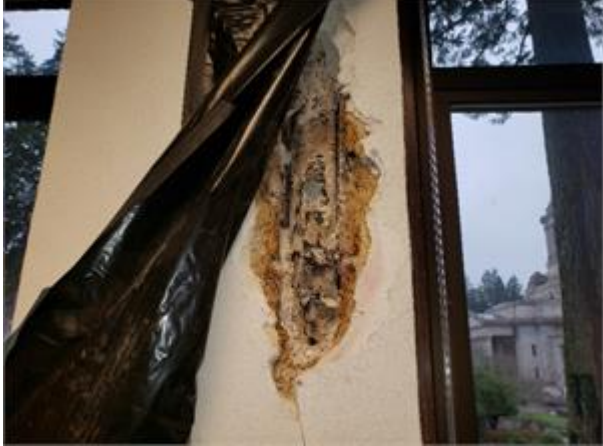
Sample		Sample Date	05-Jan-2022
<b>Project Name</b>	Irving R. Newhouse Senate Building		
<b>Sample Type</b>	Physical Sample	<b>AHERA Category</b>	TSI
<b>Sample Number</b>	04	<b>Homogenous Material Number</b>	2
<b>Material Description</b>	Pipe Insulation		
<b>Homogenous Mtl Area</b>	N/A		
<b>Sample Location</b>	Rm 212		
<b>Quantity</b>	8	<b>Unit of Measure</b>	Lineal Feet
<b>Asbestos Type/%</b>	<b>Chrysotile 50-55%</b>		
<b>Sample Photo</b>

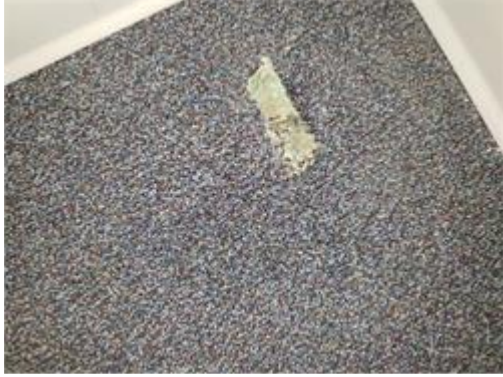
Sample		Sample Date	05-Jan-2022
<b>Project Name</b>	Irving R. Newhouse Senate Building		
<b>Sample Type</b>	Physical Sample	<b>AHERA Category</b>	Miscellaneous
<b>Sample Number</b>	05	<b>Homogenous Material Number</b>	4
<b>Material Description</b>	Carpet Mastic		
<b>Homogenous Mtl Area</b>	N/A		
<b>Sample Location</b>	2nd floor, southwest, storage closet.		
<b>Quantity</b>	640	<b>Unit of Measure</b>	Square Feet
<b>Asbestos Type/%</b>	<b>None Detected (Both Layers)</b>		
<b>Sample Photo</b>

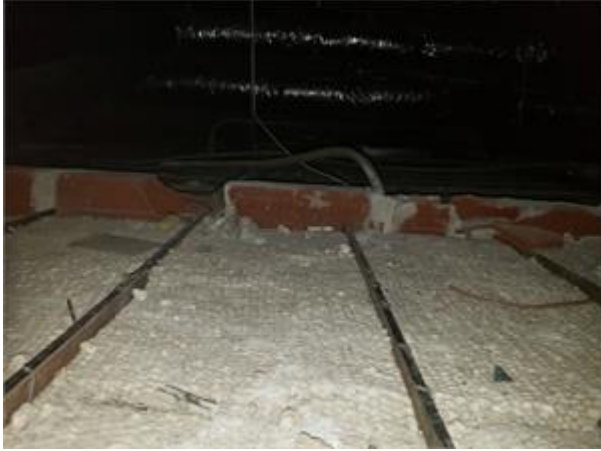
Sample		Sample Date	05-Jan-2022
<b>Project Name</b>	Irving R. Newhouse Senate Building		
<b>Sample Type</b>	Physical Sample	<b>AHERA Category</b>	Surfacing
<b>Sample Number</b>	06	<b>Homogenous Material Number</b>	11
<b>Material Description</b>	Hard Plaster Walls and Ceilings		
<b>Homogenous Mtl Area</b>	N/A		
<b>Sample Location</b>	2nd floor, at hallway, by rm 217.		
<b>Quantity</b>	Throughout.	<b>Unit of Measure</b>	Square Feet
<b>Asbestos Type/%</b>	<b>None Detected</b>		
<b>Sample Photo</b>

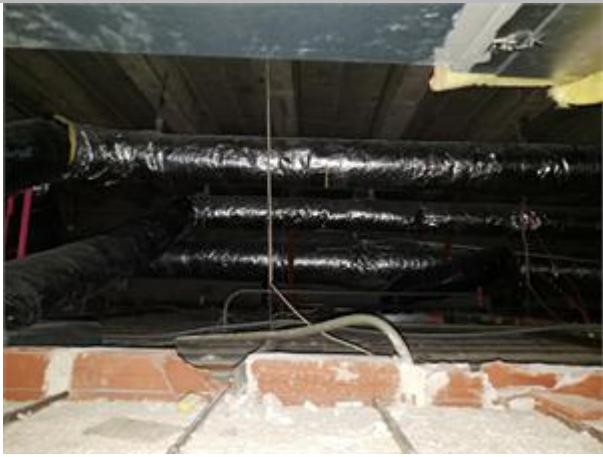
Sample		Sample Date	05-Jan-2022
<b>Project Name</b>	Irving R. Newhouse Senate Building		
<b>Sample Type</b>	Physical Sample	<b>AHERA Category</b>	Miscellaneous
<b>Sample Number</b>	07	<b>Homogenous Material Number</b>	5
<b>Material Description</b>	Wall brick.		
<b>Homogenous Mtl Area</b>	N/A		
<b>Sample Location</b>	2nd floor, in ceiling access, by rm 217.		
<b>Quantity</b>	Throughout.	<b>Unit of Measure</b>	Square Feet
<b>Asbestos Type/%</b>	<b>None Detected</b>		
<b>Sample Photo</b>

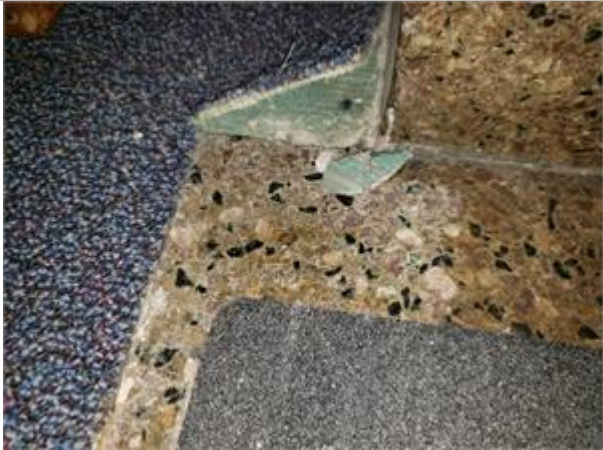
Sample		Sample Date	05-Jan-2022
<b>Project Name</b>	Irving R. Newhouse Senate Building		
<b>Sample Type</b>	Physical Sample	<b>AHERA Category</b>	Miscellaneous
<b>Sample Number</b>	08	<b>Homogenous Material Number</b>	6
<b>Material Description</b>	Floor Leveling Compound		
<b>Homogenous Mtl Area</b>	N/A		
<b>Sample Location</b>	2nd floor, at north staircase, top landing.		
<b>Quantity</b>	100	<b>Unit of Measure</b>	Square Feet
<b>Asbestos Type/%</b>	<b>None Detected (Both Layers)</b>		
<b>Sample Photo</b>

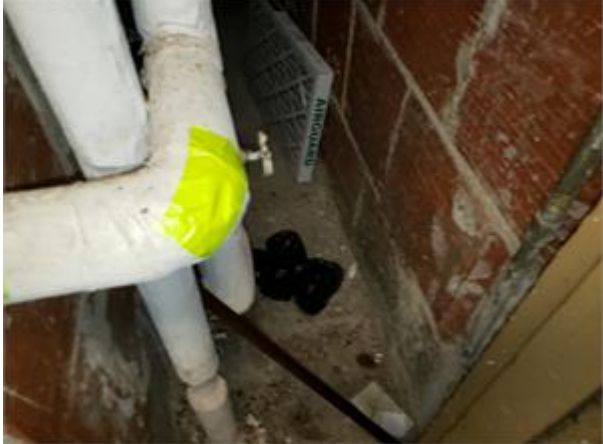
Sample		Sample Date	05-Jan-2022
<b>Project Name</b>	Irving R. Newhouse Senate Building		
<b>Sample Type</b>	Physical Sample	<b>AHERA Category</b>	TSI
<b>Sample Number</b>	10	<b>Homogenous Material Number</b>	8
<b>Material Description</b>	Pipe Fitting Insulation		
<b>Homogenous Mtl Area</b>	N/A		
<b>Sample Location</b>	2nd floor, janitorial closet		
<b>Quantity</b>	20	<b>Unit of Measure</b>	Lineal Feet
<b>Asbestos Type/%</b>	<b>Chrysotile 7-10%</b>		
<b>Sample Photo</b>

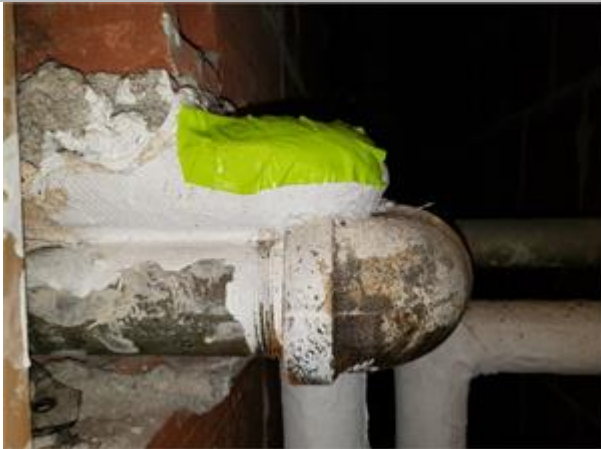
Sample		Sample Date	05-Jan-2022
<b>Project Name</b>	Irving R. Newhouse Senate Building		
<b>Sample Type</b>	Physical Sample	<b>AHERA Category</b>	TSI
<b>Sample Number</b>	12	<b>Homogenous Material Number</b>	8
<b>Material Description</b>	Pipe Fitting Insulation		
<b>Homogenous Mtl Area</b>	N/A		
<b>Sample Location</b>	2nd floor, janitorial closet.		
<b>Quantity</b>	See 10	<b>Unit of Measure</b>	Each
<b>Asbestos Type/%</b>	<b>Layer 1: (Painted wrap) None Detected</b> <b>Layer 2: (White insulation) <span style="color: red;">Chrysotile 5-7%</span></b>		
<b>Sample Photo</b>

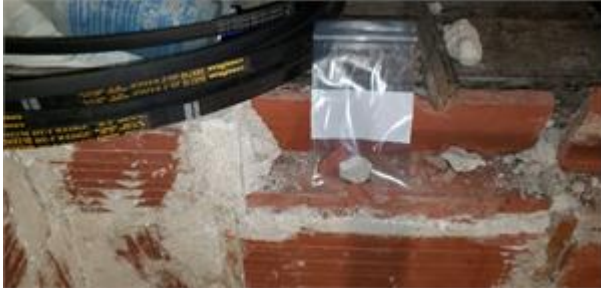
Sample		Sample Date	05-Jan-2022
<b>Project Name</b>	Irving R. Newhouse Senate Building		
<b>Sample Type</b>	Physical Sample	<b>AHERA Category</b>	Miscellaneous
<b>Sample Number</b>	13	<b>Homogenous Material Number</b>	9
<b>Material Description</b>	Wall brick and mortar.		
<b>Homogenous Mtl Area</b>	N/A		
<b>Sample Location</b>	2nd floor, south end in attic access.		
<b>Quantity</b>	Throughout.	<b>Unit of Measure</b>	Square Feet
<b>Asbestos Type/%</b>	<b>None Detected</b>		
<b>Sample Photo</b>

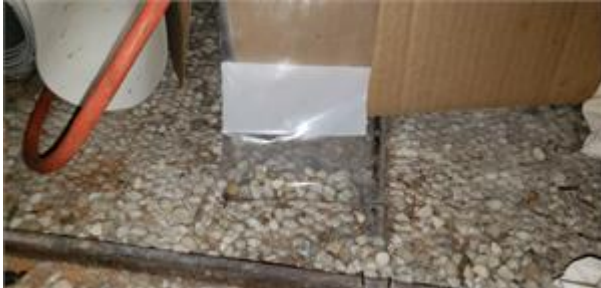
Sample		Sample Date	05-Jan-2022
<b>Project Name</b>	Irving R. Newhouse Senate Building		
<b>Sample Type</b>	Physical Sample	<b>AHERA Category</b>	Surfacing
<b>Sample Number</b>	14	<b>Homogenous Material Number</b>	11
<b>Material Description</b>	Hard Plaster Walls and Ceilings		
<b>Homogenous Mtl Area</b>	N/A		
<b>Sample Location</b>	2nd floor, in attic access.		
<b>Quantity</b>	Through out	<b>Unit of Measure</b>	Square Feet
<b>Asbestos Type/%</b>	<b>None Detected</b>		
<b>Sample Photo</b>

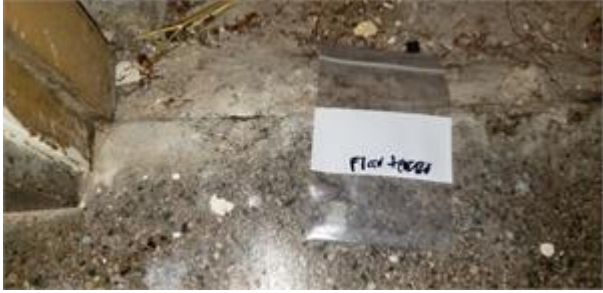
Sample		Sample Date	05-Jan-2022
<b>Project Name</b>	Irving R. Newhouse Senate Building		
<b>Sample Type</b>	Physical Sample	<b>AHERA Category</b>	Miscellaneous
<b>Sample Number</b>	15	<b>Homogenous Material Number</b>	10
<b>Material Description</b>	Cementitious Flooring		
<b>Homogenous Mtl Area</b>	N/A		
<b>Sample Location</b>	2nd floor, in janitorial closet.		
<b>Quantity</b>	Throughout.	<b>Unit of Measure</b>	Square Feet
<b>Asbestos Type/%</b>	<b>None Detected</b>		
<b>Sample Photo</b>

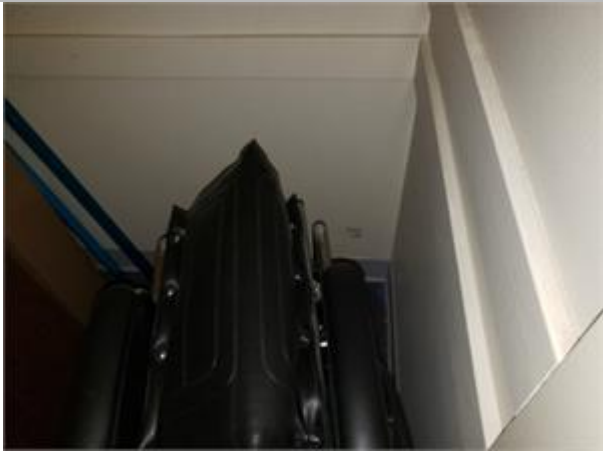
Sample		Sample Date	05-Jan-2022
<b>Project Name</b>	Irving R. Newhouse Senate Building		
<b>Sample Type</b>	Physical Sample	<b>AHERA Category</b>	Surfacing
<b>Sample Number</b>	16	<b>Homogenous Material Number</b>	12
<b>Material Description</b>	Texture on GWB		
<b>Homogenous Mtl Area</b>	N/A		
<b>Sample Location</b>	2nd floor, storage closet, north wall.		
<b>Quantity</b>	100	<b>Unit of Measure</b>	Square Feet
<b>Asbestos Type/%</b>	<b>None Detected (Both Layers)</b>		
<b>Sample Photo</b>

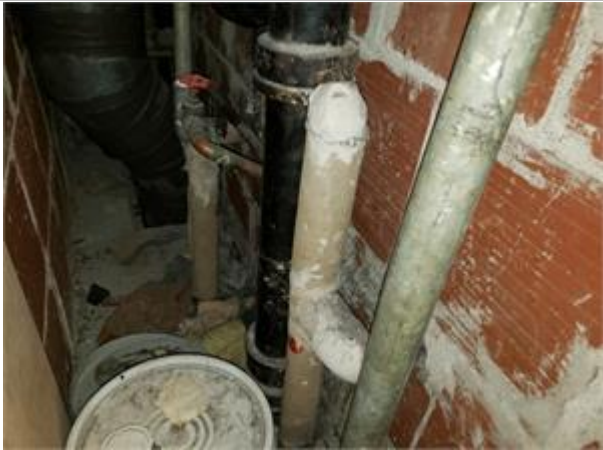
Sample			Sample Date	05-Jan-2022
<b>Project Name</b>	Irving R. Newhouse Senate Building			
<b>Sample Type</b>	Physical Sample	<b>AHERA Category</b>	TSI	
<b>Sample Number</b>	18	<b>Homogenous Material Number</b>	8	
<b>Material Description</b>	Pipe Fitting Insulation			
<b>Homogenous Mtl Area</b>	N/A			
<b>Sample Location</b>	2nd floor, at women's bathroom, pipe chase.			
<b>Quantity</b>	6	<b>Unit of Measure</b>	Each	
<b>Asbestos Type/%</b>	<b>Chrysotile 5-7%</b>			
<b>Sample Photo</b>

<b>Field Sample Number:</b> <u>18</u>	<b>Field Sample Description:</b>	<b>Field Sample Location:</b>	<b>Analyst:</b> WFG
<b>Lab ID:</b> 2022-01-0171	Pipe Fitting Insulation	2nd floor, at women's bathroom, pipe chase.	<b>Analysis Date:</b> 1/12/2022
<b>Lab Sample Description</b>	<b>Asbestos Type/%</b>	<b>Non-Asbestos Fibers</b>	<b>Non-Fibrous Materials</b>
Off-white to light grey, chalky, rust-stained insulation material with embedded fibers	<b>Chrysotile 5-7%</b>	Cellulose <1%	Mineral Aggregate, Binder, Diatomaceous Earth

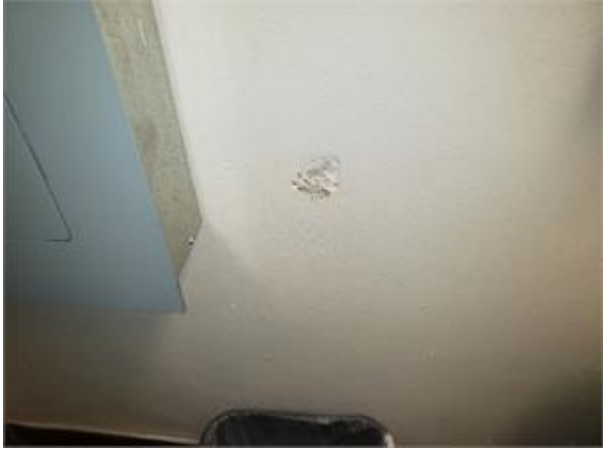
Sample		Sample Date	05-Jan-2022
<b>Project Name</b>	Irving R. Newhouse Senate Building		
<b>Sample Type</b>	Physical Sample	<b>AHERA Category</b>	Surfacing
<b>Sample Number</b>	19	<b>Homogenous Material Number</b>	11
<b>Material Description</b>	Hard Plaster Walls and Ceilings		
<b>Homogenous Mtl Area</b>	N/A		
<b>Sample Location</b>	2nd floor, janitorial closet, east wall.		
<b>Quantity</b>	Through out	<b>Unit of Measure</b>	Square Feet
<b>Asbestos Type/%</b>	<b>None Detected</b>		
<b>Sample Photo</b>

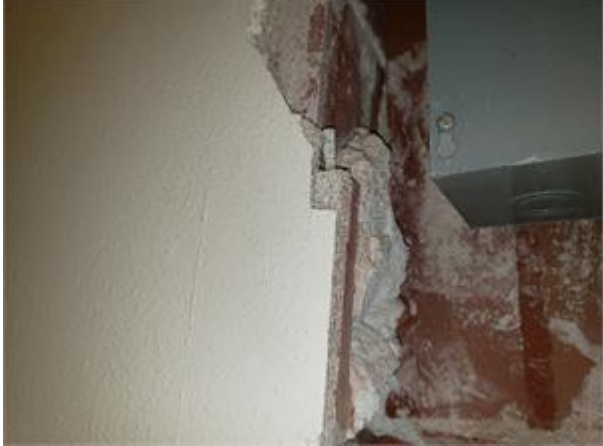
Sample		Sample Date	05-Jan-2022
<b>Project Name</b>	Irving R. Newhouse Senate Building		
<b>Sample Type</b>	Physical Sample	<b>AHERA Category</b>	Surfacing
<b>Sample Number</b>	20	<b>Homogenous Material Number</b>	11
<b>Material Description</b>	Hard Plaster Walls and Ceilings		
<b>Homogenous Mtl Area</b>	N/A		
<b>Sample Location</b>	2nd floor in IT closet, north wall.		
<b>Quantity</b>	Throughout.	<b>Unit of Measure</b>	Square Feet
<b>Asbestos Type/%</b>	<b>None Detected</b>		
<b>Sample Photo</b>

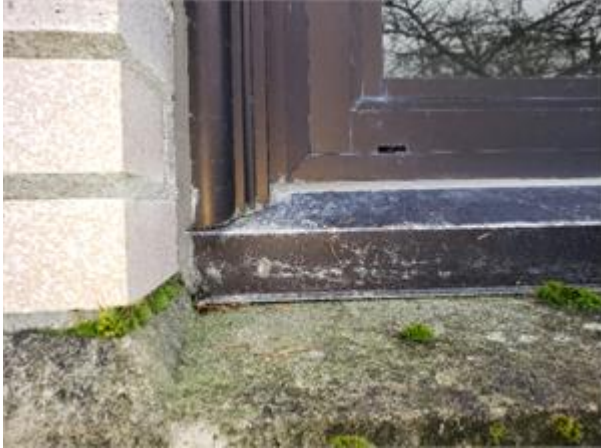
Sample		Sample Date	05-Jan-2022
<b>Project Name</b>	Irving R. Newhouse Senate Building		
<b>Sample Type</b>	Physical Sample	<b>AHERA Category</b>	Miscellaneous
<b>Sample Number</b>	22	<b>Homogenous Material Number</b>	13
<b>Material Description</b>	Window Putty		
<b>Homogenous Mtl Area</b>	N/A		
<b>Sample Location</b>	1st floor north exterior wall, window 5.		
<b>Quantity</b>	3	<b>Unit of Measure</b>	Lineal Feet
<b>Asbestos Type/%</b>	<b>Chrysotile &lt;1%</b>		
<b>Sample Photo</b>

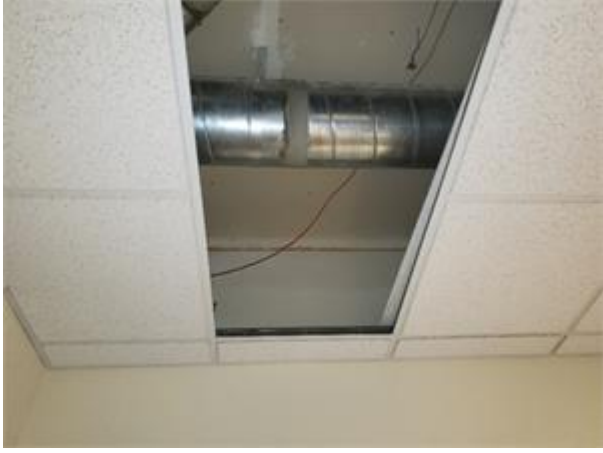
Sample		Sample Date	05-Jan-2022
<b>Project Name</b>	Irving R. Newhouse Senate Building		
<b>Sample Type</b>	Physical Sample	<b>AHERA Category</b>	Miscellaneous
<b>Sample Number</b>	23	<b>Homogenous Material Number</b>	14
<b>Material Description</b>	Duct Sealant		
<b>Homogenous Mtl Area</b>	N/A		
<b>Sample Location</b>	1st floor, in office 102, drop ceiling.		
<b>Quantity</b>	2	<b>Unit of Measure</b>	Lineal Feet
<b>Asbestos Type/%</b>	<b>None Detected</b>		
<b>Sample Photo</b>

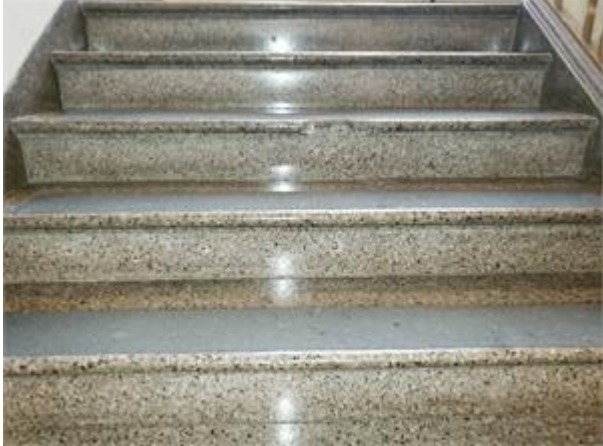
Sample		Sample Date	05-Jan-2022
<b>Project Name</b>	Irving R. Newhouse Senate Building		
<b>Sample Type</b>	Physical Sample	<b>AHERA Category</b>	Miscellaneous
<b>Sample Number</b>	24	<b>Homogenous Material Number</b>	10
<b>Material Description</b>	Cementitious Flooring		
<b>Homogenous Mtl Area</b>	N/A		
<b>Sample Location</b>	1st floor, at stairway.		
<b>Quantity</b>	Throughout.	<b>Unit of Measure</b>	Square Feet
<b>Asbestos Type/%</b>	<b>None Detected</b>		
<b>Sample Photo</b>

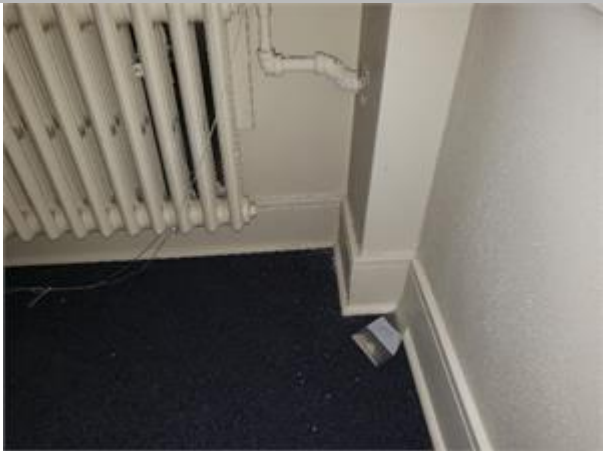
Sample		Sample Date	05-Jan-2022
<b>Project Name</b>	Irving R. Newhouse Senate Building		
<b>Sample Type</b>	Physical Sample	<b>AHERA Category</b>	Surfacing
<b>Sample Number</b>	25	<b>Homogenous Material Number</b>	11
<b>Material Description</b>	Hard Plaster Walls and Ceilings		
<b>Homogenous Mtl Area</b>	N/A		
<b>Sample Location</b>	1st floor, in office 102-S, east wall.		
<b>Quantity</b>	Throughout.	<b>Unit of Measure</b>	Square Feet
<b>Asbestos Type/%</b>	<b>None Detected</b>		
<b>Sample Photo</b>

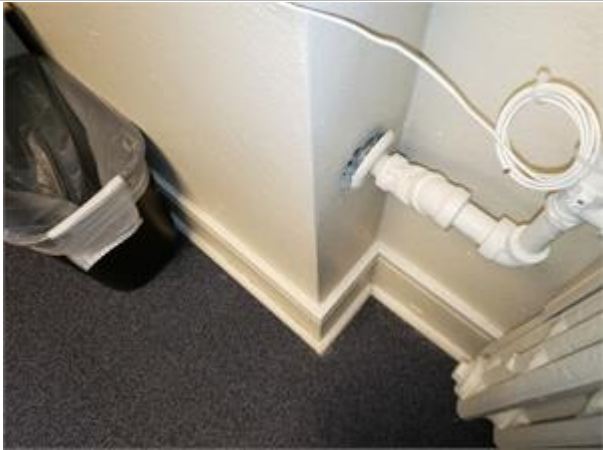
Sample		Sample Date	05-Jan-2022
<b>Project Name</b>	Irving R. Newhouse Senate Building		
<b>Sample Type</b>	Physical Sample	<b>AHERA Category</b>	Surfacing
<b>Sample Number</b>	26	<b>Homogenous Material Number</b>	11
<b>Material Description</b>	Hard Plaster Walls and Ceilings		
<b>Homogenous Mtl Area</b>	N/A		
<b>Sample Location</b>	1st floor, room, 105, west wall.		
<b>Quantity</b>	Throughout.	<b>Unit of Measure</b>	Square Feet
<b>Asbestos Type/%</b>	<b>None Detected</b>		
<b>Sample Photo</b>

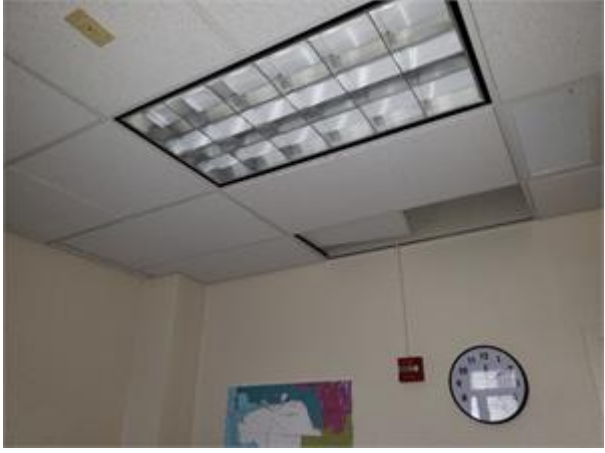
Sample		Sample Date	05-Jan-2022
<b>Project Name</b>	Irving R. Newhouse Senate Building		
<b>Sample Type</b>	Physical Sample	<b>AHERA Category</b>	Miscellaneous
<b>Sample Number</b>	27	<b>Homogenous Material Number</b>	15
<b>Material Description</b>	Ceiling Tile, 2ft by 4ft.		
<b>Homogenous Mtl Area</b>	N/A		
<b>Sample Location</b>	1st floor, rm 109-B.		
<b>Quantity</b>	8,200	<b>Unit of Measure</b>	Square Feet
<b>Asbestos Type/%</b>	<b>None Detected</b>		
<b>Sample Photo</b>

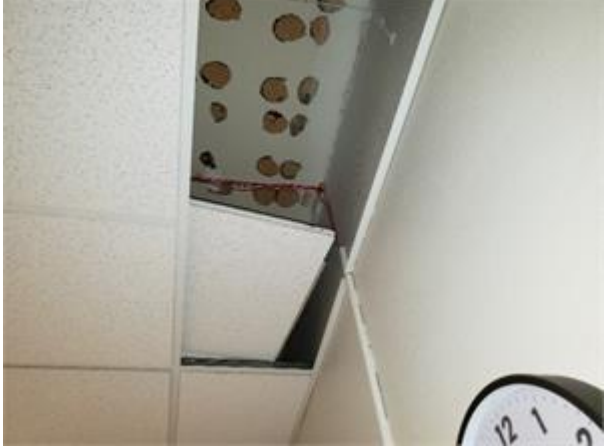
Sample		Sample Date	05-Jan-2022
<b>Project Name</b>	Irving R. Newhouse Senate Building		
<b>Sample Type</b>	Physical Sample	<b>AHERA Category</b>	Miscellaneous
<b>Sample Number</b>	28	<b>Homogenous Material Number</b>	16
<b>Material Description</b>	Ceiling tile mastic.		
<b>Homogenous Mtl Area</b>	N/A		
<b>Sample Location</b>	1st floor, rm 109-B		
<b>Quantity</b>	8,200	<b>Unit of Measure</b>	Square Feet
<b>Asbestos Type/%</b>	<b>None Detected</b>		
<b>Sample Photo</b>

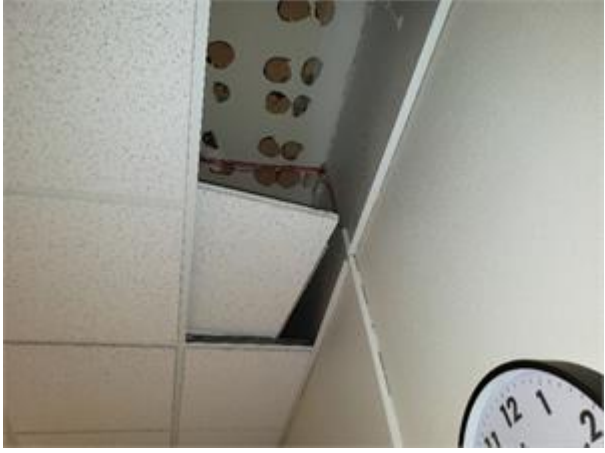
Sample		Sample Date	05-Jan-2022
<b>Project Name</b>	Irving R. Newhouse Senate Building		
<b>Sample Type</b>	Physical Sample	<b>AHERA Category</b>	Miscellaneous
<b>Sample Number</b>	29	<b>Homogenous Material Number</b>	16
<b>Material Description</b>	Ceiling Tile, mastic.		
<b>Homogenous Mtl Area</b>	N/A		
<b>Sample Location</b>	1st floor, rm 109		
<b>Quantity</b>	See 28	<b>Unit of Measure</b>	Square Feet
<b>Asbestos Type/%</b>	<b>None Detected (Both Layers)</b>		
<b>Sample Photo</b>

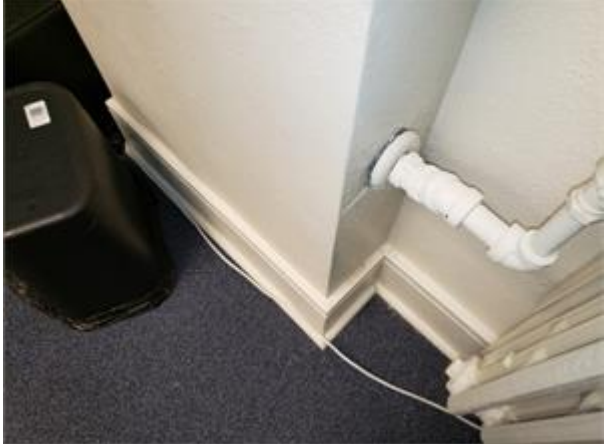
Sample		Sample Date	05-Jan-2022
<b>Project Name</b>	Irving R. Newhouse Senate Building		
<b>Sample Type</b>	Physical Sample	<b>AHERA Category</b>	Surfacing
<b>Sample Number</b>	30	<b>Homogenous Material Number</b>	11
<b>Material Description</b>	Hard Plaster Walls and Ceilings		
<b>Homogenous Mtl Area</b>	N/A		
<b>Sample Location</b>	1st floor, rm 110.		
<b>Quantity</b>	N/A	<b>Unit of Measure</b>	N/A
<b>Asbestos Type/%</b>	<b>None Detected (Both Layers)</b>		
<b>Sample Photo</b>

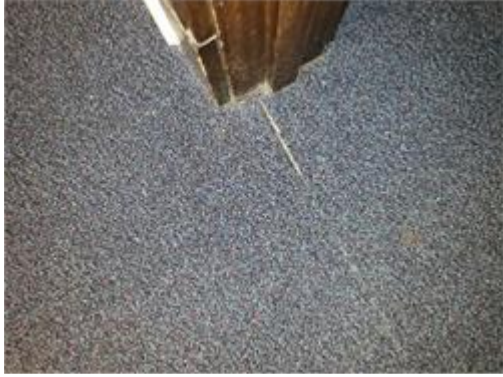
Sample		Sample Date	05-Jan-2022
<b>Project Name</b>	Irving R. Newhouse Senate Building		
<b>Sample Type</b>	Physical Sample	<b>AHERA Category</b>	Miscellaneous
<b>Sample Number</b>	31	<b>Homogenous Material Number</b>	4
<b>Material Description</b>	Carpet Mastic		
<b>Homogenous Mtl Area</b>	N/A		
<b>Sample Location</b>	1st floor rm 110		
<b>Quantity</b>	8,200	<b>Unit of Measure</b>	Square Feet
<b>Asbestos Type/%</b>	<b>None Detected</b>		
<b>Sample Photo</b>

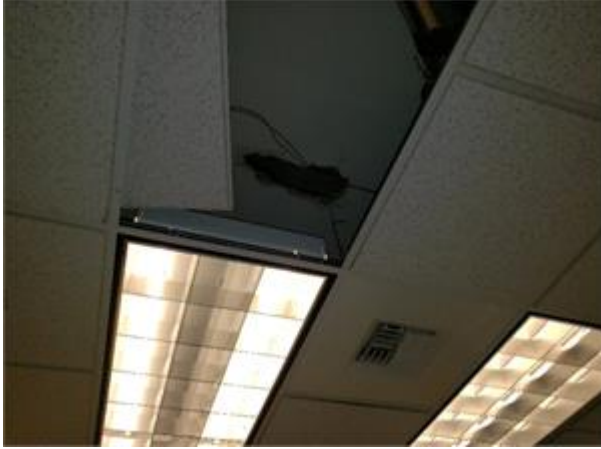
Sample		Sample Date	05-Jan-2022
<b>Project Name</b>	Irving R. Newhouse Senate Building		
<b>Sample Type</b>	Physical Sample	<b>AHERA Category</b>	Surfacing
<b>Sample Number</b>	32	<b>Homogenous Material Number</b>	11
<b>Material Description</b>	Hard Plaster Walls and Ceilings		
<b>Homogenous Mtl Area</b>	N/A		
<b>Sample Location</b>	1st floor, rm 110, ceiling.		
<b>Quantity</b>	8,200	<b>Unit of Measure</b>	Square Feet
<b>Asbestos Type/%</b>	<b>None Detected</b>		
<b>Sample Photo</b>

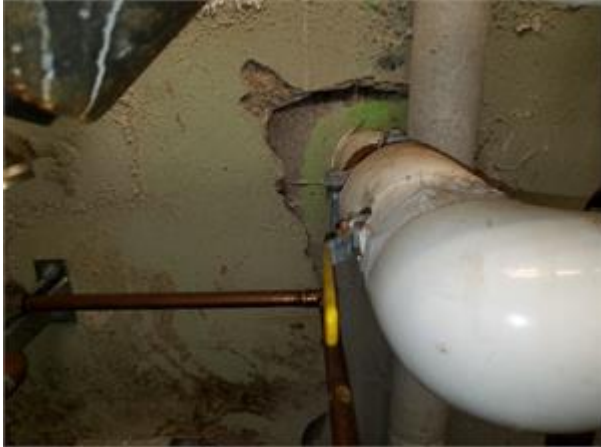
Sample		Sample Date	05-Jan-2022
<b>Project Name</b>	Irving R. Newhouse Senate Building		
<b>Sample Type</b>	Physical Sample	<b>AHERA Category</b>	Surfacing
<b>Sample Number</b>	33	<b>Homogenous Material Number</b>	3
<b>Material Description</b>	Hard Plaster Walls and Ceilings		
<b>Homogenous Mtl Area</b>	N/A		
<b>Sample Location</b>	Basement, in mechanical room, north wall.		
<b>Quantity</b>	180	<b>Unit of Measure</b>	Square Feet
<b>Asbestos Type/%</b>	<b>None Detected</b>		
<b>Sample Photo</b>

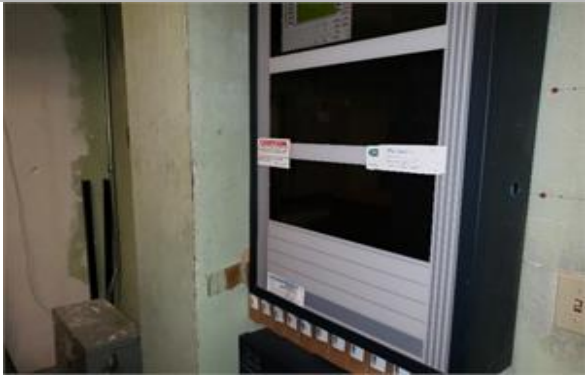
Sample		Sample Date	05-Jan-2022
<b>Project Name</b>	Irving R. Newhouse Senate Building		
<b>Sample Type</b>	Physical Sample	<b>AHERA Category</b>	Surfacing
<b>Sample Number</b>	35	<b>Homogenous Material Number</b>	3
<b>Material Description</b>	Hard Plaster Walls and Ceilings		
<b>Homogenous Mtl Area</b>	N/A		
<b>Sample Location</b>	Basement, in mechanical room, south wall.		
<b>Quantity</b>	190	<b>Unit of Measure</b>	Square Feet
<b>Asbestos Type/%</b>	<b>Layer 1: (Painted plaster) None Detected</b> <b>Layer 2: (Lt grn/wht plaster) Chrysotile &lt;1%</b>		
<b>Sample Photo</b>

<b>Field Sample Number:</b> <u>35</u>	<b>Field Sample Description:</b>	<b>Field Sample Location:</b>	<b>Analyst:</b> WFG
<b>Lab ID:</b> 2022-01-0188	Hard Plaster Walls and Ceilings	Basement, in mechanical room, south wall.	<b>Analysis Date:</b> 1/13/2022
<b>Lab Sample Description</b>	<b>Asbestos Type/%</b>	<b>Non-Asbestos Fibers</b>	<b>Non-Fibrous Materials</b>
<b>Layer: 1</b> White-painted, light grey, rust-stained, coarse-grained plaster	<b>None Detected</b>	Cellulose <1%	Mineral Aggregate, Binder, Paint
<b>Layer: 2</b> Light green/white-painted light grey, coarse-grained plaster material	<b>Chrysotile &lt;1%</b>	Cellulose <1%	Mineral Aggregate, Binder, Paint

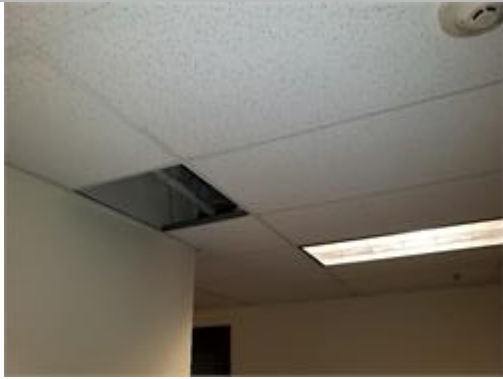
Sample		Sample Date	05-Jan-2022
<b>Project Name</b>	Irving R. Newhouse Senate Building		
<b>Sample Type</b>	Physical Sample	<b>AHERA Category</b>	Miscellaneous
<b>Sample Number</b>	36	<b>Homogenous Material Number</b>	17
<b>Material Description</b>	Ceiling Tile, 2ft by 4ft		
<b>Homogenous Mtl Area</b>	N/A		
<b>Sample Location</b>	Basement at hallway.		
<b>Quantity</b>	6,400	<b>Unit of Measure</b>	Square Feet
<b>Asbestos Type/%</b>	<b>None Detected</b>		
<b>Sample Photo</b>

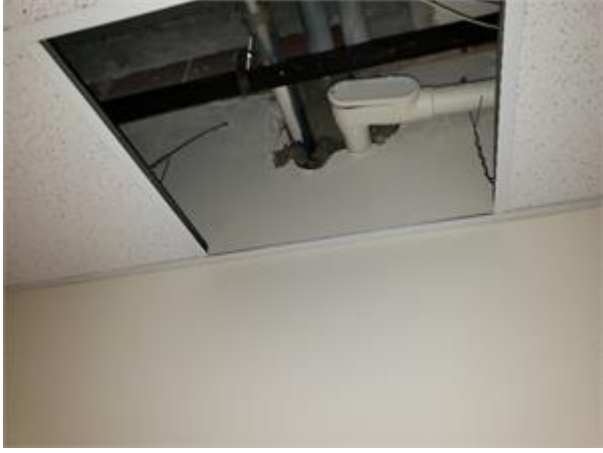
Sample		Sample Date	05-Jan-2022
<b>Project Name</b>	Irving R. Newhouse Senate Building		
<b>Sample Type</b>	Physical Sample	<b>AHERA Category</b>	Surfacing
<b>Sample Number</b>	37	<b>Homogenous Material Number</b>	3
<b>Material Description</b>	Hard Plaster Walls and Ceilings		
<b>Homogenous Mtl Area</b>	N/A		
<b>Sample Location</b>	Basement, at north end hallway.		
<b>Quantity</b>	3,000	<b>Unit of Measure</b>	Square Feet
<b>Asbestos Type/%</b>	<b>None Detected</b>		
<b>Sample Photo</b>

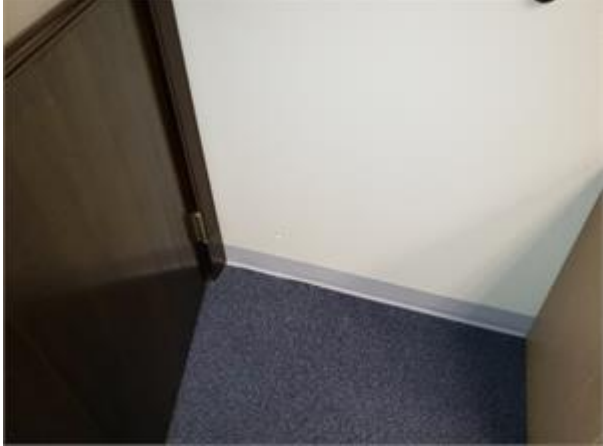
Sample		Sample Date	05-Jan-2022
<b>Project Name</b>	Irving R. Newhouse Senate Building		
<b>Sample Type</b>	Physical Sample	<b>AHERA Category</b>	Miscellaneous
<b>Sample Number</b>	38	<b>Homogenous Material Number</b>	18
<b>Material Description</b>	Sheetrock (GWB)		
<b>Homogenous Mtl Area</b>	N/A		
<b>Sample Location</b>	Basement, at room, B-2, south wall.		
<b>Quantity</b>	200	<b>Unit of Measure</b>	Square Feet
<b>Asbestos Type/%</b>	<b>None Detected</b>		
<b>Sample Photo</b>

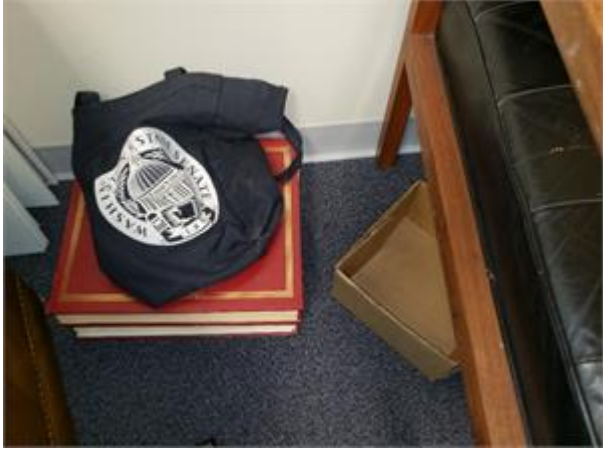
Sample		Sample Date	05-Jan-2022
<b>Project Name</b>	Irving R. Newhouse Senate Building		
<b>Sample Type</b>	Physical Sample	<b>AHERA Category</b>	Miscellaneous
<b>Sample Number</b>	39	<b>Homogenous Material Number</b>	19
<b>Material Description</b>	Cove Base Mastic, 4-inch gray.		
<b>Homogenous Mtl Area</b>	N/A		
<b>Sample Location</b>	Basement, room B-2.		
<b>Quantity</b>	N/A	<b>Unit of Measure</b>	N/A
<b>Asbestos Type/%</b>	<b>None Detected (Both layers)</b>		
<b>Sample Photo</b>

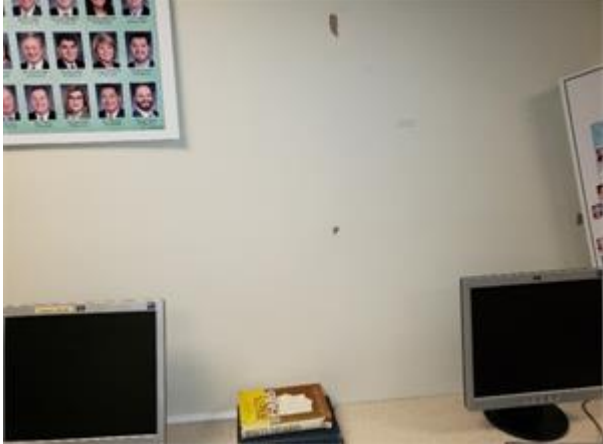
Sample		Sample Date	05-Jan-2022
<b>Project Name</b>	Irving R. Newhouse Senate Building		
<b>Sample Type</b>	Physical Sample	<b>AHERA Category</b>	Miscellaneous
<b>Sample Number</b>	40	<b>Homogenous Material Number</b>	18
<b>Material Description</b>	Sheetrock (GWB)		
<b>Homogenous Mtl Area</b>	N/A		
<b>Sample Location</b>	Basement, at room B-14		
<b>Quantity</b>	600	<b>Unit of Measure</b>	Square Feet
<b>Asbestos Type/%</b>	<b>None Detected</b>		
<b>Sample Photo</b>

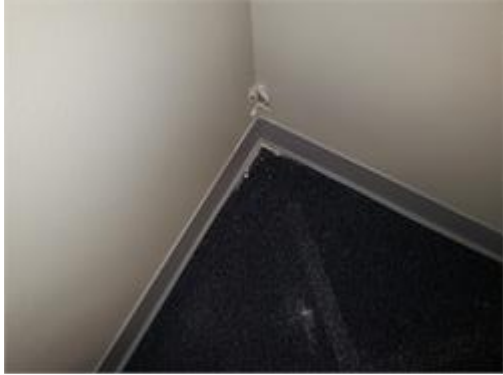
Sample		Sample Date	05-Jan-2022
<b>Project Name</b>	Irving R. Newhouse Senate Building		
<b>Sample Type</b>	Physical Sample	<b>AHERA Category</b>	Miscellaneous
<b>Sample Number</b>	41	<b>Homogenous Material Number</b>	20
<b>Material Description</b>	Gypsum Wall Board/Tape/Joint Compound		
<b>Homogenous Mtl Area</b>	N/A		
<b>Sample Location</b>	Basement, room B-4		
<b>Quantity</b>	700	<b>Unit of Measure</b>	Square Feet
<b>Asbestos Type/%</b>	<b>None Detected (Both Layers)</b>		
<b>Sample Photo</b>

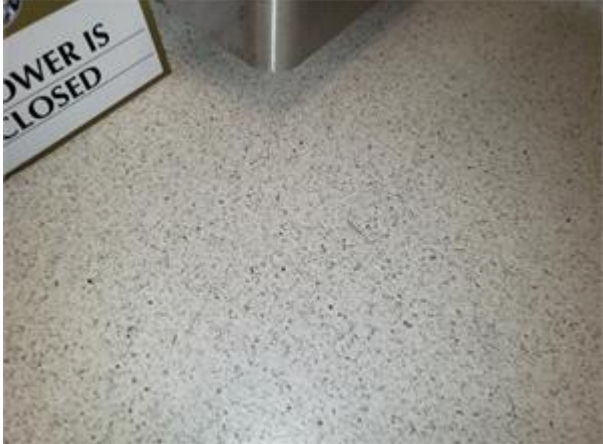
Sample		Sample Date	05-Jan-2022
<b>Project Name</b>	Irving R. Newhouse Senate Building		
<b>Sample Type</b>	Physical Sample	<b>AHERA Category</b>	Miscellaneous
<b>Sample Number</b>	42	<b>Homogenous Material Number</b>	21
<b>Material Description</b>	Flooring sheet vinyl		
<b>Homogenous Mtl Area</b>	The quantity reflects the material also seen in the women's bathroom.		
<b>Sample Location</b>	Basement, men's bathroom.		
<b>Quantity</b>	150	<b>Unit of Measure</b>	Square Feet
<b>Asbestos Type/%</b>	<b>None Detected (All Layers)</b>		
<b>Sample Photo</b>

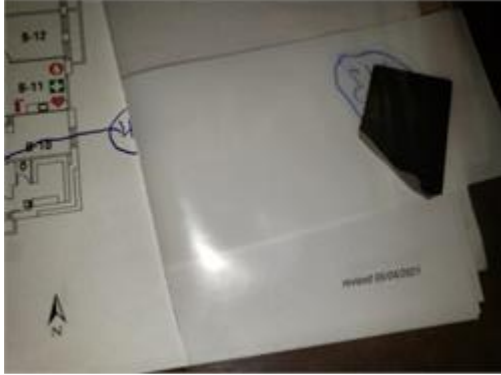
Sample		Sample Date	05-Jan-2022
<b>Project Name</b>	Irving R. Newhouse Senate Building		
<b>Sample Type</b>	Physical Sample	<b>AHERA Category</b>	Miscellaneous
<b>Sample Number</b>	43	<b>Homogenous Material Number</b>	22
<b>Material Description</b>	Cove Base Mastic, 4 inch brown.		
<b>Homogenous Mtl Area</b>	N/A		
<b>Sample Location</b>	Basement, at room B-10		
<b>Quantity</b>	45	<b>Unit of Measure</b>	Lineal Feet
<b>Asbestos Type/%</b>	<b>None Detected (All Layers)</b>		
<b>Sample Photo</b>

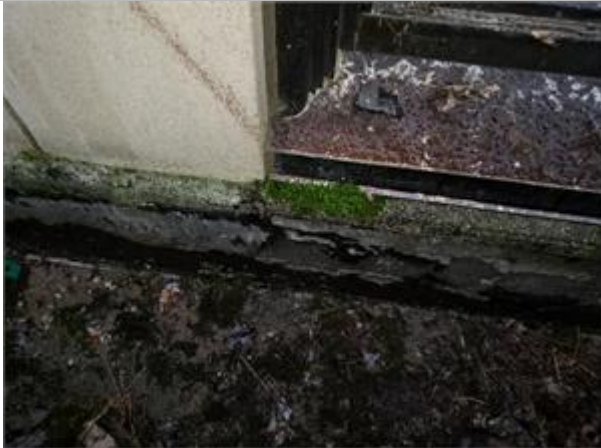
Sample		Sample Date	05-Jan-2022
<b>Project Name</b>	Irving R. Newhouse Senate Building		
<b>Sample Type</b>	Physical Sample	<b>AHERA Category</b>	Miscellaneous
<b>Sample Number</b>	44	<b>Homogenous Material Number</b>	23
<b>Material Description</b>	Waterproofing mastic		
<b>Homogenous Mtl Area</b>	N/A		
<b>Sample Location</b>	Exterior, window well, southeast corner.		
<b>Quantity</b>	250	<b>Unit of Measure</b>	Square Feet
<b>Asbestos Type/%</b>	<b>Layer 1: (Black tar) Chrysotile 3-5%</b> <b>Layer 2: (Black tar paper) None Detected</b> <b>Layer 3: (Black tar) None Detected</b>		
<b>Sample Photo</b>

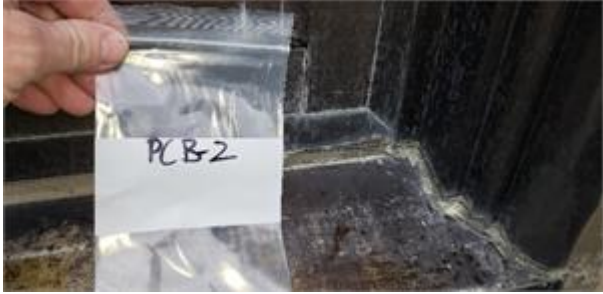
Sample			
<b>Project Name</b>	Irving R. Newhouse Senate Building		
<b>Sample Date</b>	05-Jan-2022		
<b>Sample Type</b>	Solid		
<b>Sample Number</b>	02		
<b>Material Description</b>	Window sealant		
<b>Sample Location</b>	Back of building Floor 1		
<b>PCB Result</b>	Aroclor 1254 – <b>1.3 mg/kg</b>		
<b>Sample Photo</b>
