HISTORIC STRUCTURE REPORT

LOUISE HANSON DUPLEX

1417-1419 COLUMBIA STREET SOUTHWEST  
OLYMPIA, WASHINGTON

JUNE 15, 2011

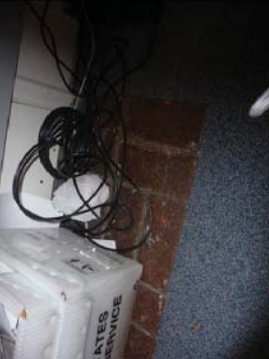
Masonry Surround/ Floor at Fireplace.	Found at both North and South Units.	None.	Good condition.

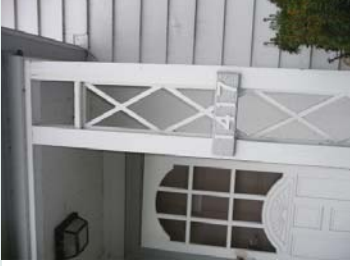
East: contemporary screen
	<u>West:</u> (1) historic 6-lite door over (1) recessed panel, contemporary hardware.	New hardware.	Both door and hardware need minor refurbishment.	  West: infilled door, new flush wood door.

CHARACTER DEFINING FEATURES	LOCATION/QUANTITY	MODIFICATION	CONDITION	IMAGE
Wood Doors and Door Hardware: Exterior	<u>North:</u> (1) historic 6-recessed panel door w/ new hardware (1) contemporary screen	Replacement of original screen/hardware.	Good.

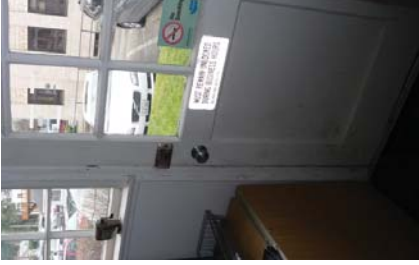
West: historic door, new hardware
	<u>East:</u> (1) historic 6-recessed panel door w/ new hardware (1) non-historic screen	Replacement of original entry door/hardware and screen.	Good.

(1) flush wood door and (1) infilled door at Basement	Replacement of one door, and removal of one door.	Good.	  East: non-historic door
	<u>South:</u> (1) historic 6-lite door over (1) recessed panel, contemporary hardware (1) historic screen	New hardware.	Good.
