Capitol Lake Dam/5th Ave Bridge, Olympia, WA UNDERWATER INSPECTION REPORT

June 22, 2007

OLYMPIA FIFTH AVENUE DAM
UNDERWATER INSPECTION

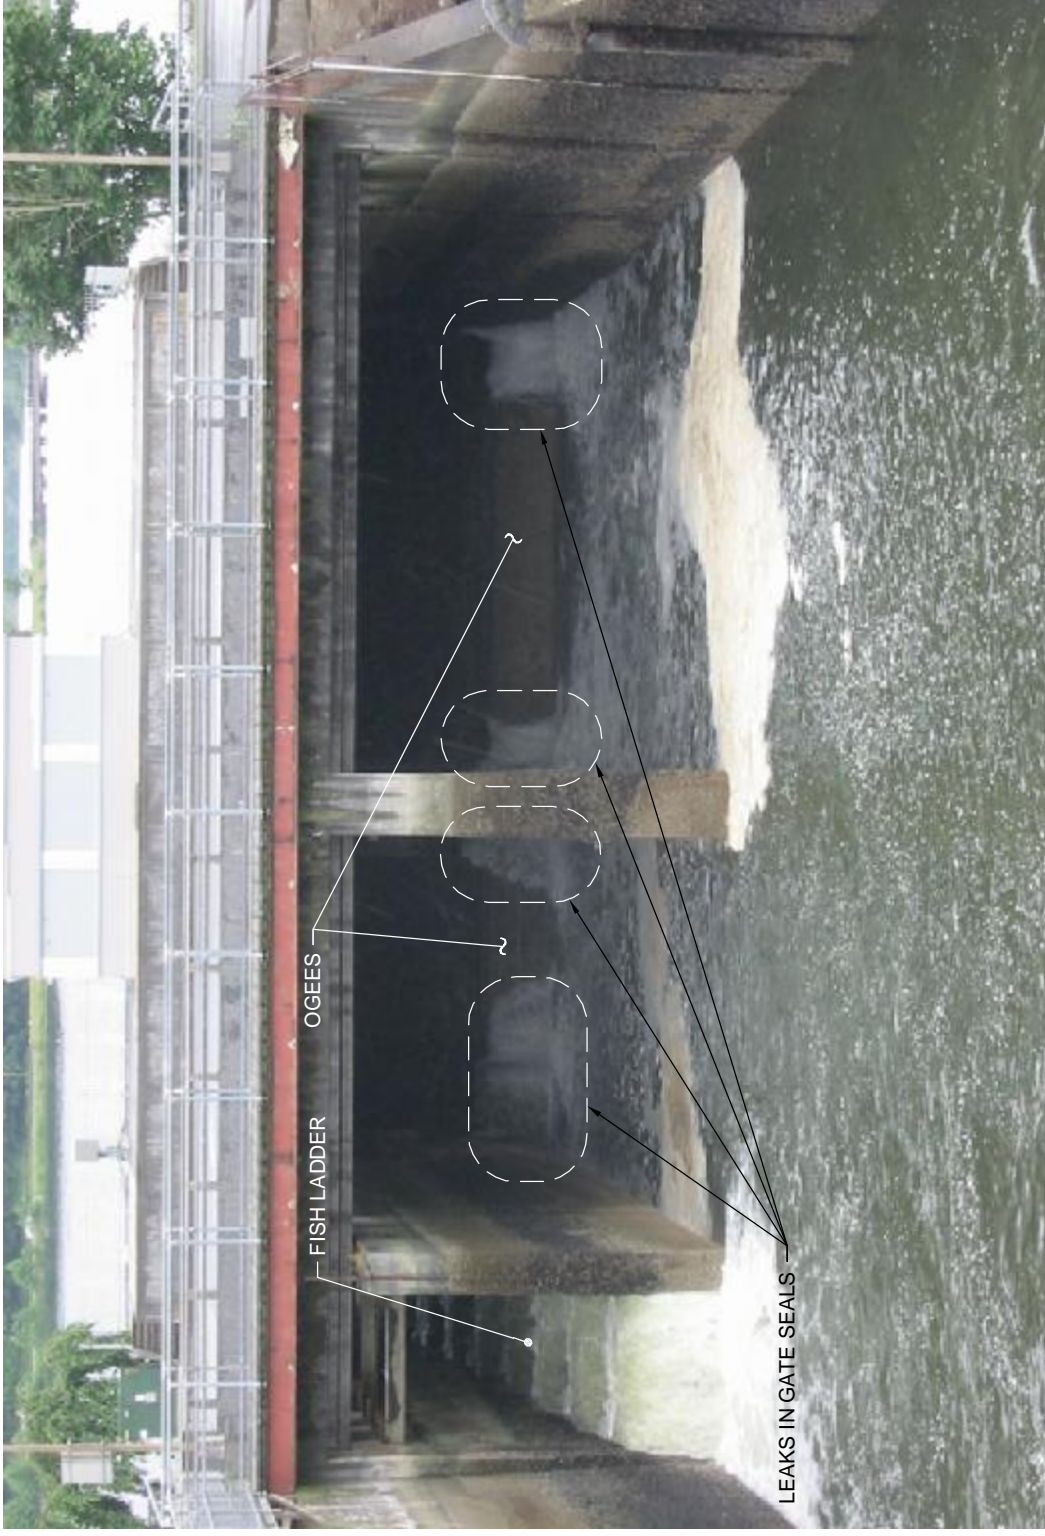
Photograph
4

WEST RADIAL ARM GATE

LOOKING SOUTH FROM BUDD INLET SIDE

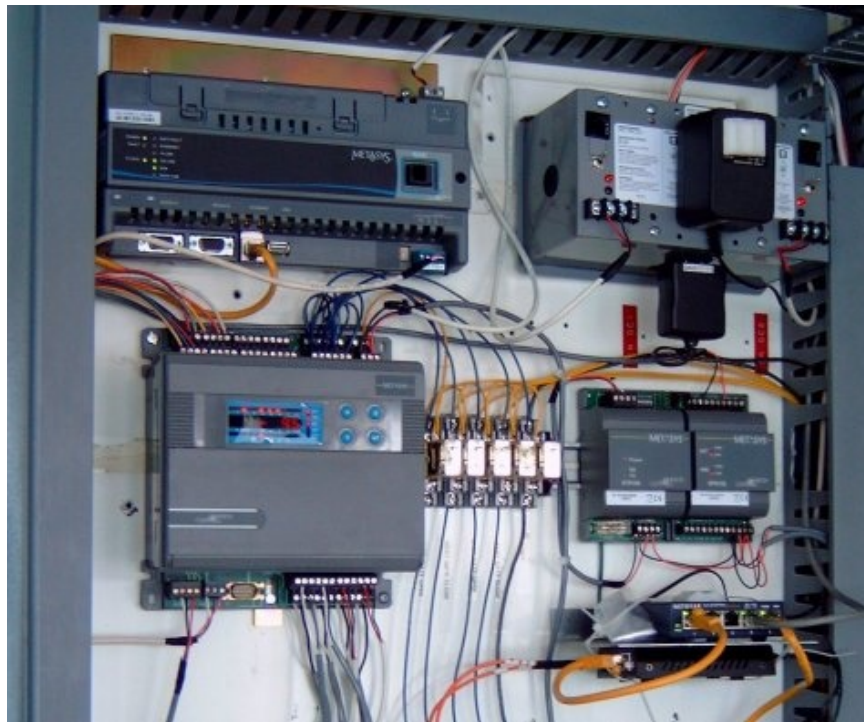
Figure 4
METASYS Controller

The dam tide gates are continuously monitored and controlled by a Johnson Controls METASYS control system (see figure 4). The METASYS control receives analog signals from sensors that measure the fresh water lake level from two points near the opening of the east and west gates, and from a third sensor which measures the salt water Budd Inlet tide level downstream from the discharge gates. The METASYS program is designed to monitor the level in Capitol Lake and that of Puget Sound. If the lake level is too high and is above that of Puget Sound, the system opens the east tide gate until the lake level falls into the acceptable range. If the rate at which the lake level is dropping is considered to be too slow, the METASYS controls will open the west gate to increase the discharge rate. When the water level in Puget Sound nears or exceeds that of Capitol Lake, the METASYS closes the east and west tide gates.

to the METASYS controller through a local Ethernet connection and acts as the man-machine interface (MMI) (see figure 4). The METASYS controller and the MMI are connected to the Capitol campus LAN through an optical link.

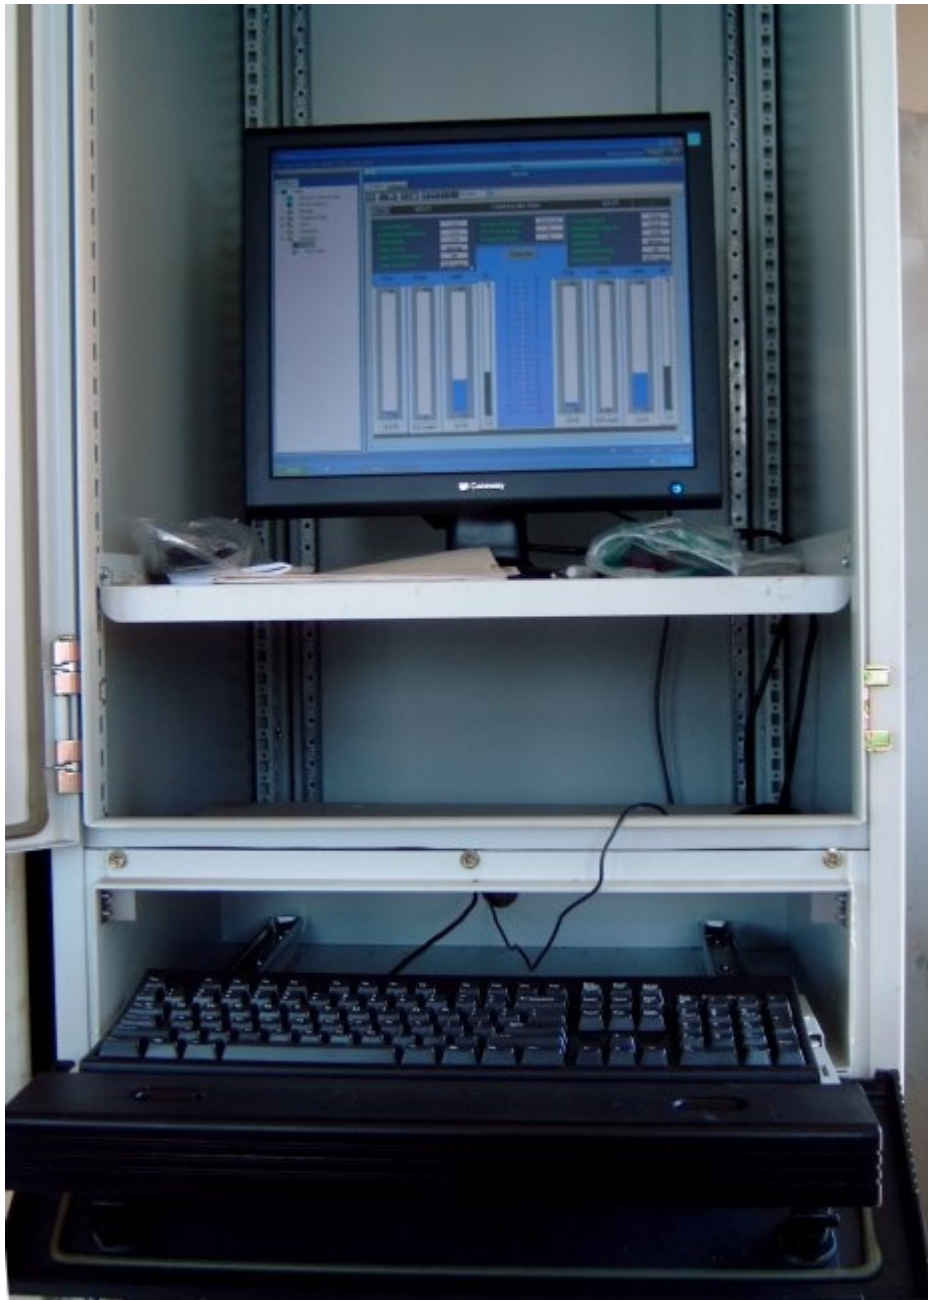
Figure 5
METASYS Operator Station (MMI)

levels. This information is also available locally at the control house through the METASYS operator station (see figure 5).
