Subject: City of Everett Application for Project Approval Using Design-Build (D-B)
Water Filtration Plant East Clearwell Roof Replacement

ROOF ASSESSMENT REPORT

Everett Water Filtration Plant

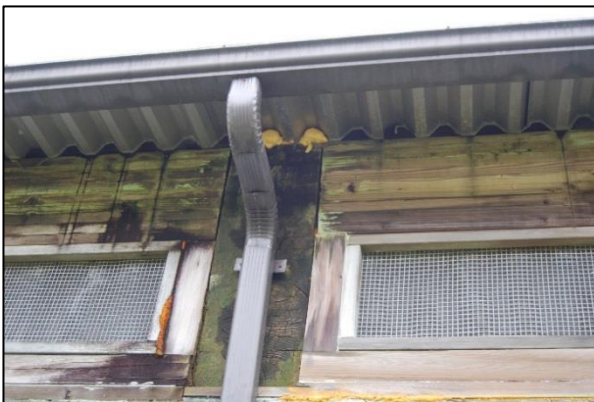
Gutter and Downspout Attached to Posts

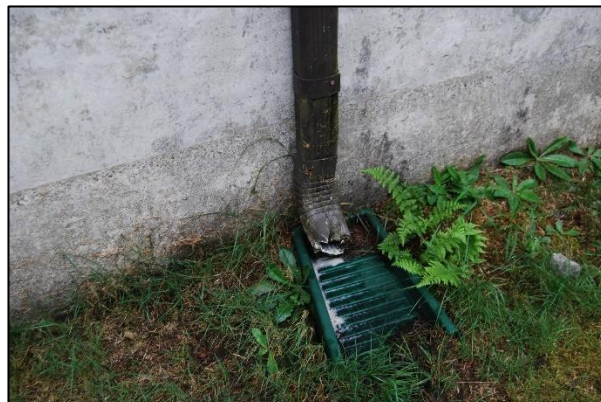
Downspouts and Plastic Splash Blocks (typ.)

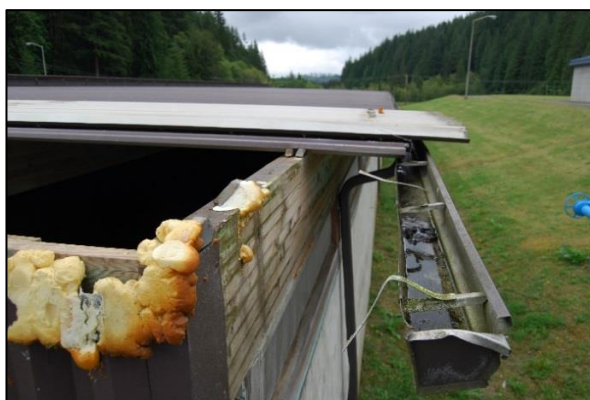
Northwest Corner Panel Removal

During our site visit on 08/10/16, two aluminum deck panels were removed at the northwest corner of the building to observe the condition of the structure. Corrosion of the panel edges and at the fastener connections was visible in several places. The wood framing members supporting the aluminum decking were soaked from the condensation accumulating on the underside of the decking. As the second panel was being removed from the north side around the access hatches, there was sinking of the structure of the roof as some of the hangers were missing. Repairs had to be made before the inspection could continue. After the repairs to the access hatches had been made, an additional site visit was made on 10/18/16 where the panels at the south end of the building were removed to observe the condition of the structure. The general contractor, K-A General Construction, also took pictures of the framing and connectors from inside the building on 10/19/16 for our review.

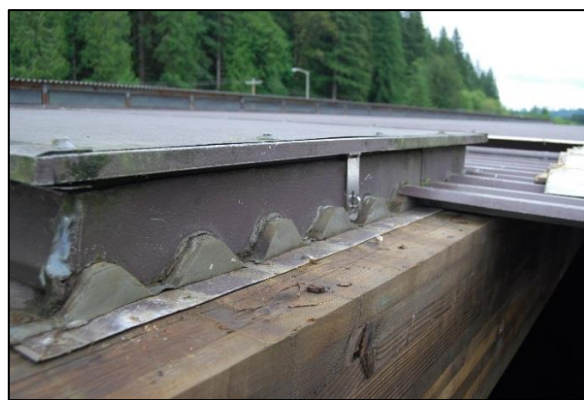
North Panel Removal around Access Hatch

- **Flashing and Caulking**
The flashing around the access hatches was in poor condition and had been patched using caulk. The exposed fasteners throughout the roof showed evidence of being overdriven and had been caulked over to fix leakage.
