Legislative Chambers Skylight Restoration Feasibility Study

Washington State Legislative Building

Washington State Department of Enterprise Services

April 4, 2017

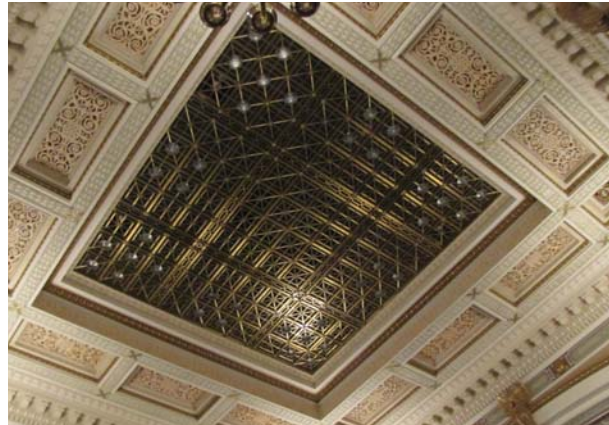
The ceiling laylight was reviewed from below in the chamber space and from above in the skylight attic space. It is evident that the bronze bars have been modified to incorporate larger light fixtures with a thinner metal ring (see Figure 16 & 17). In general, the bronze material appears to be in good condition though a full assessment will be required once the insulation boards are removed.

Figure 16: House bronze ceiling laylight

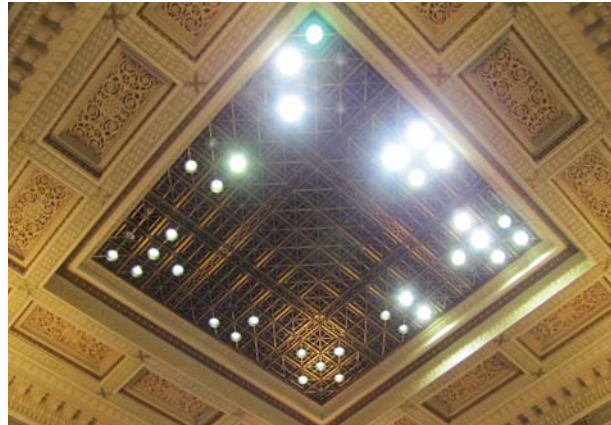
The installed downlights were not designed for the current application and do not fit properly in the openings of the grid. The rings/ downlight reflectors do not line up, creating light leaks around the grid system (see Figure 21). Color shifting, which is when the color of the lamp changes (for instance from more of a warm tone to a greenish or bluish tone) was also present as seen in Figure 19 which is common for metal halide lamps as they age.

Figure 19: House ceiling laylight, showing downlight configuration

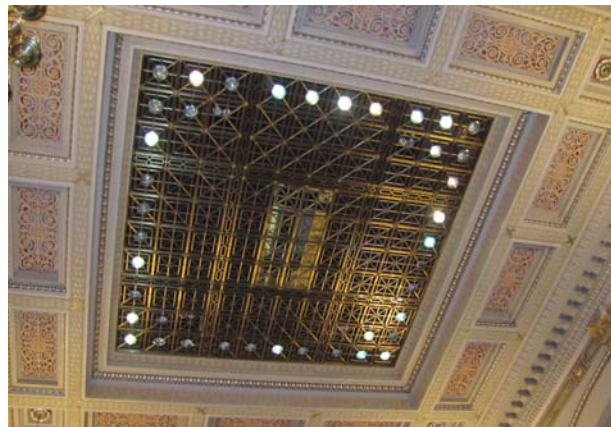
Figure 20: Senate ceiling laylight, showing downlight configuration

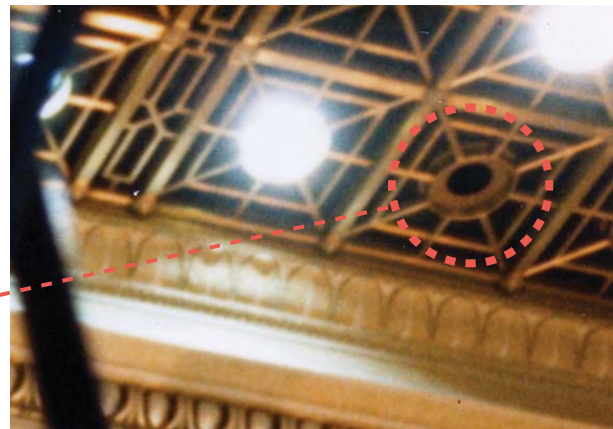
High bay lights added in 1967 show a smaller diameter light with a flat bronze housing.

Figure 34: 1967 Lights

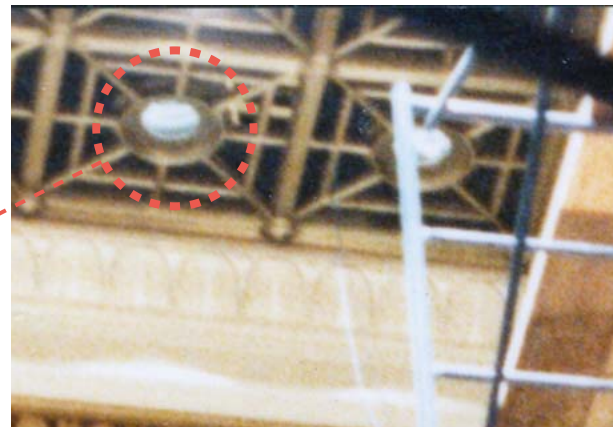
Early incandescent lights show a smaller diameter with a concave bronze reflector.

Figure 35: Early Lights added between 1923 and 1967

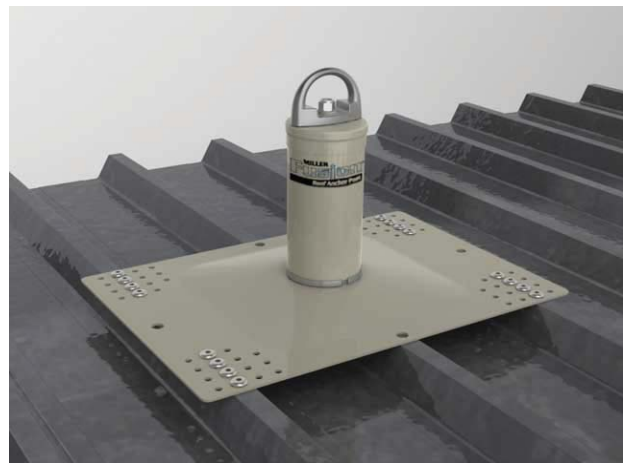
Figure 60: Raised roof tie-off connection (recommended)

The roof tie-off system should be replaced with a more appropriate modern system that has mounting brackets that allow for the free-passage of water and a cable line that does not rest on the surface of the roof. The current roof tie-off system is creating a water dam between the battens which may lead to eventual penetration of water at the weak points (the bolt connections). The steel cable resting on the metal roof will continue to abrade the surface, eventually leading to a thinning of the material. This work should be completed whether or not the skylight project moves forward.
