State Project No. 2013-245

Washington State Legislative Building Dome / Access Stair Evaluation

State Capitol Campus, Olympia, WA

June 28, 2013

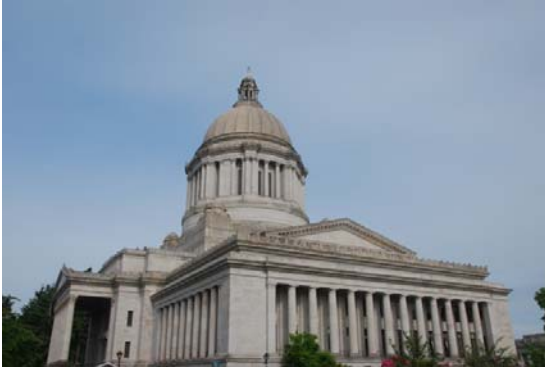
Photo 1.1

The construction of the Washington State Legislative Building (Photo 1.1) began in 1923, with completion of the dome and stairs in 1926. The stairs have performed adequately since that time and, until recently, were open to use by the public.

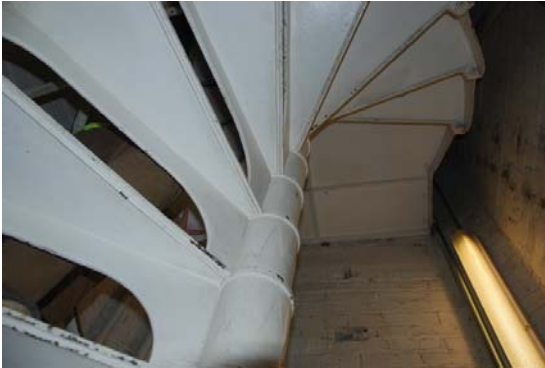
Photo 3.1

The cast iron spiral stairs (Photos 2.1 to 7.1) consist of 178 stacked treads that slide over a 4" (outside diameter) vertical pipe with bolts on the exterior side of the treads to provide continuity to hold them in place (Photo 6.1). A computer model was developed to theoretically depict the spiral staircase, representing a complete 360° spiral from landing to landing. This model was analyzed with various loading conditions to check the stresses in all components for worse case loading conditions. The performance of the system is adequate for the service load as described above, however there is observed movement of the stair as people transit up and down the stair. This movement is more of a nuisance and does not indicate the stairs have inadequate strength.

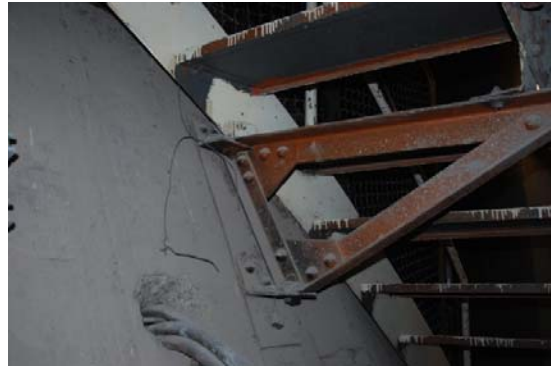
Photo 10.1

The arcing stairs (Photo 9.1 to 13.1) wrap around the concrete cone that supports the lantern and is located between the inner and outer domes. It starts at the top of the spiral stairs at the base of the cone and continues to an elevation of approximately 8 feet below the lantern. The cast iron arcing stairs are braced with triangular steel frames (Photos 10.1 and 11.1) at the landings (Photo 12.1) and at mid-flight between landings. The triangular steel frames and their through-bolt plated anchors were analyzed and found to be structurally sufficient. The arcing stairs have a steel shroud cage (Photo 13.1) installed around each side of the stairs which has minimal structural effect on the stairs. The arching stairs are adequate for reference loading.

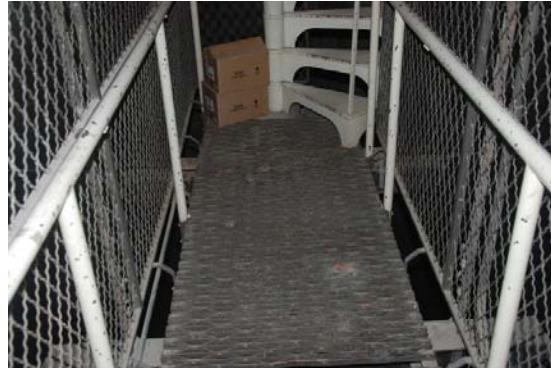
Photo 14.1

The cantilever platform with spiral staircase atop (Photos 14.1 to 18.1) is located at the top of the cone roughly 8 feet below the elevation of the lantern. The cantilever platform consists of channels with steel grating (Photo 14.1) and is supported by the concrete cone and by tension rods embedded into the concrete cone above (Photo 18.1). Steel cables were previously added to support the platform vertically and reduce the lateral operating sway (Photo 17.1). The platform is structurally adequate for service loading.
