Inspection Report

Facility: Tacoma Rhodes Broadway Building

Department of Enterprise Services, Tacoma, WA

Work Order #: 35207

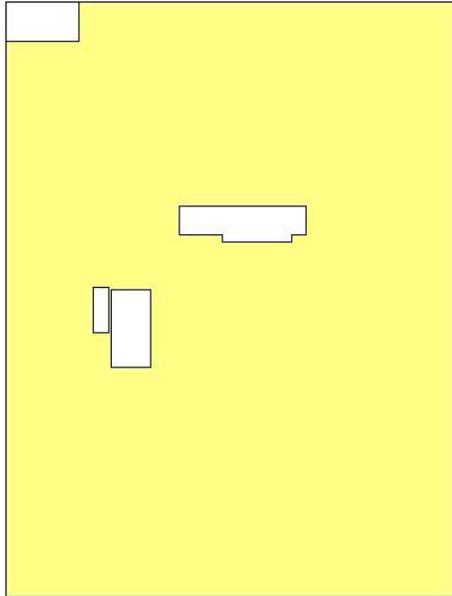
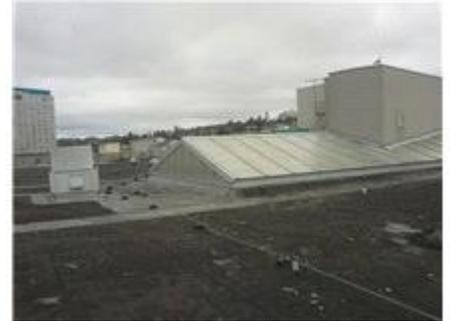
Roof: Roof A

Condition Assessment: 25 - Poor

Roof is in poor condition and in need of immediate attention. Without the recommended repairs or replacement water damage is imminent

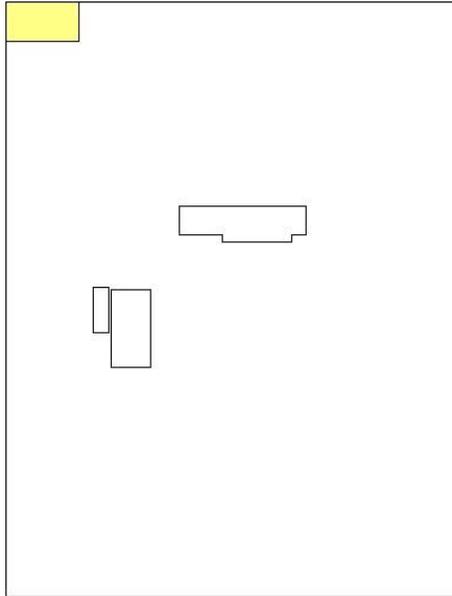
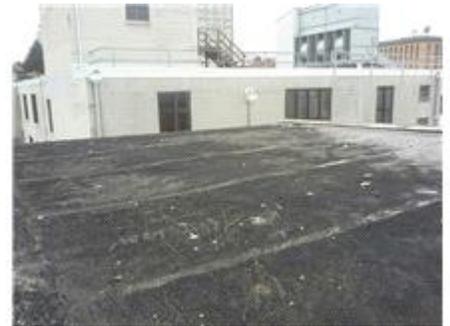
Roof: Roof B

Condition Assessment: 25 - Poor

Roof is in poor condition and in need of immediate attention. Without the recommended repairs or replacement water damage is imminent

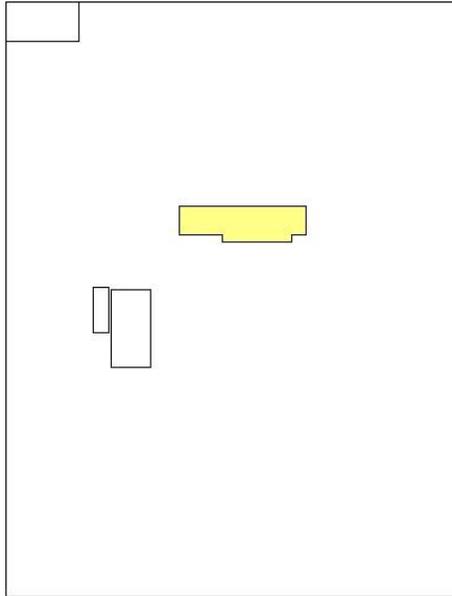
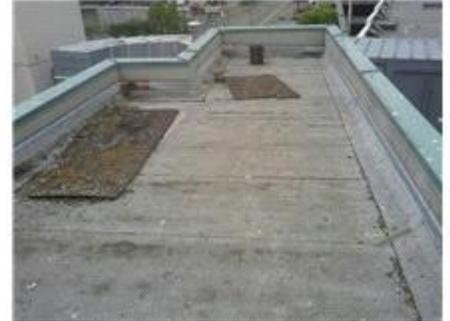
Roof: Roof C

Condition Assessment: 75 - Fair - Good

Roofs in fair to Good condition has only very minor problems that should be addressed when possible.

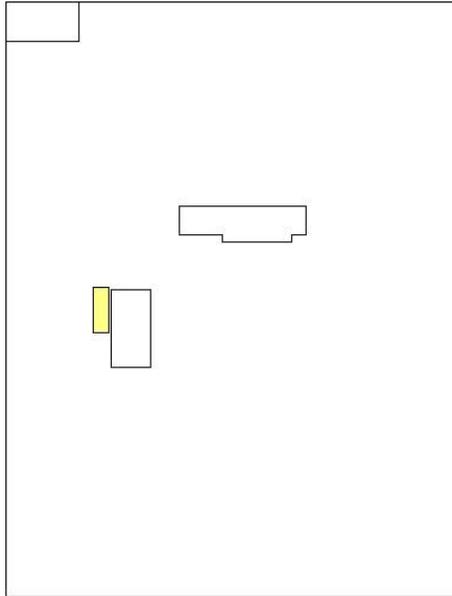
Roof: Roof D

Condition Assessment: 50 - Fair

Roofs in fair condition and has only minor problems that should be addressed when possible.

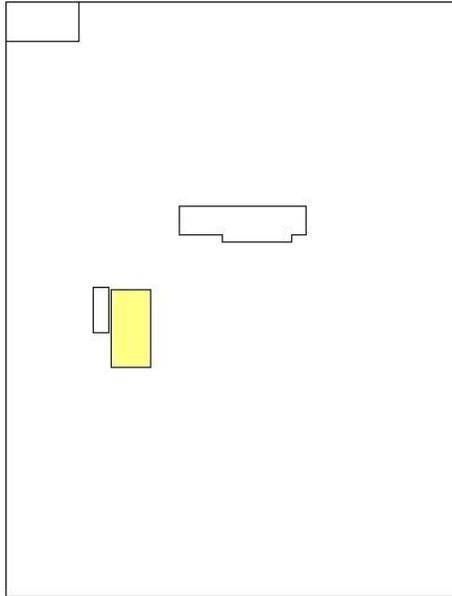
Roof: Roof E

Condition Assessment: 25 - Poor

Roof is in poor condition and in need of immediate attention. Without the recommended repairs or replacement water damage is imminent
