RESERVOIR 3 STRUCTURAL REPAIRS

Washington State CPARB PRC Application

Everett Reservoir #3

CG Project No.: 18297.10
October 18, 2019

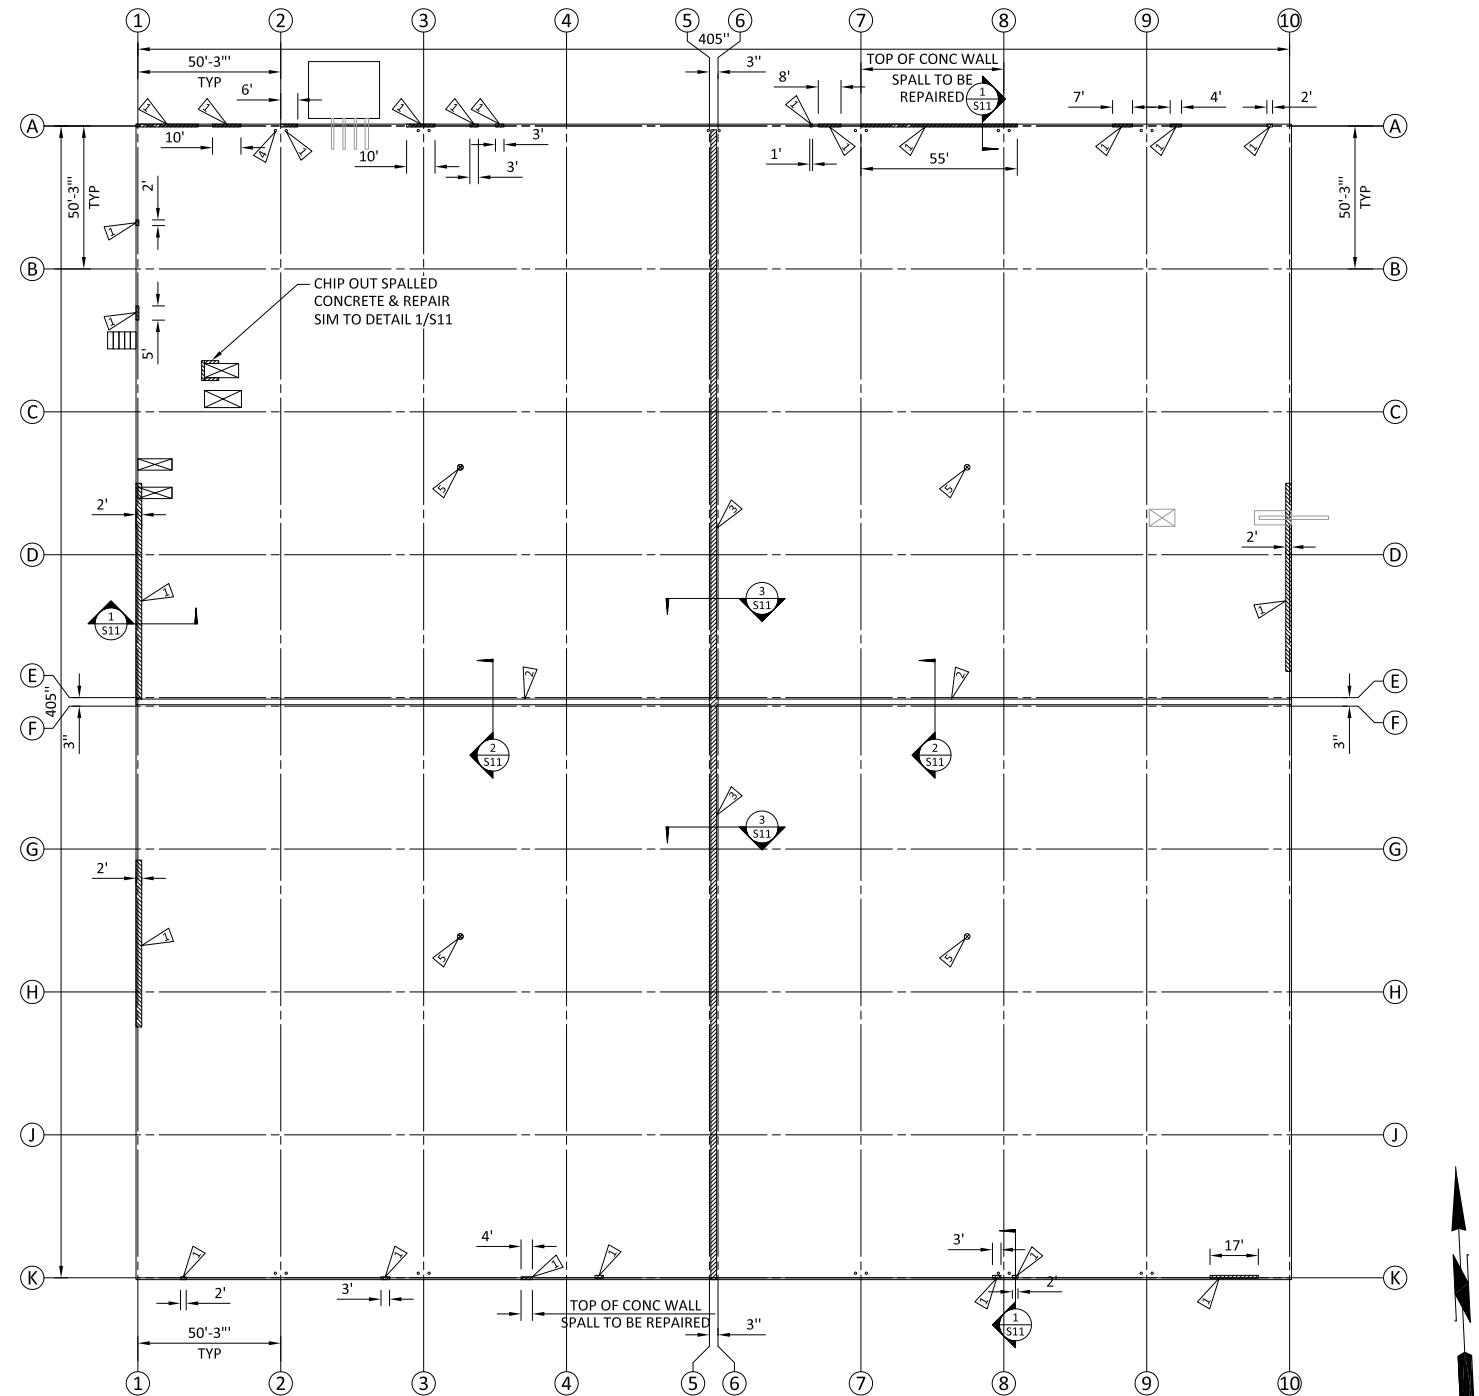
1 LID REPAIR PLAN
S4 SCALE: 1" = 30'

- LID REPAIR PLAN NOTES:**
- 1 > TOPPING SLAB REPAIR PER DETAIL 1/S11.
 - 2 > REPAIR EXPANSION JOINT PER DETAIL 2/S11 FOR FULL 405'-0" LENGTH.
 - 3 > REPAIR EXPANSION JOINT PER DETAIL 3/S11 FOR FULL 405'-0" LENGTH.
 - 4 > CORE HOLE FOR MIRCOPILES PER DETAILS 1/S9 & 4/S11 (22 LOCATIONS).
 - 5 > CORE HOLE FOR NEW ROOF VENTS PER SHEETS C1 AND 55-S8 (4 LOCATIONS).

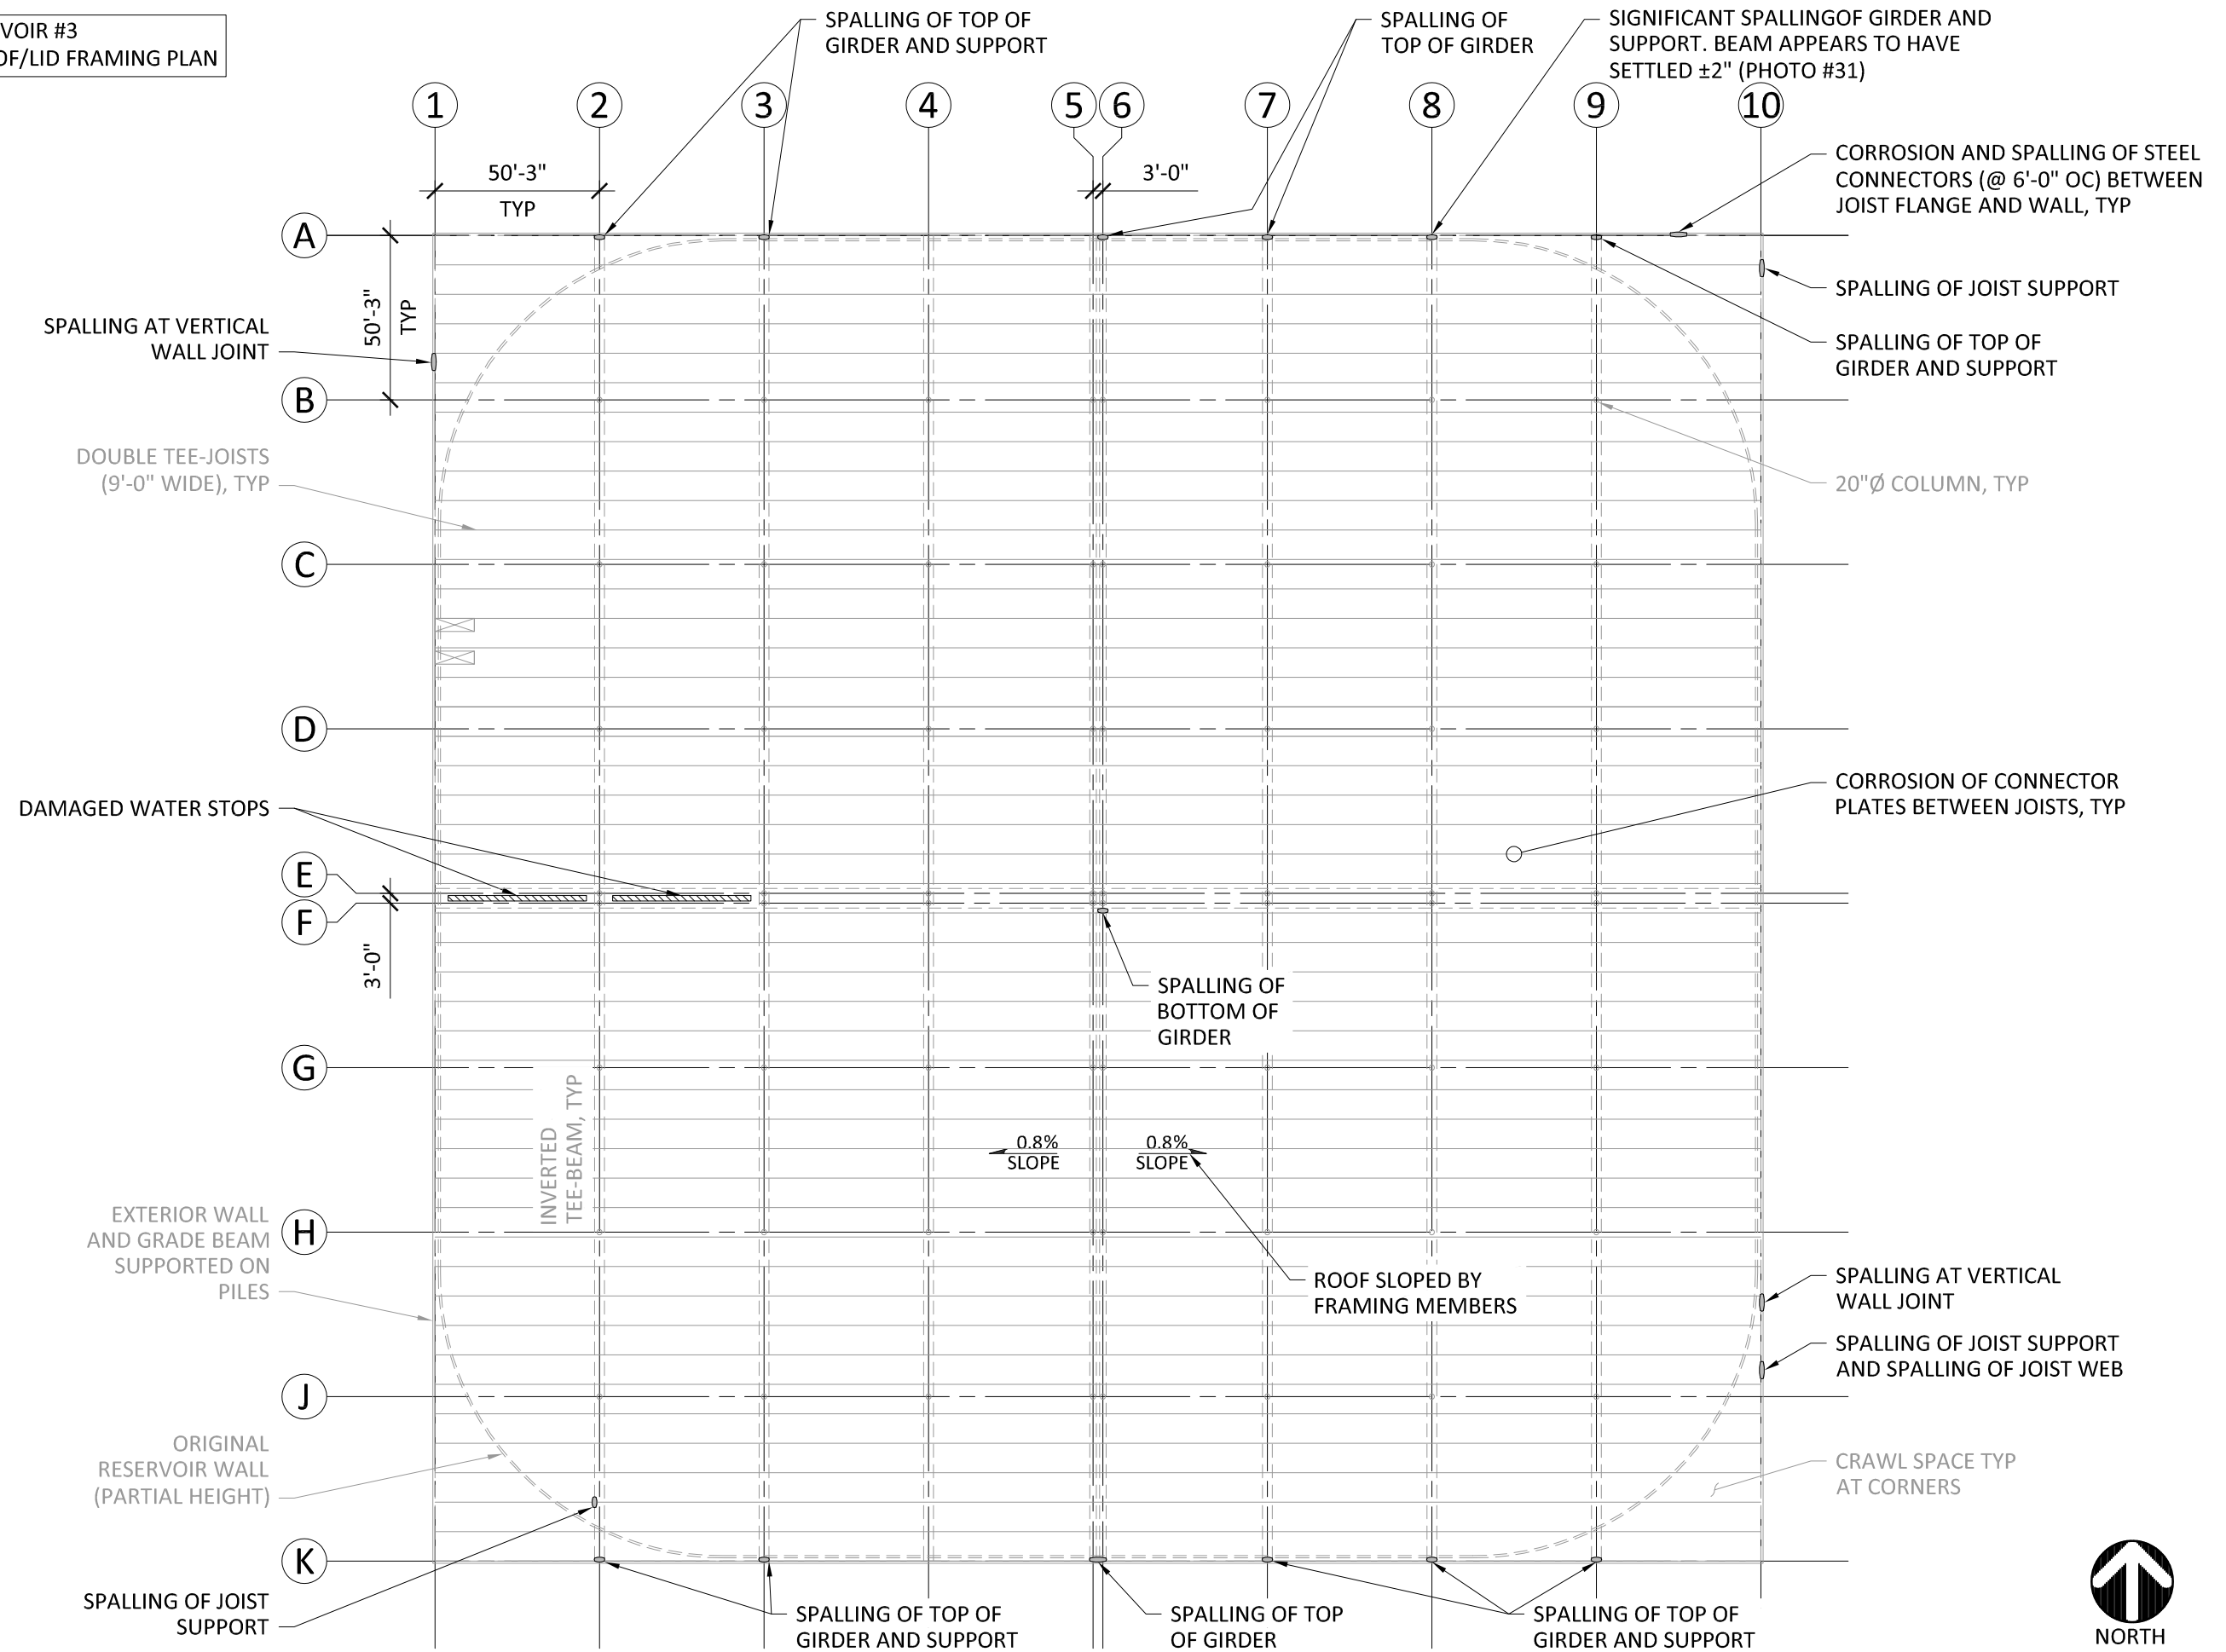
EVERETT RESERVOIR #3
RESERVOIR ROOF/LID FRAMING PLAN

Significant spalling of both the concrete girder ends and their grade beam supports was observed. In general, enough concrete had spalled away to expose the reinforcing steel and steel embedment plates that anchor the girders to the foundation. Additionally, some spalling of the girder end at the center of the structure was observed. Significant corrosion of all the exposed reinforcing steel was observed. Refer to the attached roof plan for a summary of observed girder spalling.
