# McNeil Island Repair and Replacement Options 10182200022

Prepared by KPFF Consulting Engineers  
Draft Repair and Replacement Options  
June 30, 2022

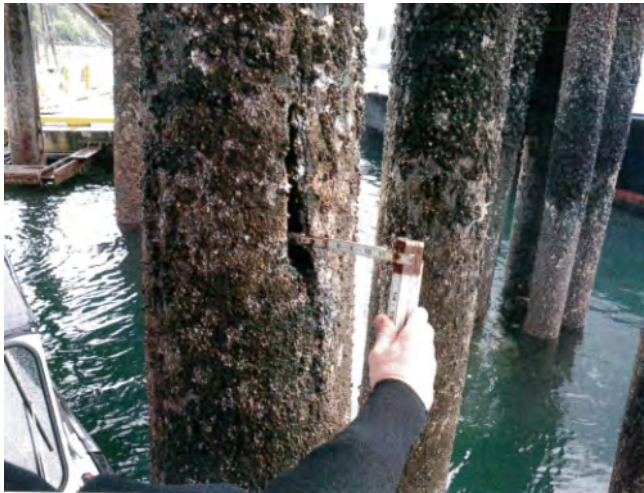
Photo 8: Pile 8.9A Rot cavity (2013)  
6"W x 12"H x 6"D

**Minimum Repairs** – Fiber reinforced jacket on pile 8.9A, replace timber curbing along trestle, sandblast and coat pile collars, repair leaking cell, relocate conduit, and replace keeper bolts.

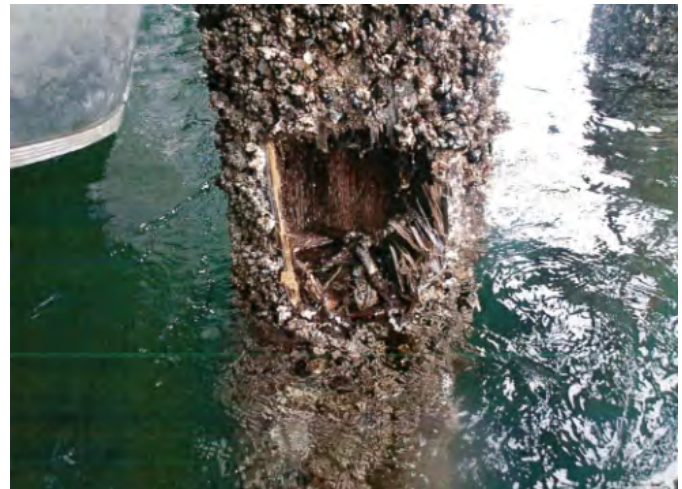
Photo 9: Pile 8.9A Rot cavity (2017)  
9"W x 16"H x 8"D

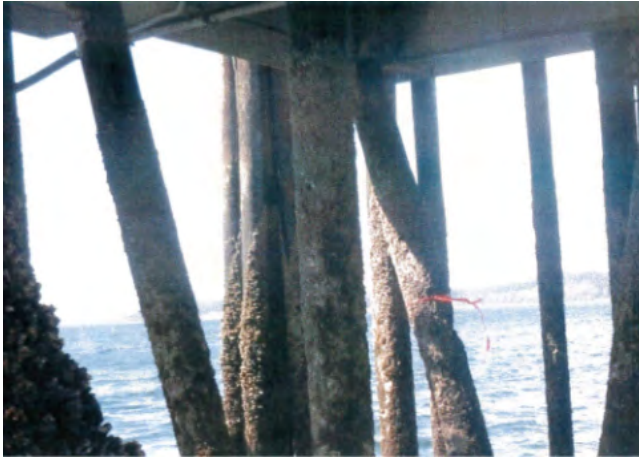
Photo 10: Pile 8.9A Rot cavity (2021)  
12"W x 21"H x 12"D

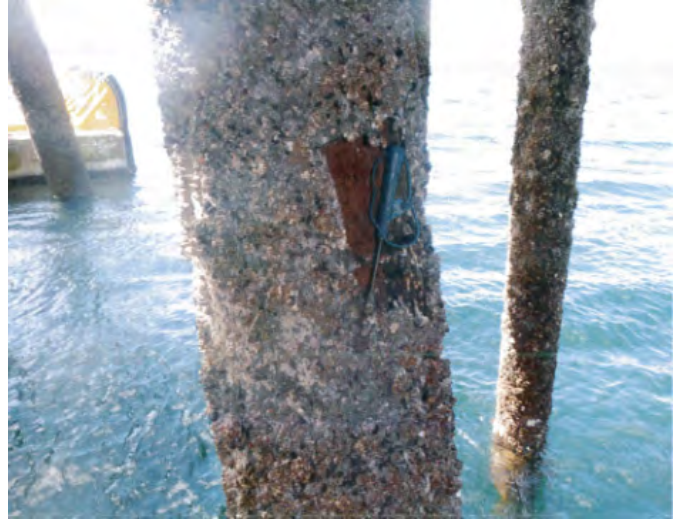
Photo 11: Pile 8.9A Rot cavity (2019)

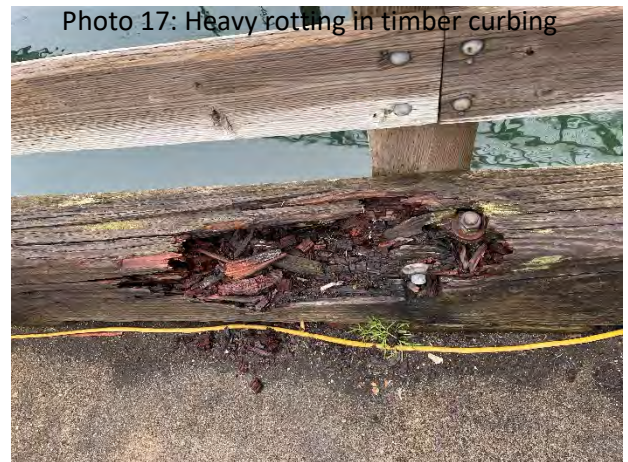
Photo 17: Heavy rotting in timber curbing

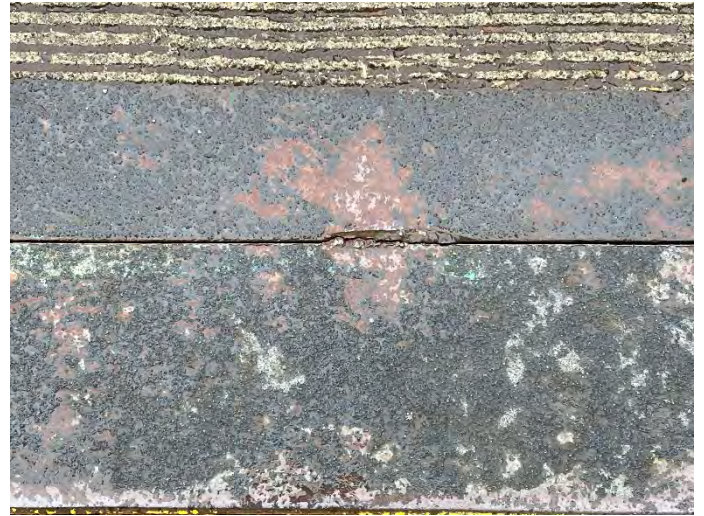
Photo 19: Steel sliding plate stitch welds breaking

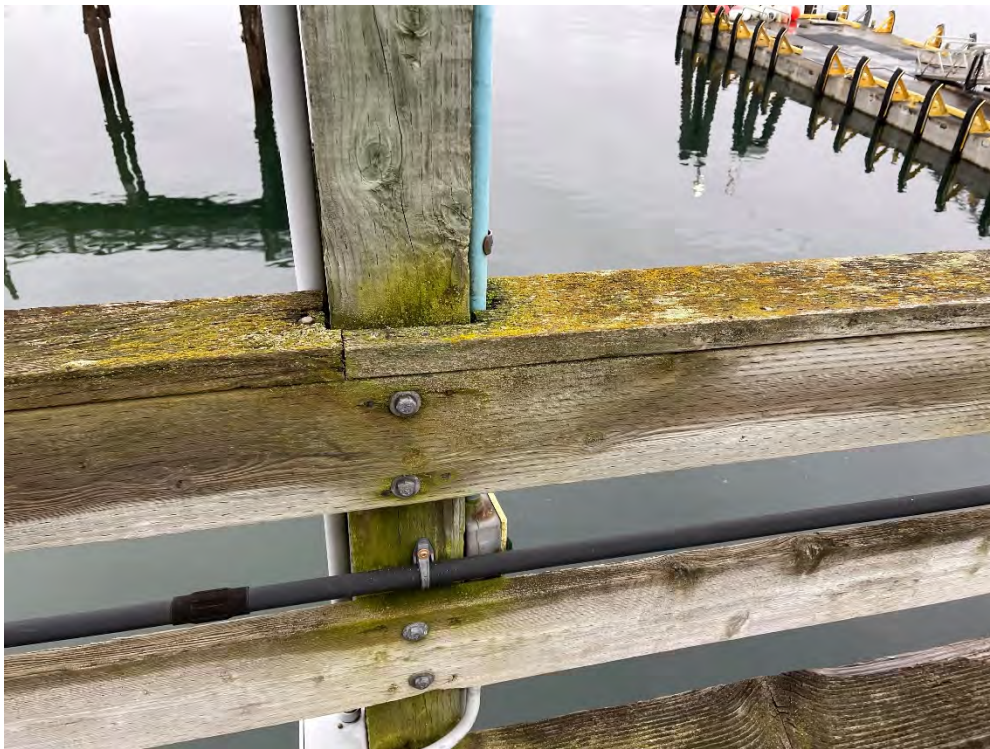
Photo 20: Wooden guard rail with heavy green moss algae

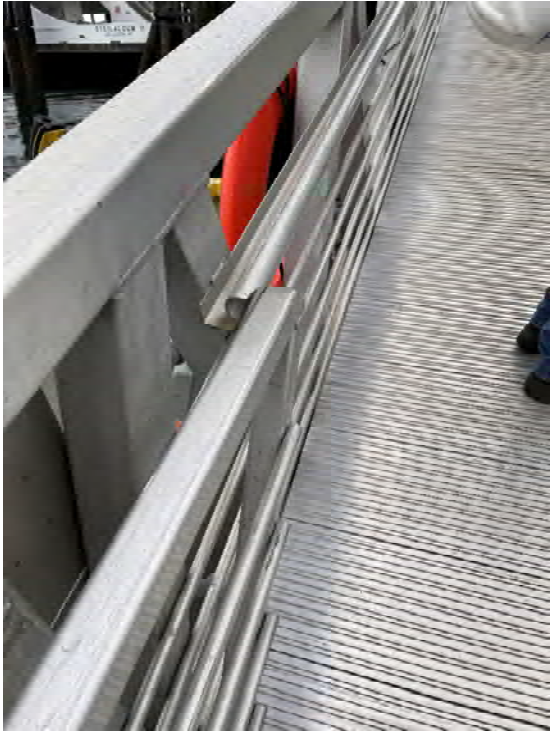
Photo 21: Loading ramp handrail with sharp edge

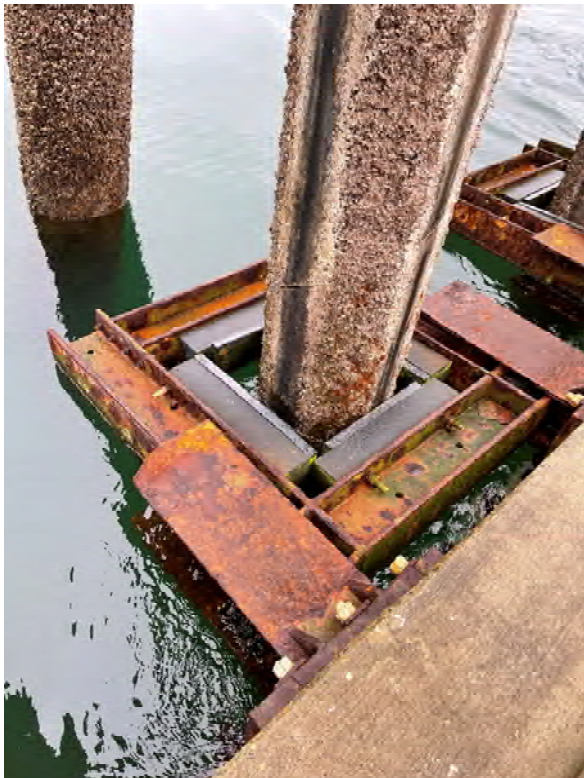
Photo 27: Pile collar with bent angle

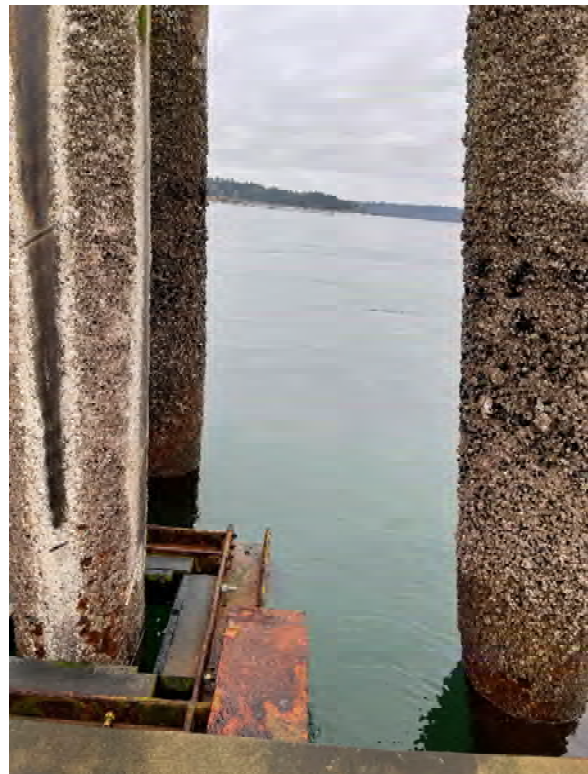
Photo 28: Pile collar with bent angle from batter pile

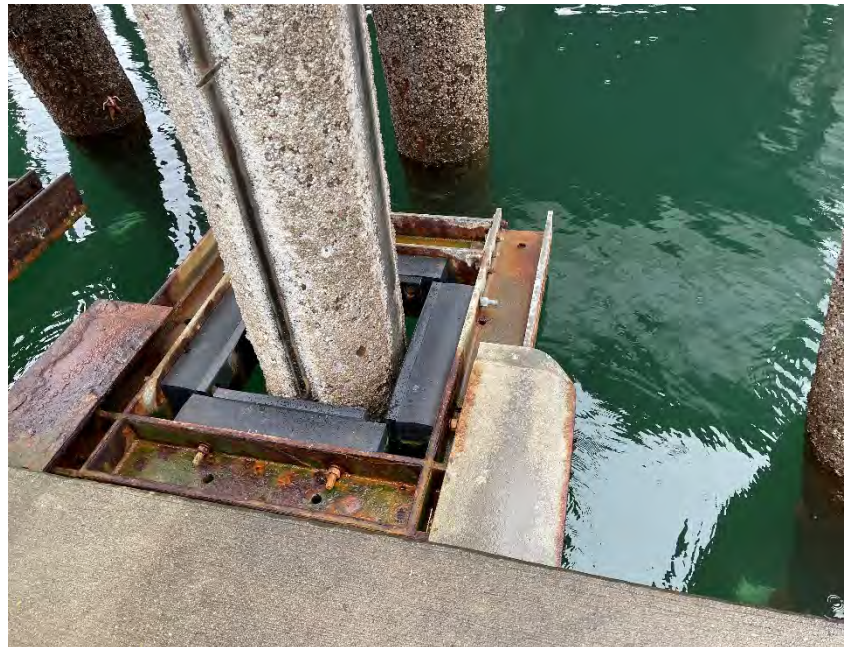
Photo 30: Pile collar with bent angle from batter pile

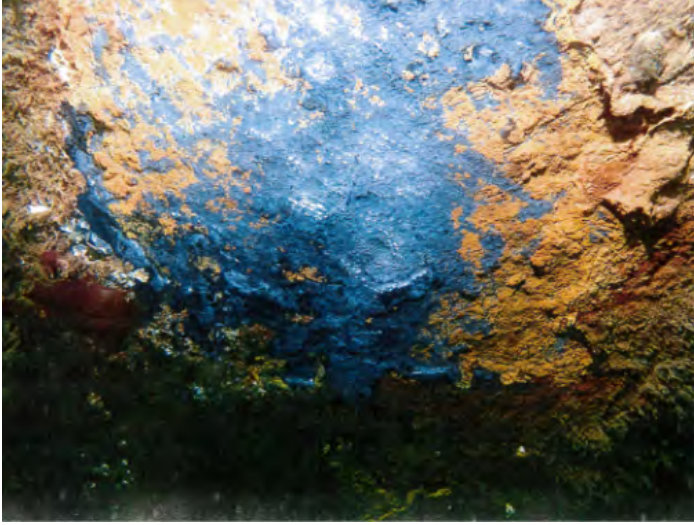
Photo 33: SP3B surface corrosion and section loss

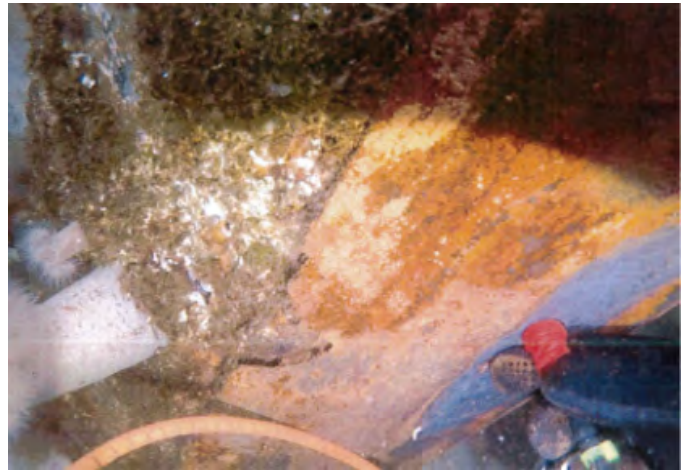
Photo 36: SP2-A heavy corrosion and section loss

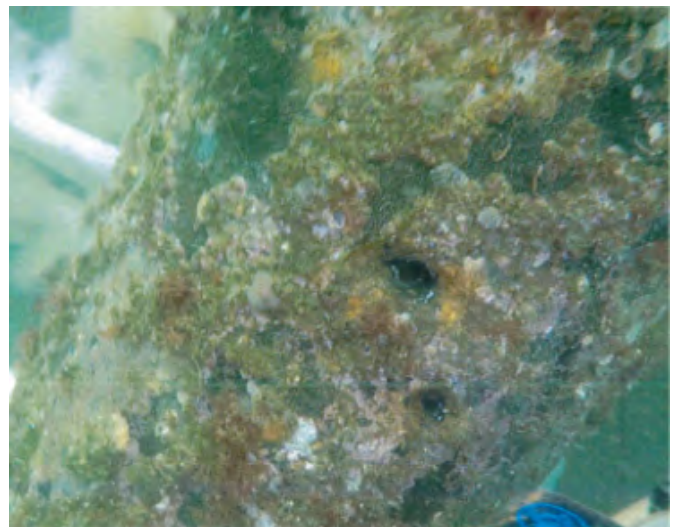
Photo 38: SP3-C holed through pitting

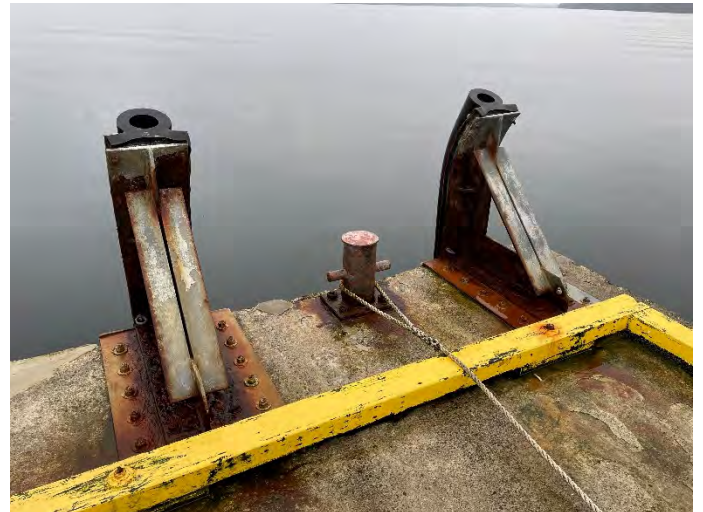
Photo 50: Mooring cleat with surface corrosion

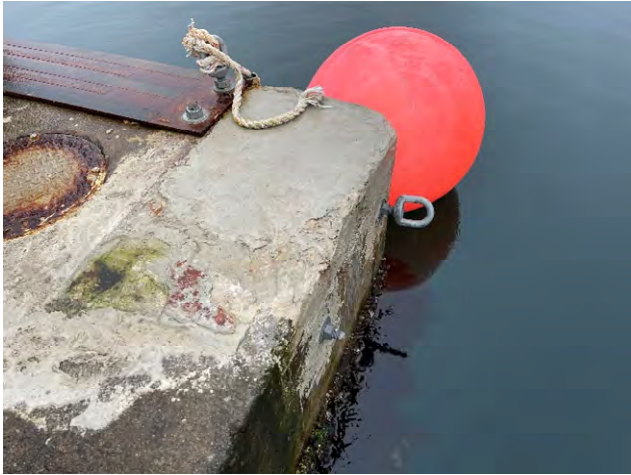
Photo 51: Fender removed and concrete float patched

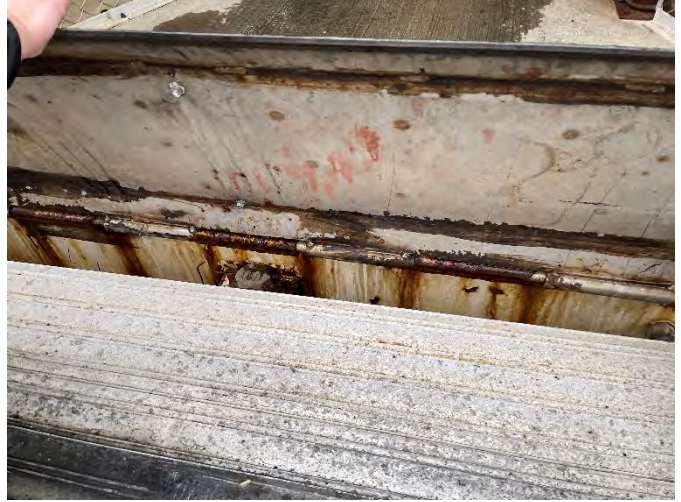
Photo 60: Surface corrosion on connections between floats

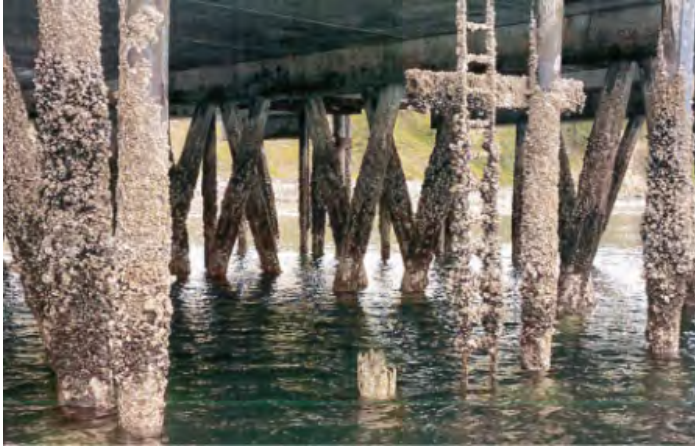
Photo 63: Pile F10 broken, South ladder is unsecured

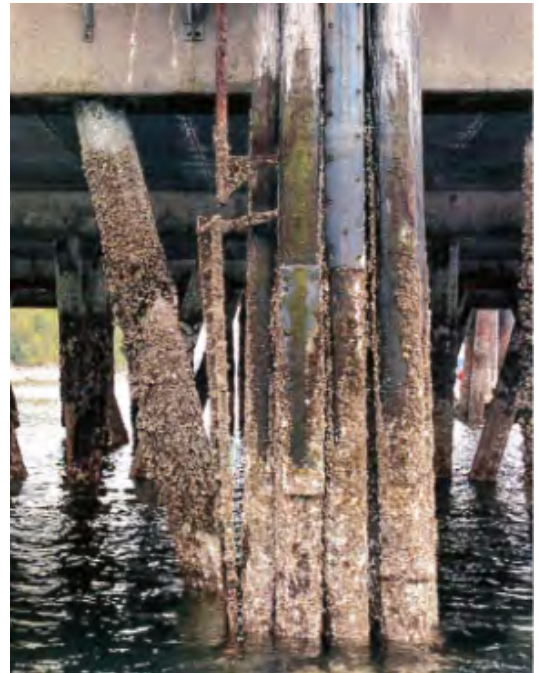
Photo 66: Dolphin D2 with abrasion damage, ladder detached

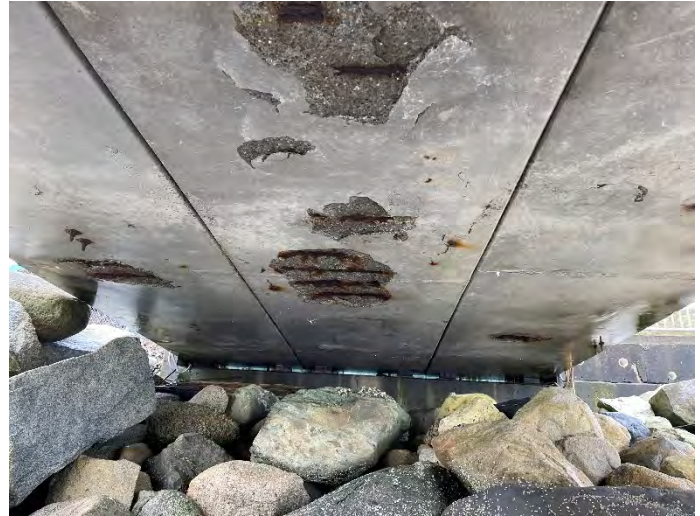
Photo 72: Concrete spalling below trestle

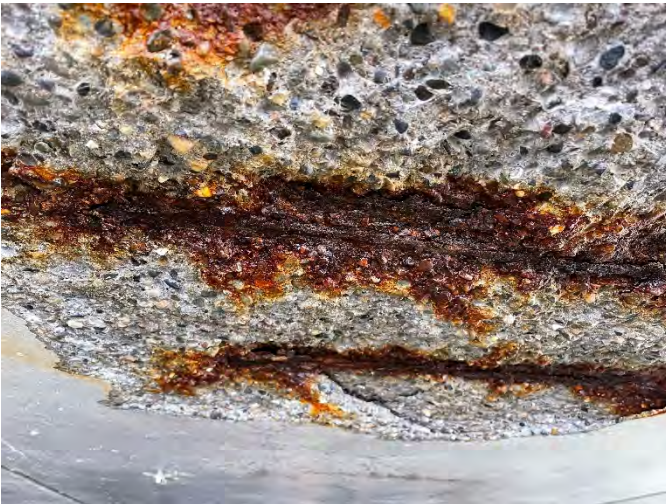
Photo 73: Exposed reinforcement from concrete spalling

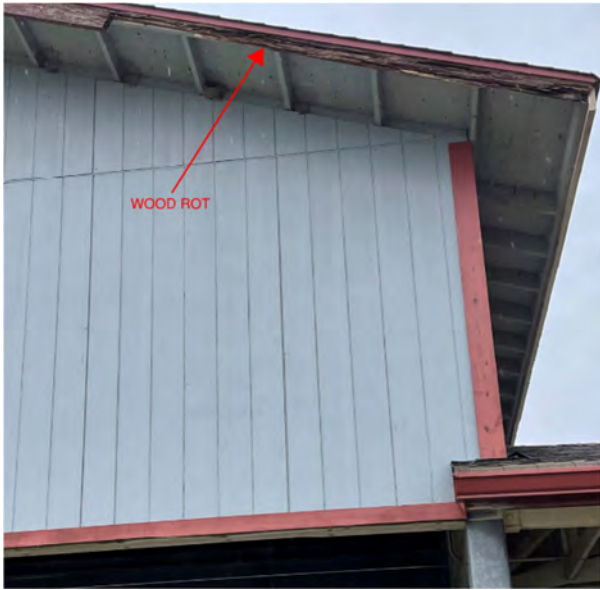
Photo 79: Wood rot on Fascia board

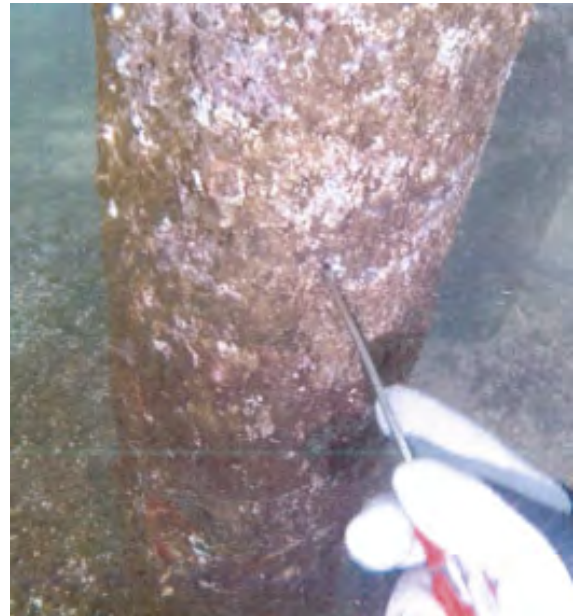
Photo 82: Pile 4A Marine borer entry

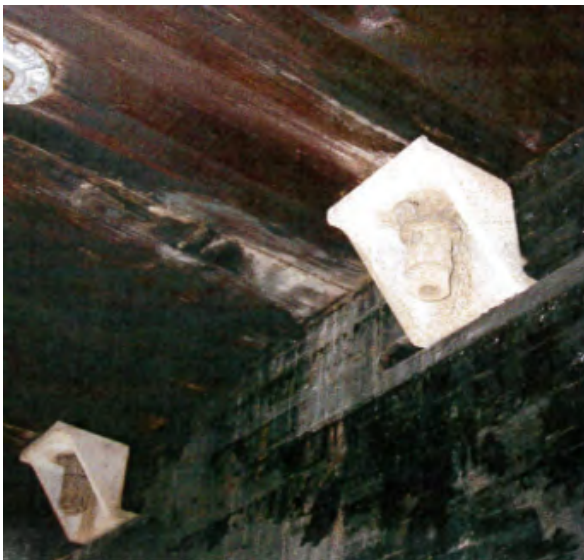
Photo 83: Loose timber deck hold down bolts

Minimum Repairs – Replace girder brackets, replace tie rings, repair lower section of wingwalls, repair top end of wingwall piles, repair hold down bolts, grease cables, repair perforated deck bolts.

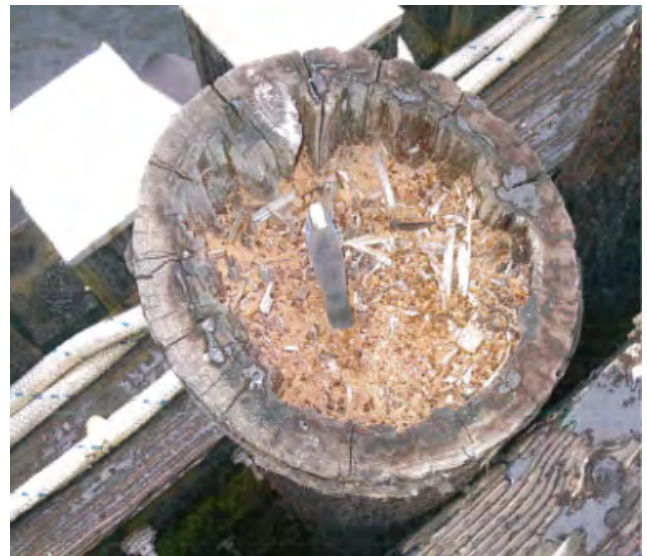
Photo 84: Typical wingwall pile with top rot

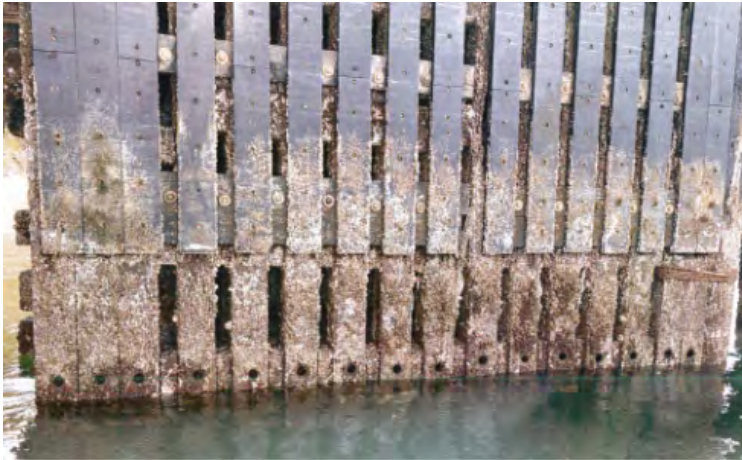
Photo 85: Left wingwall with rot below UHMW sheets

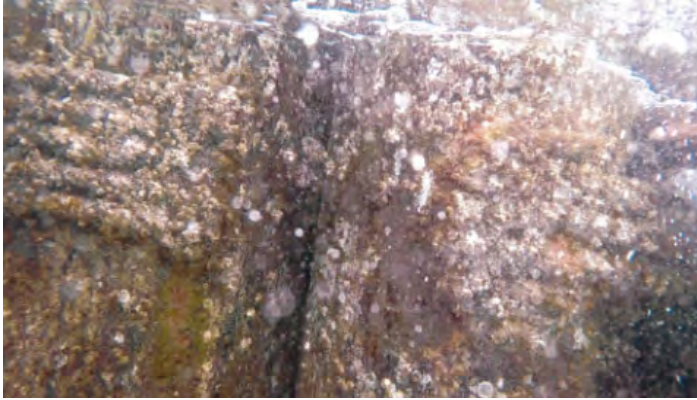
Photo 91: Left wingwall end dolphin lower wraps broken

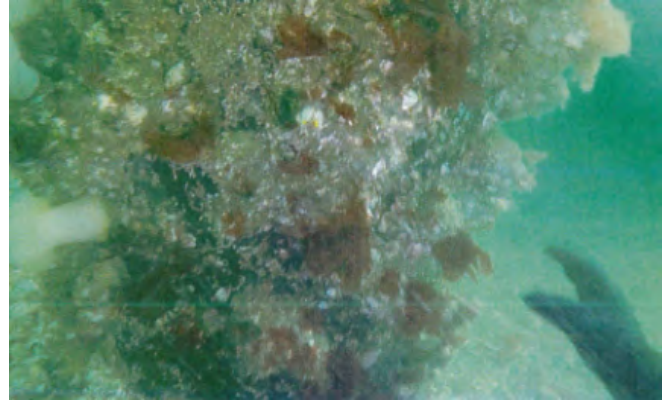
Photo 92: Pile 3A, typical conditions of other piles

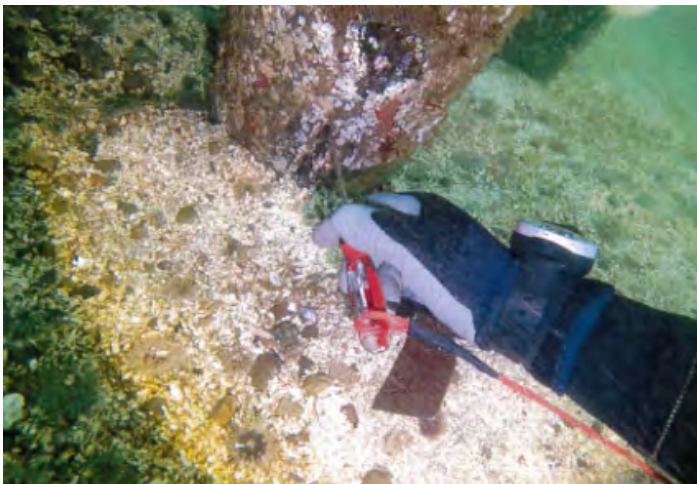
Photo 93: Right wingwall, pile 31 with MBE

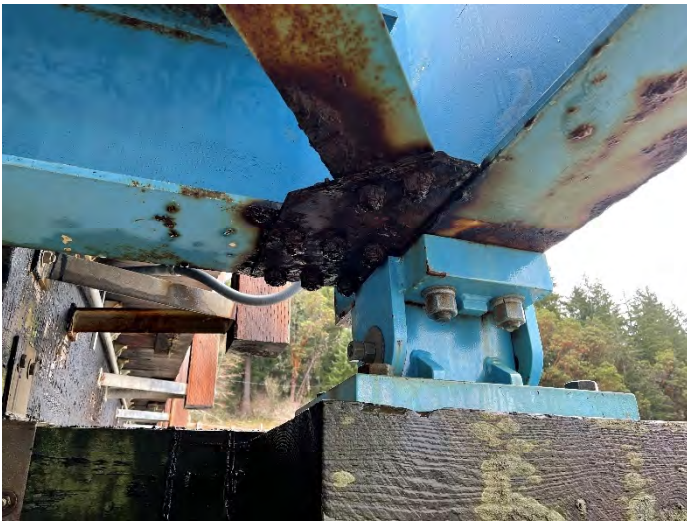
Photo 97: Heavy surface corrosion on fasteners

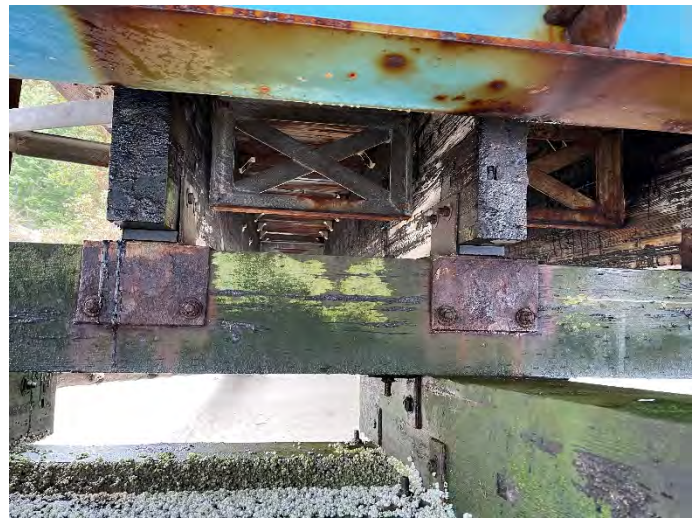
Photo 98: Heavy surface corrosion on girder brackets

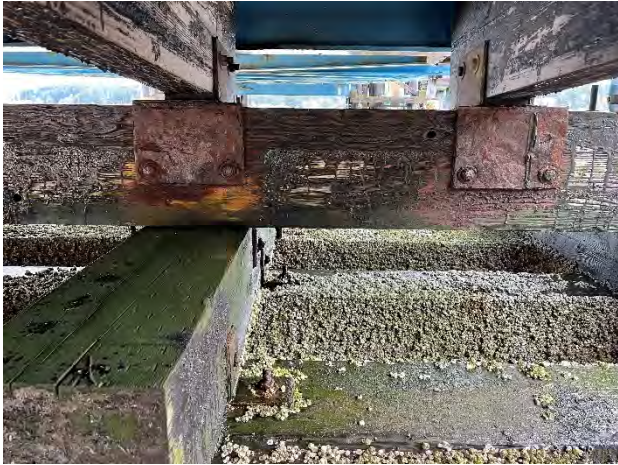
Photo 99: Heavily corroded and delaminating girder brackets

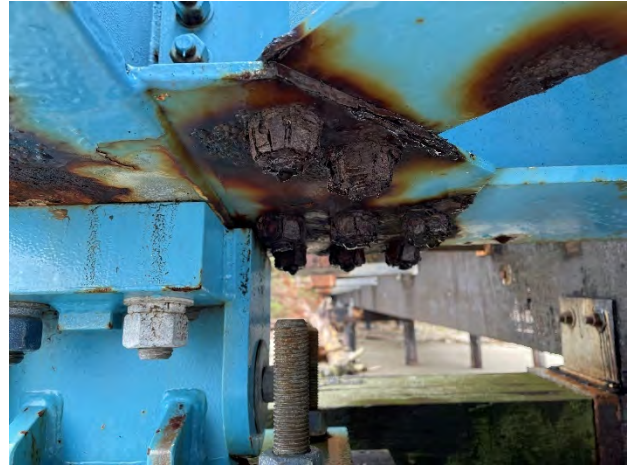
Photo 100: Heavily corroded and delaminating nuts

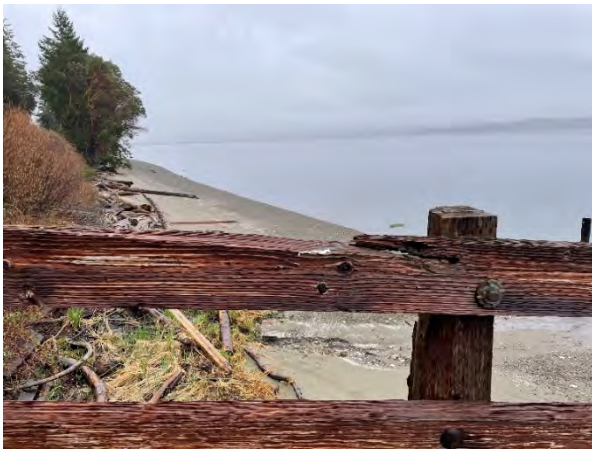
Photo 101: Timber guard rail splitting

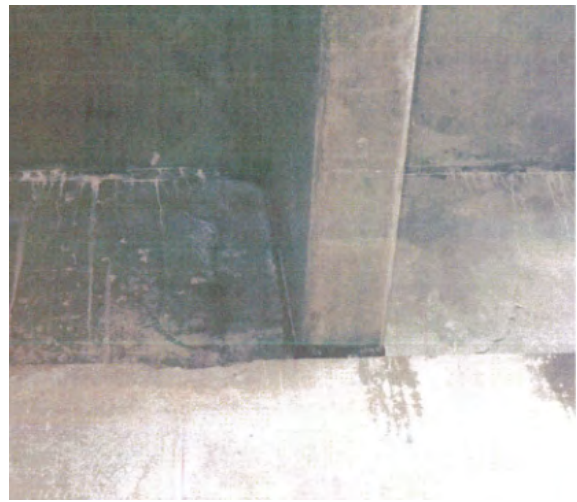
Photo 105: Pier 2 end diaphragm has delamination on the right web of Span 1

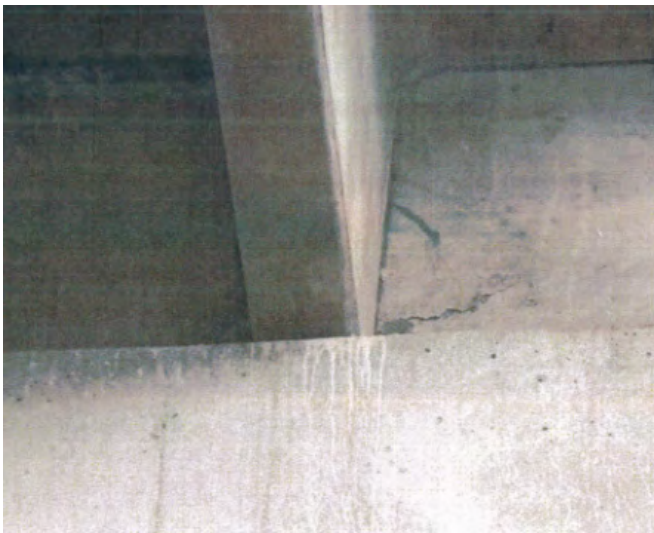
Photo 106: Pier 7 end diaphragm has delamination at the left web of Span 7

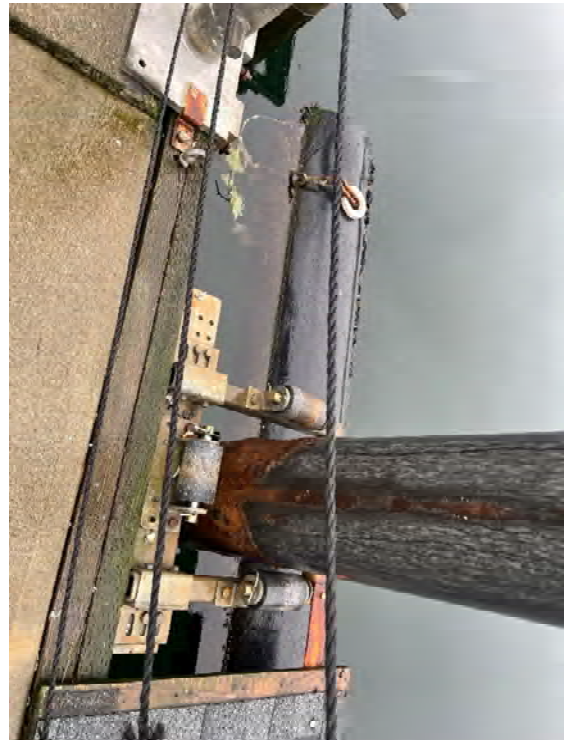
Photo 107: Panels E and F are uneven up to 1"

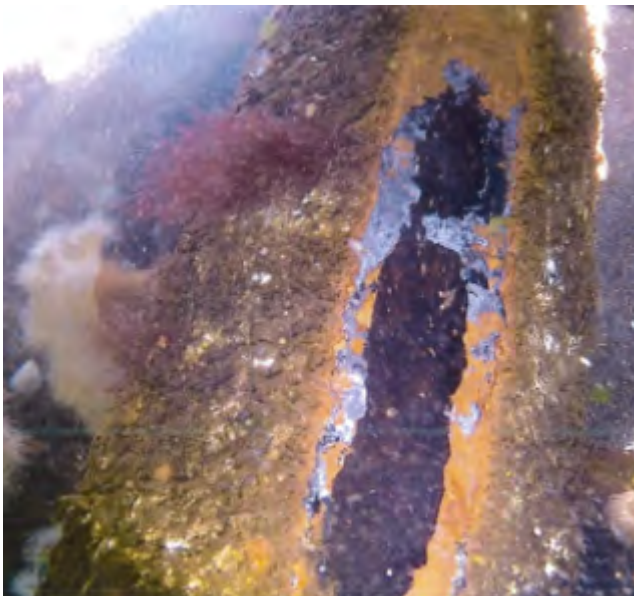
Photo 110: Pile A, 18" H x 4" W hole from mechanical abrasion

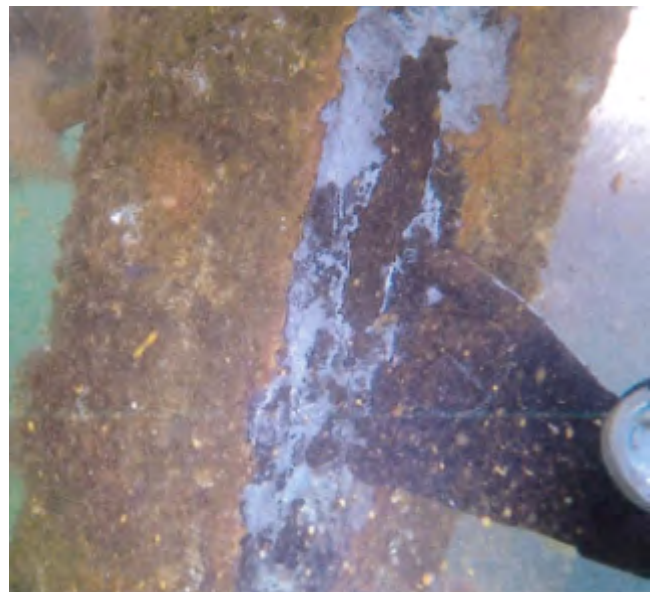
Photo 111: Pile J, 12" H x 2.5" W hole from mechanical abrasion

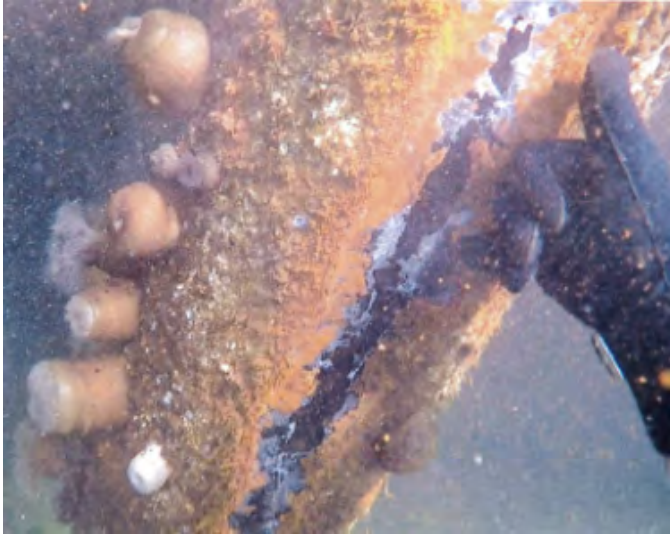
Photo 111: Pile O, 18" H x 4" W hole from mechanical abrasion

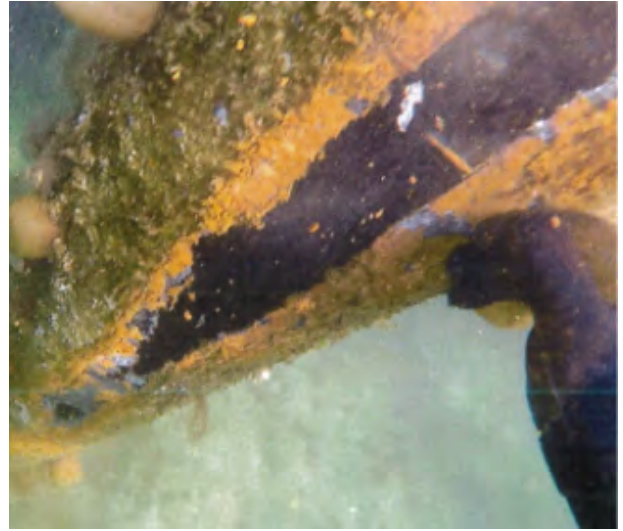
Photo 112: Pile P, 3 ft vertical hole from mechanical abrasion

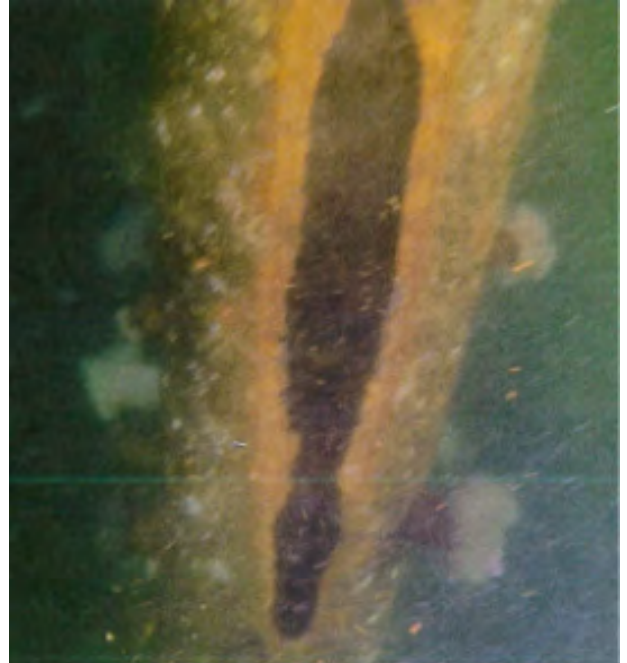
Photo 114: Pile D, 4" W x 36" H hole from mechanical abrasion

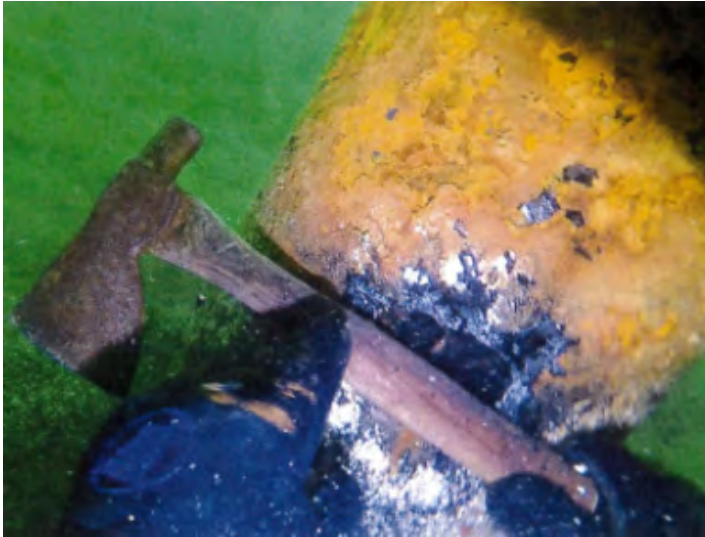
Photo 115A: Pile D, 5" W x 2" H hole

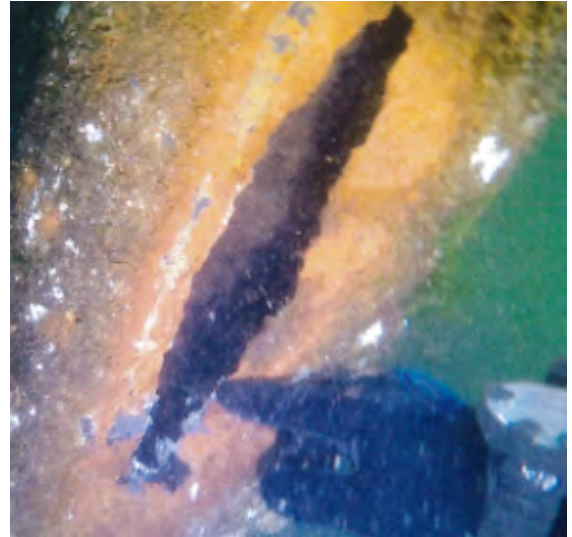
Photo 115B: Pile E, 2" W x 18" H hole from mechanical abrasion

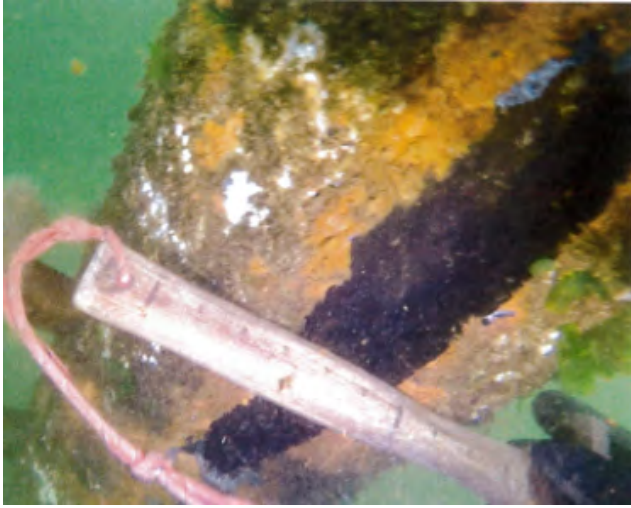
Photo 118: Pile J, 3" W x 18" H hole from mechanical abrasion

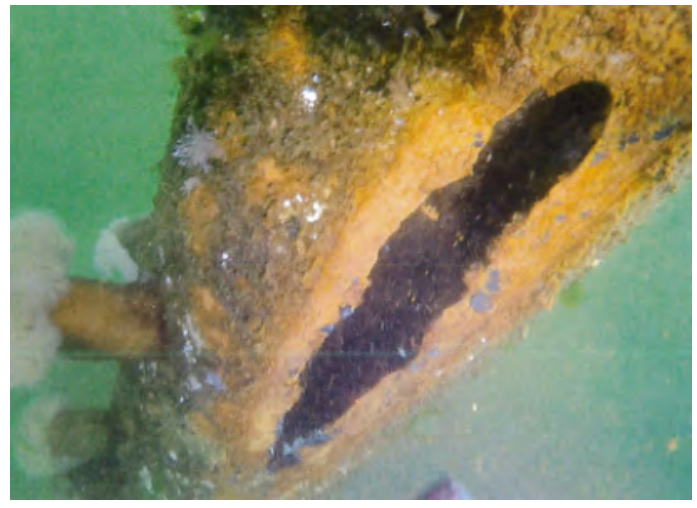
Photo 119: Pile L, 3" W x 24" H hole from mechanical abrasion

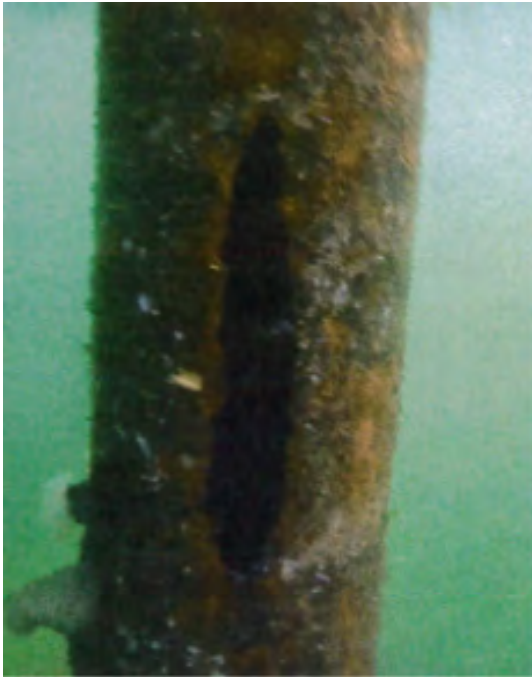
Photo 120: Pile O, 4" W x 24" H hole from mechanical abrasion

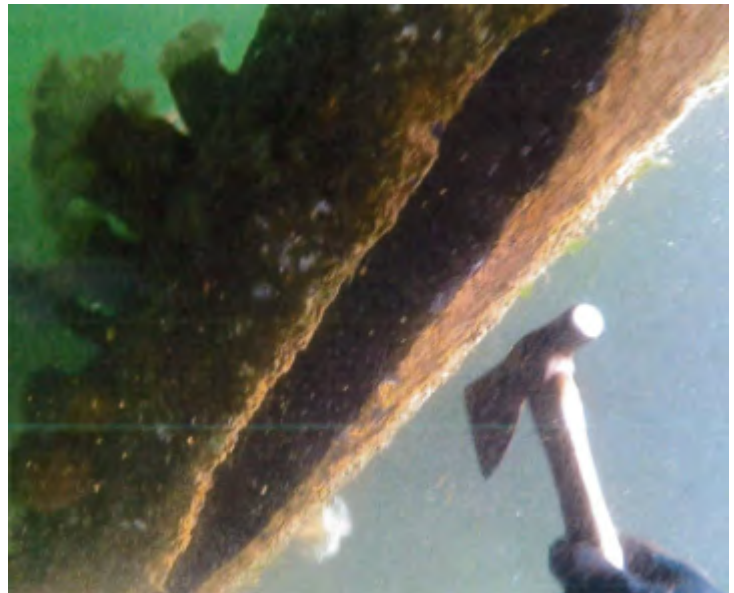
Photo 121: Pile P, 5" W x 54" H hole from mechanical abrasion

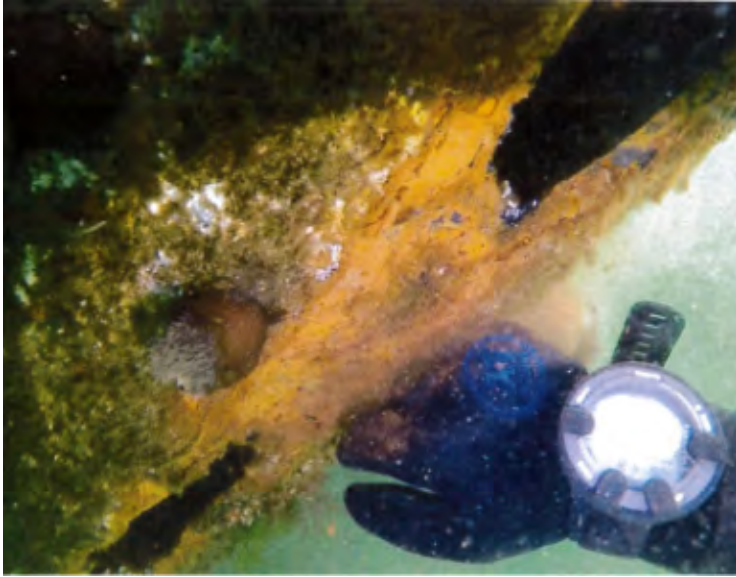
Photo 122: Pile V, 4" W x 24" H hole and 3" W x 14" H hole from mechanical abrasion

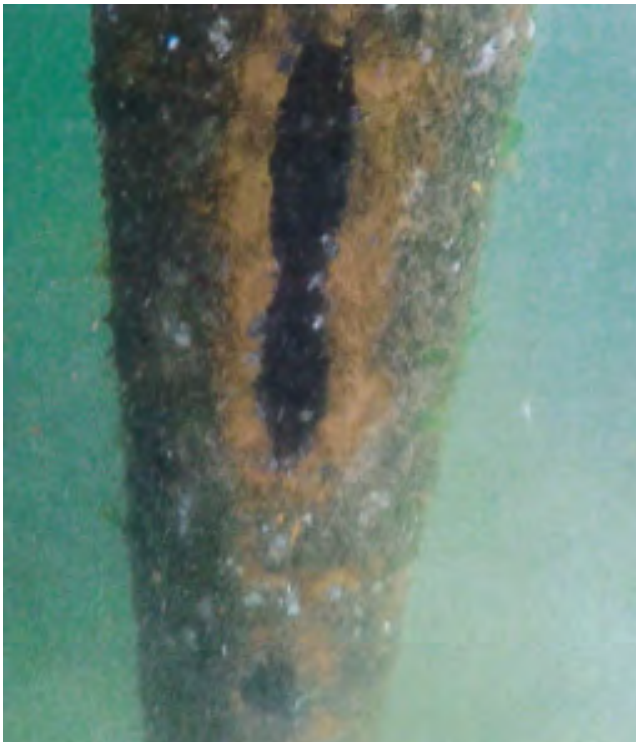
Photo 124: Pile Y, 3" W x 18" H hole and 3" W x 6" H hole from mechanical abrasion

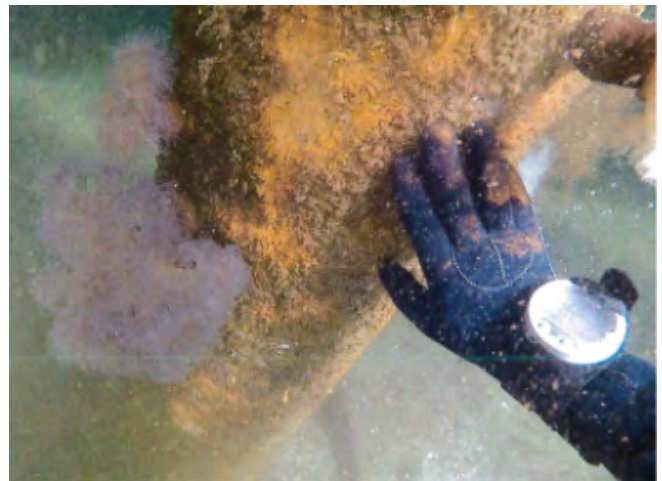
Photo 125: Typical pile condition underwater, 25%-50% coating failure and surface corrosion

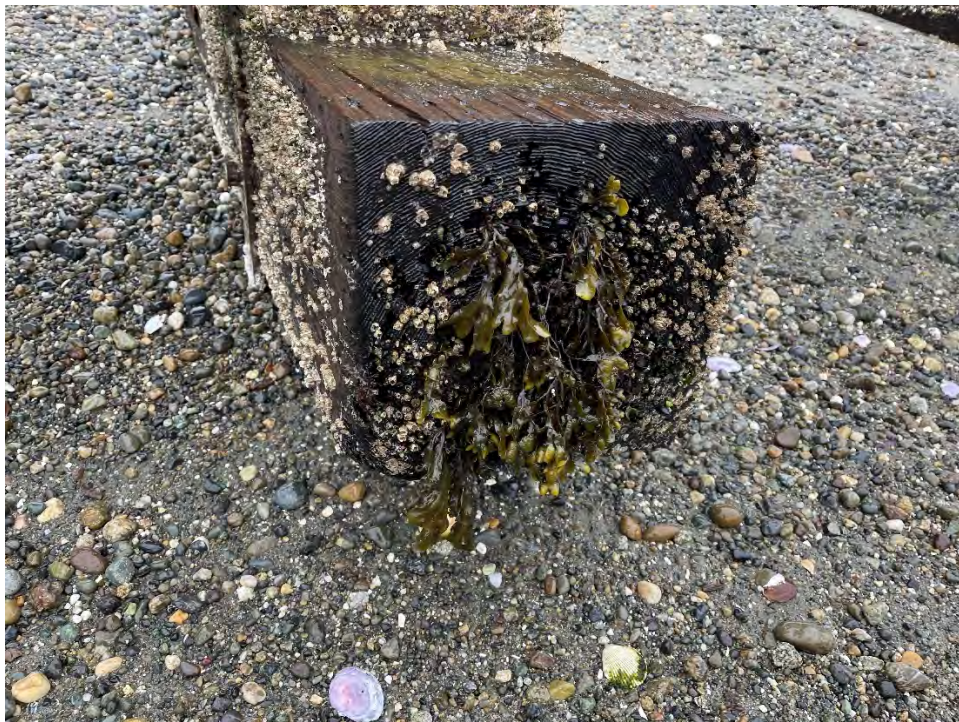
Photo 143: 17<sup>th</sup> pile cap with early stages of hollowing

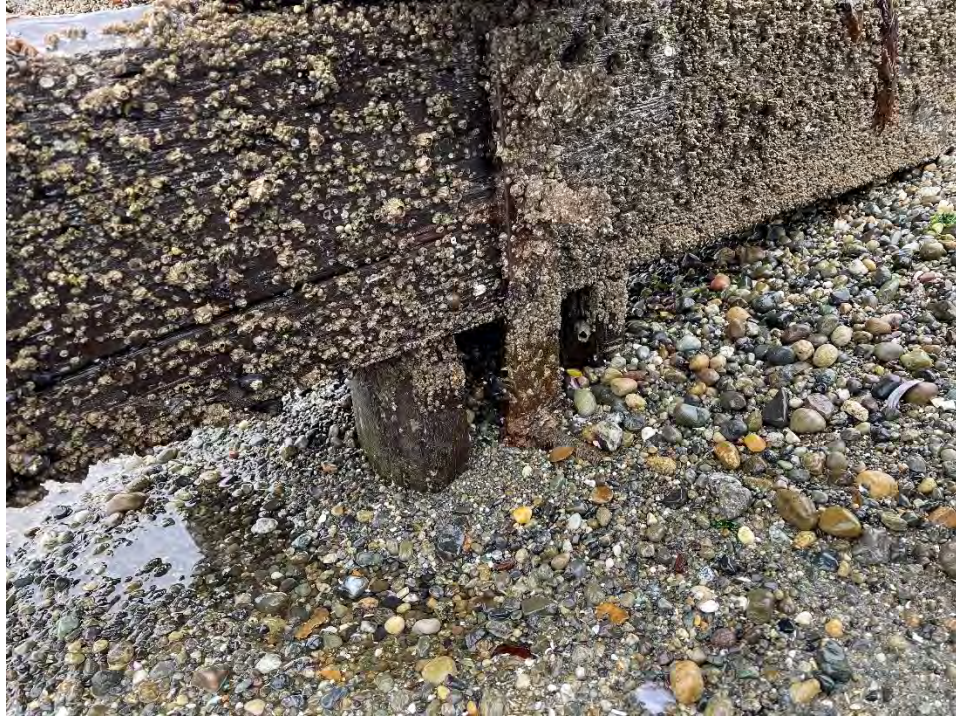
Photo 144: Pile 6A, hollowing around pile cap fastener

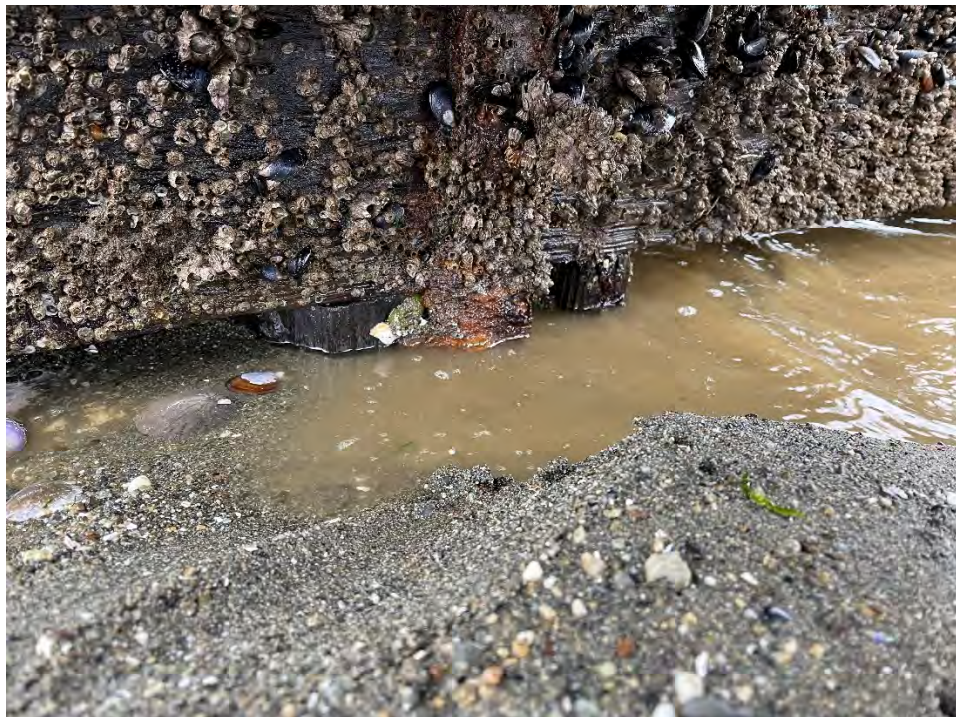
Photo 145: Pile 9A, hollowing around pile cap fastener

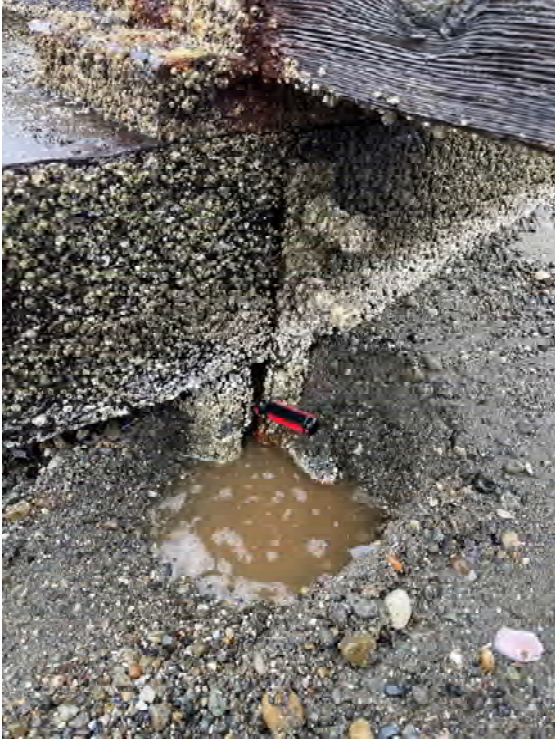
Photo 146: Pile 10B, hollowing around pile cap fastener

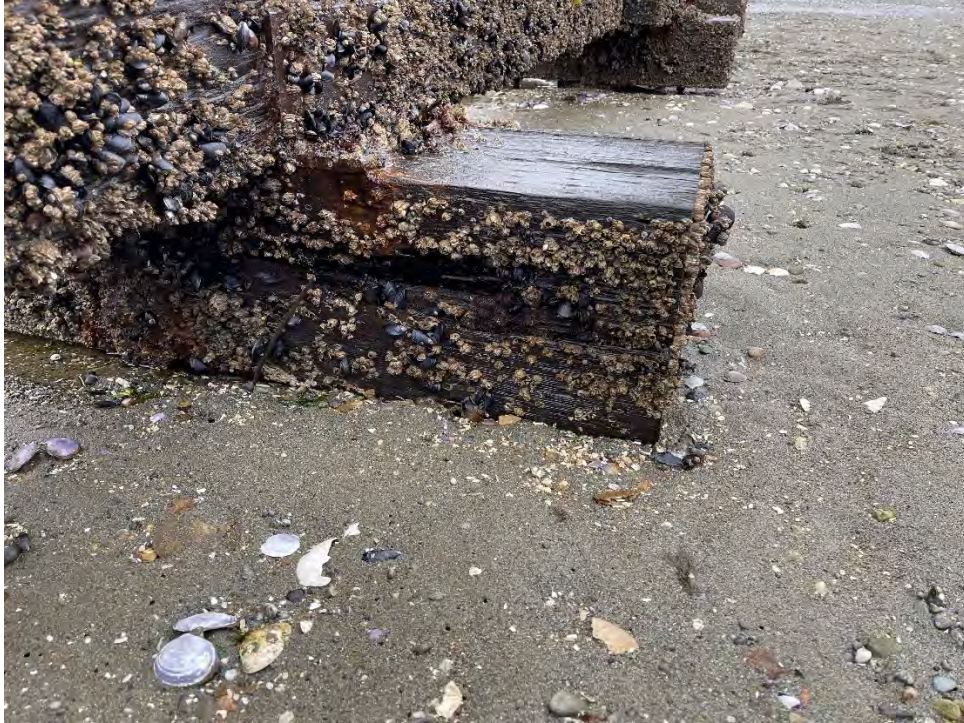
Photo 150: 16<sup>th</sup> pile cap with hollowing

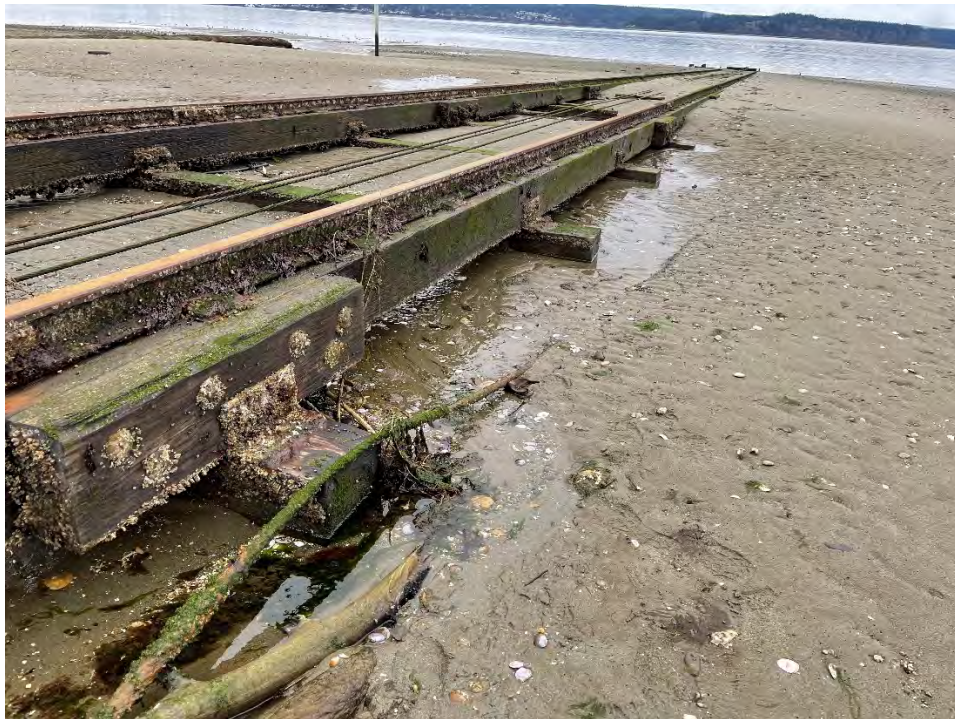
Photo 151: Timber rail splice beam with heavy marine growth
