# McNeil Island Repair and Replacement Options 10182200022

Prepared by KPFF Consulting Engineers  
Draft Repair and Replacement Options  
June 30, 2022

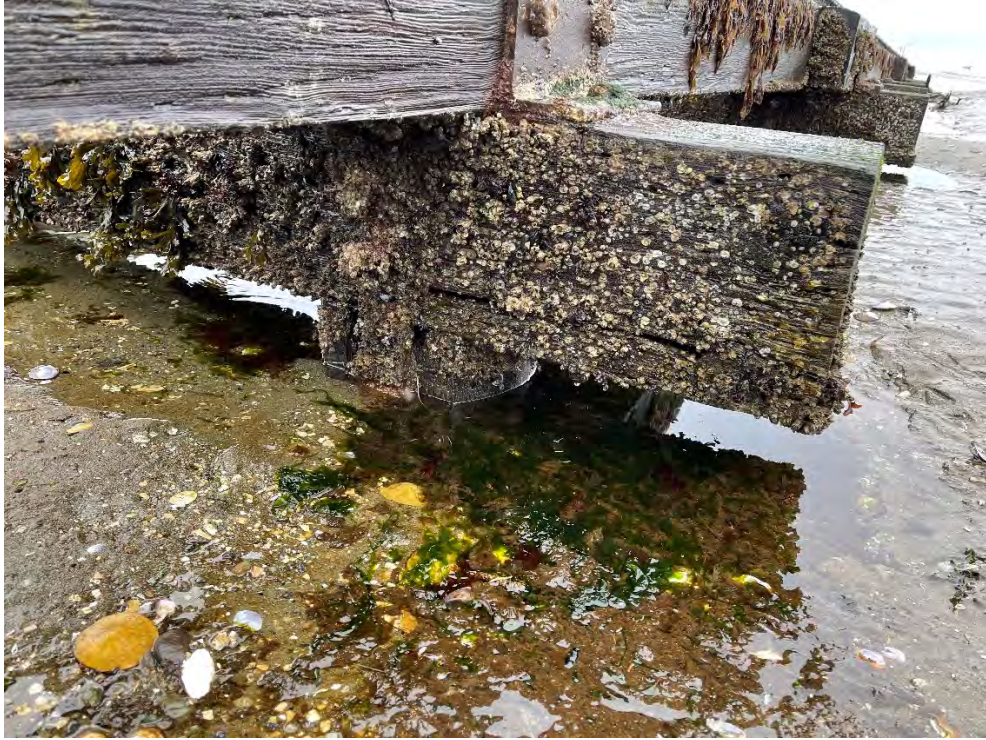
Photo 152: Pile 8B, early stages of hollowing

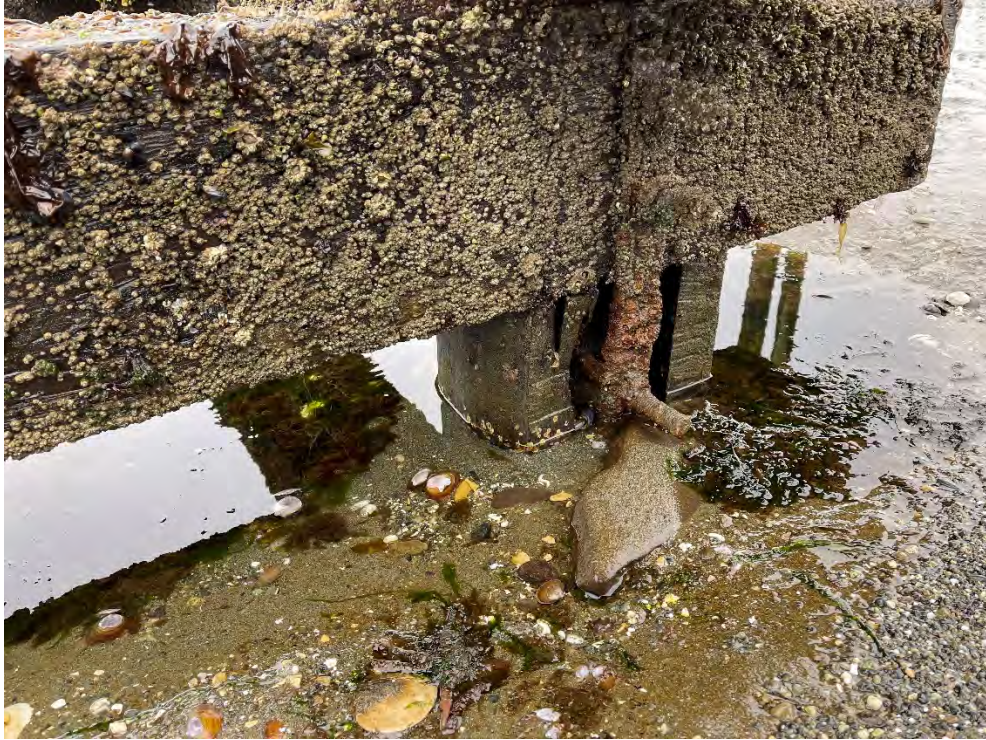
Photo 153: Pile 12A, hollowing around pile cap fastener

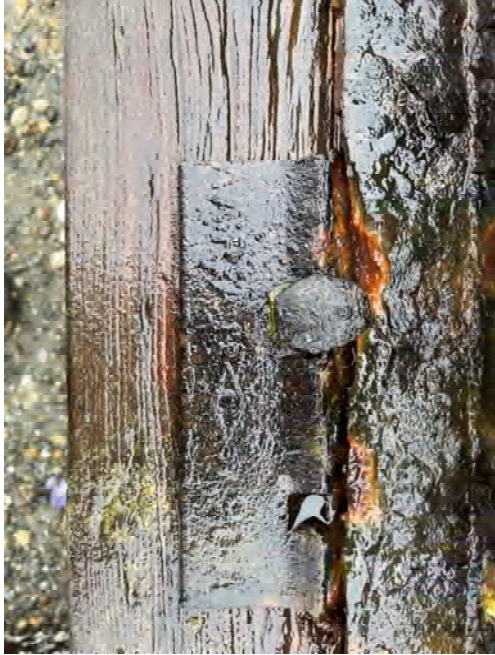
Photo 169: Rail clip and rail near bulkhead burning up

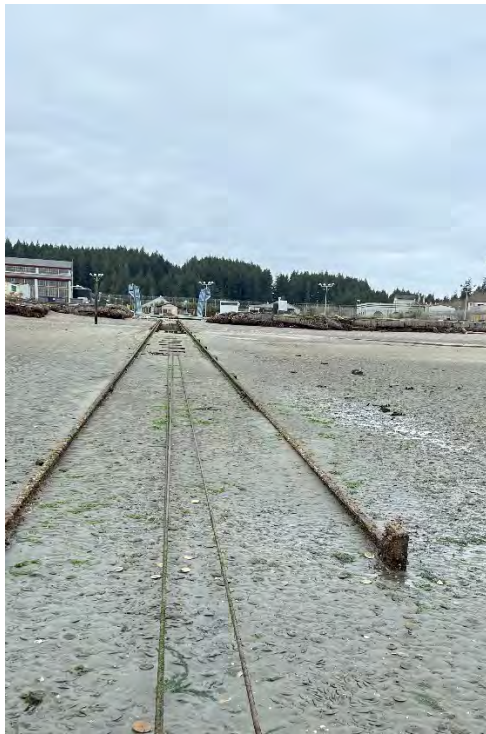
Photo 171: Buried members on Southern section of rail system

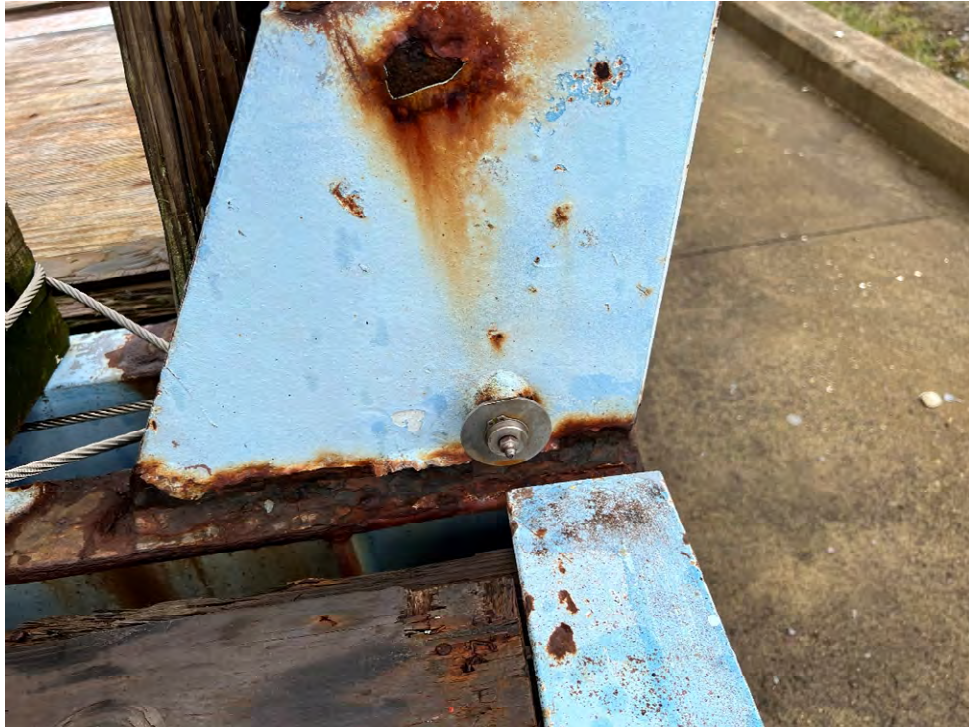
Photo 193: Bilge block wire rope

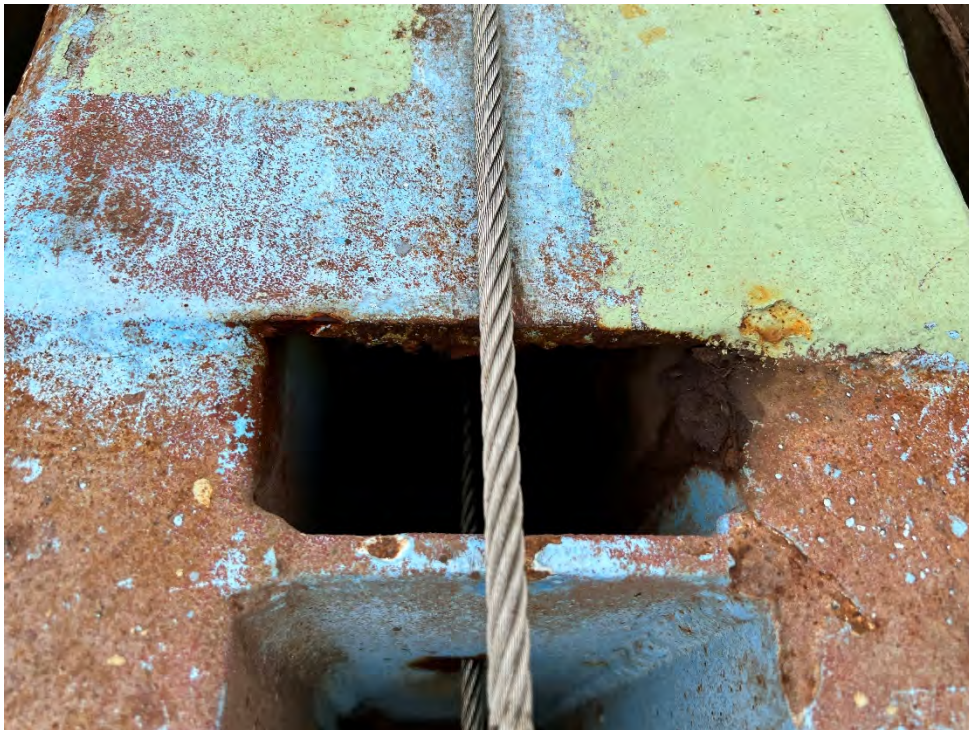
Photo 194: Base of column on cradle
