**Project 2020-148**  
**Pierce College, Puyallup STEM Building**

**Geotechnical Engineering Services Report**

Pierce College Puyallup – STEM Building Design Study  
Puyallup, Washington

**File No. 21342-002-00**

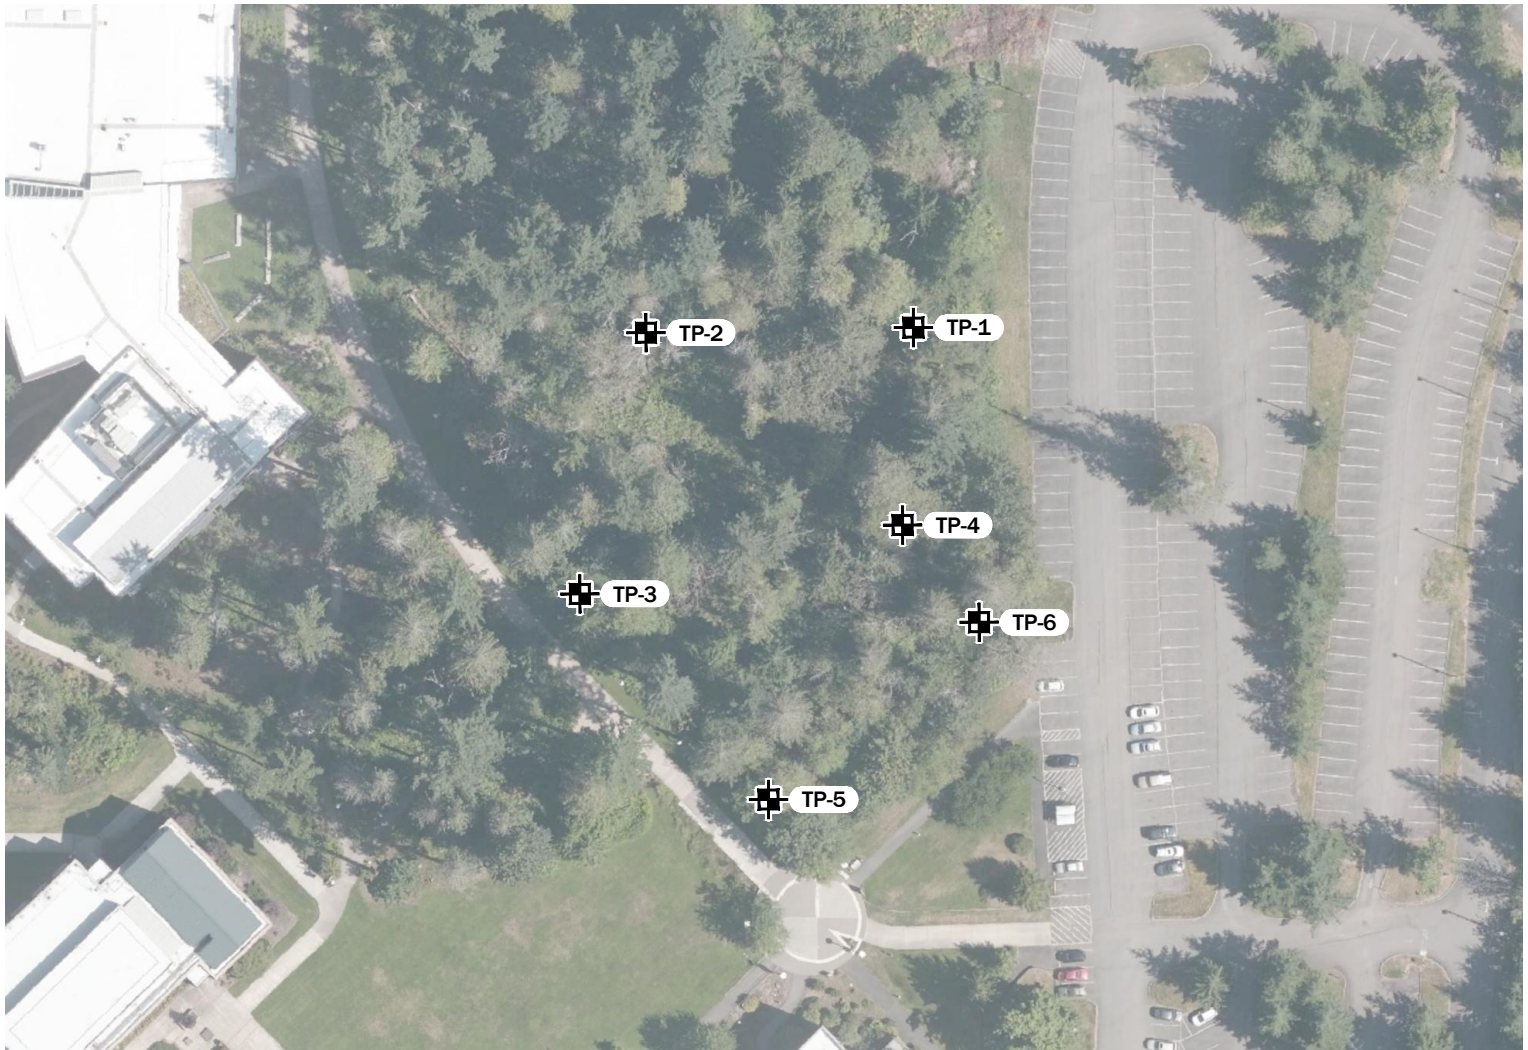
**Legend**  
TP-1

We explored subsurface conditions at the site by excavating six test pits (TP-1 through TP-6) at the approximate locations shown on the attached Site Plan, Figure 2. A description of our subsurface exploration program and summary exploration logs are provided in Appendix A.

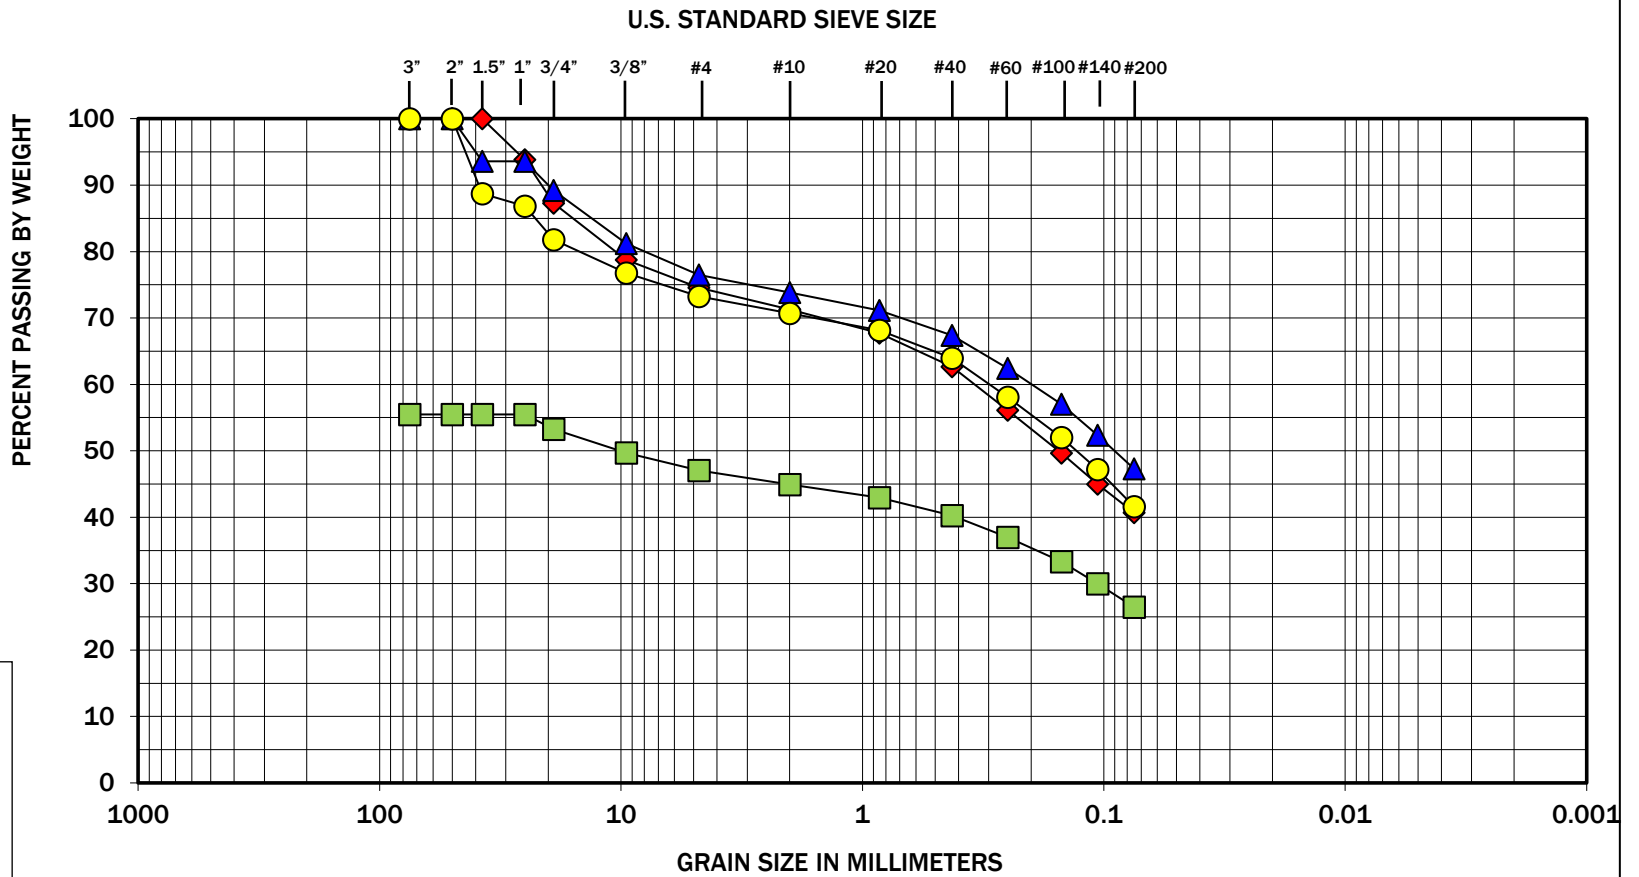
COBBLES	GRAVEL		SAND			SILT OR CLAY
	COARSE	FINE	COARSE	MEDIUM	FINE

Symbol	Test Pit Number	Depth (feet)	Moisture (%)	Soil Description
◆	TP-1	5.75	15	Silty sand with gravel (SM)
■	TP-2	4.5	9	Silty gravel with sand (GM)
▲	TP-3	3.5	8	Silty sand with gravel (SM)
●	TP-6	3.5	10	Silty sand with gravel (SM)

Selected samples collected from our test pits were tested in our laboratory to confirm field classifications and to evaluate pertinent engineering properties. Our laboratory testing program included grain-size distribution analyses and moisture content determinations. A summary of our laboratory testing program and the test results are provided in Appendix A.
