Legislative Campus Modernization

PREDESIGN REPORT

STATE OF WASHINGTON
**DEPARTMENT OF ENTERPRISE
SERVICES**
PROJECT NO. 18-527

FEBRUARY 05, 2021

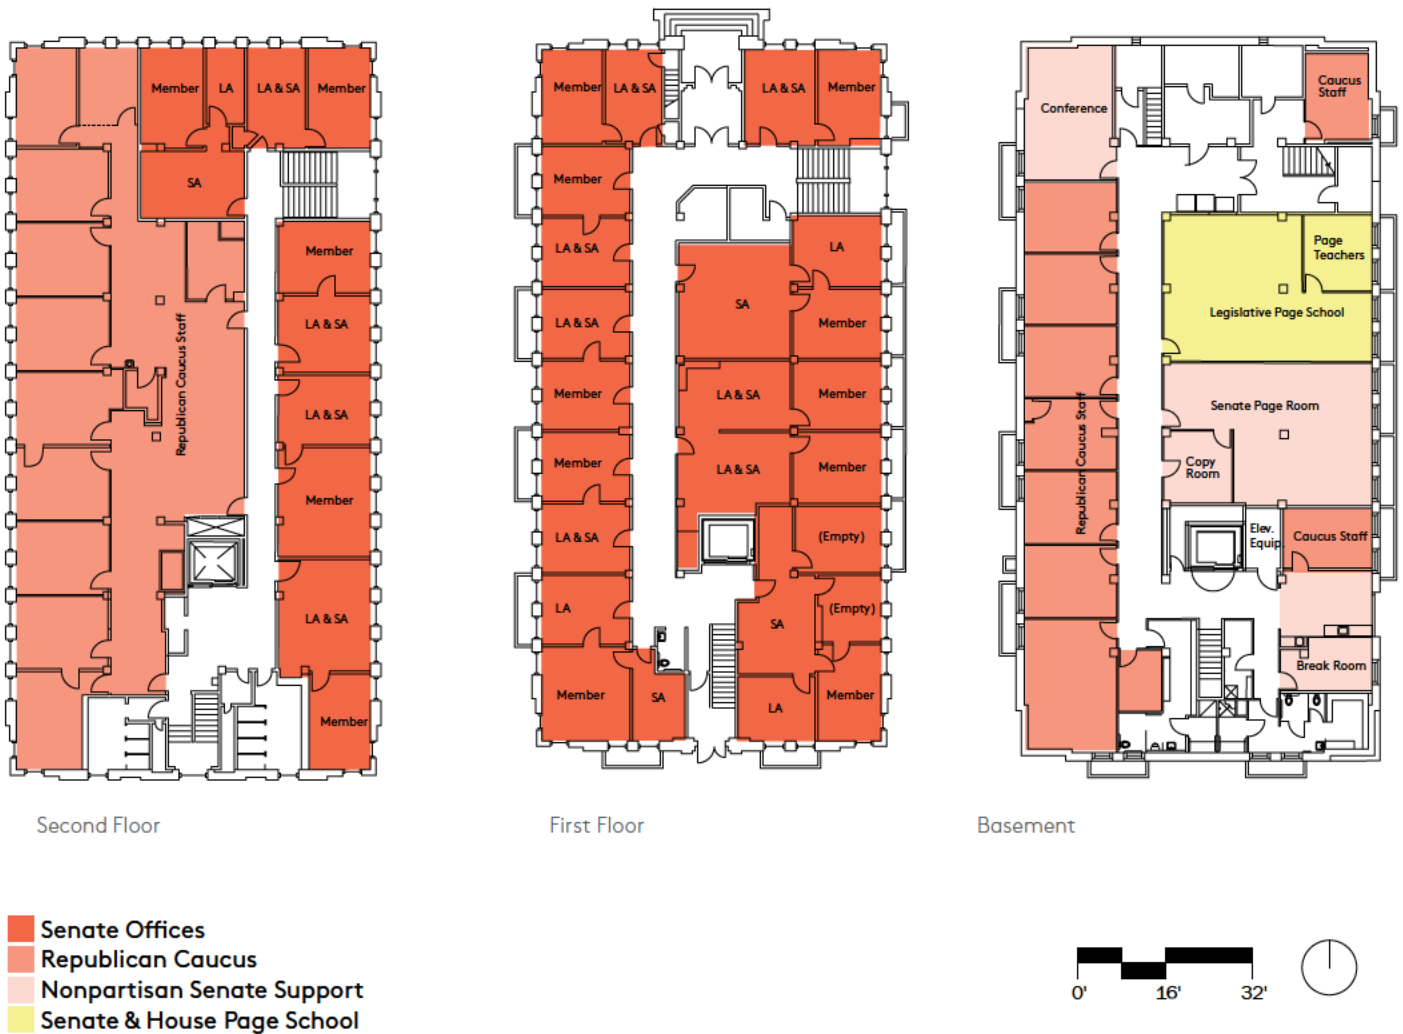
[FIGURE 03] CURRENT/EXISTING NEWHOUSE BUILDING

The structure of the floors, columns and roof is designed for live gravity loads that meet current standards. Engineering in the 1930's, however, did not include provisions for resisting the lateral forces associated with earthquakes. The structure does not have a lateral force-resisting system that would be considered adequate for major earthquakes in the Puget Sound region. The exterior walls are brick veneer supported by clay tile back up walls that were common during the early 1900's. In an earthquake the brick and clay tile walls will crack and will contribute no additional strength to the building. Plastered clay tile walls were also used for the interior partitions separating offices and in the corridors. In a major earthquake the brittle clay tile walls without internal reinforcing are likely to fall and pose life-safety risks, especially in exit corridors and stairs.

The exterior brick walls supported by clay tile infill walls are not built to contemporary standards for thermal performance or weather protection. The exterior walls are not properly insulated to meet contemporary energy codes. Contemporary standards for construction of brick veneer exterior walls acknowledge the porous nature of brick and mortar. An air space between the brick veneer and the supporting back up wall allows moisture that does get in through the brick veneer construction to find its way back out of the wall through weep holes that are integrated into the mortar joints of the brick veneer. A weather barrier on the supporting wall behind the brick veneer prevents rainwater that does get into the cavity from entering the interior construction.

The exterior construction of the Newhouse building has none of these features. As a result the exterior walls allow rainwater to leak into the interior. Over the past 20 years there have been three major repair projects

to address water damage in addition to emergency repairs. Water repellents have been applied but do not prevent water penetration through structural cracks or defects. The design flaws of the existing exterior construction cannot be remedied. A weather barrier, proper air space and weep holes can only be addressed by rebuilding the entire exterior brick veneer wall.

Mechanical, electrical and plumbing systems do not meet code. Ad hoc HVAC systems simultaneously heat and cool, increasing energy use and decreasing occupancy comfort. The domestic water piping is corroded. Sanitary sewer piping is combined with the storm water system. Sewer gas backs up through abandoned fixtures adversely affecting indoor air quality. Storm water backs up causing the lower level

to flood. Water infiltrating exterior walls creates a life safety issue for electrical wiring and devices. The fire alarm system is inadequate and constitutes a life safety hazard. Physical security measures are inadequate and do not meet current industry standards.

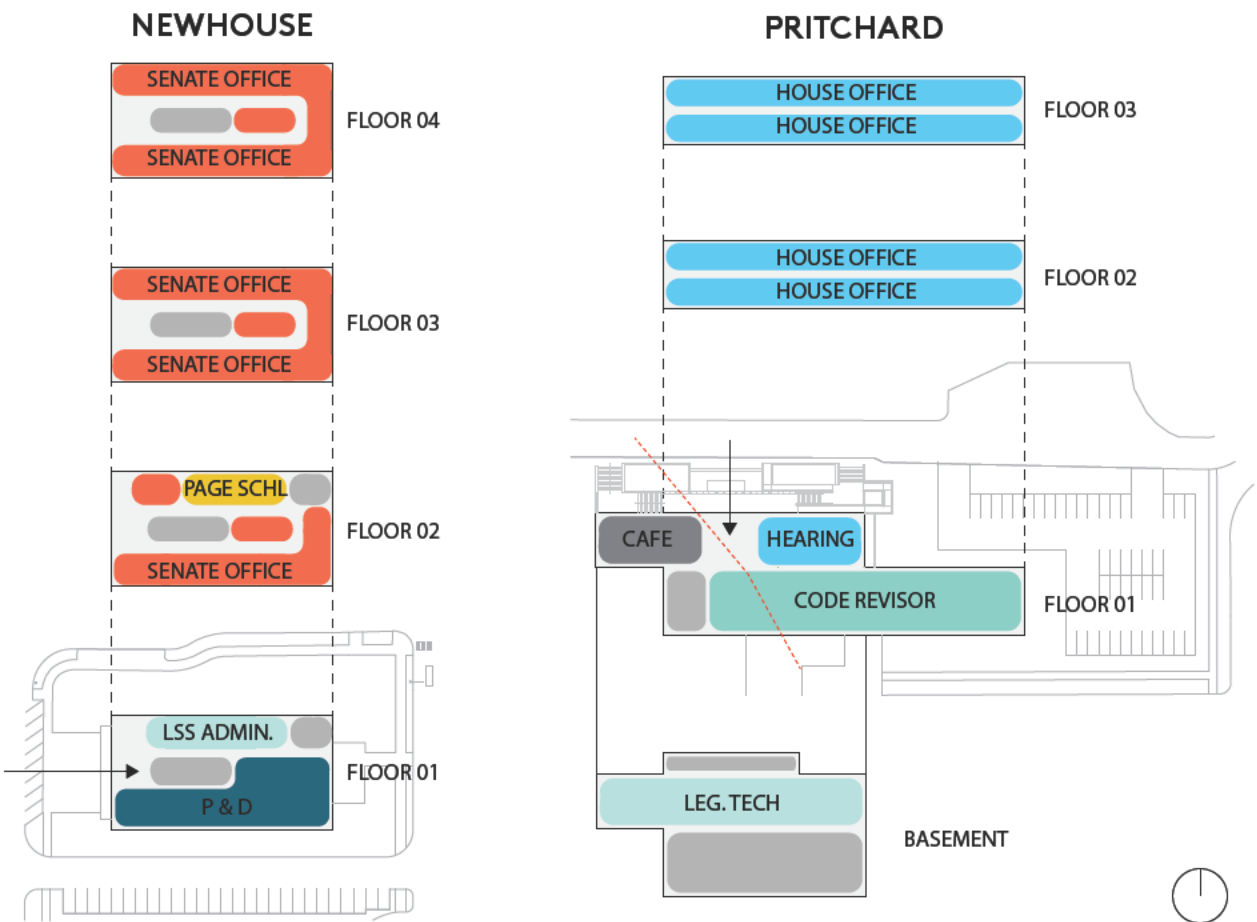
[FIGURE 15] OPTION A.2

Option A.2 adds a fourth floor to the Newhouse building, matching the height of the Cherberg and O'Brien buildings. The upper two floors have Senate office and other Senate spaces, the second floor has Senate space and the Page School, and the ground floor has Production and Design and LSS administrative spaces. The LSS administrative program is accommodated in this option, allowing for space in the Legislative Building for the press.

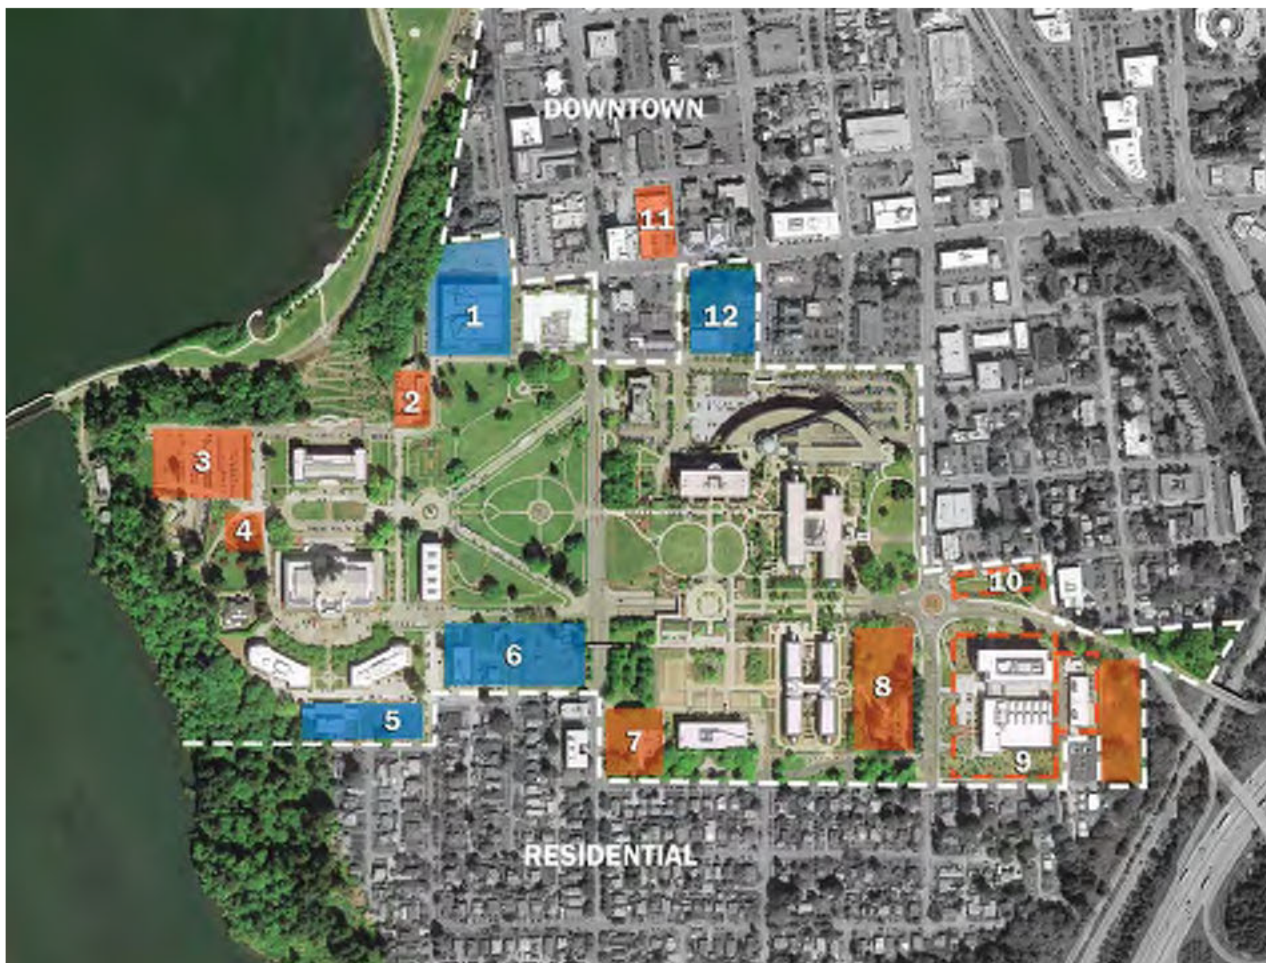
[FIGURE 40] 2017 DEVELOPMENT STUDY OPPORTUNITY SITES

The Master Plan for the Capitol of the State of Washington (2006) provides an overall vision for the campus. It describes this site as a transition from the great central campus lawn to the downtown urban core. Another resource guiding campus development is the State Capitol Development Study (2017), which identifies specific opportunity sites and examines their development potential. The site for the Pritchard building is identified as Opportunity Site Five (5) and for Newhouse as Opportunity Site (6) in the 2017 Study.

- PREDESIGN OPPORTUNITY SITES
- OTHER OPPORTUNITY SITES

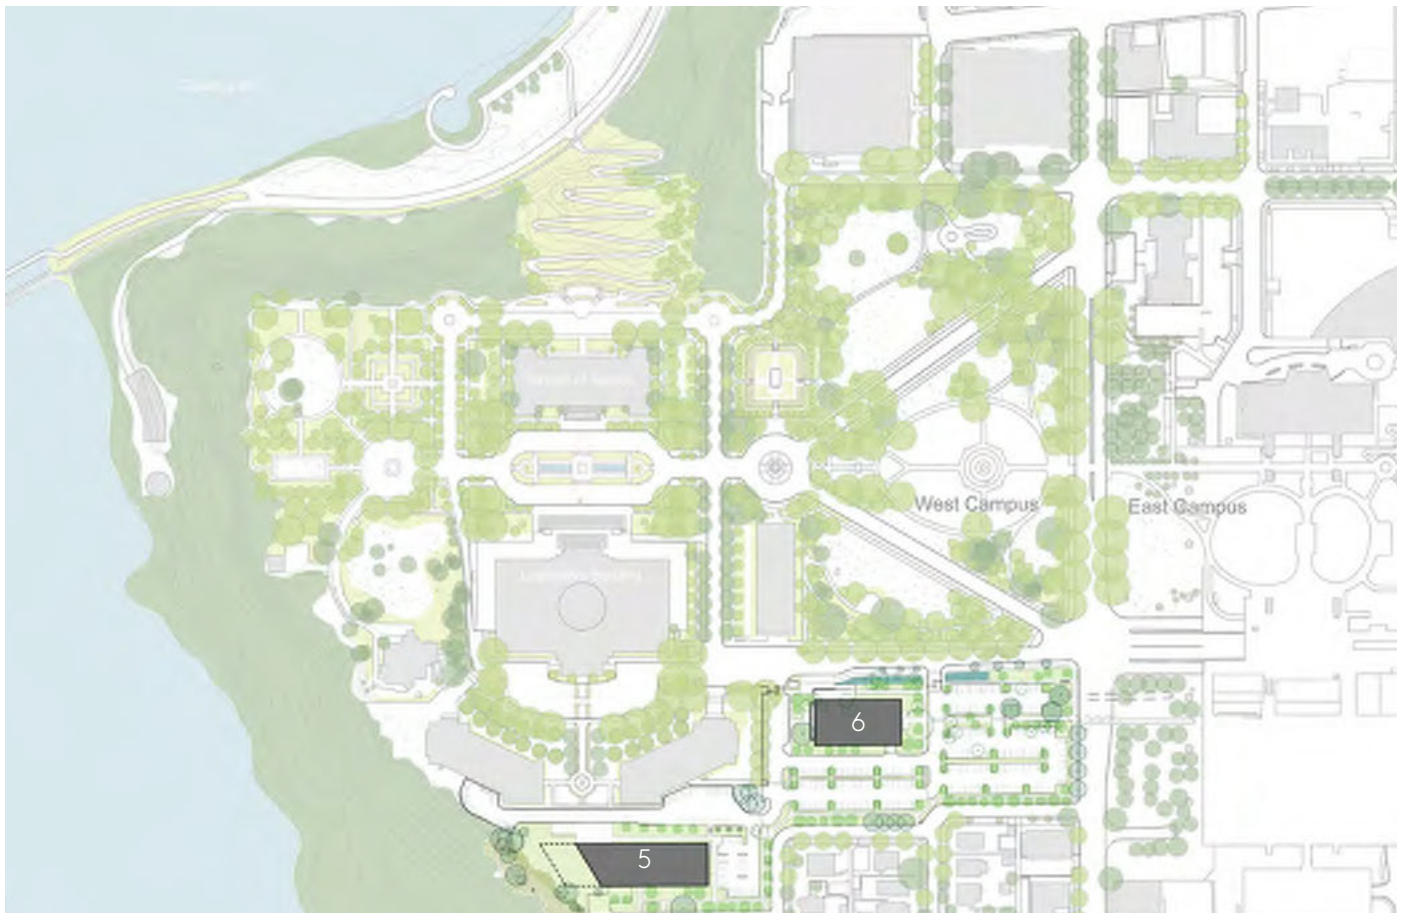
[FIGURE 41] PRITCHARD AND NEWHOUSE LOCATIONS

The Newhouse Building and Press Houses are eligible for the National Register of Historic Places but have not been nominated for listing. The Newhouse building is a health and life safety hazard and is not suitable for occupancy. Any improvements that extend the life of the building will trigger requirements to bring the entire building up to code. The Press Houses and Visitor Information Center do not serve their functions adequately.

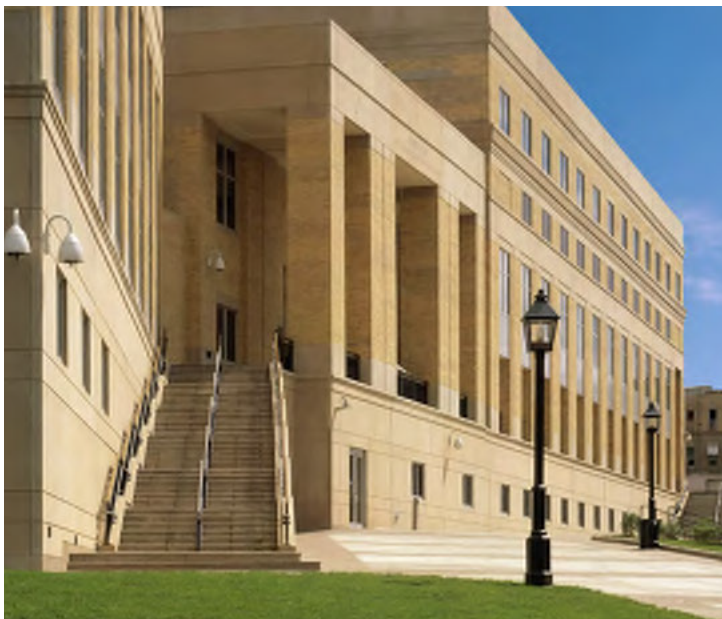
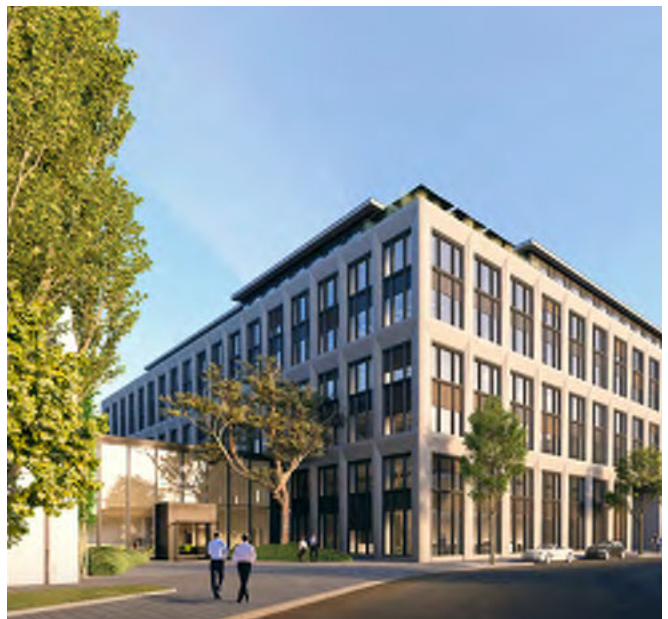
[FIGURE 48] LEFT: ROBERT C. BYRD FEDERAL BUILDING (RAMSA); RIGHT: OFFICE BUILDING (CHIPPERFIELD)

Considering these guidelines in the context of Washington's Capitol Campus, the project budget includes money to be applied towards enhanced depths and detailing of the facades of the replacement Newhouse and Pritchard buildings to appropriately fit into the vocabulary of the historic buildings without replicating them exactly. Themes such as base-shaft-capital expression across the building and depth and relief in the facade that are common in American Neoclassical designs can be included without relying on specific classical elements such as pediments, columns or capitals. Examples of this intent can be seen in the civic buildings pictured in Figure 48: the Robert C. Byrd Federal Building and Courthouse by Ramsa and the office building in Munich by David Chipperfield Architects.

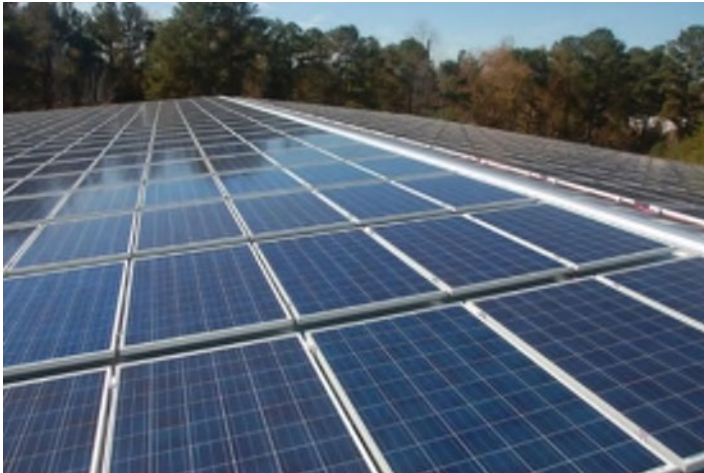
Figure 3: Rooftop Solar with Minimal Spacing

Rooftop PV systems can be optimized during design by eliminating the need for clearance between rows. This can be achieved by sloping the roof slightly (5-10 degree) to allow for the panels to lay flat on the surface.

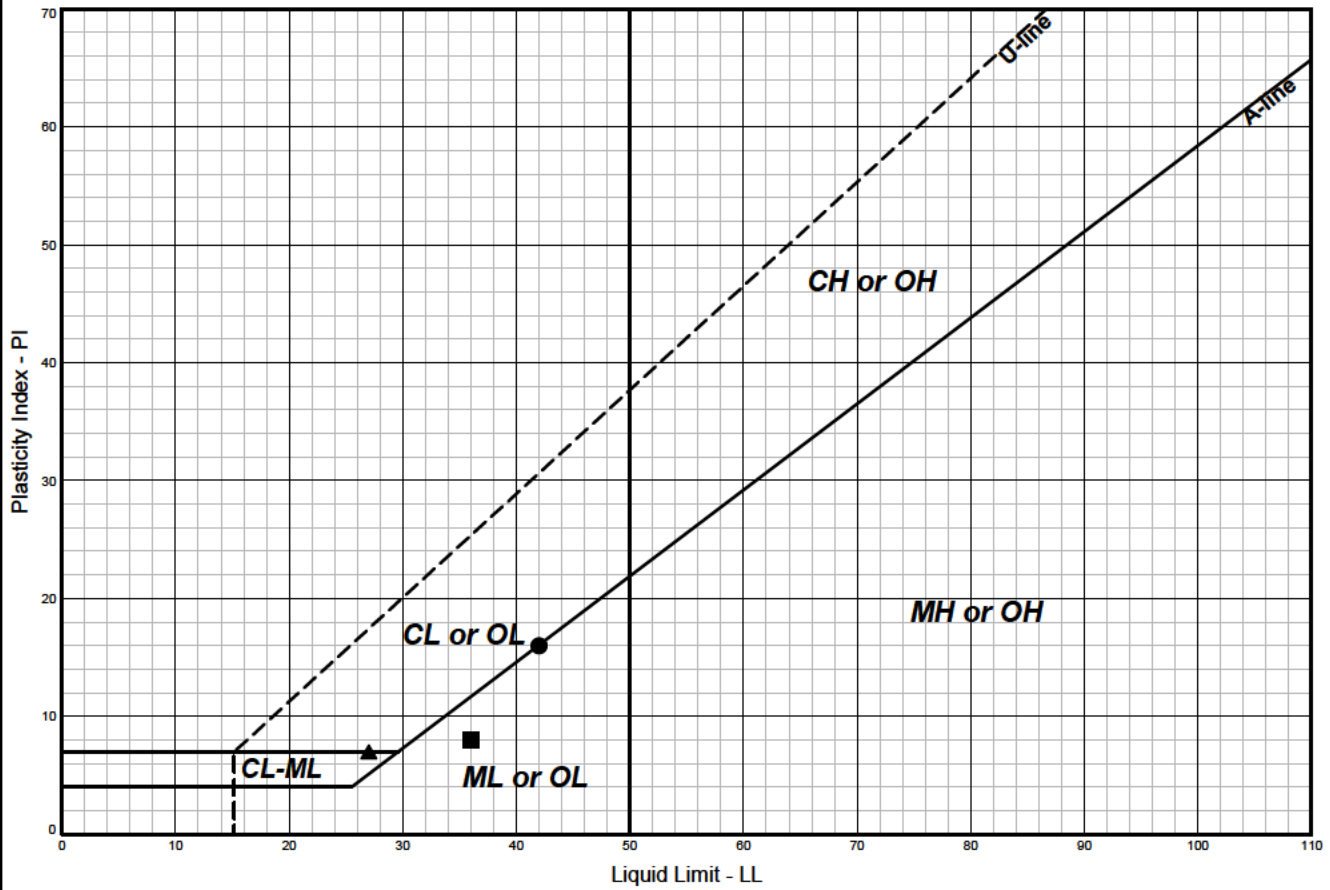
BORING SW-1

Sample Identification	Depth (ft)	USCS Group Symbol	USCS Group Name	LL	PL	PI	WC %	Gravel %	Sand %	Fines %	< 2µm %	Tested By	Review By	ASTM Std.
● SW-1, S-6A	15.0	ML	Silt	42	26	16	48.9					MRH		D4318
■ SW-1, S-7	17.5	ML	Silt	36	28	8	40.1					MRH		D4318
▲ SW-1, S-13	45.0	CL-ML	Silty Clay	27	20	7	25.6	3	11	86		AKV		D4318

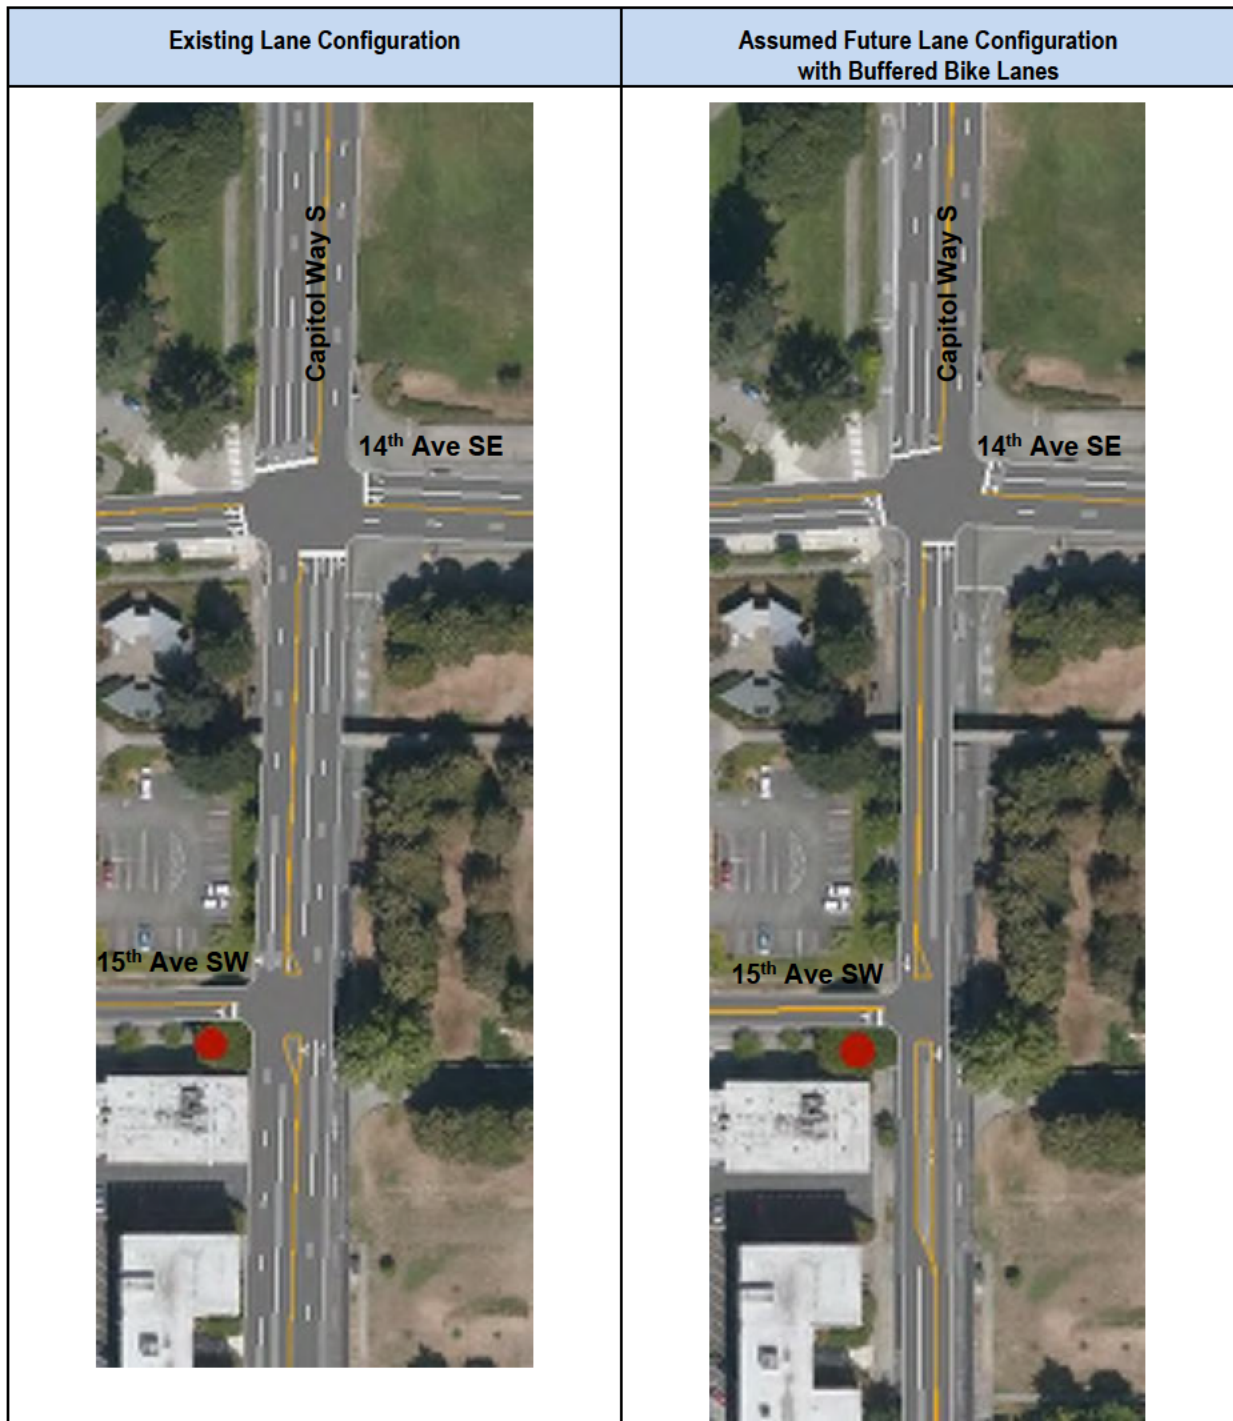
Figure 7. Existing and Assumed Future Geometry at Capitol Way S/14th Ave SW Intersection

Source: Images from Synchro files. It is noted that auxiliary movements such as those to and from the Plaza Garage on 14th Avenue SE are not shown, but were accounted for in the model.

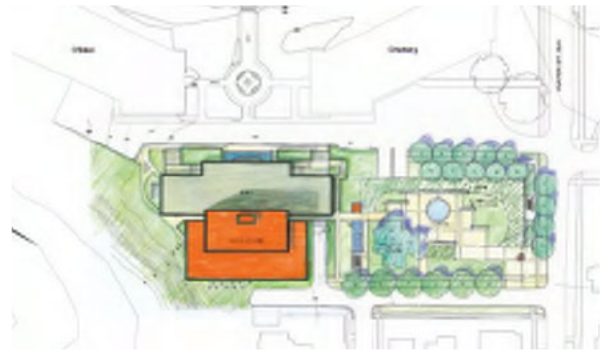
FIGURE 3-3 2006 PREDESIGN

Study to adapt the building for use as legislative offices and a cafeteria, and build below grade parking with a plaza on the adjacent surface parking lot. Multiple options were evaluated. The preferred alternative was:

- 63,290 gross square foot renovation/addition with below grade, 210 car garage.
- Lack of adaptability in the existing configuration of the building resulted in very high project costs.

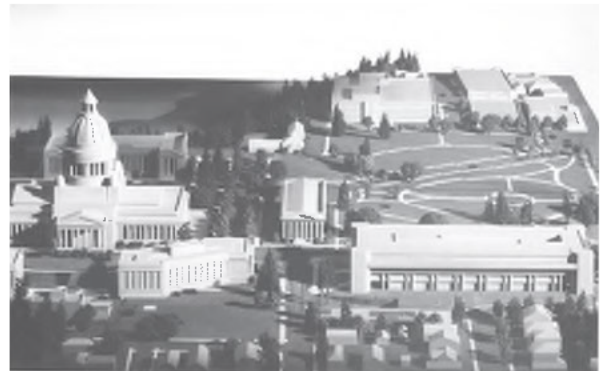
FIGURE 3-5 1974: EXECUTIVE OFFICE BUILDING

Detailed design for 291,691 gross square foot Executive Office Building with below grade parking with 568 stalls. The proposal vacated Columbia Street.
