# McNeil Island Repair and Replacement Options 10182200022

Prepared by KPFF Consulting Engineers  
Draft Repair and Replacement Options  
June 30, 2022

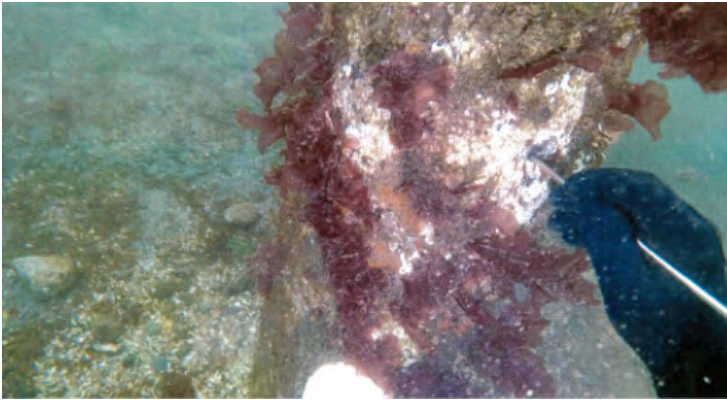
Photo 12: Pile 3B two marine borer entries (MBE)

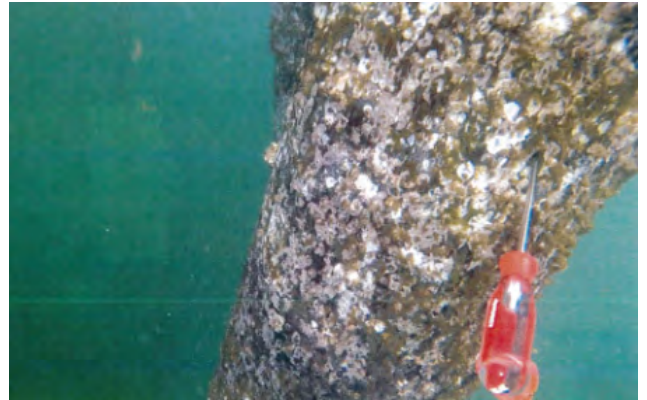
Photo 13: Pile 7.1H marine borer entry (MBE)

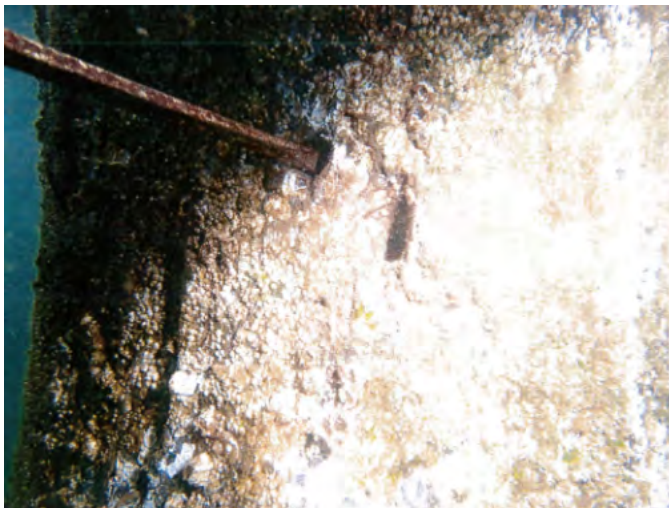
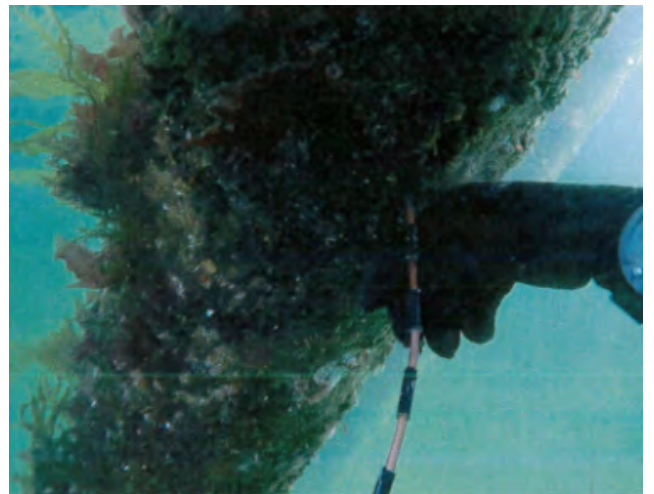
Photo 14: Pile 9B 3 marine borer entry (MBE) holes

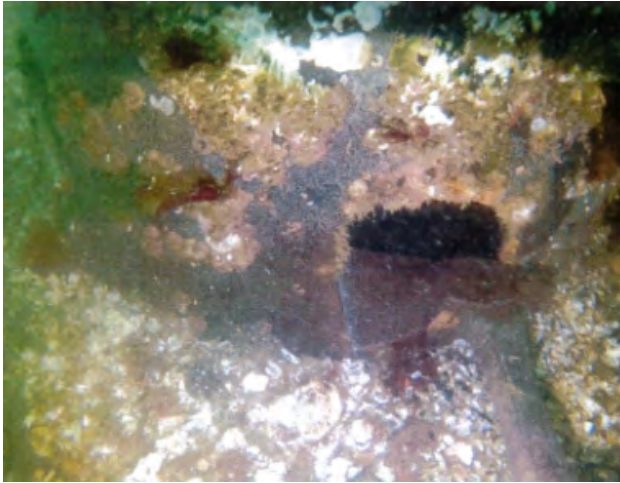
Photo 35: SP1-D holed through

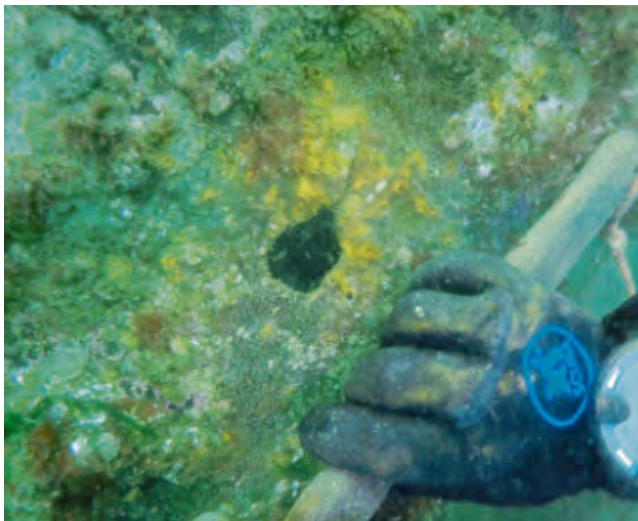
Photo 37: SP3-B holed through

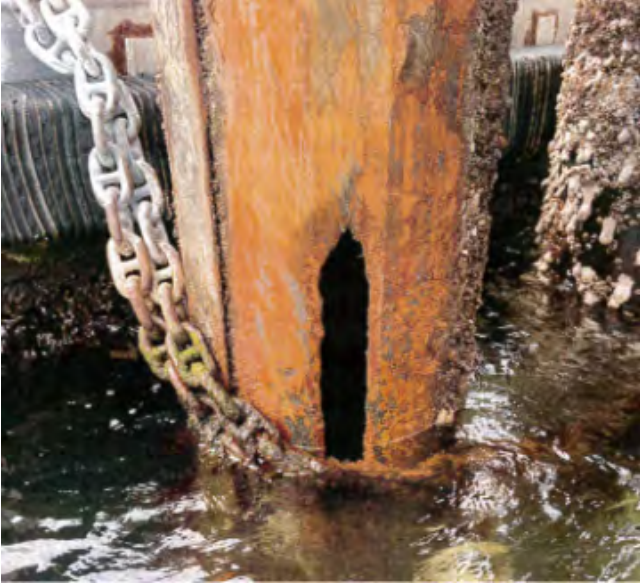
Photo 39: SP4-A holed through

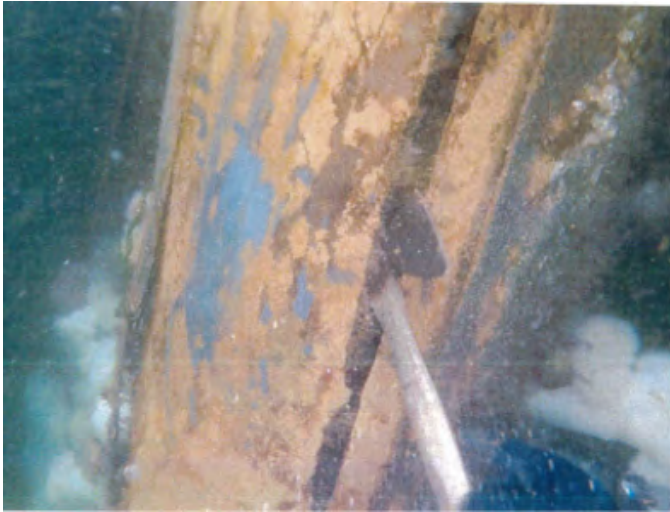
Photo 43: SP1-A holed through

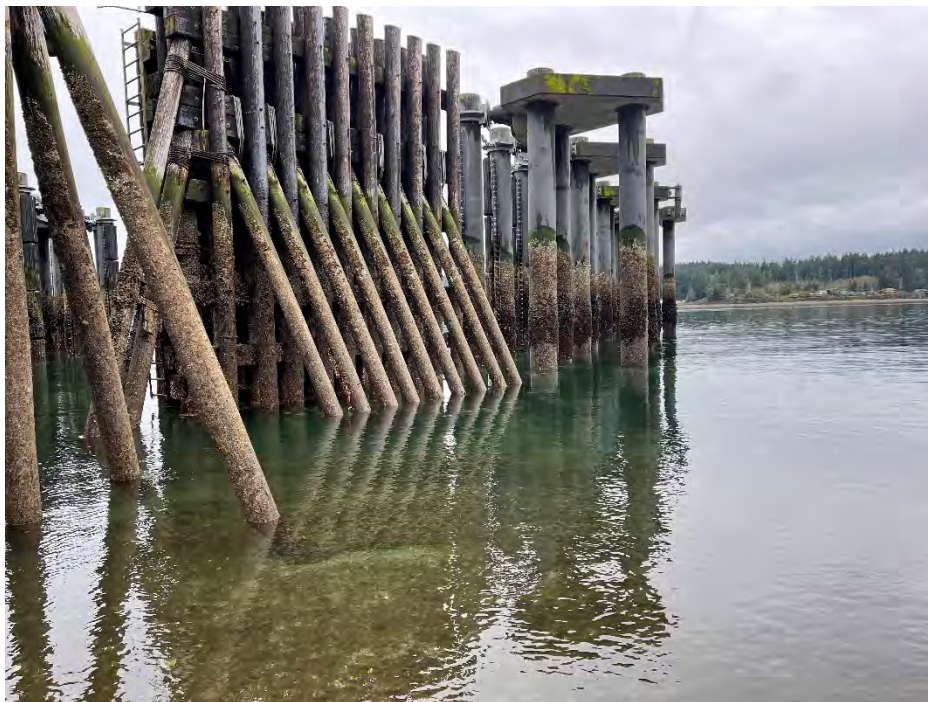
Photo 90: Right wingwall

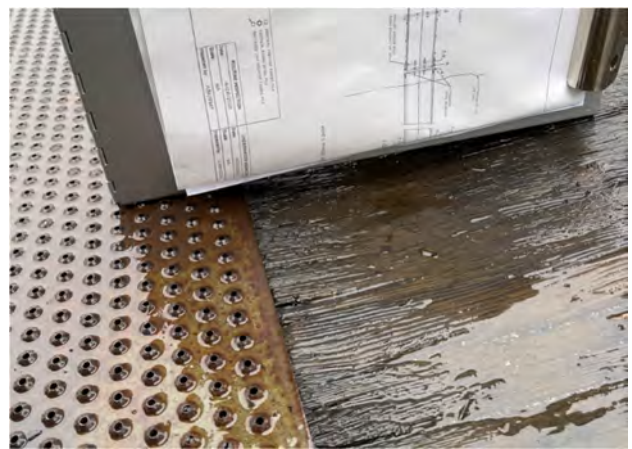
Photo 102: 0.625" deep rutting

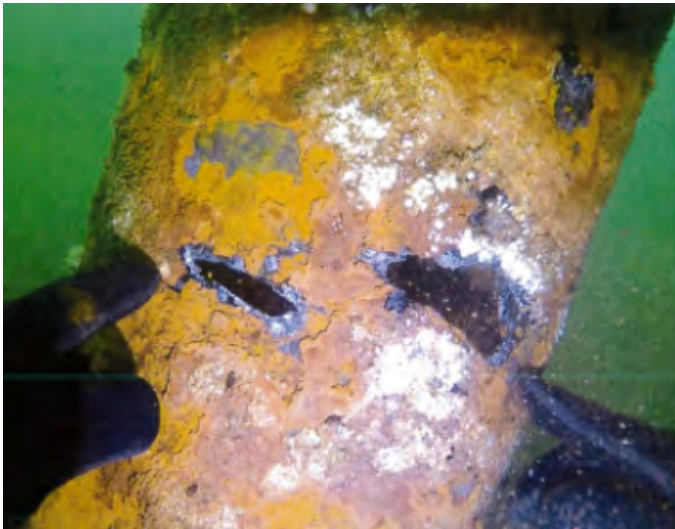
Photo 116: Pile E, 4.5" W x 1.5" H hole and 3.5" W x 0.75" H hole
